**RE: TREE CONSERVATION REPORT FOR 3996 INNES ROAD**

This report details a pre-construction tree conservation report (TCR) for the above-noted property in Ottawa. The need for this TCR is related to the proposed redevelopment of the subject property. Trees on properties slated for development are protected under the City of Ottawa's Tree Protection By-law (By-law no. 2020-340).

**3996 Innes Road  
CITY OF OTTAWA**

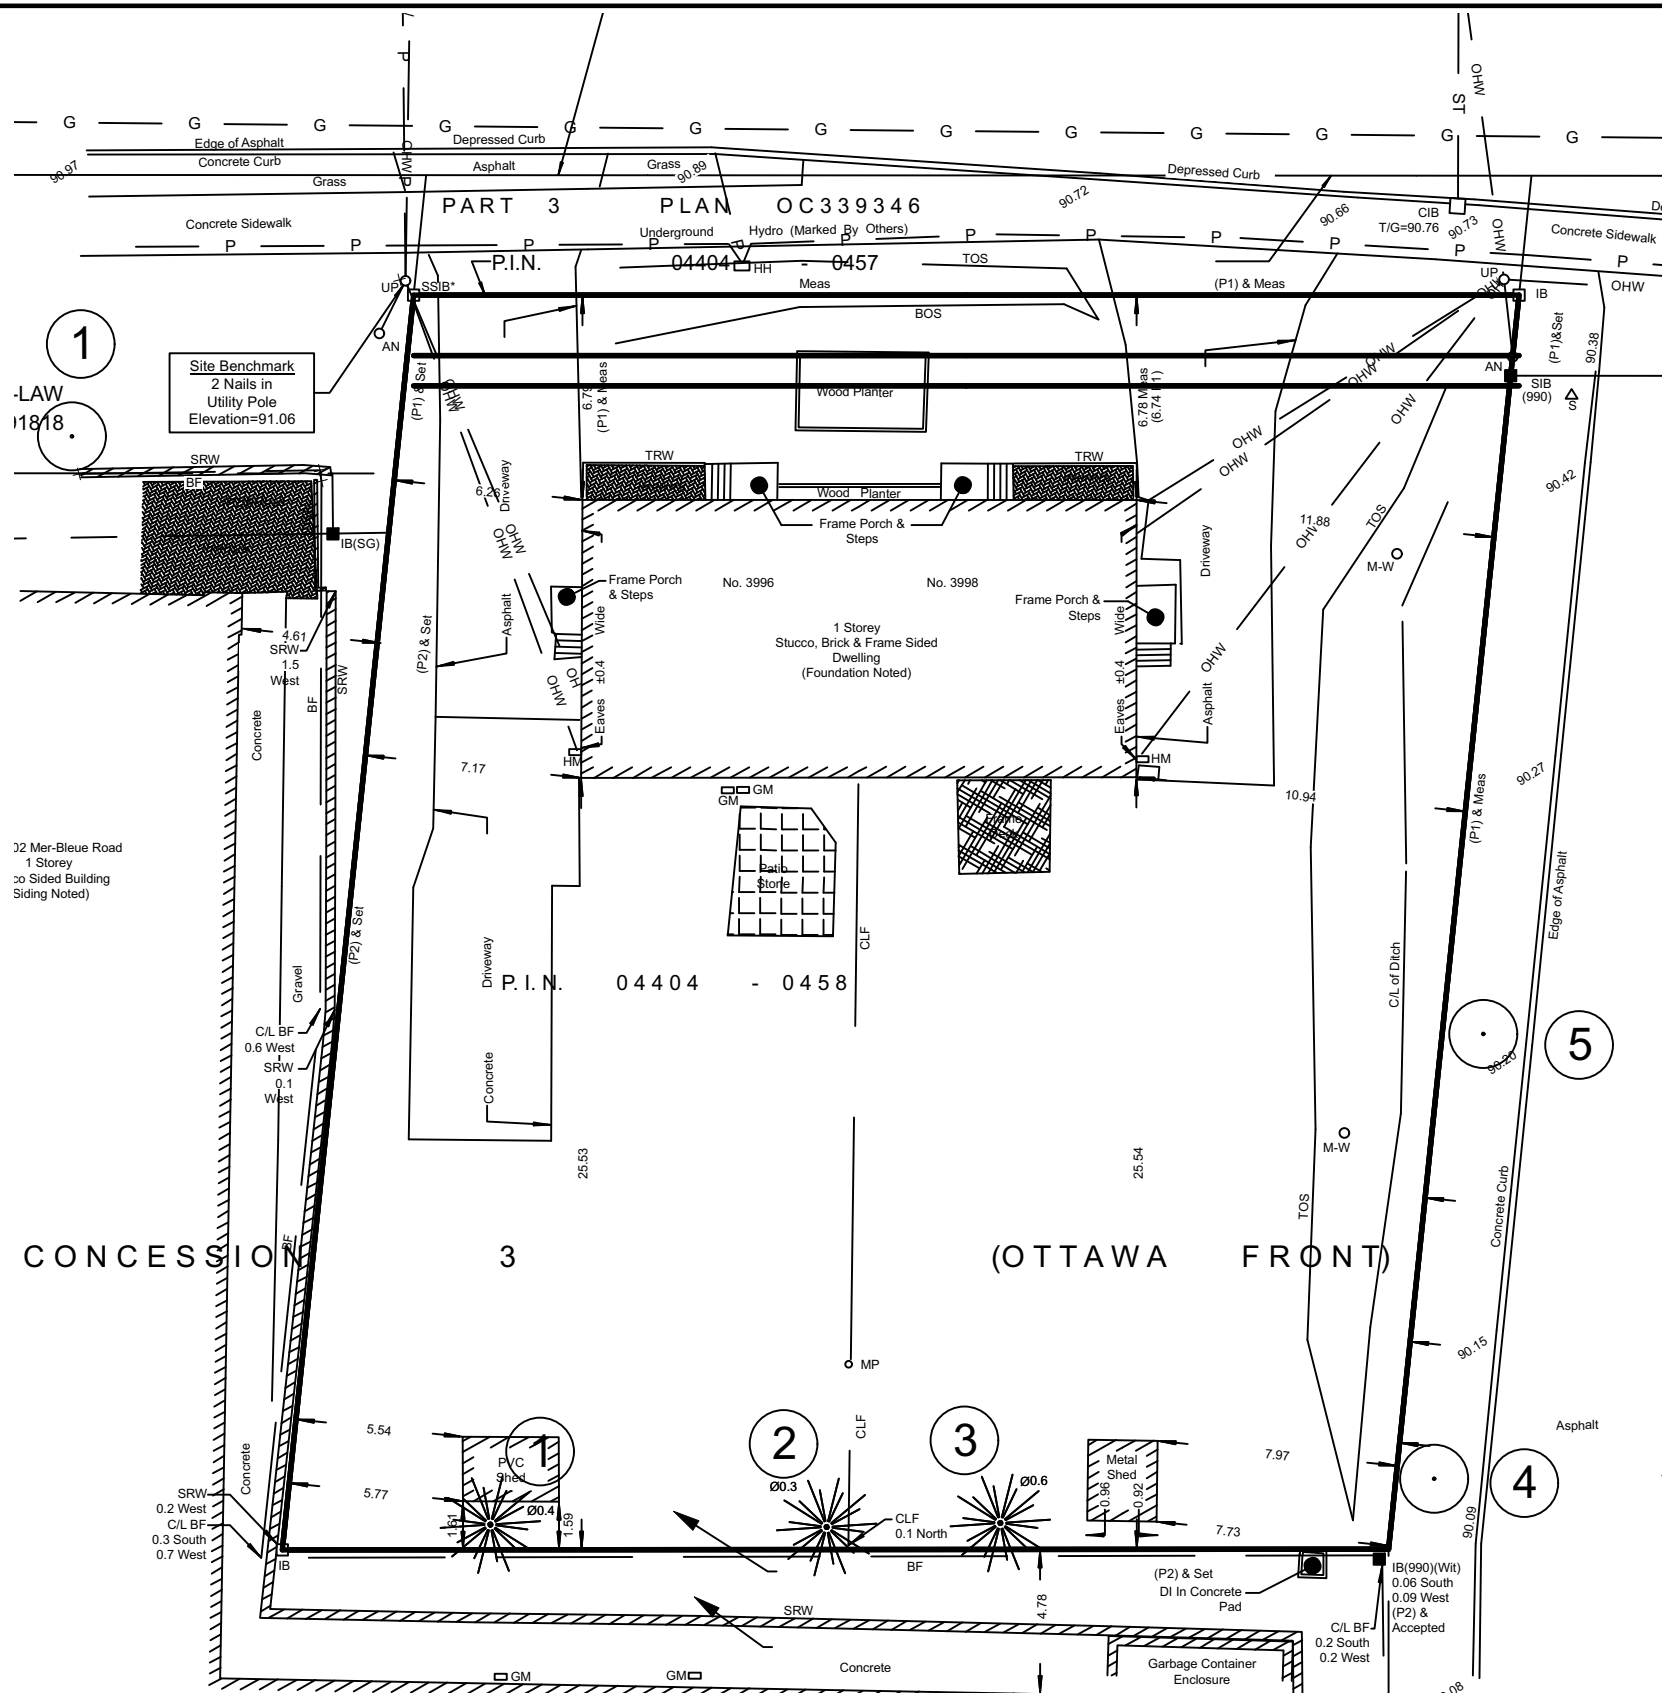
**MAP #1**

**REFER TO CHART FOR TREE ID,  
CONDITION, ACTION**

**MAP # 1 - CURRENT VEGETATION**

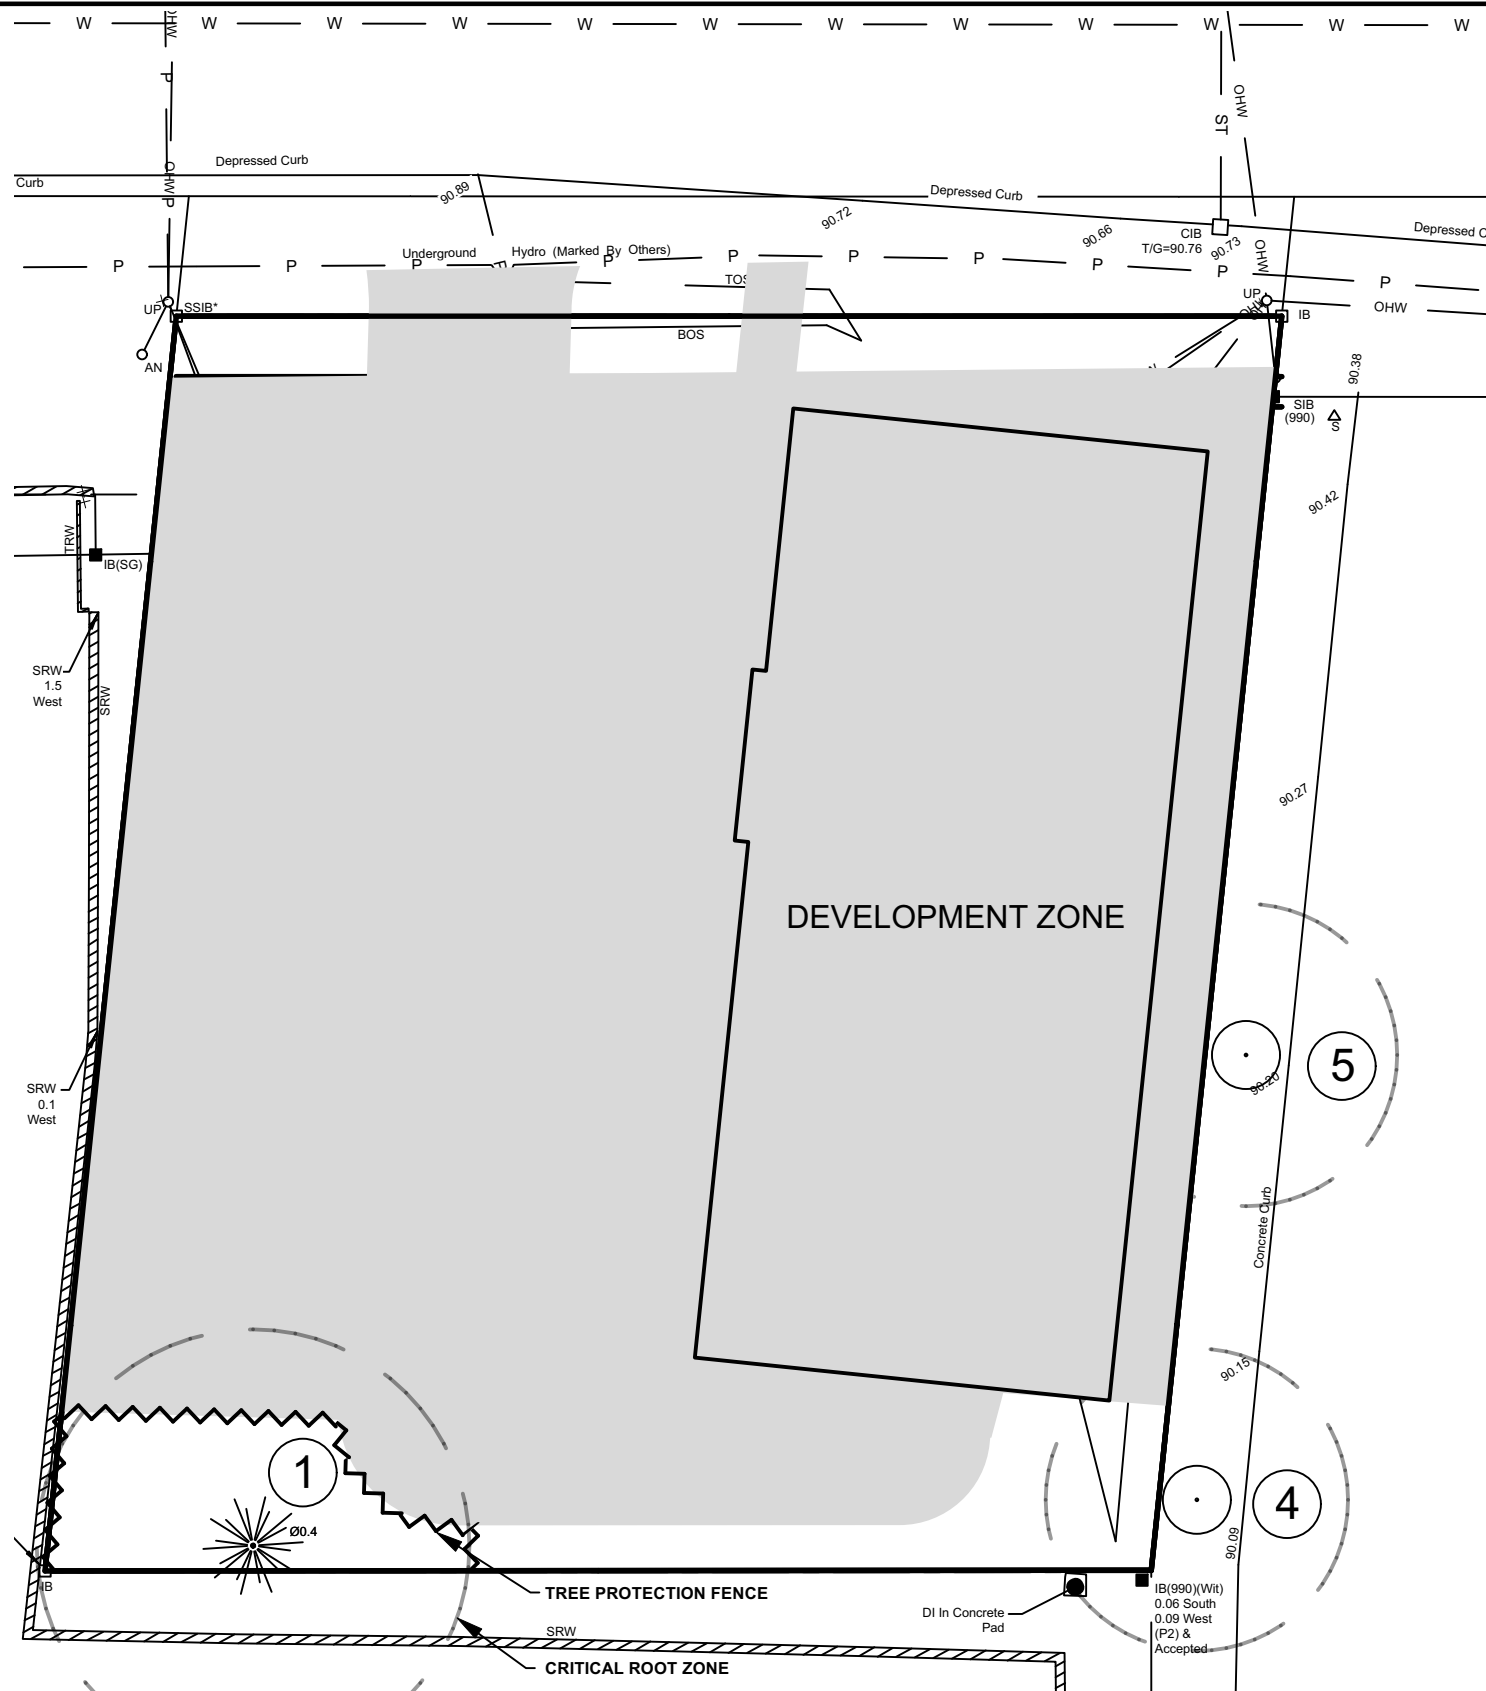
DATE: FEB 2013  
REV: JAN 2020  
DWG No: F7

TITLE:  
**TREE PRESERVATION PROTECTION FENCE**

- PRIOR TO ANY WORK ACTIVITY WITHIN THE CRITICAL ROOT ZONE (CRZ = 10 X DIAMETER) OF A TREE, TREE PROTECTION FENCING MUST BE INSTALLED SURROUNDING THE CRITICAL ROOT ZONE, AND REMAIN IN PLACE UNTIL THE WORK IS COMPLETE.

- DO NOT EXTEND HARD SURFACE OR SIGNIFICANTLY CHANGE LANDSCAPING
- TREE PROTECTION FENCING MUST BE AT LEAST 1.2M IN HEIGHT, AND CONSTRUCTED OF RIGID OR FRAMED MATERIALS (E.G. MODULOC - STEEL, PLYWOOD HOARDING, OR SNOW FENCE ON A 2"x4" WOOD FRAME) WITH POSTS 2.4M APART, SUCH THAT THE FENCE LOCATION CANNOT BE ALTERED. ALL SUPPORTS AND BRACINGS MUST BE PLACED OUTSIDE OF THE CRZ, AND INSTALLATION MUST MINIMISE DAMAGE TO EXISTING ROOTS. (SEE DETAIL)

- THE LOCATION OF THE TREE PROTECTION FENCING MUST BE DETERMINED BY AN ARBORIST AND DETAILED ON ANY ASSOCIATED PLANS FOR THE SITE (E.G. TREE CONSERVATION REPORT, TREE DISCLOSURE REPORT, ETC). THE PLAN AND CONSTRUCTED FENCING MUST BE APPROVED BY CITY FORESTRY STAFF PRIOR TO THE COMMENCEMENT OF WORK.

- IF THE FENCED TREE PROTECTION AREA MUST BE REDUCED TO FACILITATE CONSTRUCTION, MITIGATION MEASURES MUST BE PRESCRIBED BY AN ARBORIST AND APPROVED BY CITY FORESTRY STAFF. THESE MAY INCLUDE THE PLACEMENT OF PLYWOOD, WOOD CHIPS, OR STEEL PLATING OVER THE ROOTS FOR PROTECTION OR THE PROPER PRUNING AND CARE OF ROOTS WHERE ENCOUNTERED.
