REPORT ON

**HYDROGEOLOGICAL  
STUDY  
PROPOSED COACH HOUSE  
5812 RED CASTLE RIDGE  
OSGOODE WARD  
CITY OF OTTAWA, ONTARIO**

DATE July 20, 2022

RE: HYDROGEOLOGICAL AND TERRAIN STUDY  
PROPOSED COACH HOUSE  
5812 RED CASTLE RIDGE  
OSGOODE WARD  
CITY OF OTTAWA, ONTARIO

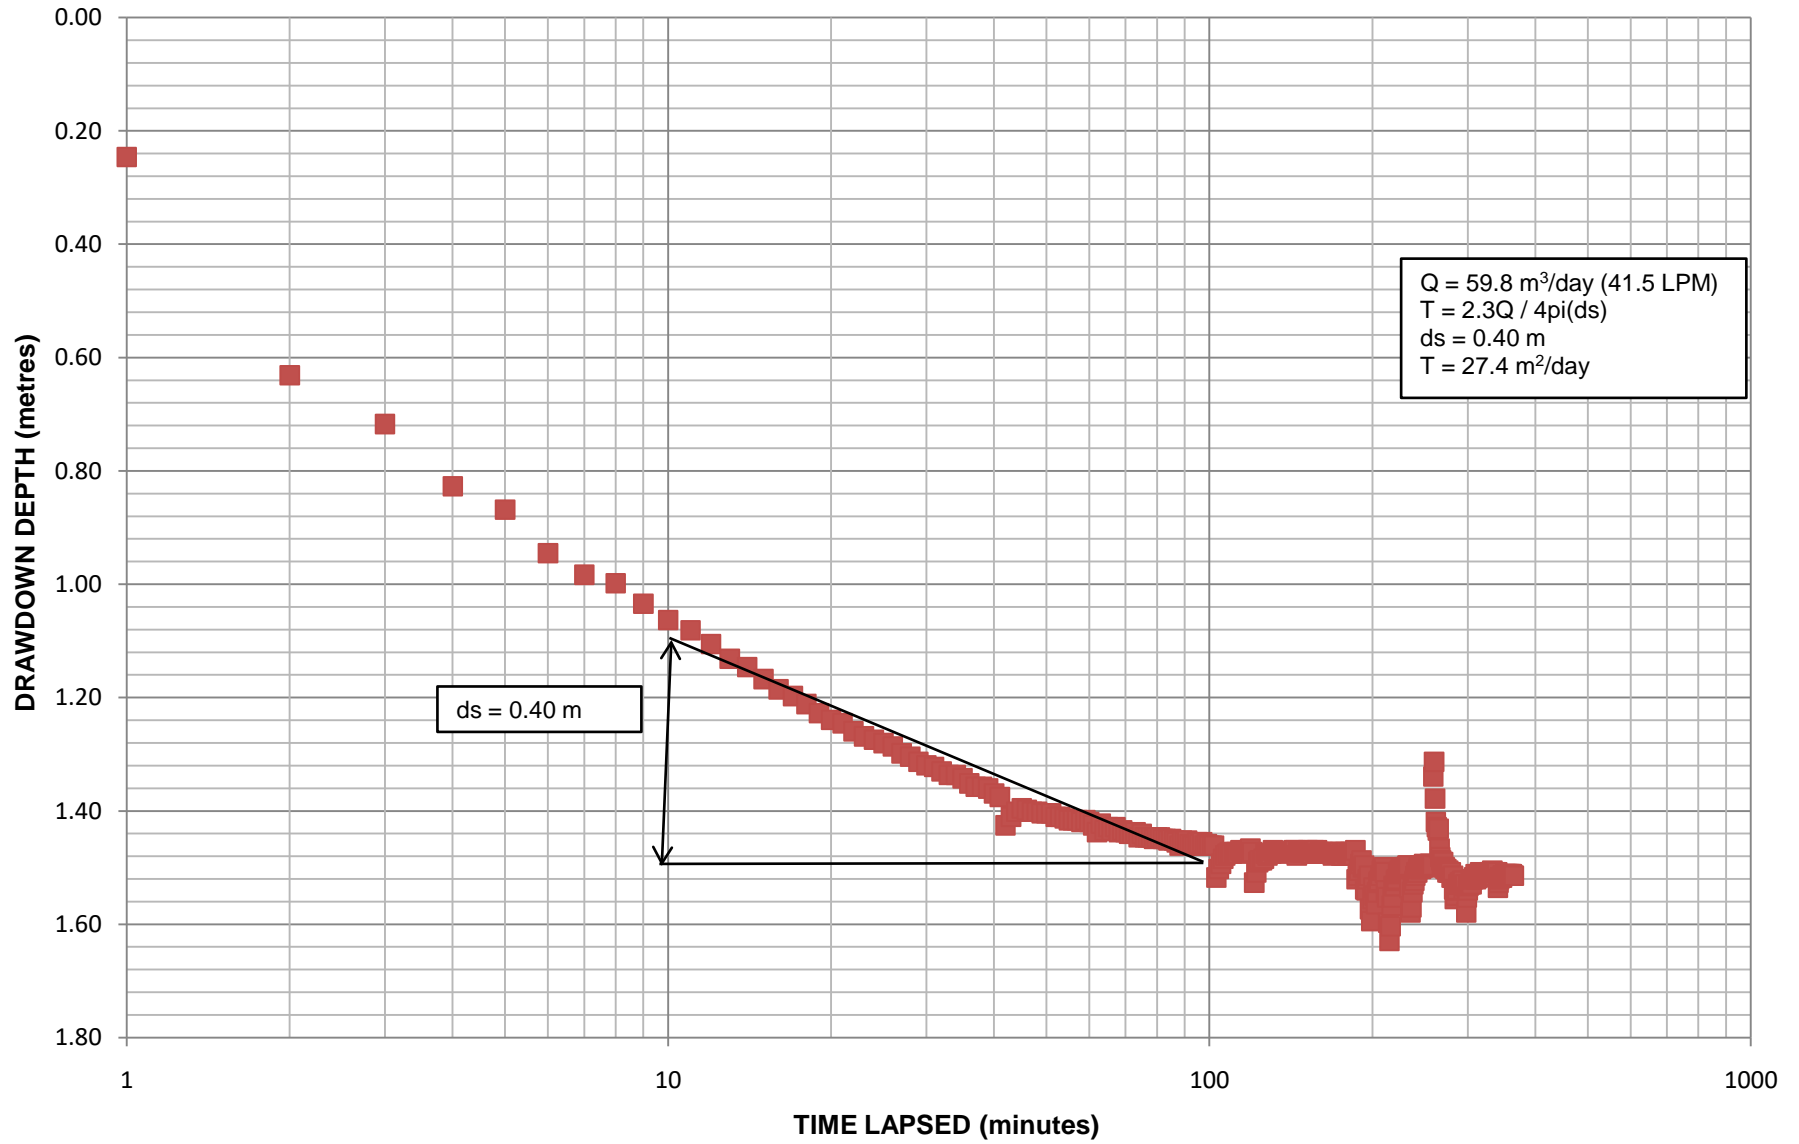
# TW1-WELL DRAWDOWN VS. TIME-KOLLAARD FILE 220067

The well was pumped for about 360 minutes at a pumping rate of about 41.5 litres per minute. Over the course of the pumping test, the water level in the well dropped some 1.53 metres. At the end of pumping, 95% recovery of the total drawdown in the static water level created during pumping was measured after about 72 minutes.

The pumping test drawdown and recovery data and plots for TW1 are provided as Attachment C. The drawdown and recovery data provided were measured with reference to the top of the well casing at the test well location.

The pumping test data for the test well was analyzed using the method of Cooper and Jacob (1946). Although the assumptions on which these equations are based are not strictly met, this method provides a reasonable estimate of the aquifer transmissivity.

Based on the pumping test drawdown and recovery data, the transmissivity of the aquifer is estimated to be between about 27.4 and 19.9 m<sup>2</sup>/day, respectively.
