PROJECT NAME
CIRCLE K STORES INC.
R&R No. 52287

**1545 WOODROFFE AVENUE
 NEPEAN, ON, CANADA
 K2G 1W2**

SHEET TITLE
TREE PRESERVATION AND PROTECTION EXISTING CONDITIONS PLAN

SHEET TITLE
PROPOSED DEVELOPMENT
CONSERVED VEGETATION
PLAN

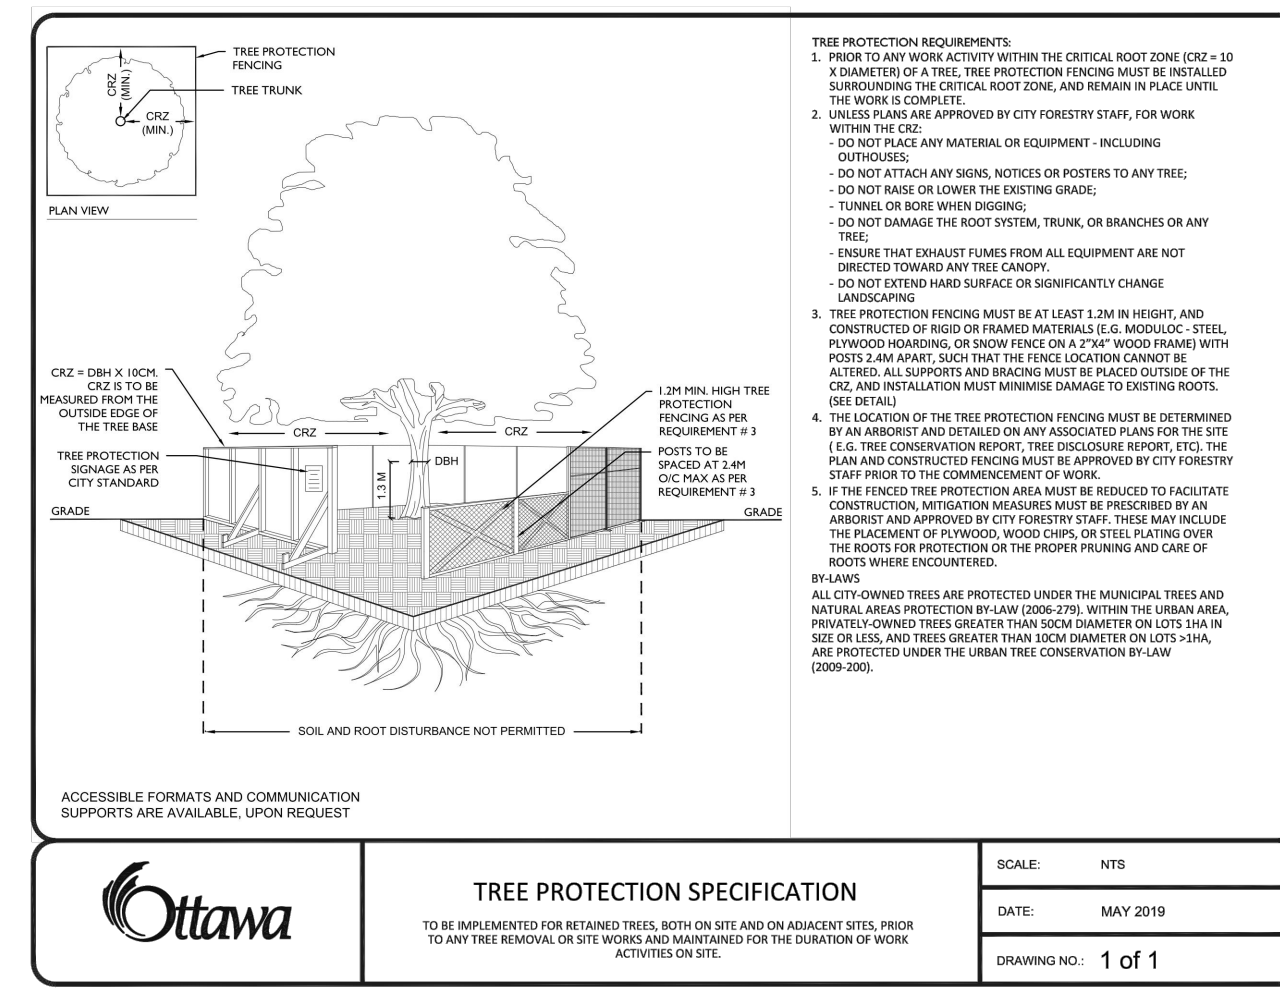
- DENOTES SURVEYED LOCATION OF EXISTING TREES, & # SPECIES / CALIPER / CONDITIONS / REMARKS ARE AS NOTED IN ARBORIST REPORT & TREE INVENTORY LIST
- TREE PRESERVATION FENCE, PER OTTAWA TREE PROTECTION SPECIFICATION DETAIL
- DENOTES EXISTING TREES TO BE REMOVED FOR DEVELOPMENT, AS NOTED, SEE ARBORIST REPORT

- ALL EXISTING TREES WHICH ARE TO REMAIN SHALL BE FULLY PROTECTED WITH FENCING ERECTED AROUND THE ENTIRE PERIMETER OF THE TREE PROTECTION ZONE IN ACCORDANCE WITH TPZ MINIMUM DISTANCE REQUIREMENTS. GROUPS OF TREES AND OTHER EXISTING PLANTINGS TO BE PROTECTED, SHALL BE DONE IN A LIKE MANNER WITH FENCING AROUND THE ENTIRE CLUMP(S).
