**Phase I Environmental Site Assessment**

439 Churchill Avenue North  
Ottawa, Ontario

March 22, 2021

Report: PE5189-1

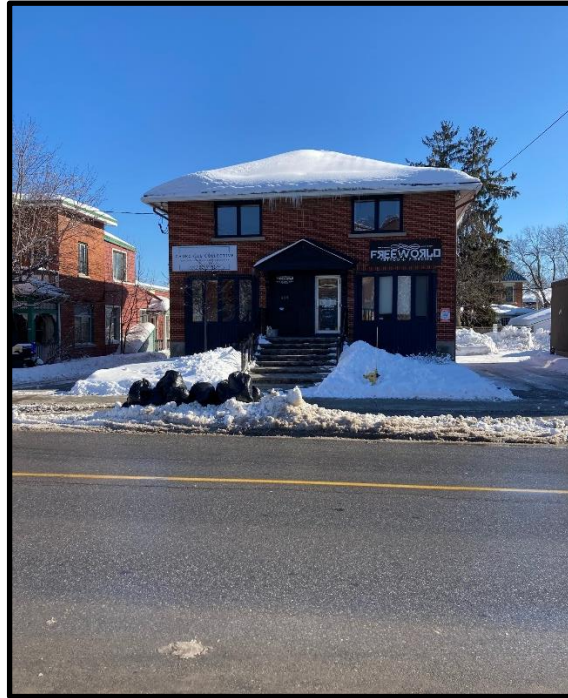
Photograph 1: Street view of 439 Churchill Avenue North, looking east.

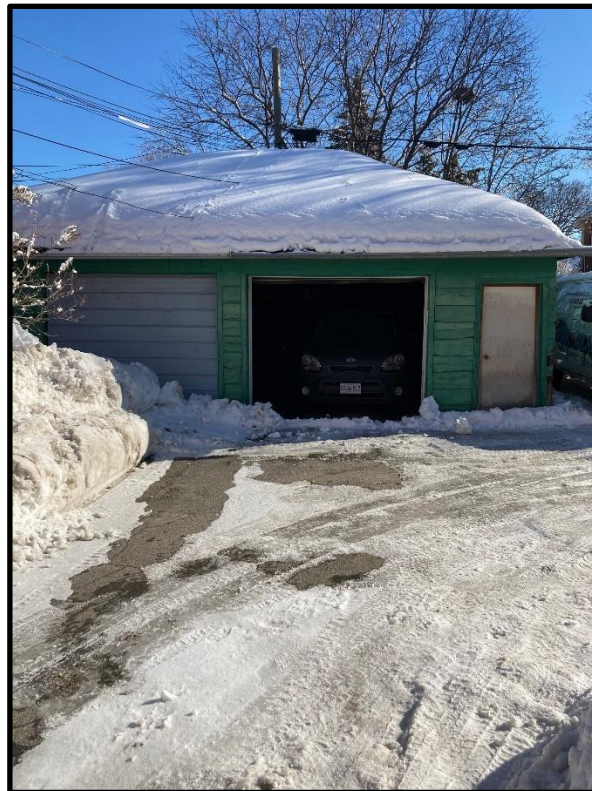
Photograph 2: View of private garage at the rear of 439 Churchill Avenue North.

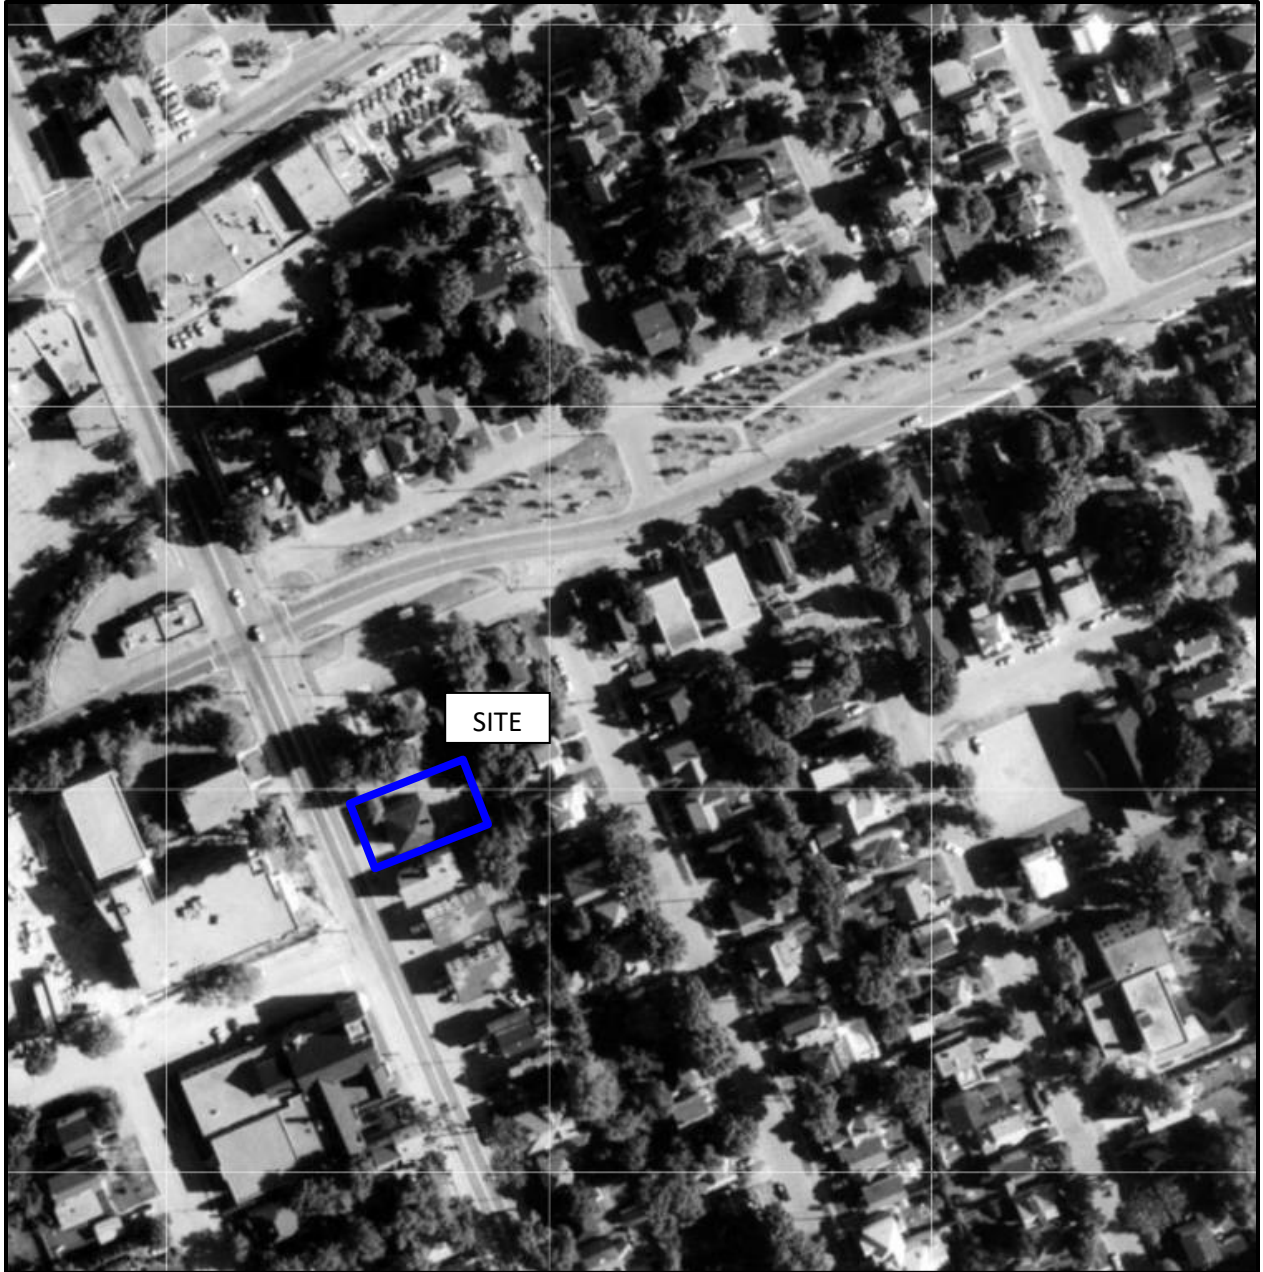
AERIAL PHOTOGRAPH  
1991

- 
- 1991 (City of Ottawa) No apparent changes have been made to the Phase I Property since the previous photograph. The property to the west of the Phase I Property, across Churchill Avenue North, has been redeveloped with a large building structure. Otherwise, the adjacent and neighbouring properties appear to remain unchanged from the previous photograph.
- 2002 (City of Ottawa) The existing private garage has been developed in the northeast corner of the Phase I Property. No significant changes are apparent with respect to the surrounding properties.
- 2011 (City of Ottawa) No significant changes are apparent with respect to the Phase I Property and the surrounding properties.
- 2019 (City of Ottawa) No significant changes are apparent with respect to the Phase I Property and the surrounding properties.
