**1161 OLD MONTREAL ROAD
ORLEANS, ONTARIO**

**TREE CONSERVATION REPORT
FOR SITE PLAN APPROVAL**

**PREPARED BY: RON KOUDYS LANDSCAPE
 ARCHITECTS INC**

DATE: NOVEMBER 2021

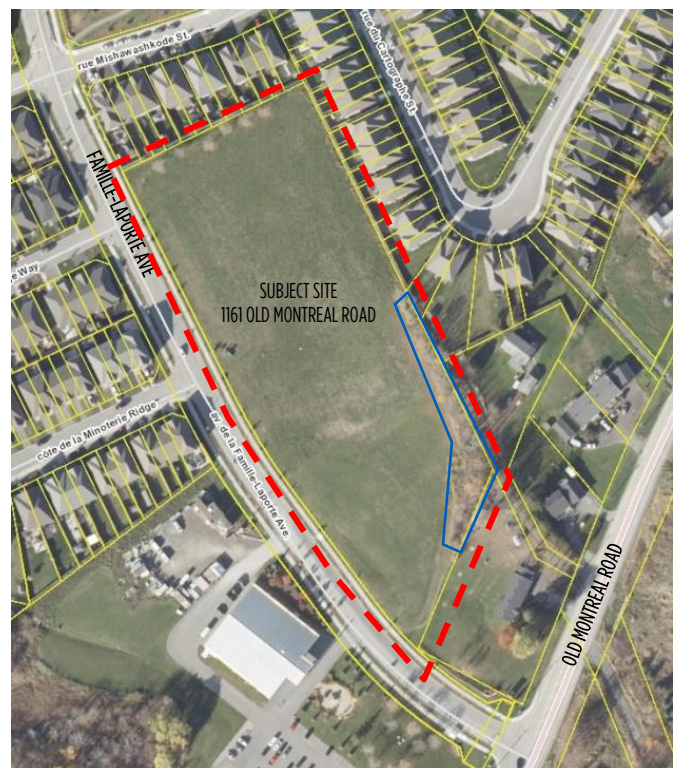
Figure 1 - Image capture from GeoOttawa with 2019 aerial
Red dashed line - limit of tree inventory
Blue line - dense group of trees

The scope of this tree inventory includes the subject site as well as trees within 3m of the subject site property line. Refer to Figure 1 for scope of tree inventory.
