## Phase I - Environmental Site Assessment

Existing Commercial Property  
1040 Somerset Street West  
Ottawa, Ontario

Claridge Homes Inc.

Report: PE2636-1

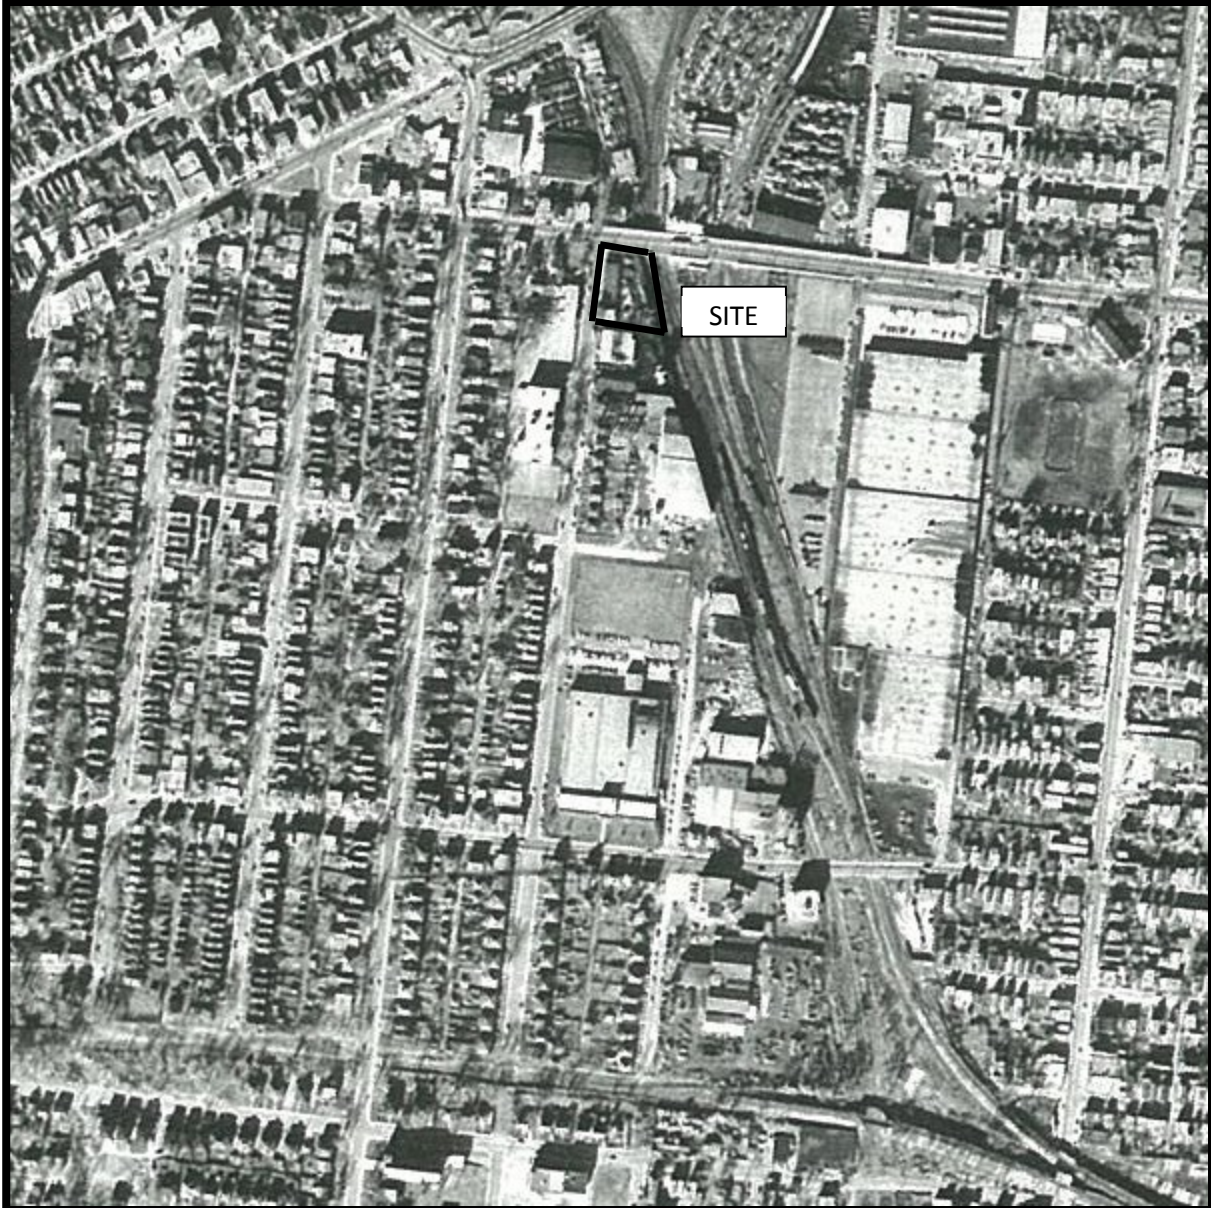
AERIAL PHOTOGRAPH  
1958

| 1958 | What appears to be a storage building can be observed on the western portion of the property. No other significant changes can be observed from the photograph. |

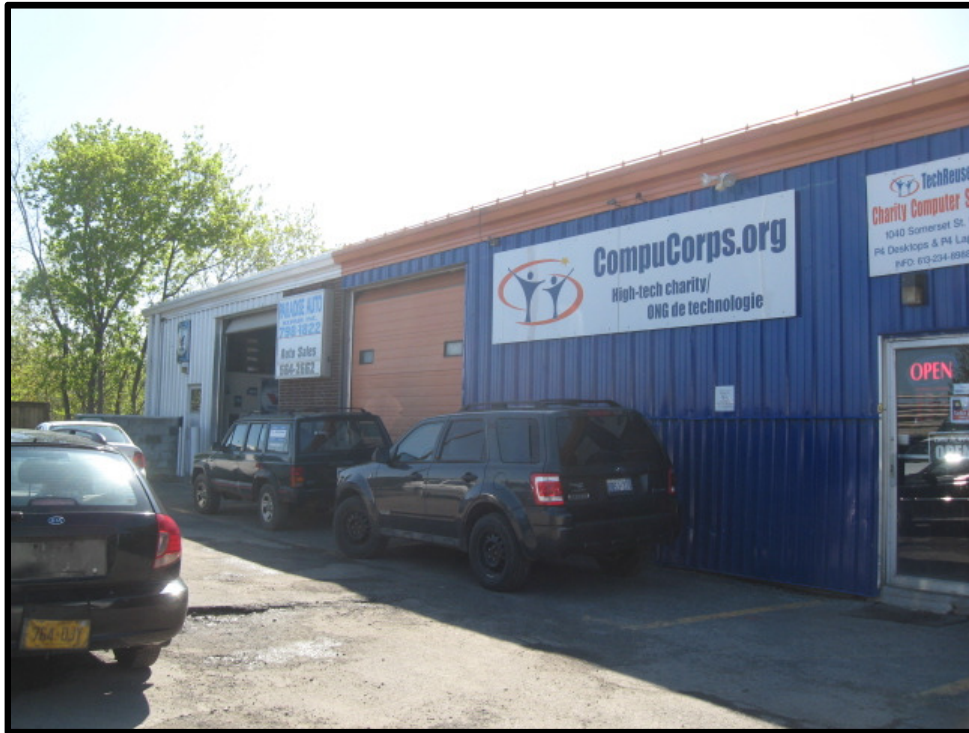
Photograph 1: View of the north side of the subject structure looking southeast. Photograph illustrates the location the automotive service garage, at the east end of the building, and CompuCorps.

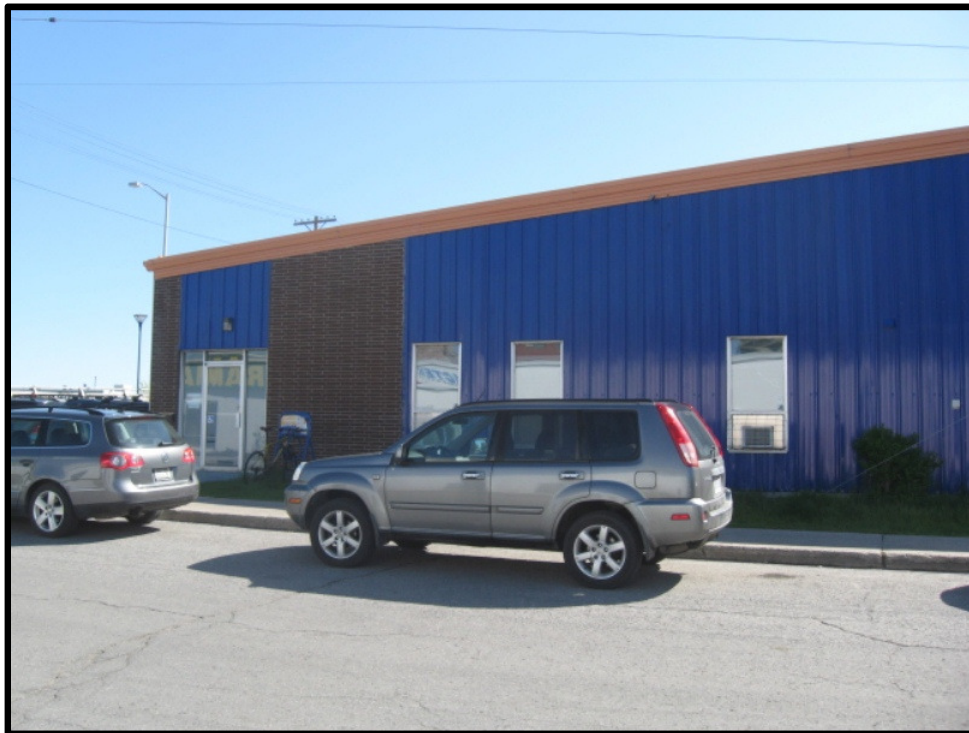
Photograph 2: View of the west side of the northern portion of the subject building, looking northeast. Photograph illustrates the entrance to the consulting firm, QuIRC.

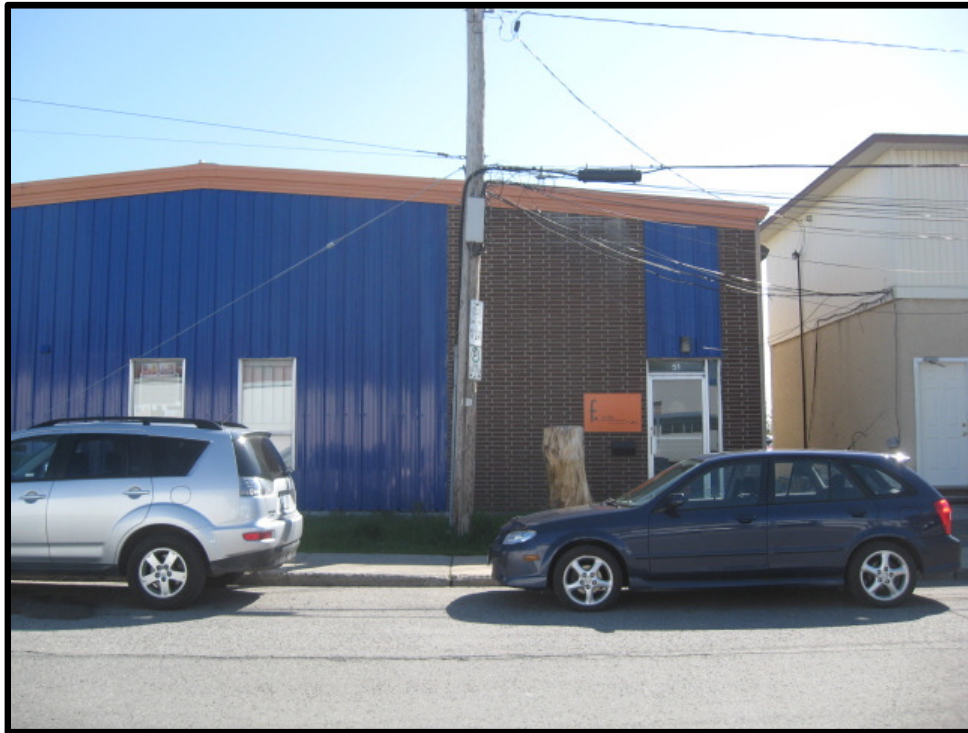
Photograph 3: View of west side of southern portion of subject building, looking east. Photograph illustrates the entrance to F-Studio, the blown glass art studio.

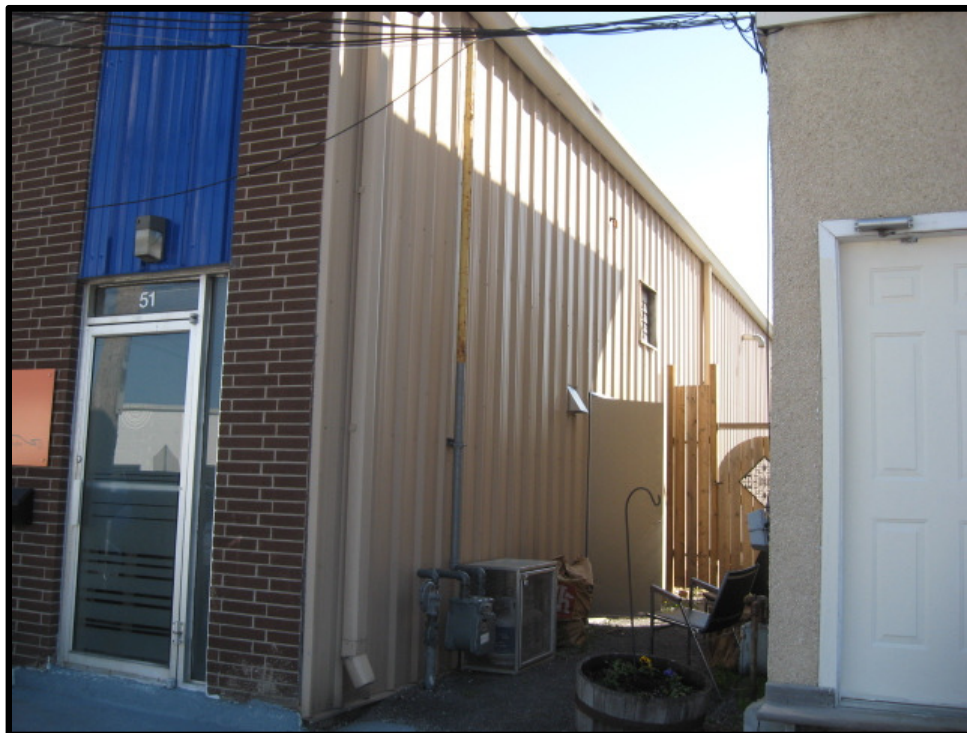
Photograph 4: View of southwest corner of building, looking northeast. Photograph illustrates natural gas connection and propane cage.

Two (2) propane canisters were noted on the exterior of the subject property, near the southwest corner of the subject structure, at the time of the site assessment. The canisters were stored in a cage and are not considered to pose a concern to the subject property.

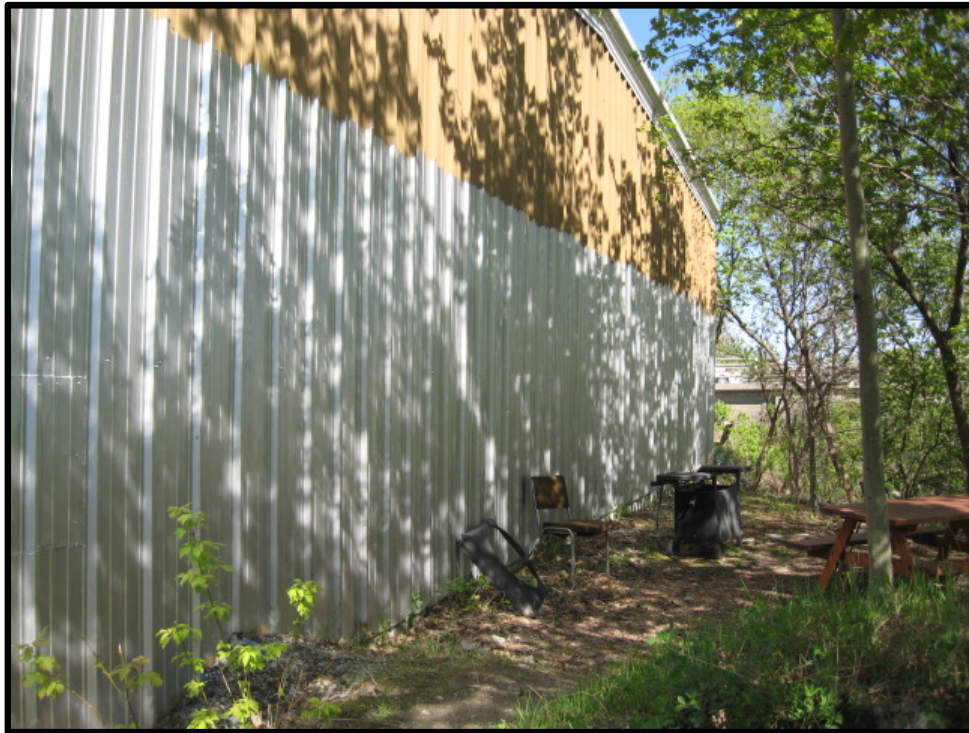
Photograph 5: View of southern portion of site and subject building, looking northeast.

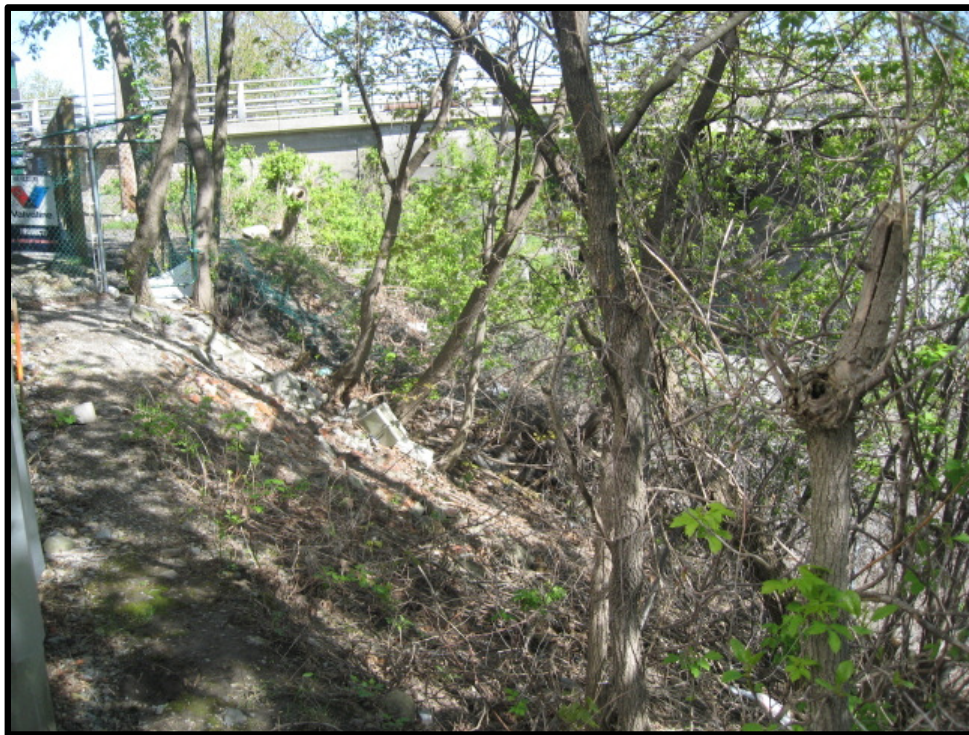
Photograph 6: View of eastern portion of site, looking north. Photograph illustrates proximity of rail line to the east.

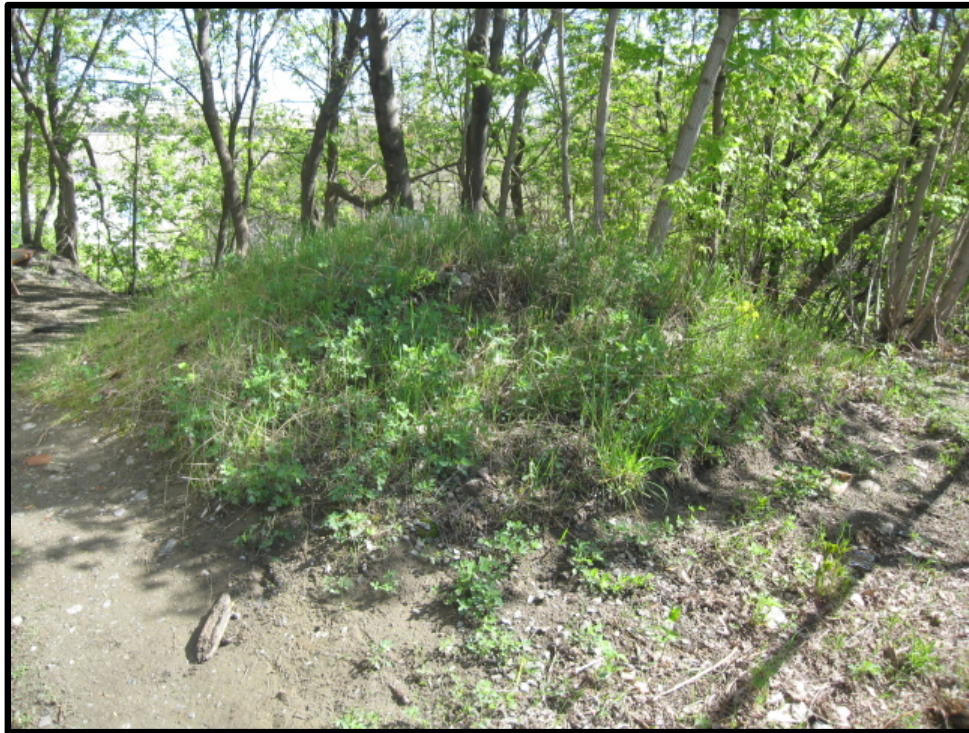
Photograph 7: View of the southeast corner of subject property, looking east. Photograph illustrates fill pile at location of decommissioned well.

The source of water at the subject site is municipally treated water. The water connection and water meter were not noted at the time of the site inspection, however, based on water locates provided by the City, the connection is expected to be located along the west portion of the subject building. The building is considered to have always been serviced with municipal water. The well located southeast of the subject structure was used in the past for cooling of the building and/or industrial process conducted onsite and has since been decommissioned.

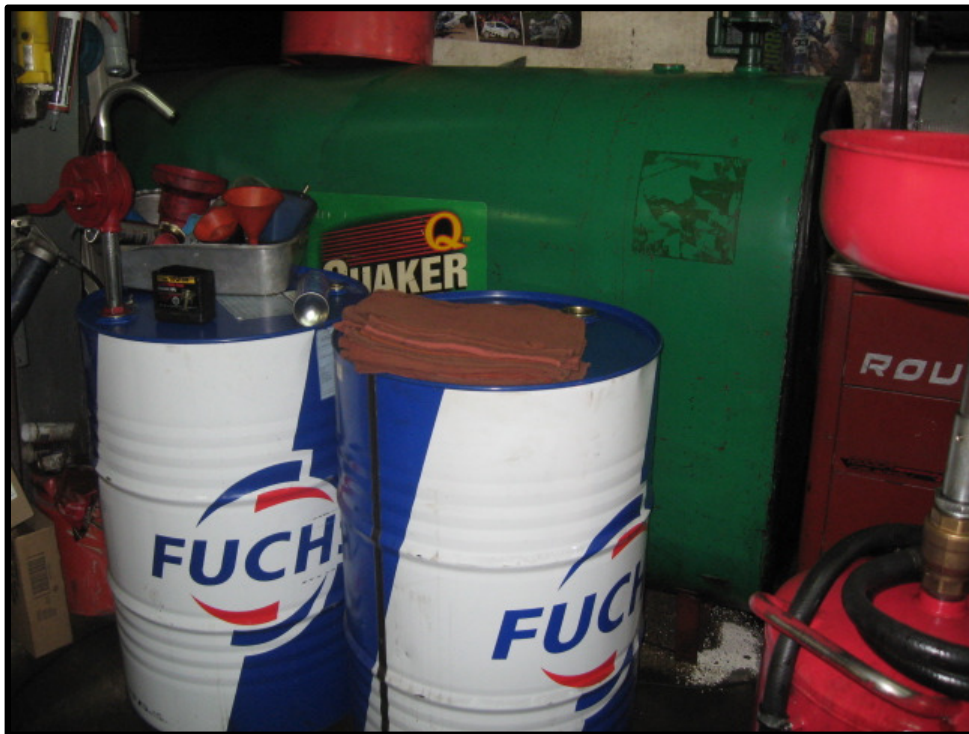
Photograph 8: View of the interior southwest corner of the garage, looking southwest. Photograph illustrates, waste oil storage, staining on floor surface and absorbent material beneath AST.

Two (2) 910 L aboveground storage tanks were observed along the interior west wall of the garage. One (1) of the tanks was reported to be empty while the other was reported to contain waste oil. Four (4) 200 L drums were used for the purposes of draining and storing used filters, waste oil and rags. Two (2) 200 L drums containing new oil were also observed on site. Several empty 200 L drums and jerry cans, to be removed in the near future, were situated adjacent to the empty AST noted above. Cleaning solvents, antifreeze, and gear lube were also observed in the garage as well as general cleaning and maintenance chemicals. At the time of the assessment, these chemicals were observed to be properly stored on workbenches and on shelves in the storage area.

There are two (2) aboveground hoists located in the automotive service garage. The hoists are located in the central portion of the south end of the garage bay, while work benches are located along the south interior. Staining was noted on the concrete floor in the southern portion of the building, in the vehicle equipment and maintenance portion of the garage. The concrete floor was in fair to good condition, with no significant cracks noted at the time of the assessment. There were no floor drains or other potential migratory pathways observed in the immediate vicinity of the staining.
