RE: TREE CONSERVATION REPORT FOR 12-24 HAWTHORNE AVENUE, OTTAWA

DRAWING: Tree Conservation Plan

PROJECT: 18 HAWTHORNE AVENUE
CITY OF OTTAWA

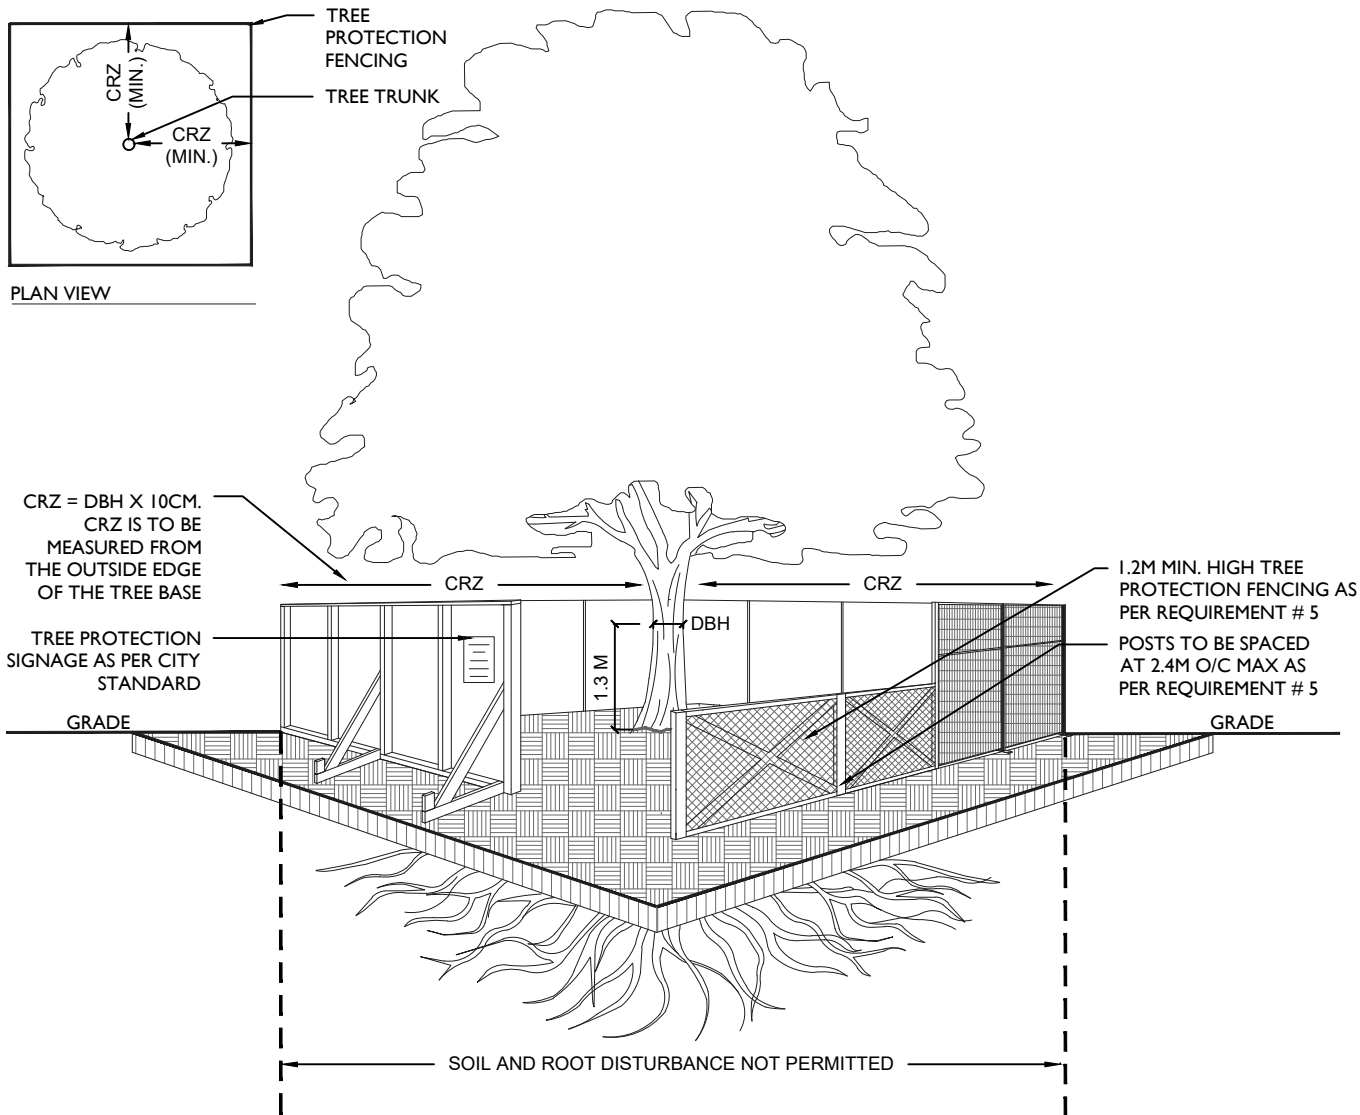
TREE PROTECTION BARRIER SPEC.

5. TREE PROTECTION FENCING MUST BE AT LEAST 1.2M IN HEIGHT, AND CONSTRUCTED OF RIGID OR FRAMED MATERIALS (E.G. MODULOC - STEEL, PLYWOOD HOARDING, OR SNOW FENCE ON A 2"X4" WOOD FRAME WITH POSTS TO BE SPACED AT A MAXIMUM OF 2.4 M APART), SUCH THAT THE FENCE LOCATION CANNOT BE ALTERED. ALL SUPPORTS AND BRACING MUST BE PLACED OUTSIDE OF THE CRZ, AND INSTALLATION MUST MINIMISE DAMAGE TO EXISTING ROOTS. (SEE DETAIL)

1. As per the City of Ottawa's tree protection barrier specification (included on page 5), erect a fence as close as possible to the CRZ of the tree(s);
2. Do not place any material or equipment within the CRZ of the tree(s);
3. Do not attach any signs, notices or posters to any tree;
4. Do not raise or lower the existing grade within the CRZ without approval;
5. Tunnel or bore instead of trenching within the CRZ of any tree;
6. Do not damage the root system, trunk or branches of any tree;
7. Ensure that exhaust fumes from all equipment are NOT directed towards any tree's canopy.

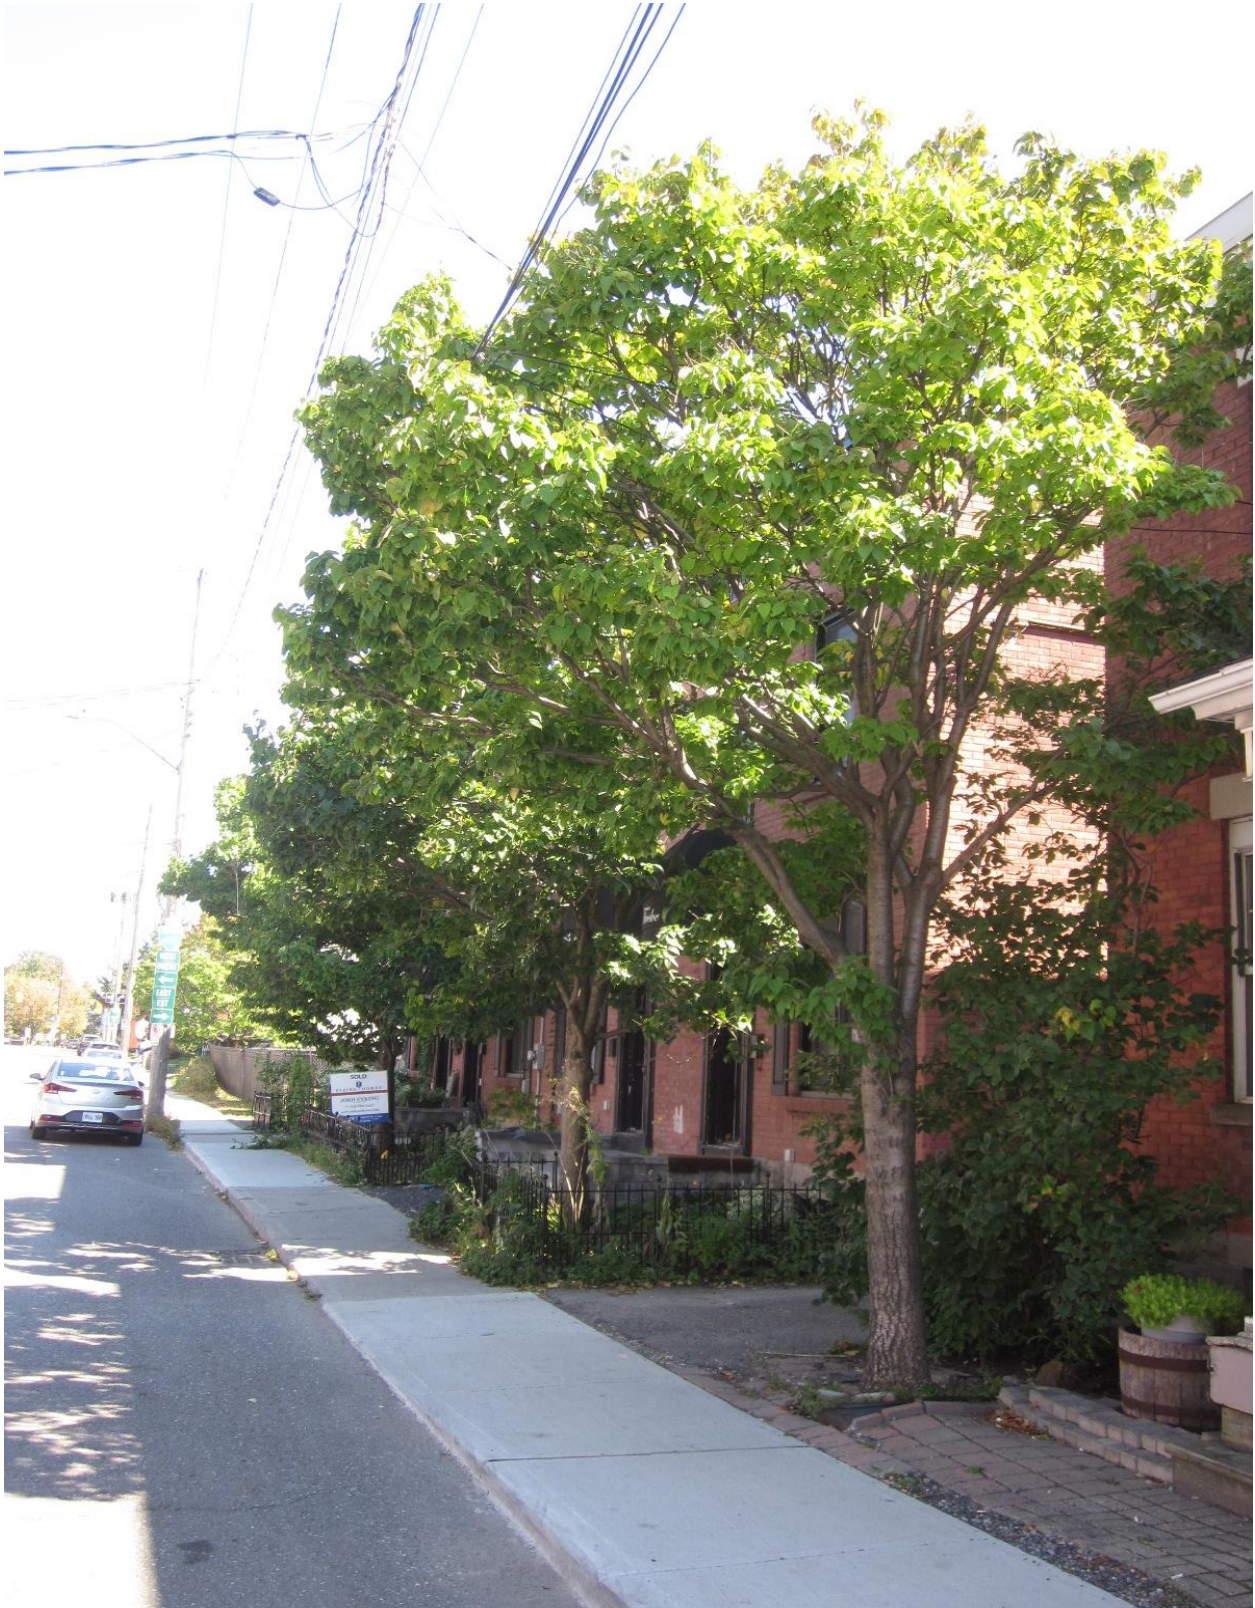
Tree No.	Tree species	Ownership ¹	DBH ² (cm)	Tree Condition; Age Class; Condition Notes; Species Origin & Preservation Status (to be removed or preserved and protected)
1	Japanese tree lilac (<i>Syringa reticulata</i>)	Neighbour	24.6	Fair; mature; central dominant stem with two suppressed laterals at 1.5m from grade; crown asymmetric towards northwest due to past clearance work from building; very restricted available rooting area; cultivar; to be preserved
2	Japanese tree lilac (<i>Syringa reticulata</i>)	Private	24.1	Fair; mature; co-dominant stems at 1.75m with suppressed laterals 1.5-2.75m from grade; crown asymmetric due to past clearance pruning from building; moderately restricted available rooting area; cultivar; to be removed (conflicts with construction)
3	Japanese tree lilac (<i>Syringa reticulata</i>)	Private	25.2	Good; mature; central stem with suppressed lateral at 1.5m on northeast; crown asymmetric due to past clearance pruning from building; good crown density and leaf colour; mildly restricted available rooting area; cultivar; to be removed (conflicts with construction)

Picture 1. Trees #1-3 (right to left) at 12-24 Hawthorne Avenue

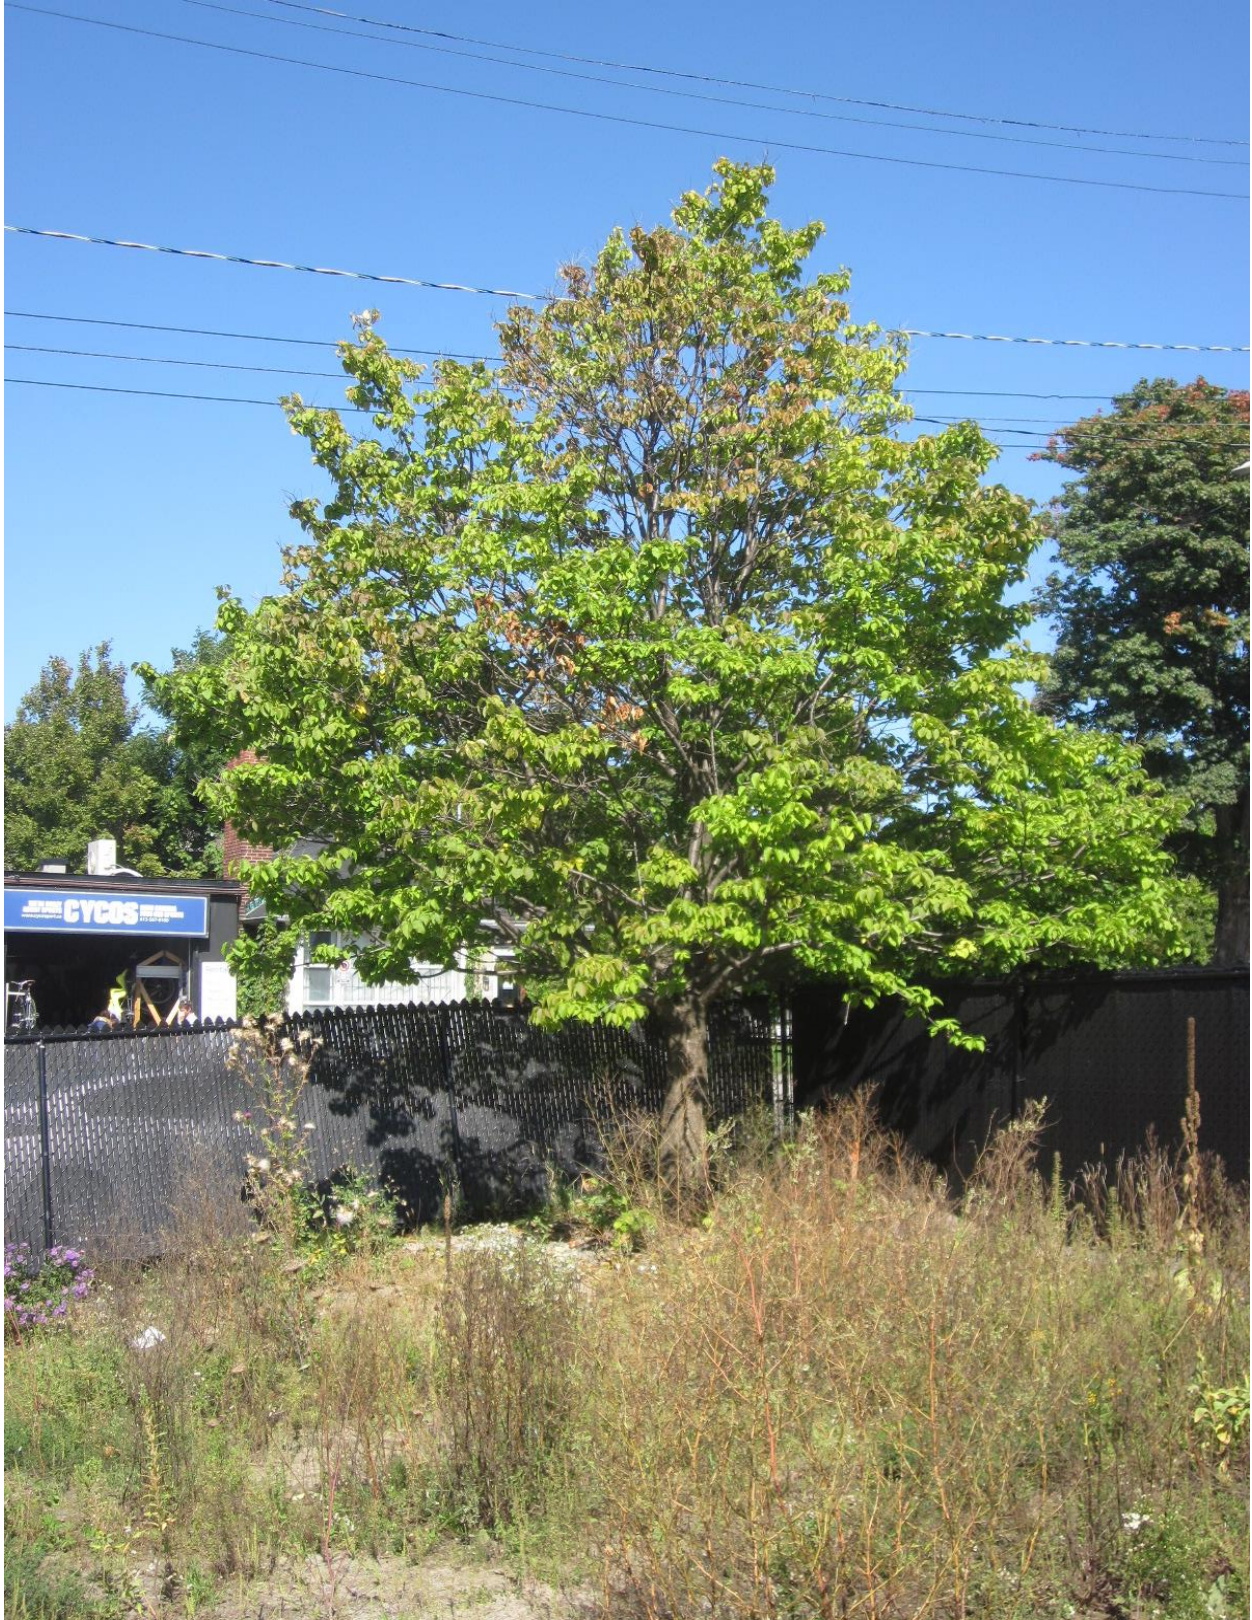
4	Japanese tree lilac (<i>Syringa reticulata</i>)	Private	27.7	Fair; mature; central stem with suppressed and competing laterals starting at 1.5m; recent root loss due to demolition activities; broad but thin crown; cultivar; to be removed (conflicts with construction)
5	Manitoba maple (<i>Acer negundo</i>)	Private	-	Standing dead; to be removed
6	Bur oak (<i>Quercus macrocarpa</i>)	Private	46.3	Good; mature; single upright stem to 5m from grade with multiple strongly upright co-dominant stems above; crown asymmetric towards south/east due to influence of tree #7; vine growth along bole; native species; to be removed (conflicts with construction)
7	Manitoba maple (<i>Acer negundo</i>)	Private	51.1	Fair; mature; co-dominant stems 4.5m – central with suppressed lateral towards southwest; mildly divergent form and moderately asymmetric crown towards southwest/west due to influence of tree #6; vine growth along bole; naturalized species; to be removed (conflicts with construction)

Picture 2. Tree #4 at 12-24 Hawthorne Avenue

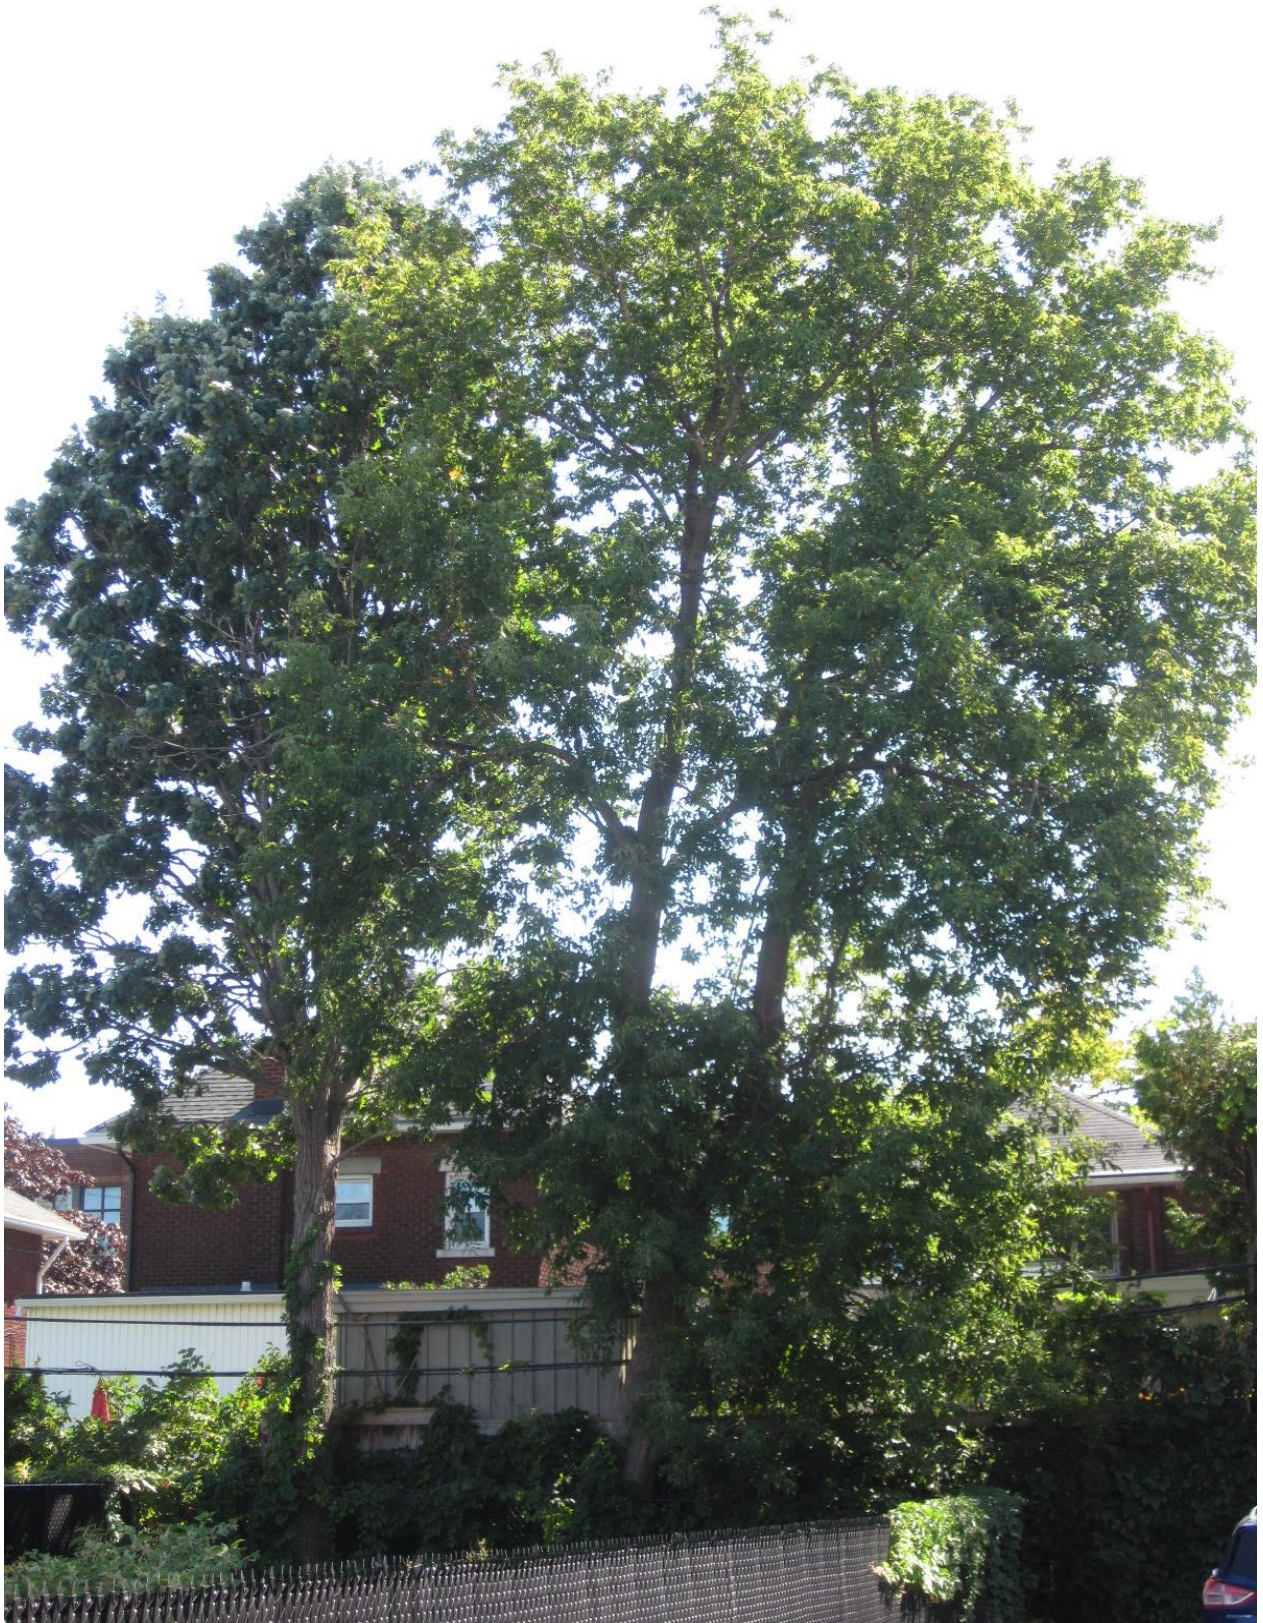
Picture 3. Tree #6 and 7 (left to right) at 12-24 Hawthorne Avenue
