# PHASE TWO ENVIRONMENTAL SITE ASSESSMENT 476 WILBROD STREET, OTTAWA, ON

Project No.: CCO-22-3130

Sleepwell Property Management  
423 Bronson Avenue  
Ottawa, Ontario  
K1R 6J5

August 11, 2022

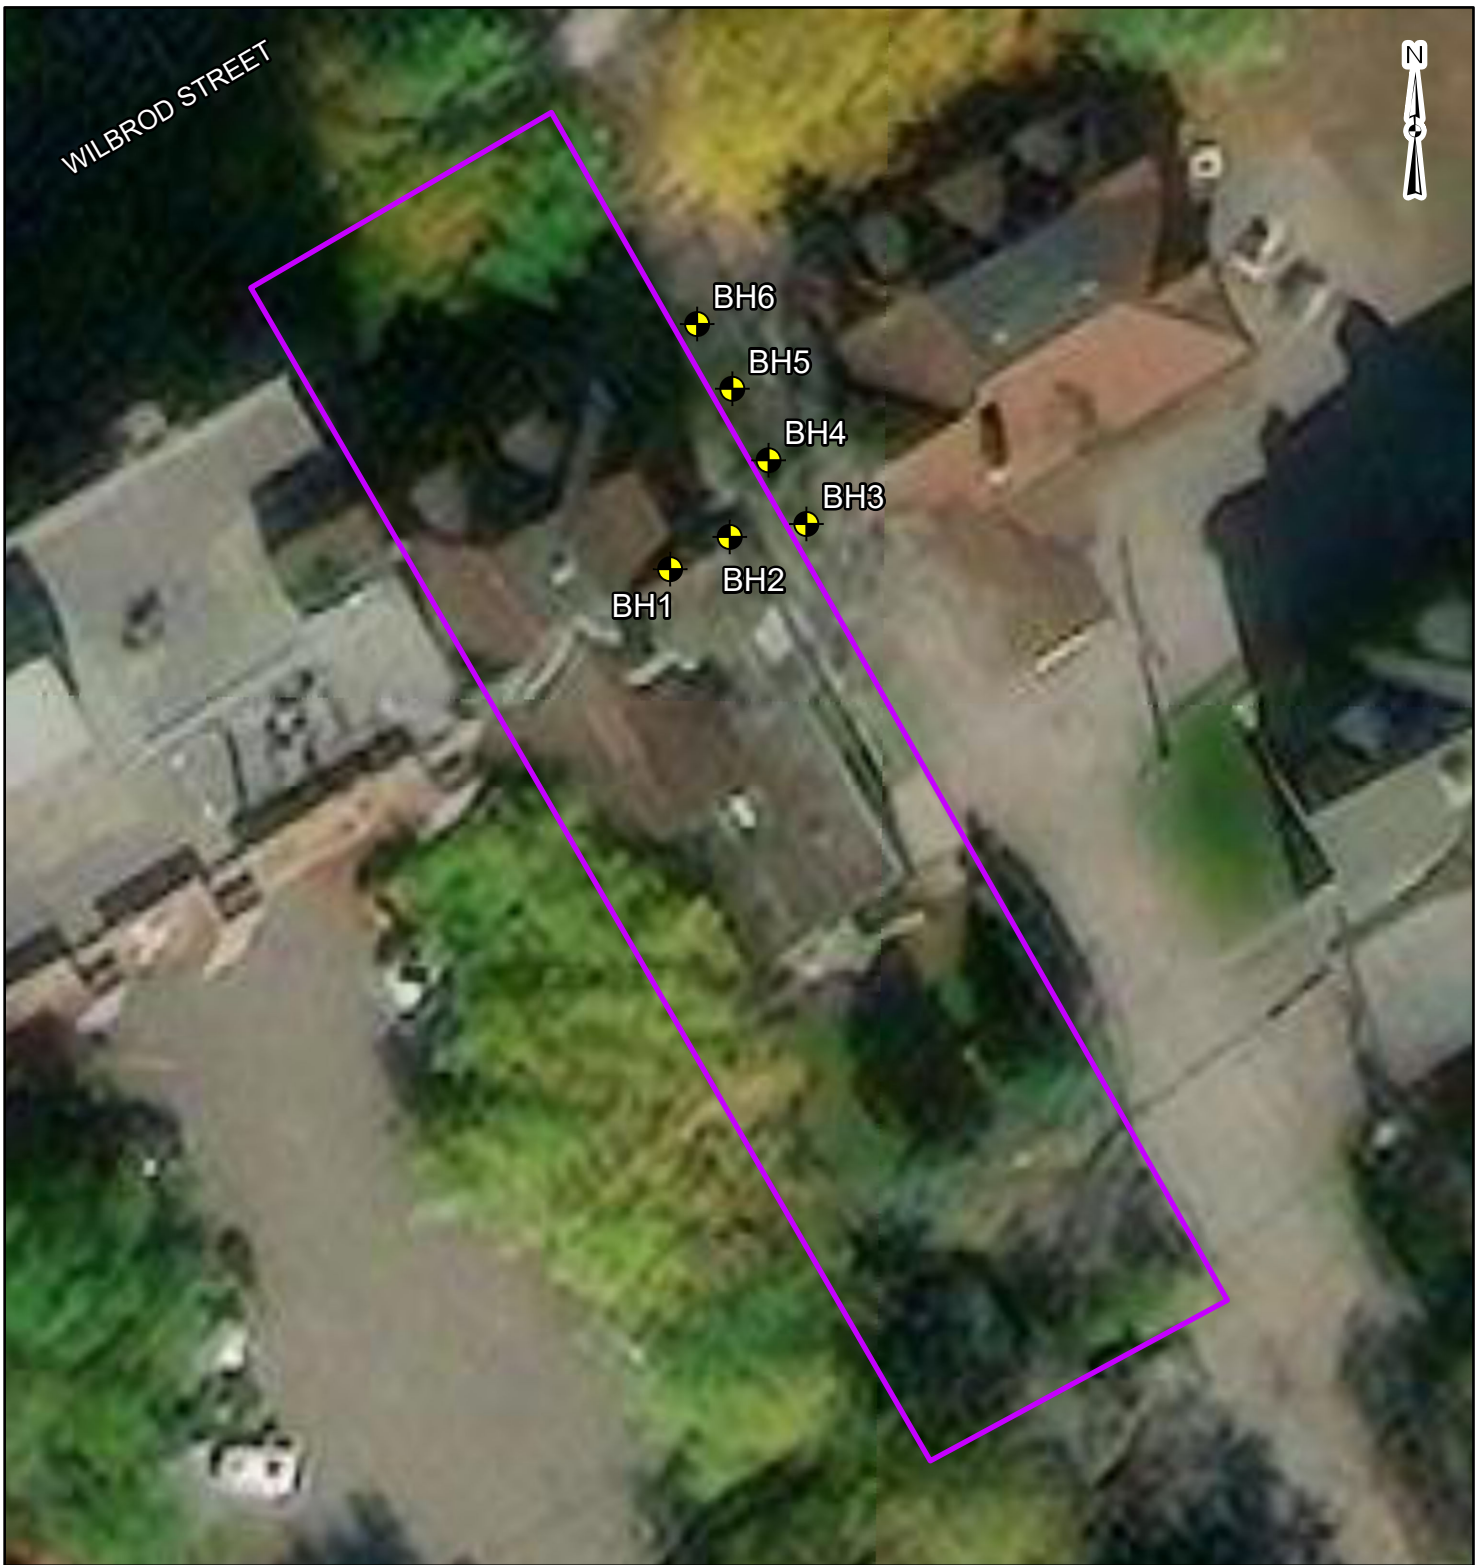
- Approximate Site Boundary
- Borehole (location approximate)

Kevin Cortez (Environmental Engineering Intern) of McIntosh Perry supervised a drilling and sampling program at the Site on July 20, 2022. McIntosh Perry advanced six (6) boreholes (BH1 through BH6) at the locations indicated on Figure 2.

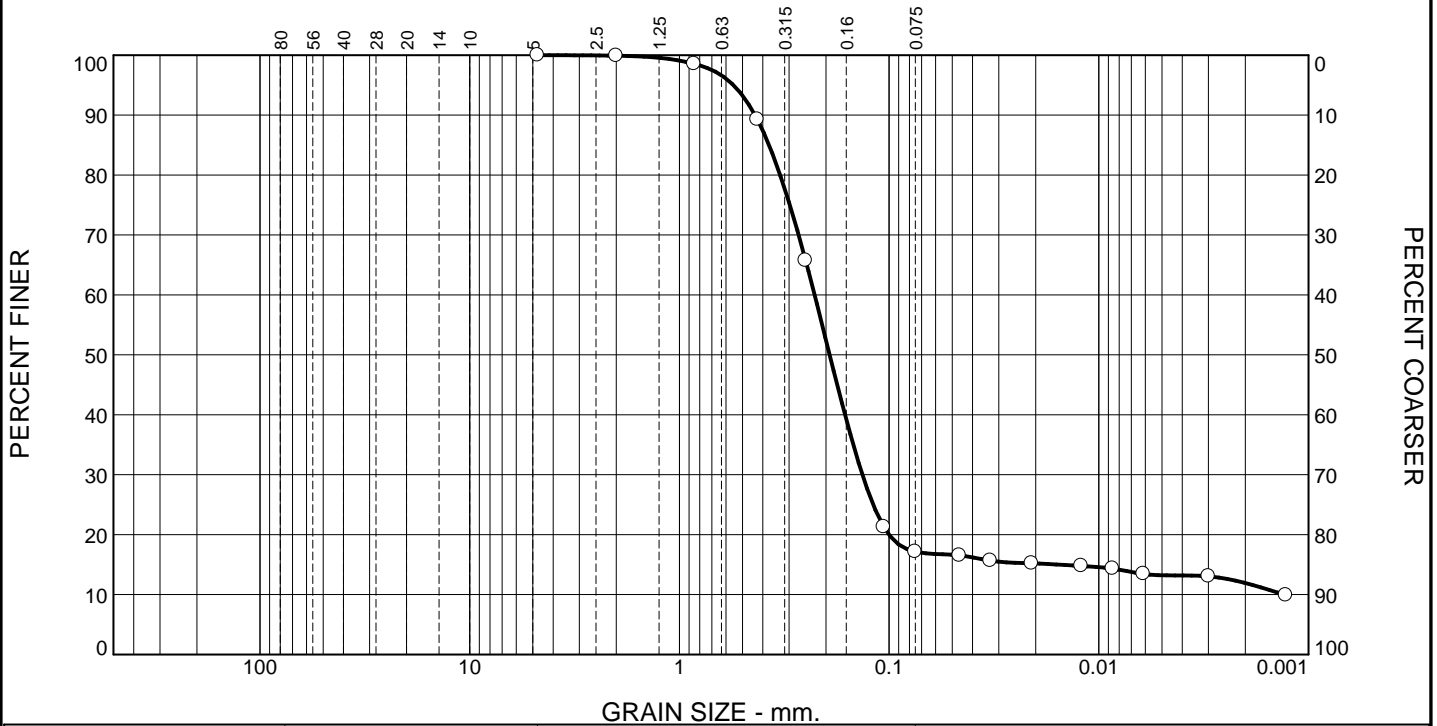
# Particle Size Distribution Report

% +75mm	% Gravel		% Sand			% Fines	
	Coarse	Fine	Coarse	Medium	Fine	Silt	Clay
0.0	0.0	0.0	0.1	10.6	72.1	5.3	11.9

TEST RESULTS			
Opening Size	Percent Finer	Spec.* (Percent)	Pass? (X=Fail)
4.75mm	100.0		
2.00mm	99.9		
.850mm	98.5		
0.425mm	89.3		
0.250mm	65.7		
0.106mm	21.3		
0.075mm	17.2		
0.0462 mm.	16.5		
0.0329 mm.	15.7		
0.0209 mm.	15.2		
0.0121 mm.	14.8		
0.0086 mm.	14.3		
0.0061 mm.	13.4		
0.0030 mm.	13.0		
0.0013 mm.	9.9

Representative soil samples from the sand and clay layers were submitted for grain size analysis to determine appropriate Site Condition Standards. Based on the grain size analysis and the interbedded nature of sand and clay at the Site, the more stringent coarse-grained Site Condition Standards are considered appropriate as a conservative measure.
