Phase Two Environmental Site Assessment 266 and 268 Carruthers Avenue, Ottawa, Ontario

Phase Two Environmental Site Assessment

OTT-22009213-C0

2022-10-03

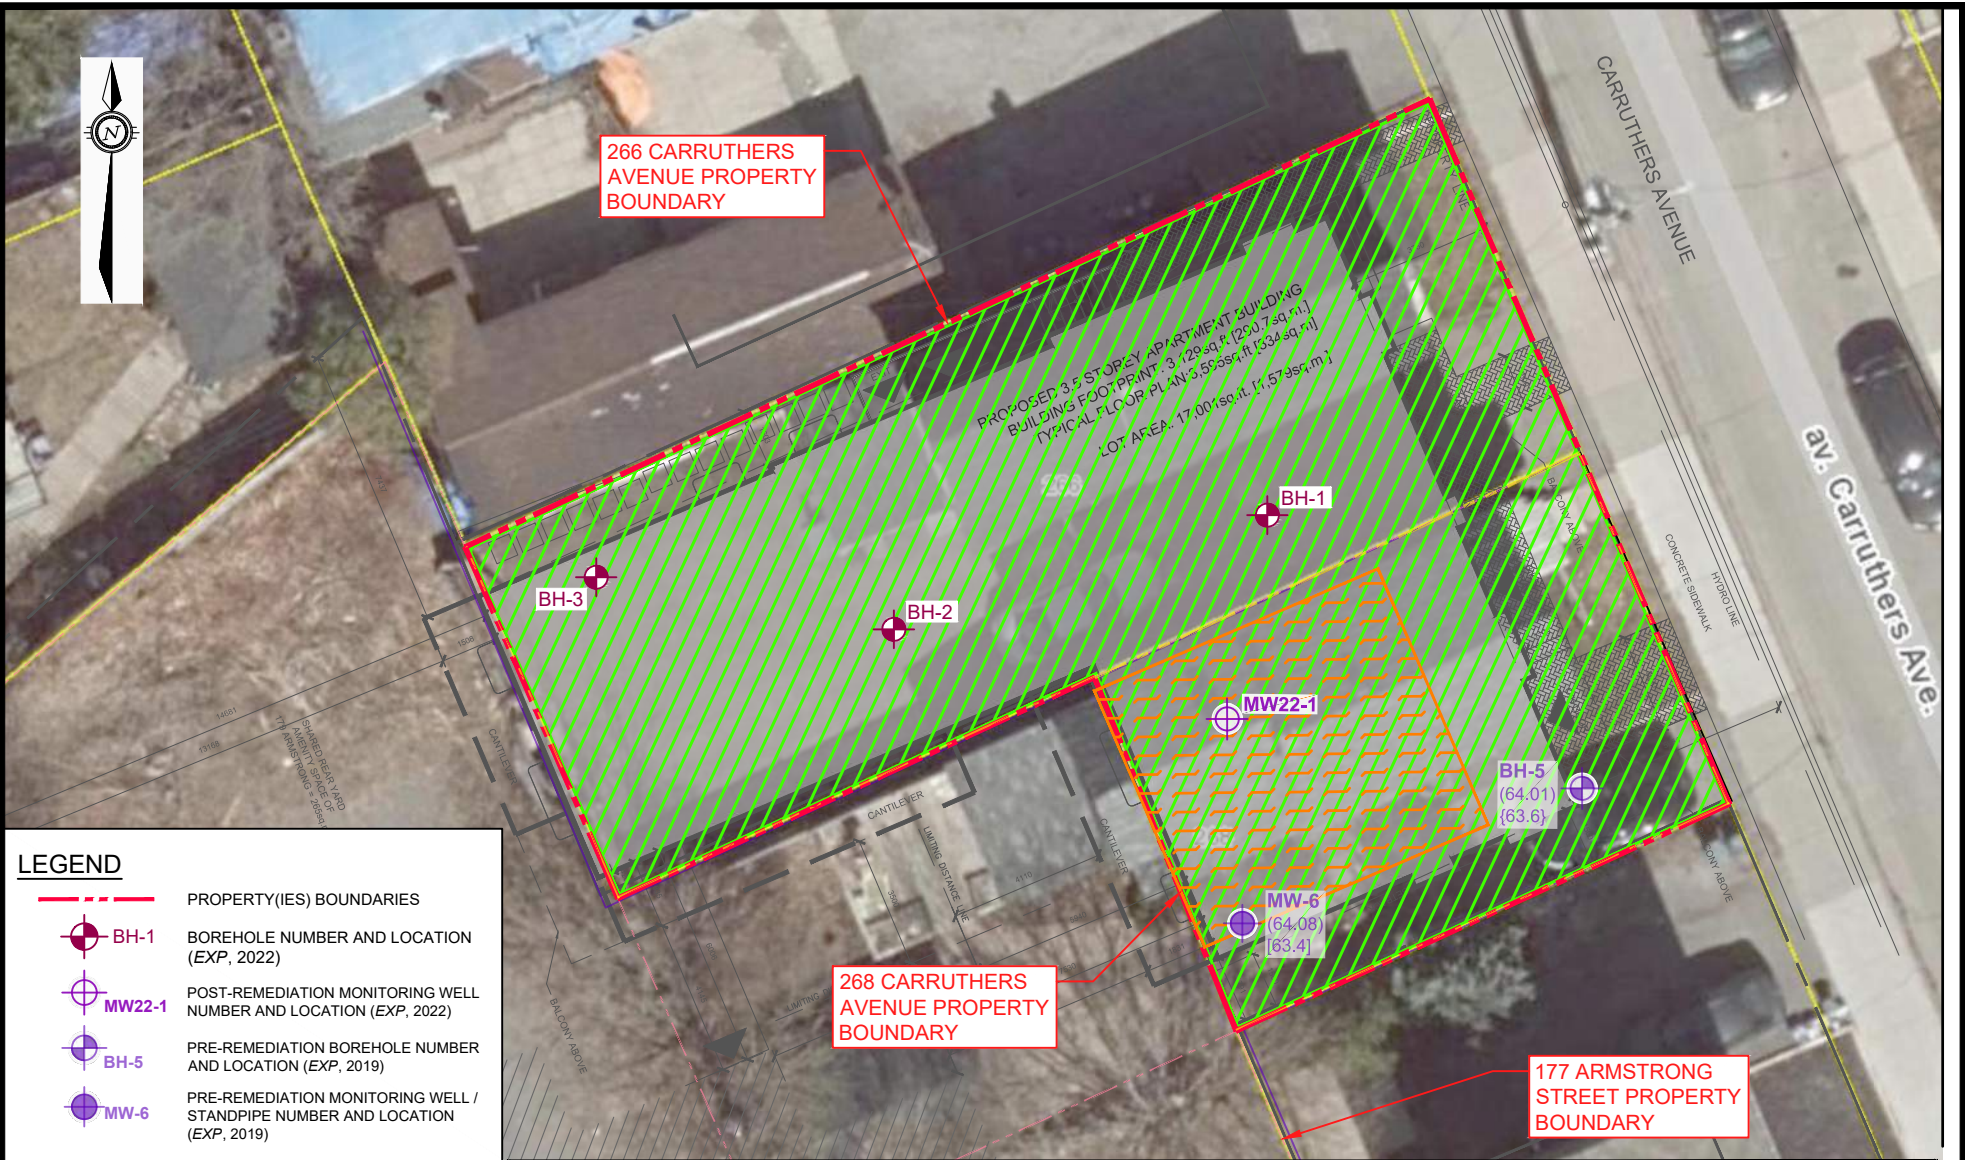
DATE SEPTEMBER 2022		PHASE TWO ENVIRONMENTAL SITE ASSESSMENT (ESA) 266 AND 268 CARRUTHERS AVENUE, OTTAWA, ONTARIO		project no. OTT-22009213-C0
DESIGN MM	CHECKED CH			scale 1:200
DRAWN BY AS		TITLE: AREAS OF POTENTIAL ENVIRONMENTAL CONCERN		FIG 3

The purpose of the Phase Two ESA was to investigate the soil quality at the Phase Two property and to characterize conditions in the fill material related to the PCA described above within the APEC shown on Figure 3 in Appendix A.

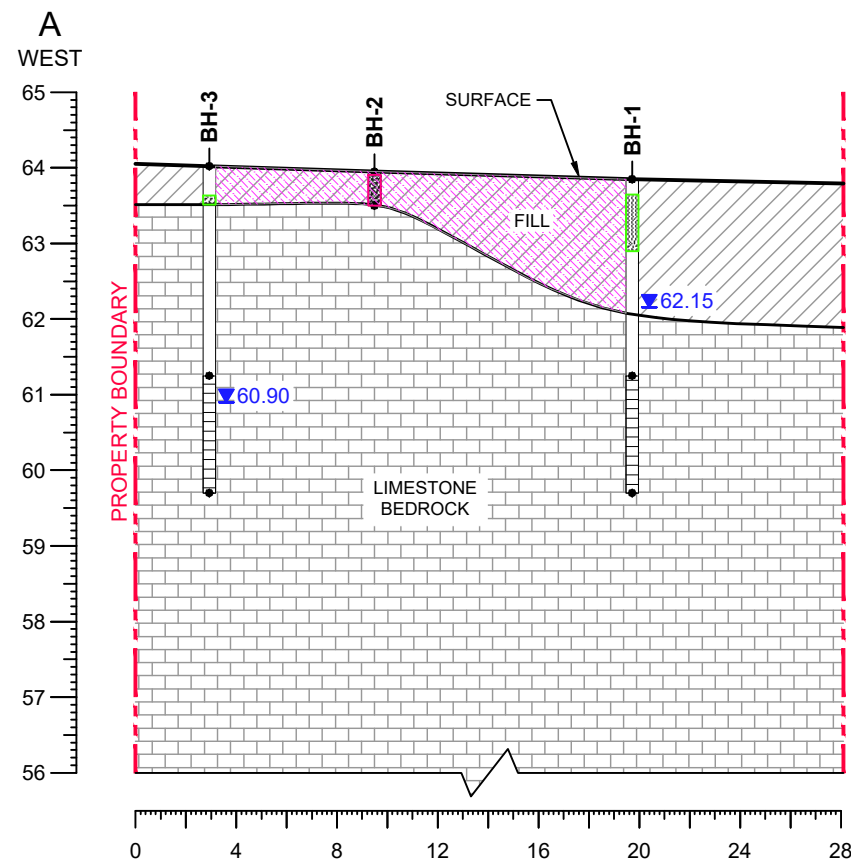
CROSS SECTION A-A'

The general stratigraphy at the Phase Two property, as observed in the boreholes, consisted of fill overlying grey limestone bedrock at depth of 0.4 m to 1.6 m bgs. A brief description of the soil stratigraphy at the Phase Two property, in order of depth, is summarized in the following sections.

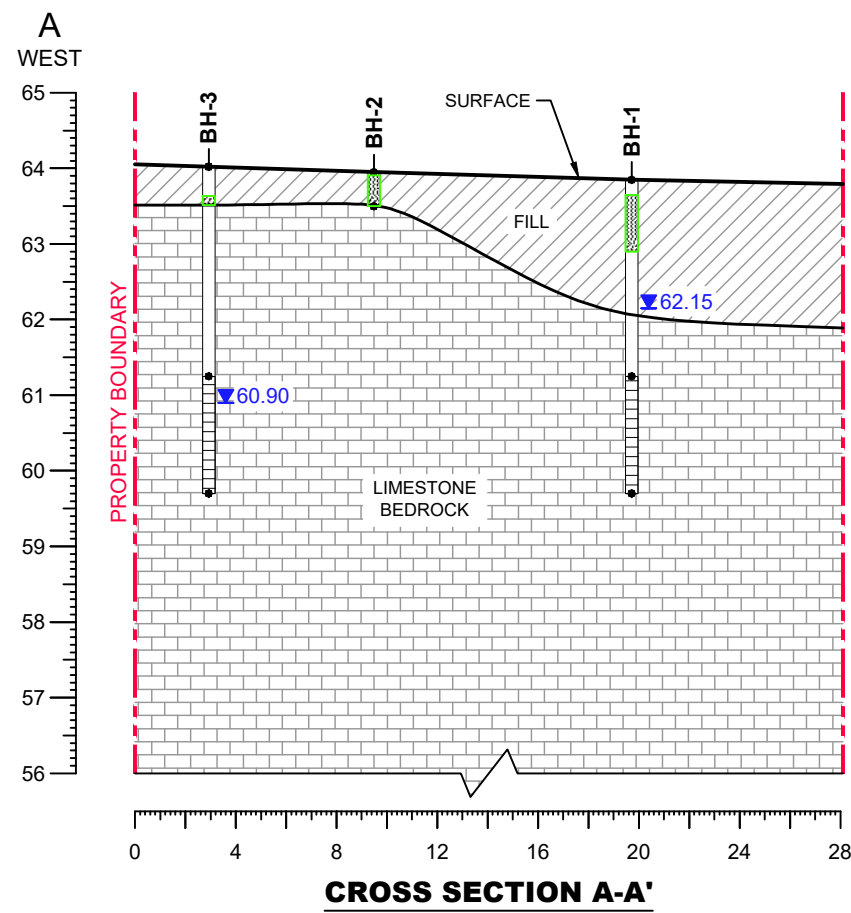
DATE SEPTEMBER 2022	PHASE TWO ENVIRONMENTAL SITE ASSESSMENT (ESA) 266 AND 268 CARRUTHERS AVENUE, OTTAWA, ONTARIO	project no. OTT-22009213-CO
DESIGN MM	CHECKED CH	scale HORZ. 1:300 / VERT. 1:100
DRAWN BY AS		TITLE: CROSS SECTION A-A' & B-B' ANALYTICAL RESULTS - PAH
		FIG 11

Borehole	Depth (mbgs)	22-Jul-22																	
		Ace	AcI	An	B(a)A	B(a)P	B(b)F	B(ghi)P	B(k)F	C	DA	Fl	F	I(123)P	T-MN	N	P	Py	
BH-1	Run1	0.15 - 0.75	< 0.05	< 0.05	< 0.05	< 0.05	< 0.05	< 0.05	< 0.05	< 0.05	< 0.05	< 0.05	< 0.05	< 0.05	< 0.05	< 0.05	< 0.05	< 0.05	
BH-2	SS2	0.15 - 0.5	< 0.05	< 0.07	0.08	0.26	0.23	0.3	0.11	0.11	0.3	0.05	0.43	< 0.09	0.12	< 0.05	< 0.07	0.32	0.38
BH3	GS3	0.35 - 0.45	< 0.05	< 0.05	< 0.05	0.17	0.15	0.22	0.07	0.09	0.18	< 0.05	0.28	< 0.05	0.09	< 0.05	< 0.05	0.13	0.21
BH3	Dup1	0.35 - 0.45	< 0.05	< 0.05	< 0.05	0.12	0.13	0.18	0.06	0.06	0.15	< 0.05	0.21	< 0.05	0.07	< 0.05	< 0.05	0.12	0.18
