# **Environmental Impact Statement Mattamy – Half Moon Bay West**

**Revised Report  
February 28, 2019**

**KILGOUR & ASSOCIATES LTD.**  
[www.kilgourassociates.com](http://www.kilgourassociates.com)  
Project Number: MATT514

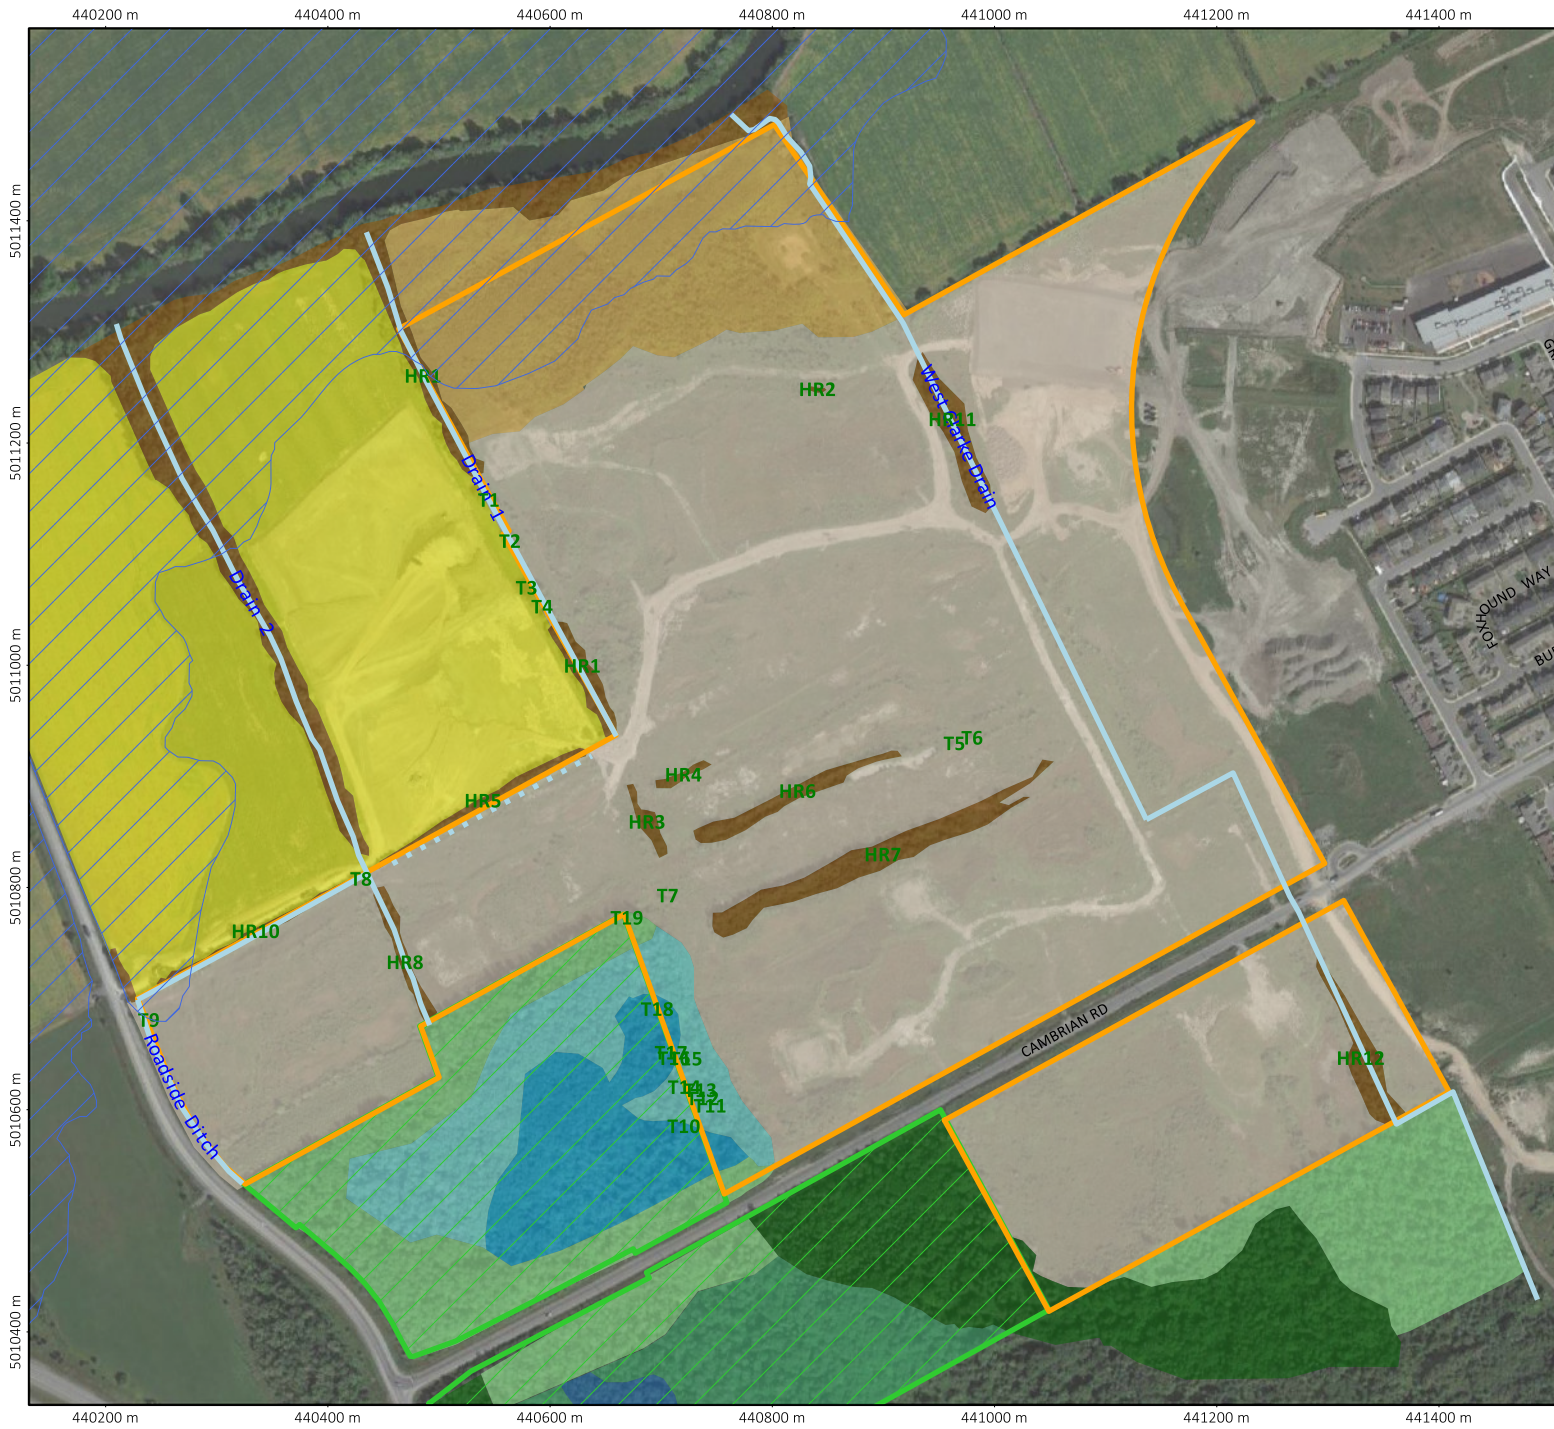
**Figure 1:** Current vegetation and tree distribution.

The north and west edges of the north UNA forest block consist of a contiguous band of fresh moist poplar deciduous forest (FOD8-1) composed primarily of trembling aspen. Other tree species present include Manitoba Maple, Balsam Poplar, White Birch with some young Crack Willow along the edges. Common buckthorn is found throughout the community and is especially abundant along the western edge, which has been subject to significant wind throw damage. Several large Green Ash are growing on the north-east edge. Except for this section, the forest edge along the north side is located approximately 5 m south of the property line, leaving a gap of cultural meadow.

The southern UNA wood block is significantly more coniferous than the northern wood block. The western edge of the forest is fresh-moist cedar coniferous forest (FOC4-1) sub-dominated with White Spruce and Balsam Fir. This area western edge has experienced a significant amount of wind throw damage. Most of the central portion of this block is a fresh-moist poplar mixed forest (FOM8-1). The community includes Trembling Aspen, White Spruce, Balsam Fir, White Birch, Manitoba Maple, Balsam Poplar, Basswood, White Elm and a small a number of Black Cherries. The understory includes Glossy Buckthorn, Red-Osier Dogwood, Staghorn Sumac, Red Elderberry, Round-Leaved Dogwood, Pussy Willow, Slender Willow, Speckled Alder, Nannyberry and Grey Dogwood, False Dogwood as shrubbery with False Nettle, Poison Ivy, Sensitive Fern, Foamflower, Common Strawberry, Rattlesnake Fern and Dwarf Raspberry as ground cover. Forest cover is especially dense in the northwest corner. There is a dense White Cedar swamp inclusion toward the west side (SWC3-1).

Patch 1 is the remnant hedgerow along Drain 1. It includes some larger willows and ash trees, most of which are in poor condition. Patches 2 through 6 (windrows) are all small, mostly linear areas of young trees (less than 30 cm DBH) and saplings that provide limited nesting areas to birds and cover for wildlife. These areas were originally created by piling of topsoil during clearing of the site in 2008. No tree crevices or snags were observed in these patches during the surveys which makes it unlikely to be SAR bat habitat. These small patches are not predicted to provide potential SAR habitat.

Patches 7 through 9, 11, and 12 (hedgerows) are also small linear patches, but they are composed of a combination of some large Crack Willow, Manitoba Maple and Green Ash with small trees of the same species and saplings. These patches are part of the hedgerows visible in the 1976 air photos, which is the reason that they contain the largest trees on site. A few snags were also present in these patches; however, it is unlikely that these patches would provide SAR bat habitat due to their linear composition. Additionally, these small patches are not predicted to provide potential SAR habitat.

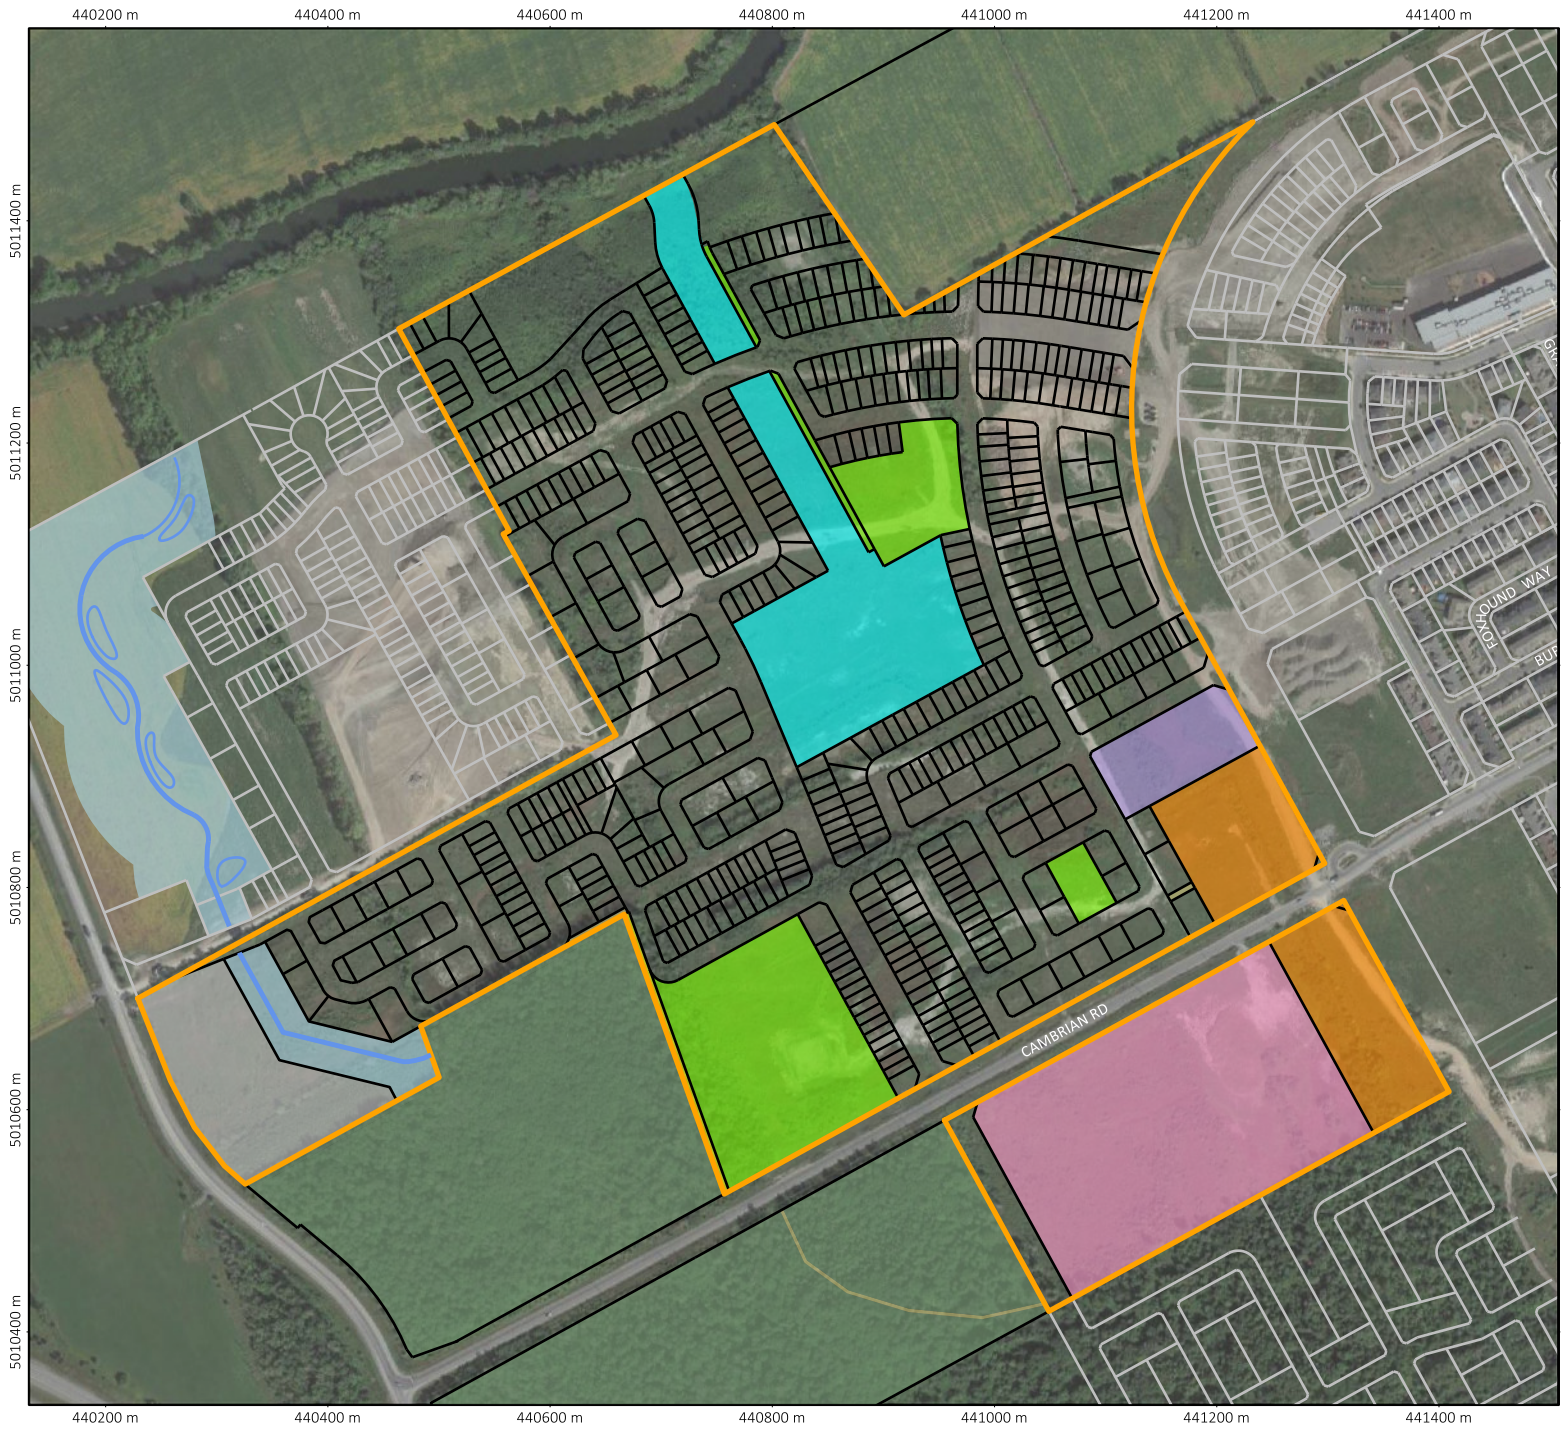
**Figure 2: Community plan**

The Drain 1 will be removed along the eastern edge of the site, from its starting point at the south boundary down to the point where it intersects the floodplain. The channel and its associated treed riparian buffer will be maintained within the floodplain. The HDFA for the site (Kilgour, 2016) found the only significant ecological function of the East Drain to be its contribution of surface water runoff to downstream features. Under the proposed development, waters from that portion of the sub-catchment will be conveyed to the Jock instead through Clarke SMP pond or through the realigned Drain 2.
