**PATERSON
GROUP**

Phase II Environmental Site Assessment

357, 361 and 363 Preston Street
Ottawa, Ontario

Report: PE5699-2
July 12, 2022

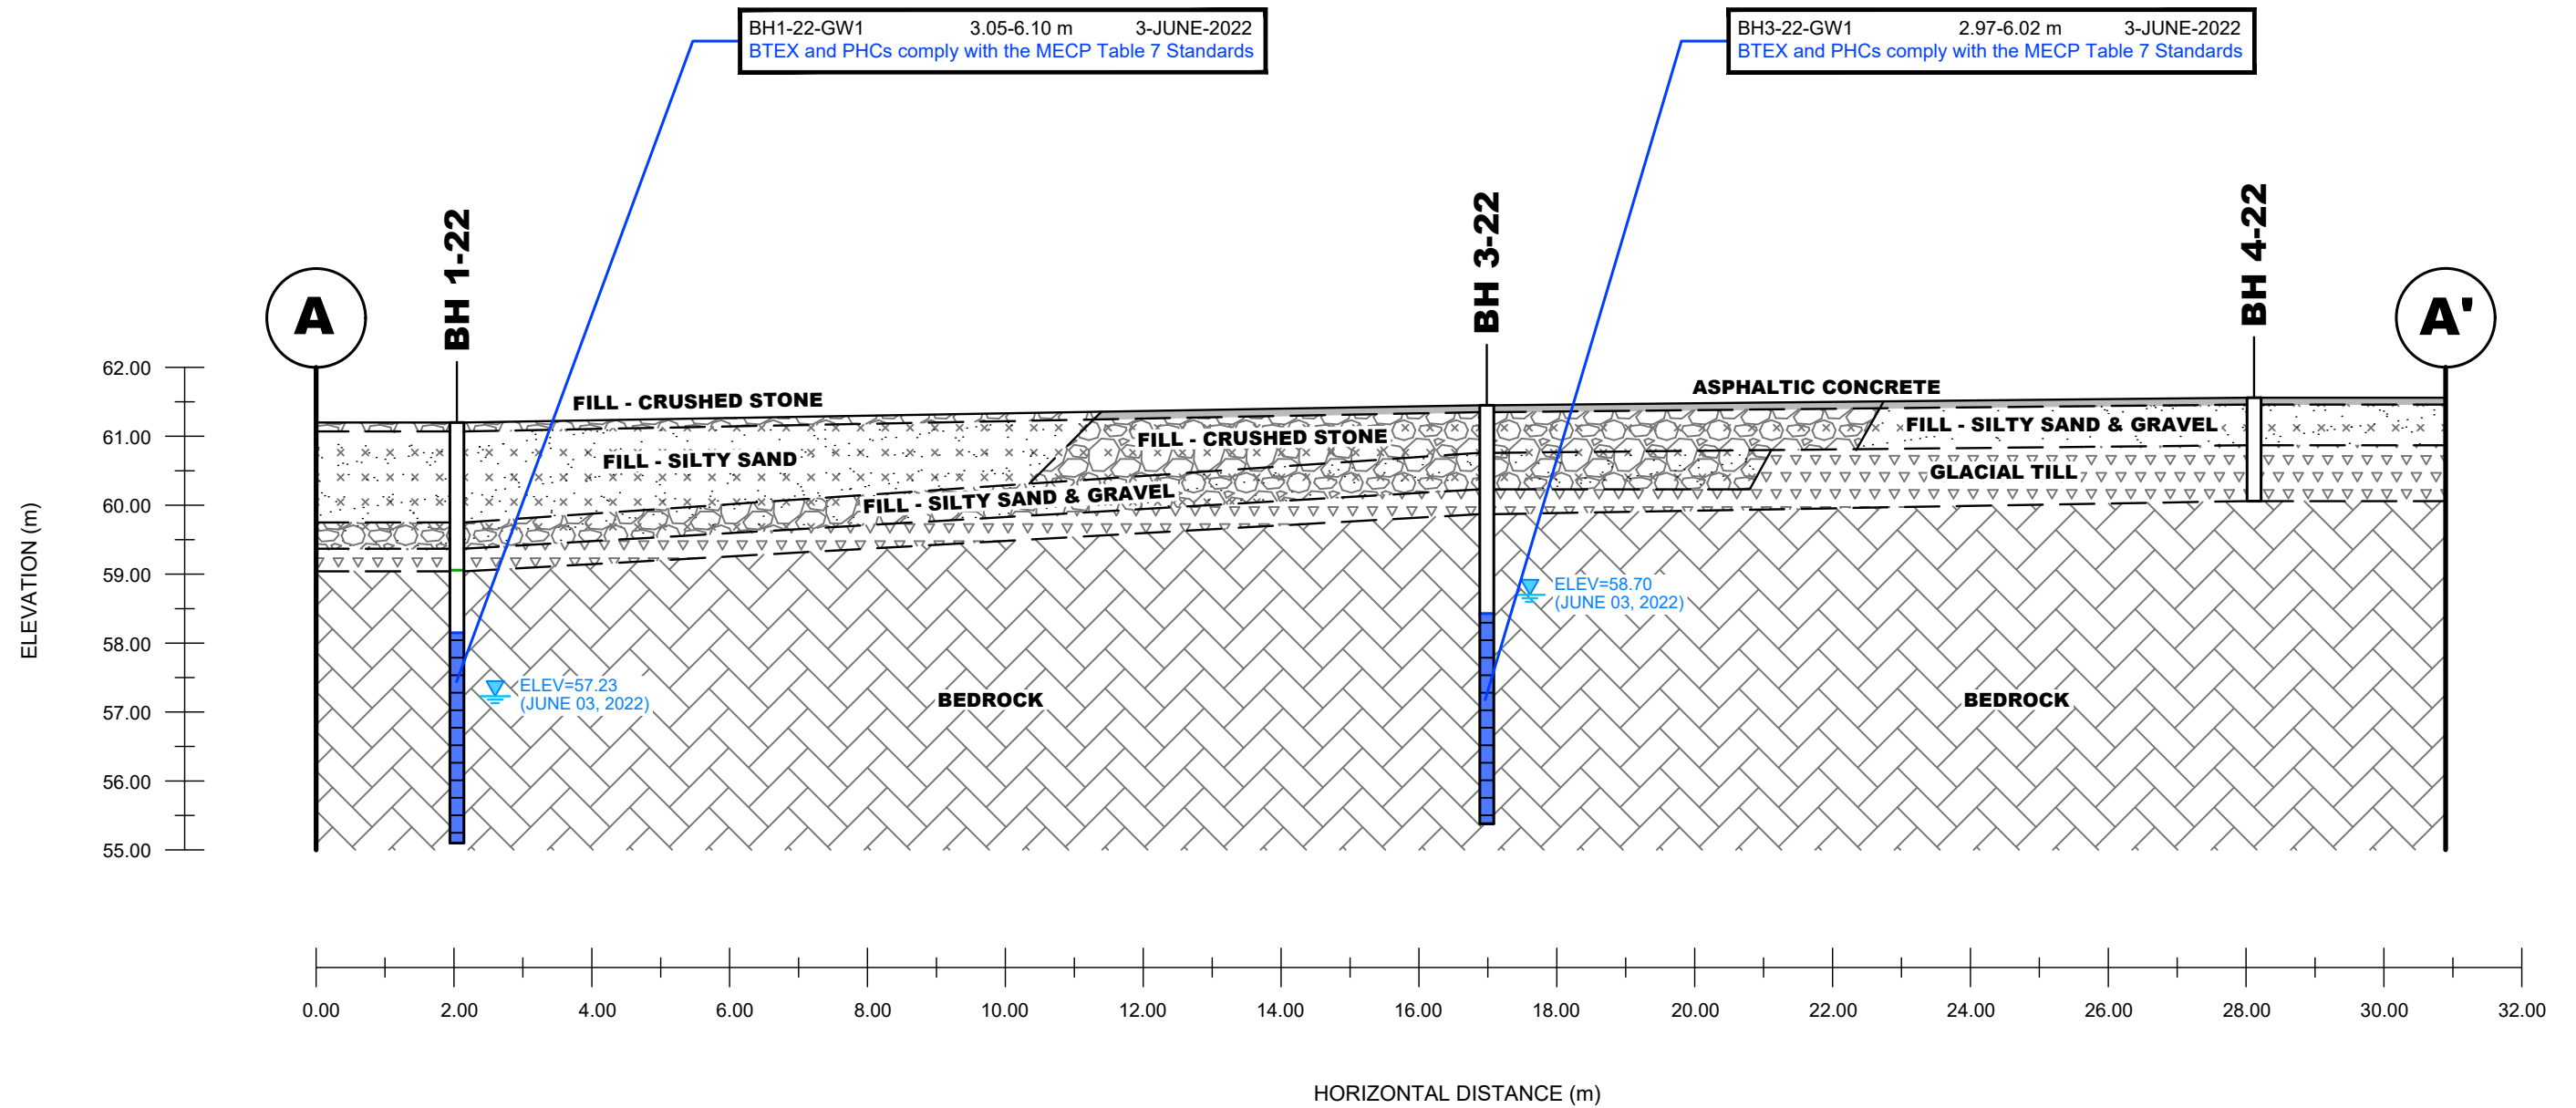
Scale:	1:250	Date:	06/2022
Drawn by:	YA	Report No.:	PE5699-2
Checked by:	JD	Dwg. No.:	PE5699-7
Approved by:	MSD	Revision No.:

1503839 ONTARIO INC.
PHASE II - ENVIRONMENTAL SITE ASSESSMENT
 357, 361 & 363 PRESTON STREET
 OTTAWA, ONTARIO
 Title: **ANALYTICAL TESTING PLAN - GROUNDWATER (BTEX, PHCs)**
