ARBORIST REPORT

Tree Conservation Report
for
2375 St. Laurent Blvd, Ottawa, Ontario

Report 22-003

Submitted
June 6, 2022

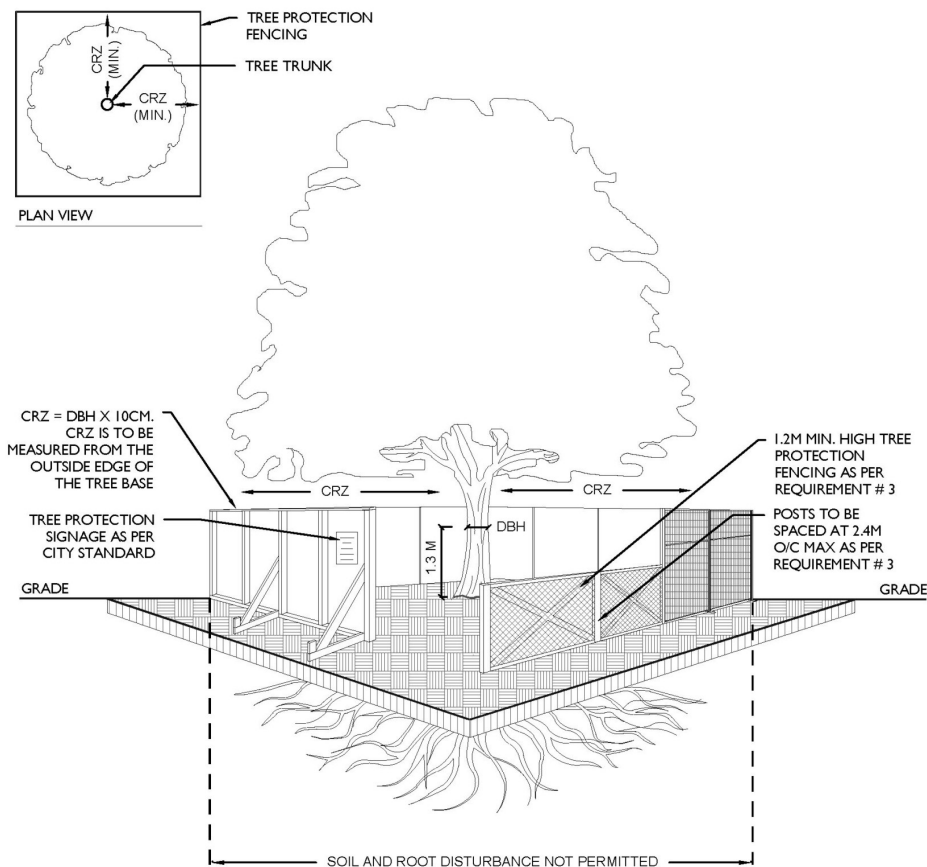
- DO NOT EXTEND HARD SURFACE OR SIGNIFICANTLY CHANGE LANDSCAPING
3. TREE PROTECTION FENCING MUST BE AT LEAST 1.2M IN HEIGHT, AND CONSTRUCTED OF RIGID OR FRAMED MATERIALS (E.G. MODULOC - STEEL, PLYWOOD HOARDING, OR SNOW FENCE ON A 2"X4" WOOD FRAME) WITH POSTS 2.4M APART, SUCH THAT THE FENCE LOCATION CANNOT BE ALTERED. ALL SUPPORTS AND BRACING MUST BE PLACED OUTSIDE OF THE CRZ, AND INSTALLATION MUST MINIMISE DAMAGE TO EXISTING ROOTS. (SEE DETAIL)

Barriers shall be constructed under the guidance of an arborist. Neighbouring trees shall be protected with staked/anchored fencing to City standards, erected a minimum of dbh x 10 at the discretion of City staff. Barrier material shall be 1.2 metre snow fence wired to steel "T" bar posts (@2.4 metres o.c. max) 50 x 150 wood top rail bolted to posts. See also Appendix A.
