PHASE I ENVIRONMENTAL SITE ASSESSMENT

3493, 3497, AND 3499 INNES ROAD OTTAWA, ONTARIO

Project Number: 200412

26 June 2020

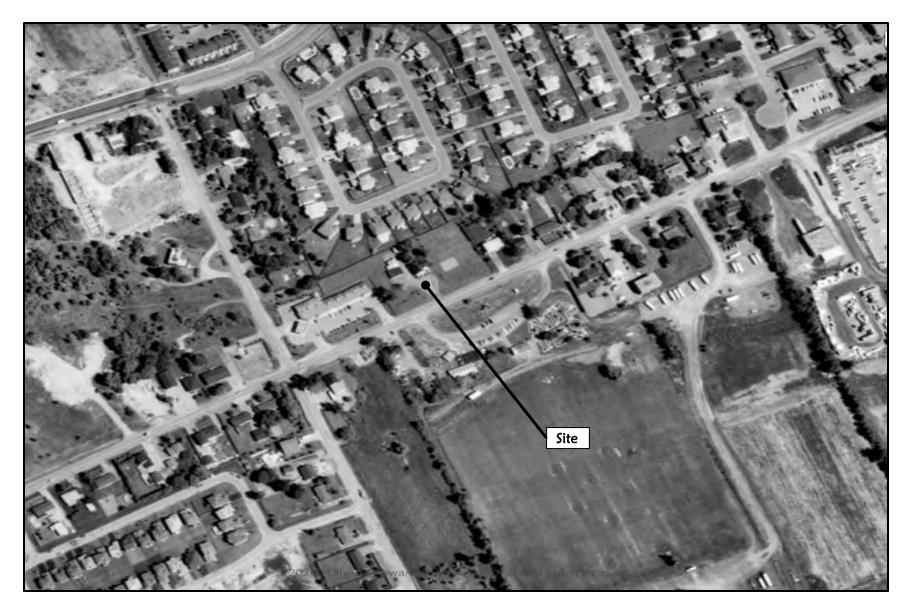
Historical Aerial Photography of the Site 3493, 3497, and 3499 Innes Road, Ottawa, Ontario 1991 200412 - June 2020

Year	Description		
i eai	Site	Phase I Study Area	
1991	There are no visible significant changes to the Phase I Property from the 1981 aerial photograph. I small garden appears to be present on the 3499 Innes Road property.	The property to the west of the subject site has been redeveloped to include the current commercial plaza and fuel service station. Further residential development is observed throughout the Study Area, including the properties to the immediate north of the Phase I Property and areas south of Innes Road.	
2002	There are no visible significant changes to the Phase I Property from the 1991 aerial photograph.	New residential development is noted west of the Phase I Property, on the west side of Page Road.	
2011	The residential development has been demolished, the garage is the only building on the Phase I Property.	I koad and innet koad have been demolithed i	
2018	A trailer used for commercial office space is present on the Phase I Property.	A retirement residence has been constructed on the southeast corner of Page road and Innes Road.
