Site Servicing Report

Hydro One Operations Centre

3440 Frank Kenny Road, Orléans ON

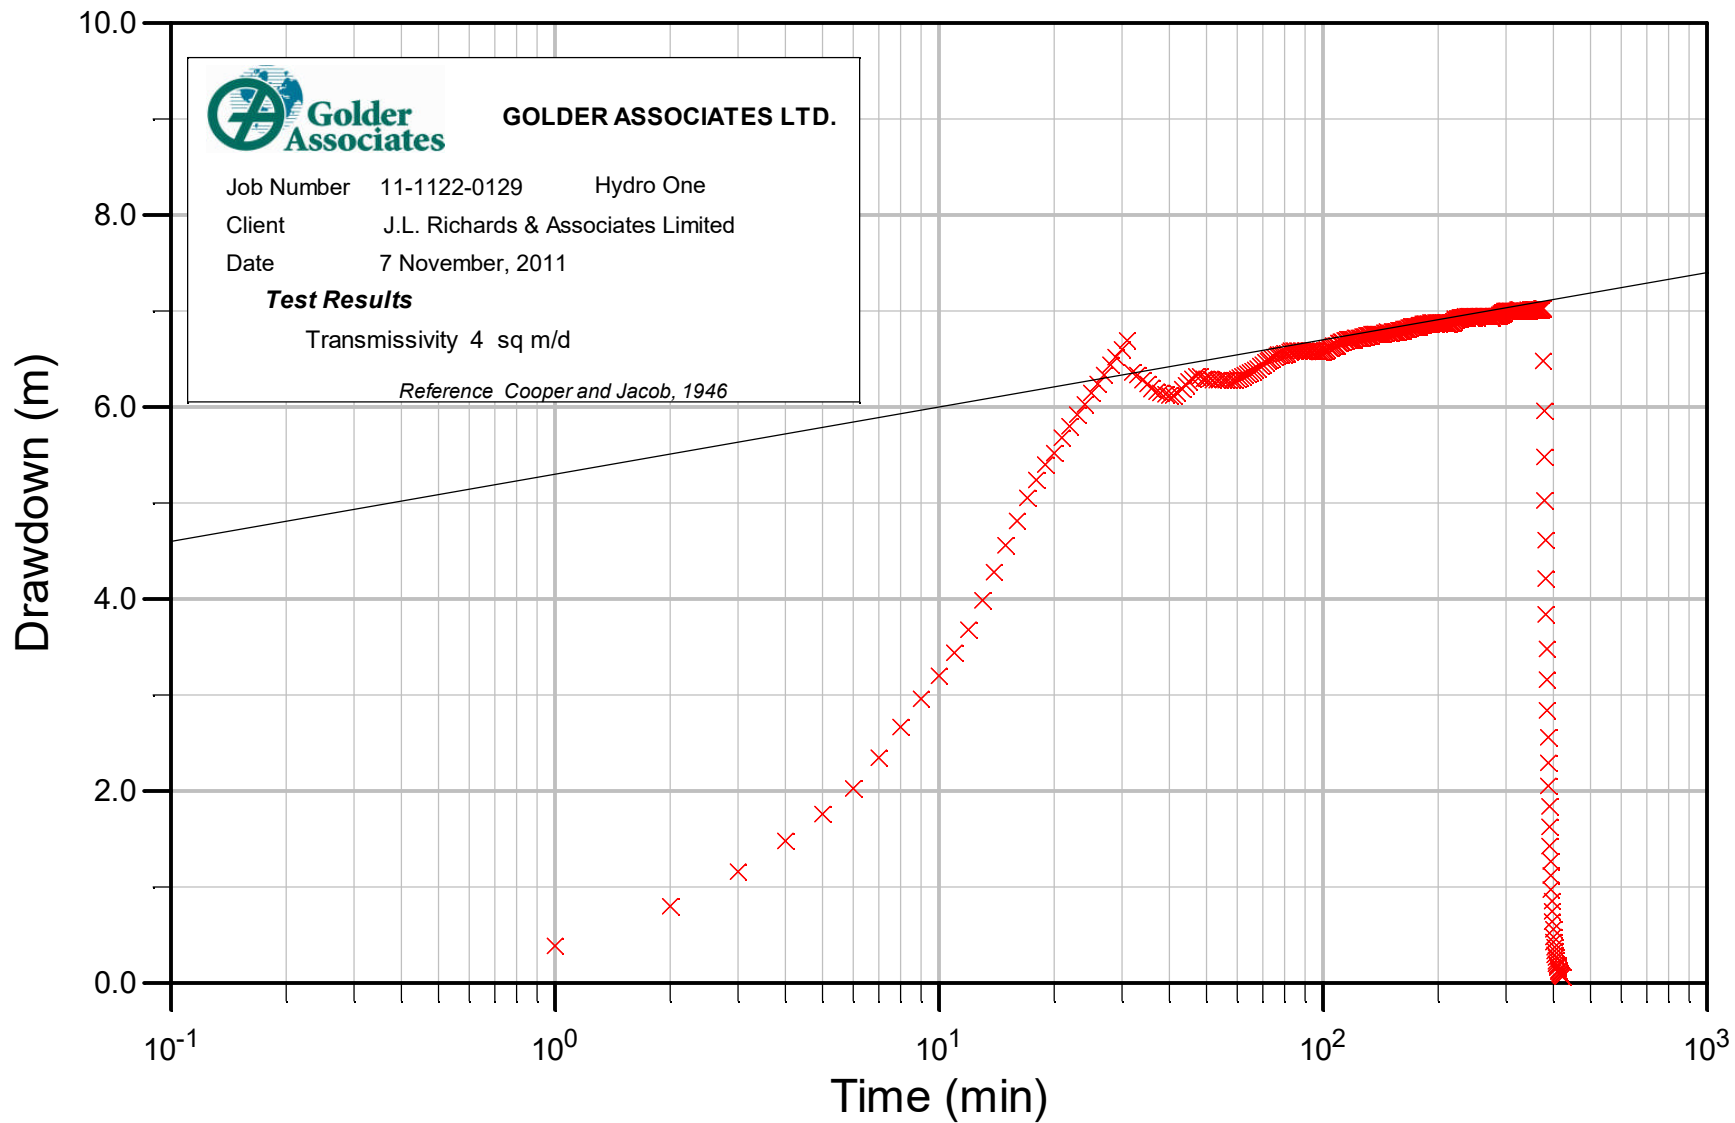
PW11-1 Cooper and Jacob

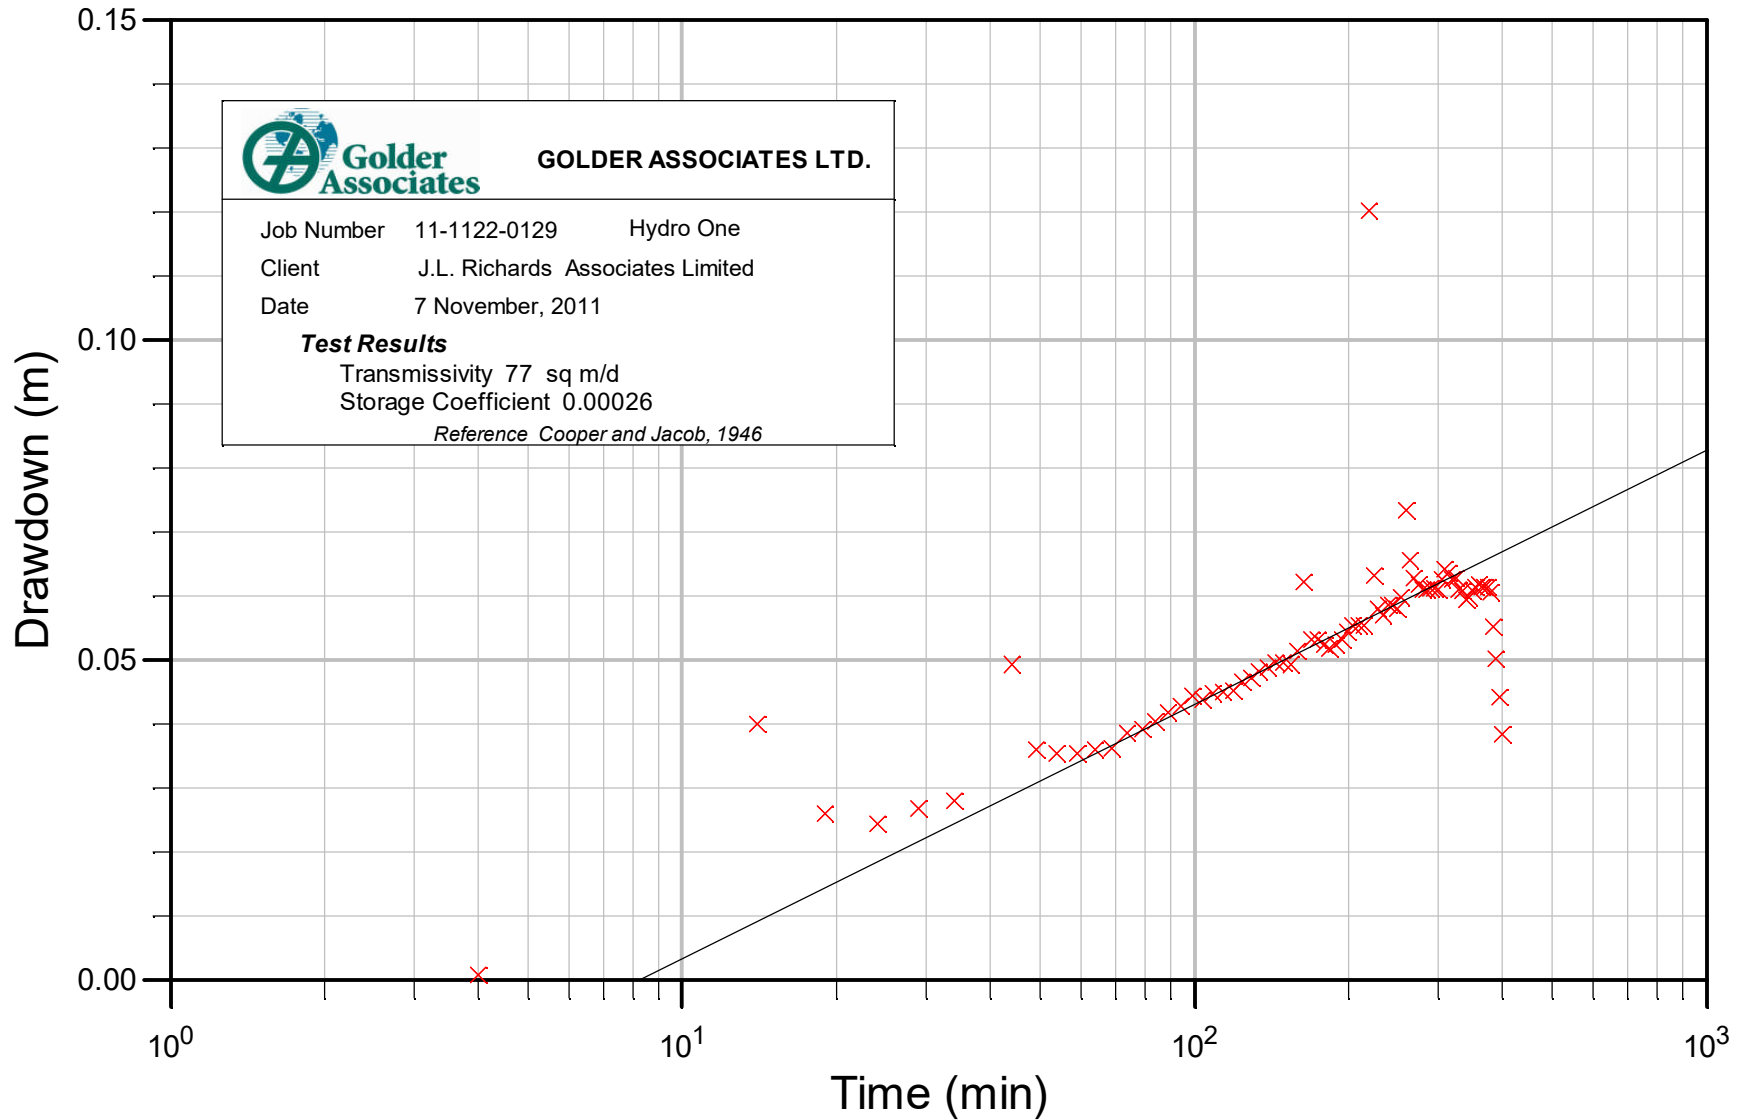
Residential Well - Cooper and Jacob
