HYDROGEOLOGICAL ASSESSMENT AND TERRAIN ANALYSIS, CORKERY COMMUNITY CENTRE, 3447 OLD ALMONTE ROAD, OTTAWA, ON

Project No.: CCO-21-3339-01

Revision 1: August 2, 2022

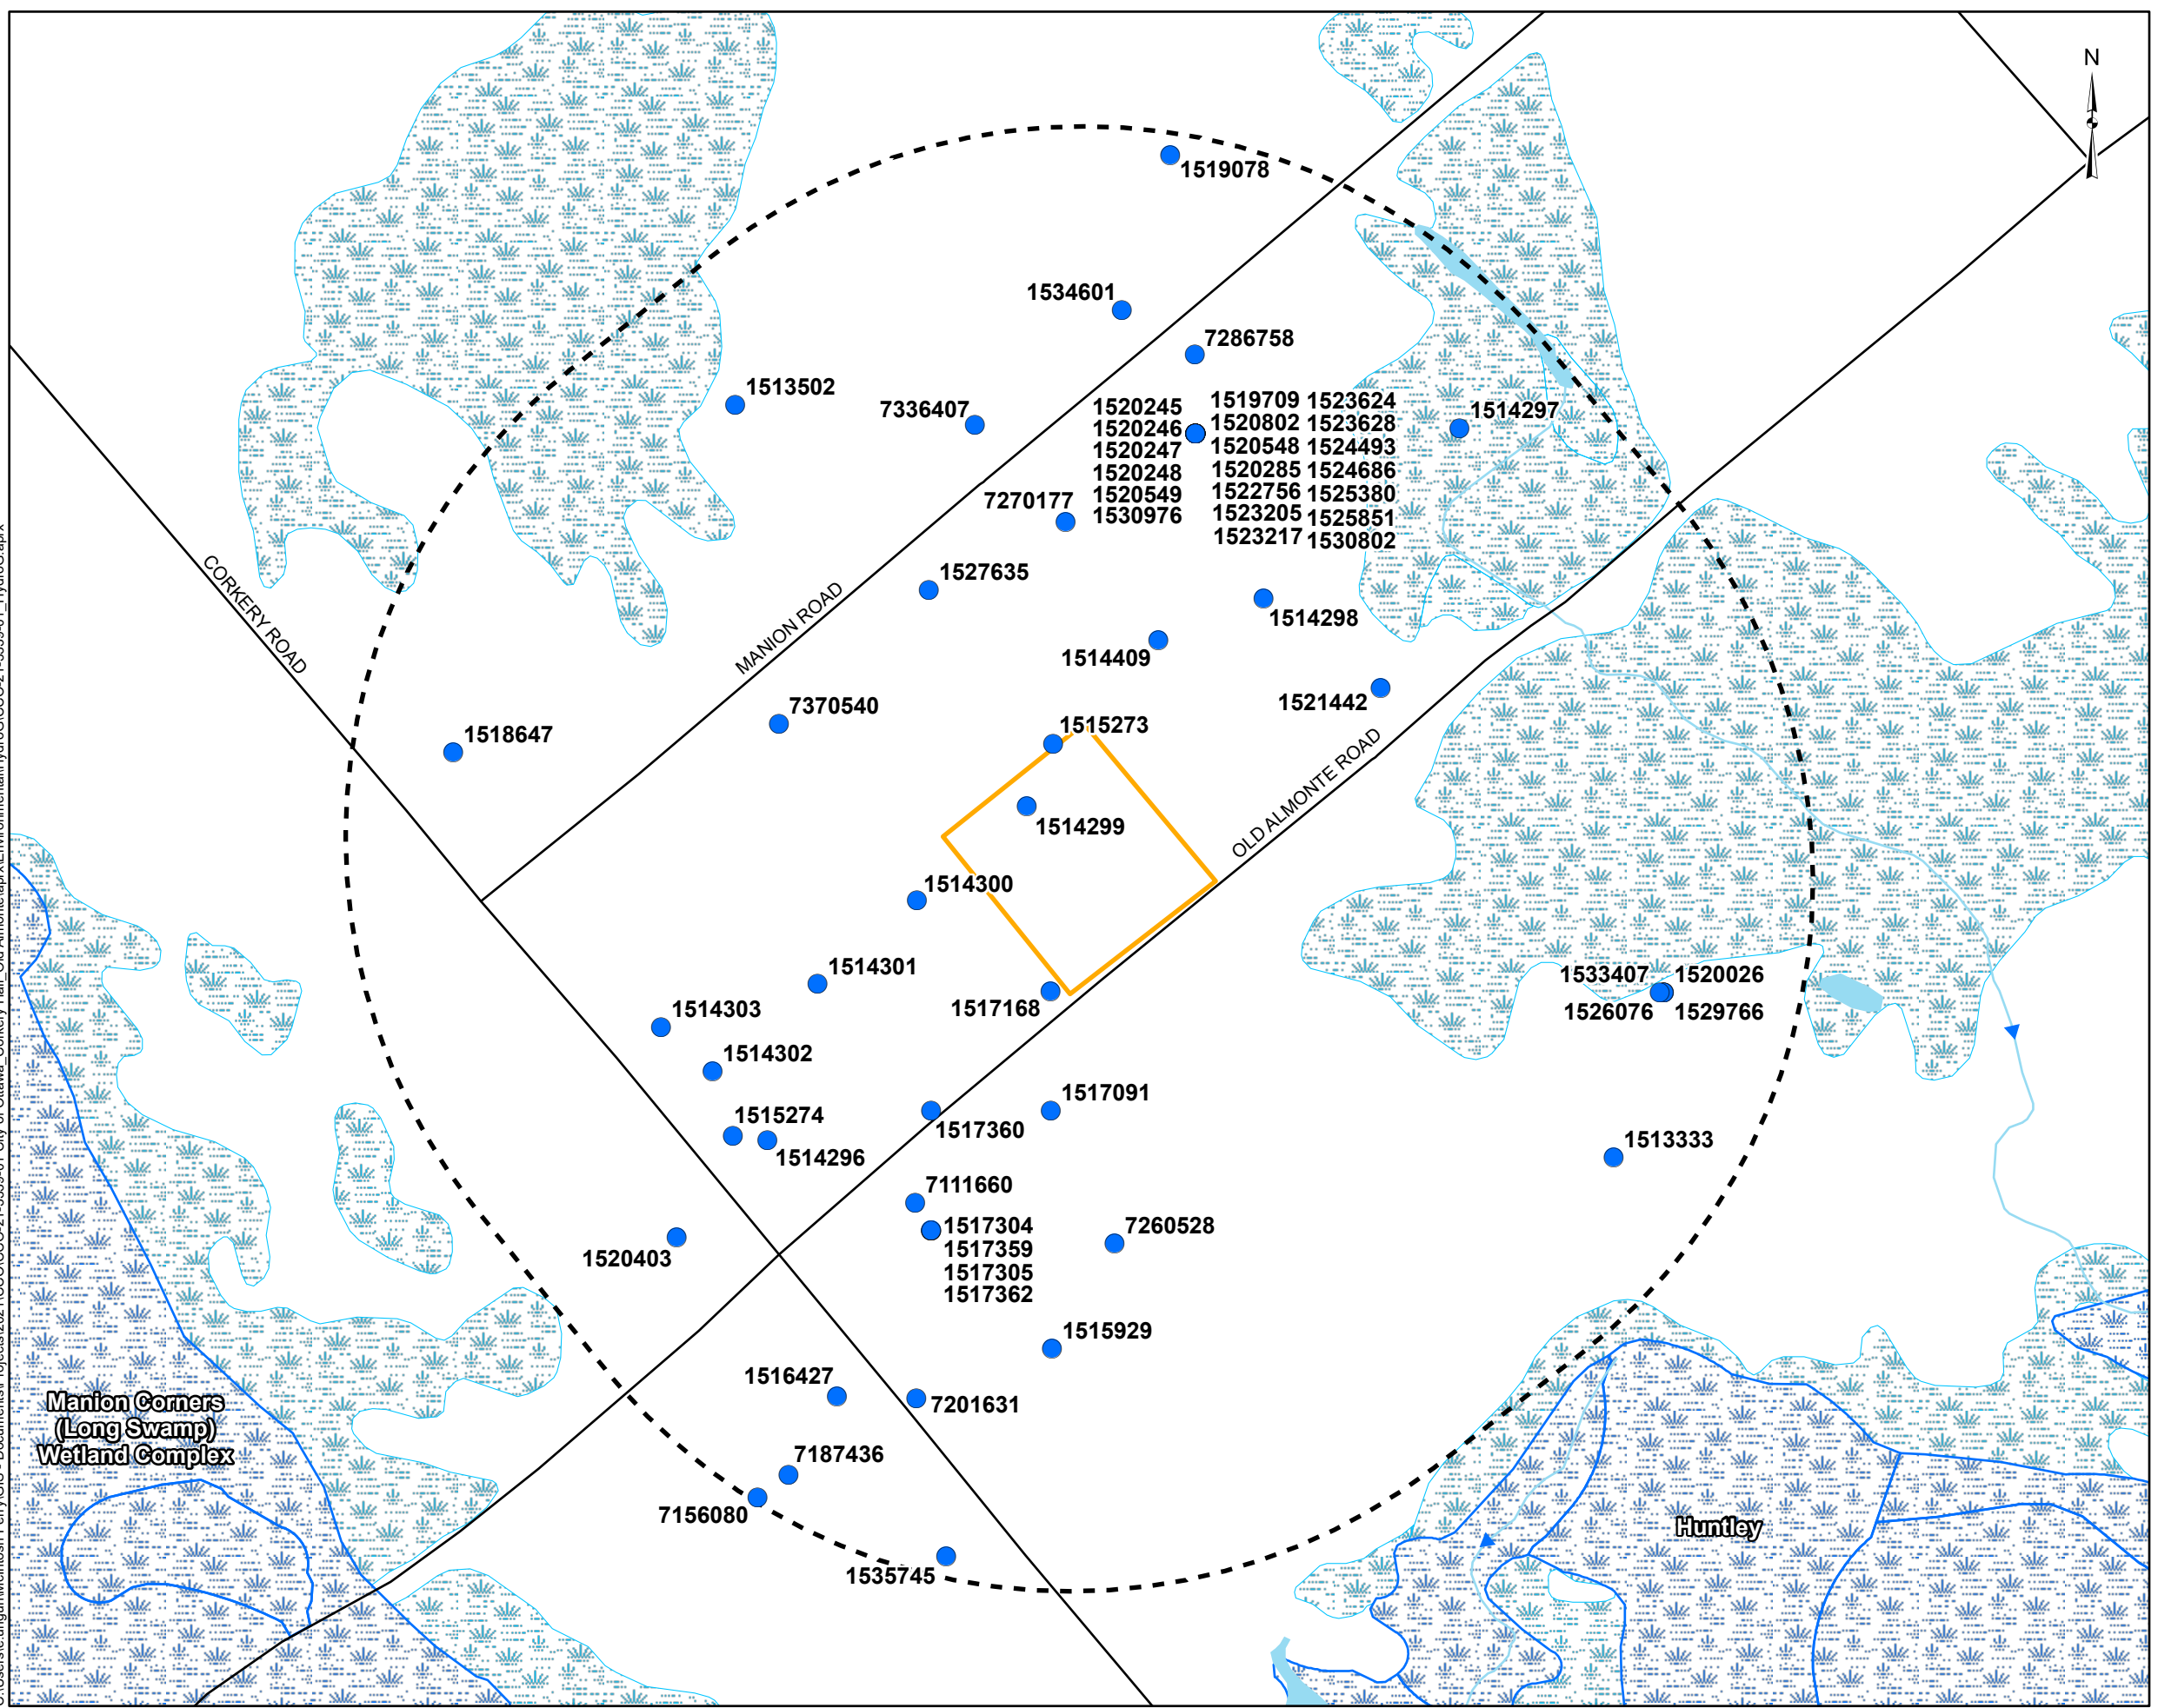
- Site Boundary
- 500m Buffer
- MECP Well Location
- Local Road
- Major Road
- Waterbody
- Watercourse
- Unevaluated Wetland
- Provincially Significant Wetland

Driller-reported well yields ranged from 9.0 – 136.4 L/min, generally at or above the recommended minimum rate of 13.7 L/min for residential occupancies.

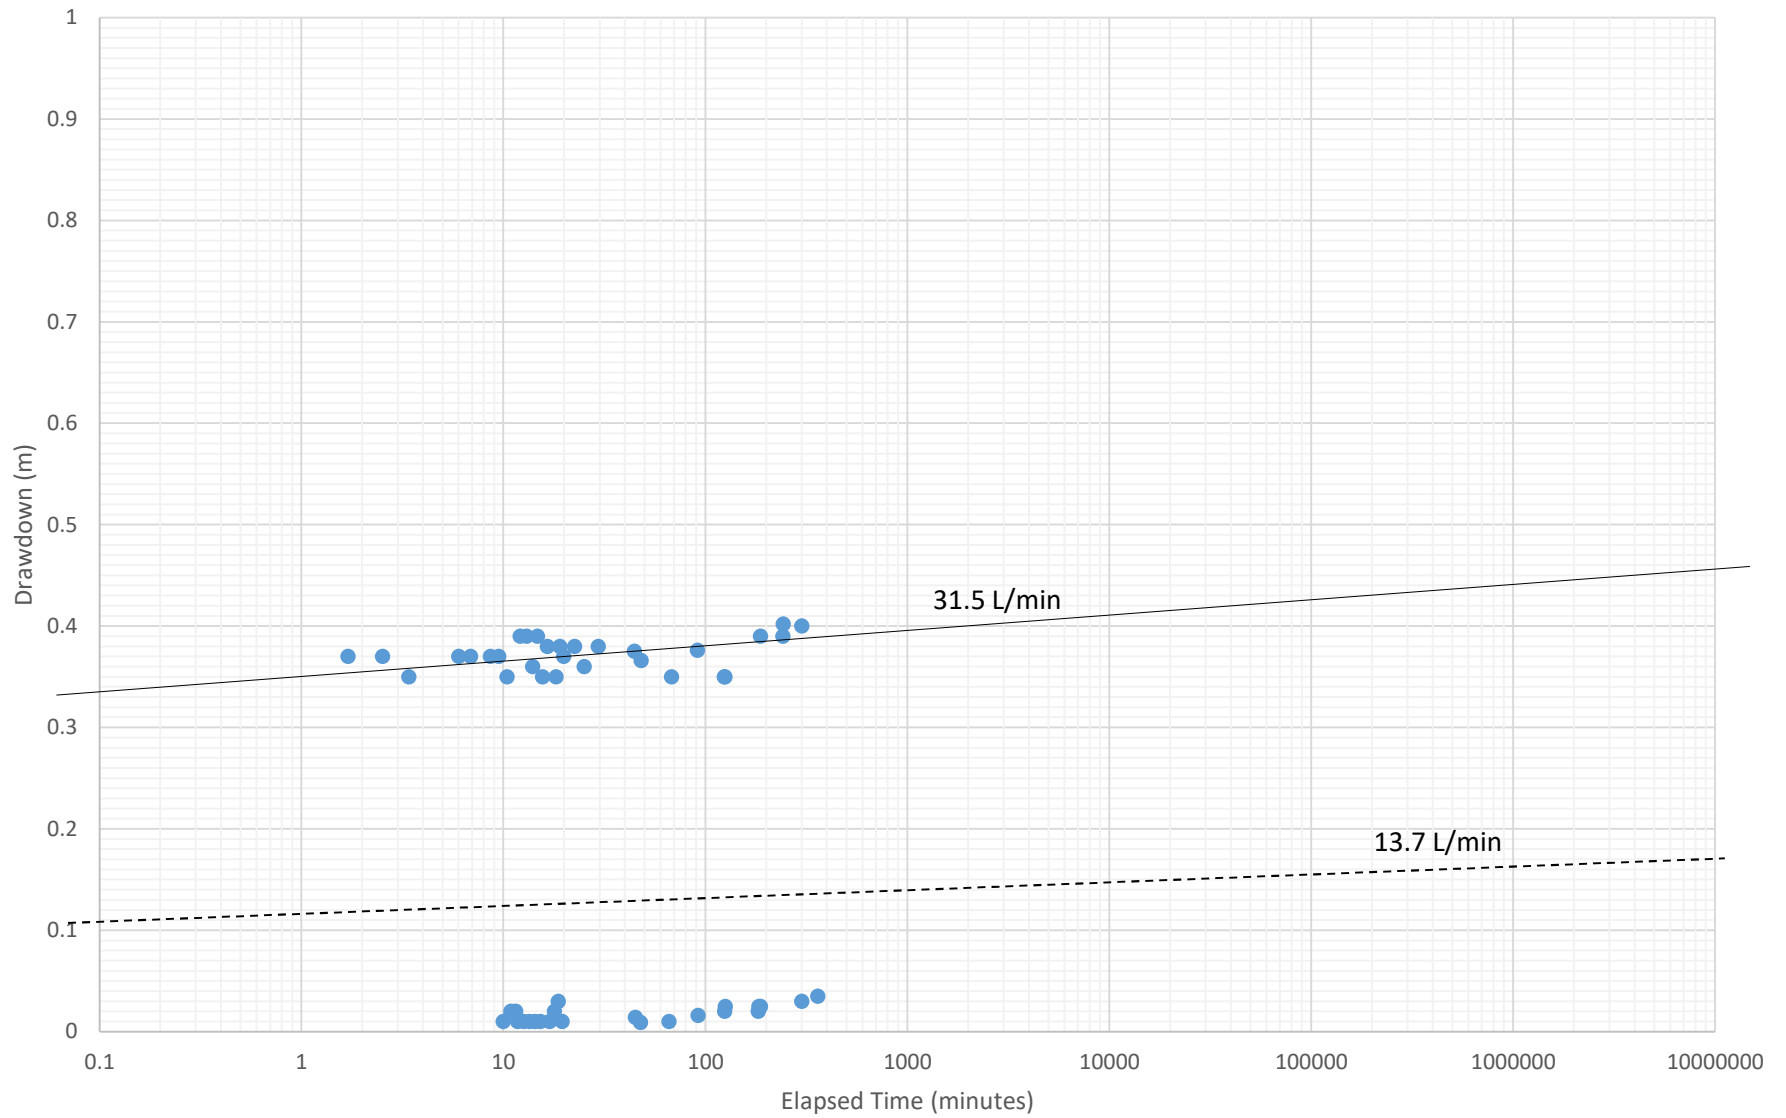
Drawdown vs Log Time
Pumping Test (Long-Term), February 3, 2022
Corkery Community Centre

Using drawdown and recovery data, respective transmissivities of 301 m²/d and 3375 m²/day were calculated using the Cooper-Jacob method. The transmissivity of 301 m²/day calculated from the drawdown was used in the calculations as it is the more conservative value. It is noted that recovery data are likely more representative of aquifer conditions, as drawdown data were complicated by the cycling of TW1's pressure tank.

The theoretical long-term safe yield was calculated using both the Farvolden and Moell methods. Drawdown data were used, as they are likely more representative of aquifer conditions (see above Section 4.2.2).

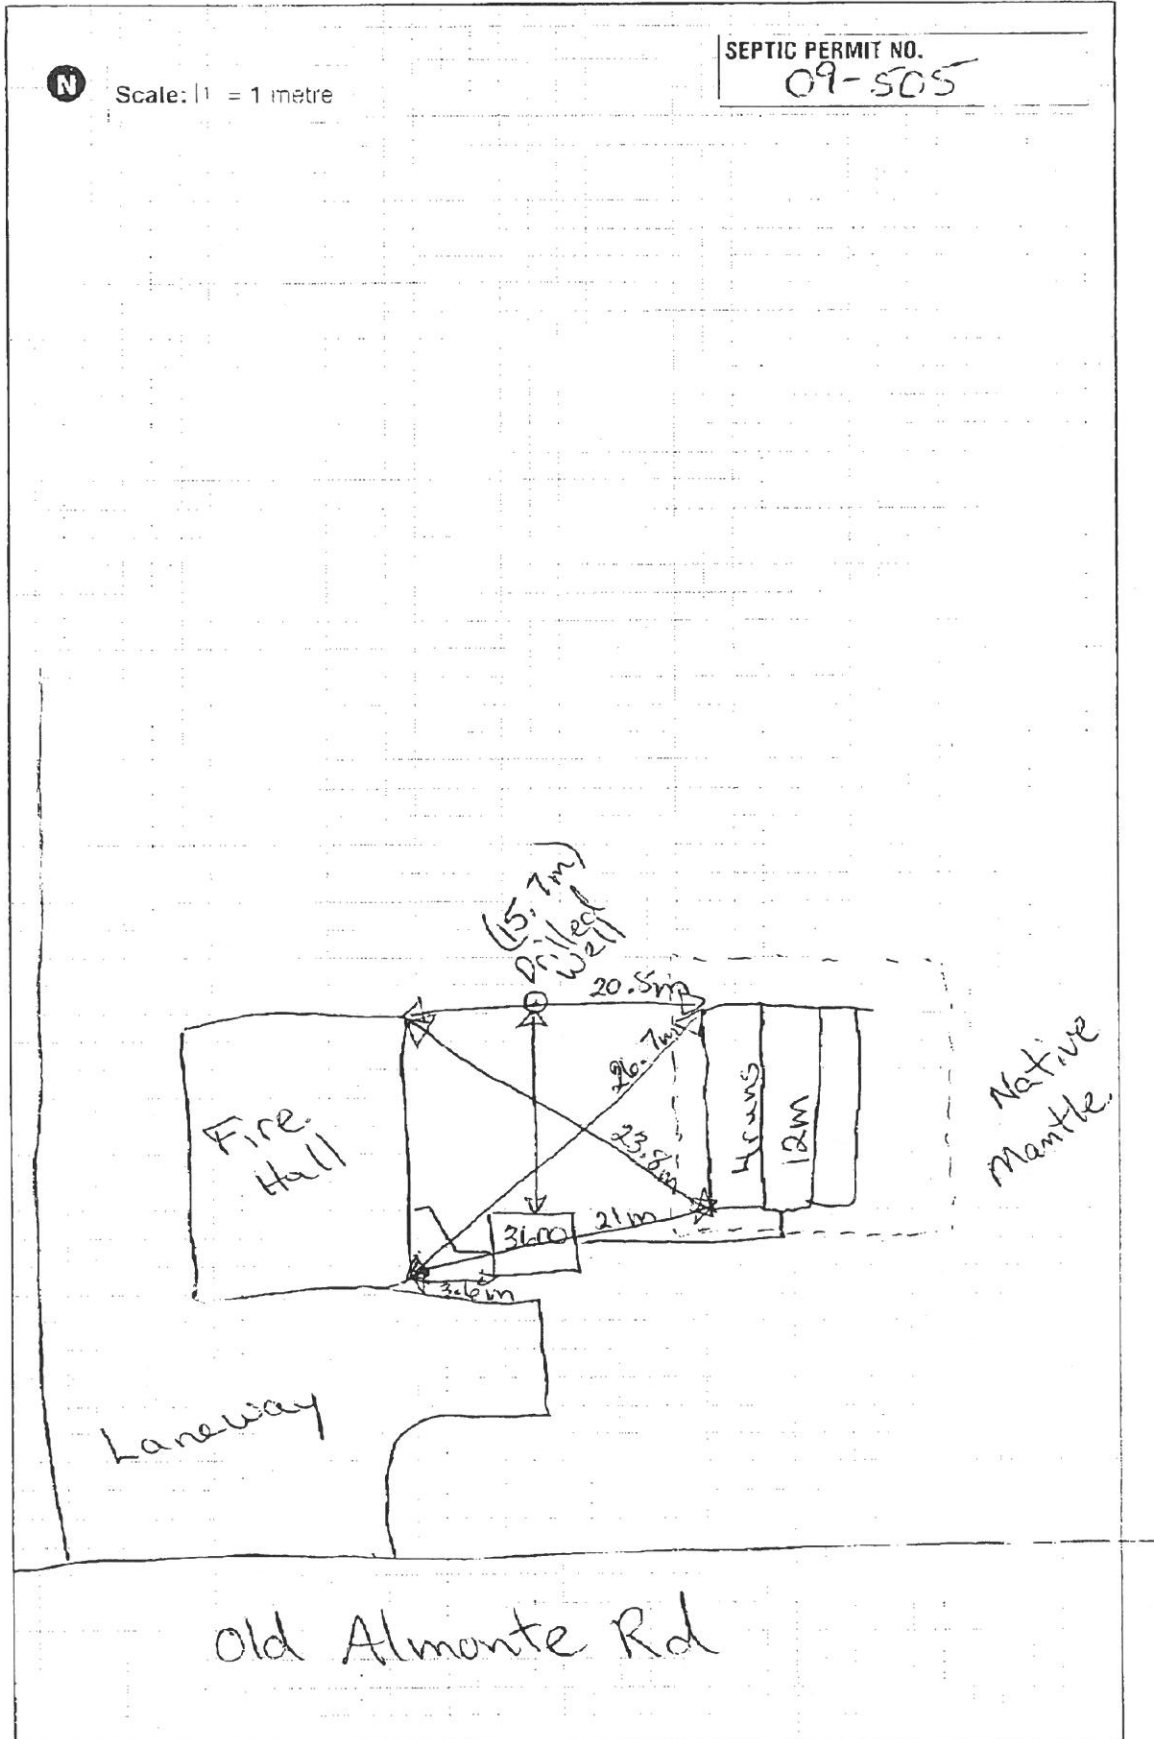
AS-BUILT DRAWING

NOTE:
 Drilled well • 15 metres to septic tank
 • 15 – 18 metres to distribution pipes
 Dug well • 15 metres septic tank
 • 30 – 33 metres to distribution pipes
