HYDROGEOLOGICAL ASSESSMENT AND TERRAIN ANALYSIS 273-275 RUSS BRADLEY ROAD, CARP, ONTARIO

Project No.: CCO-22-1643-01

February 3, 2023

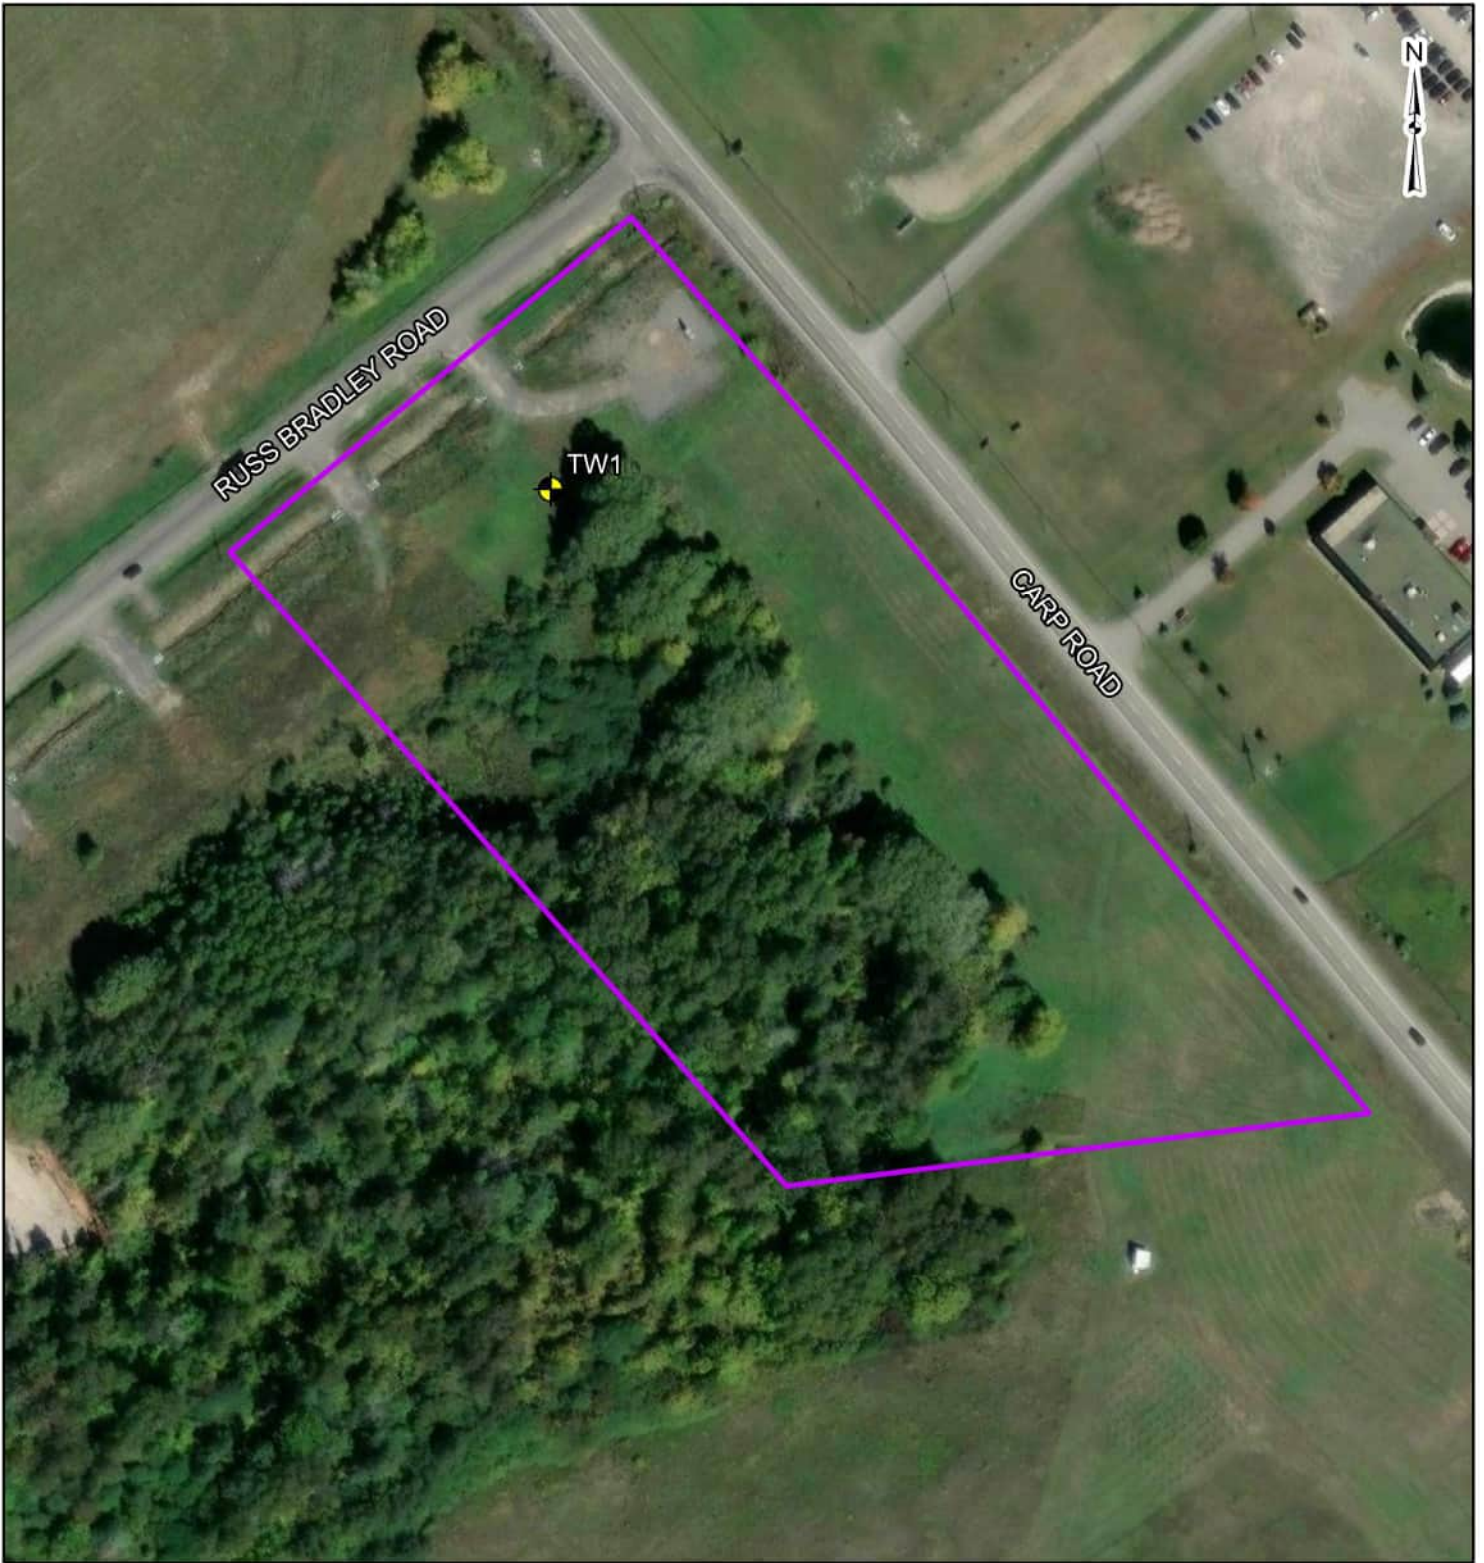
C:\Users\james.mclintosh\Documents\Projects\2022\CCO\CCO-22-1643-Trevor Watkins - EIS - 1600-Thornton-Arquivalenced\Environmental\CCO-22-1643 - Hydrogeological Assessment and Terrain Analysis.mxd

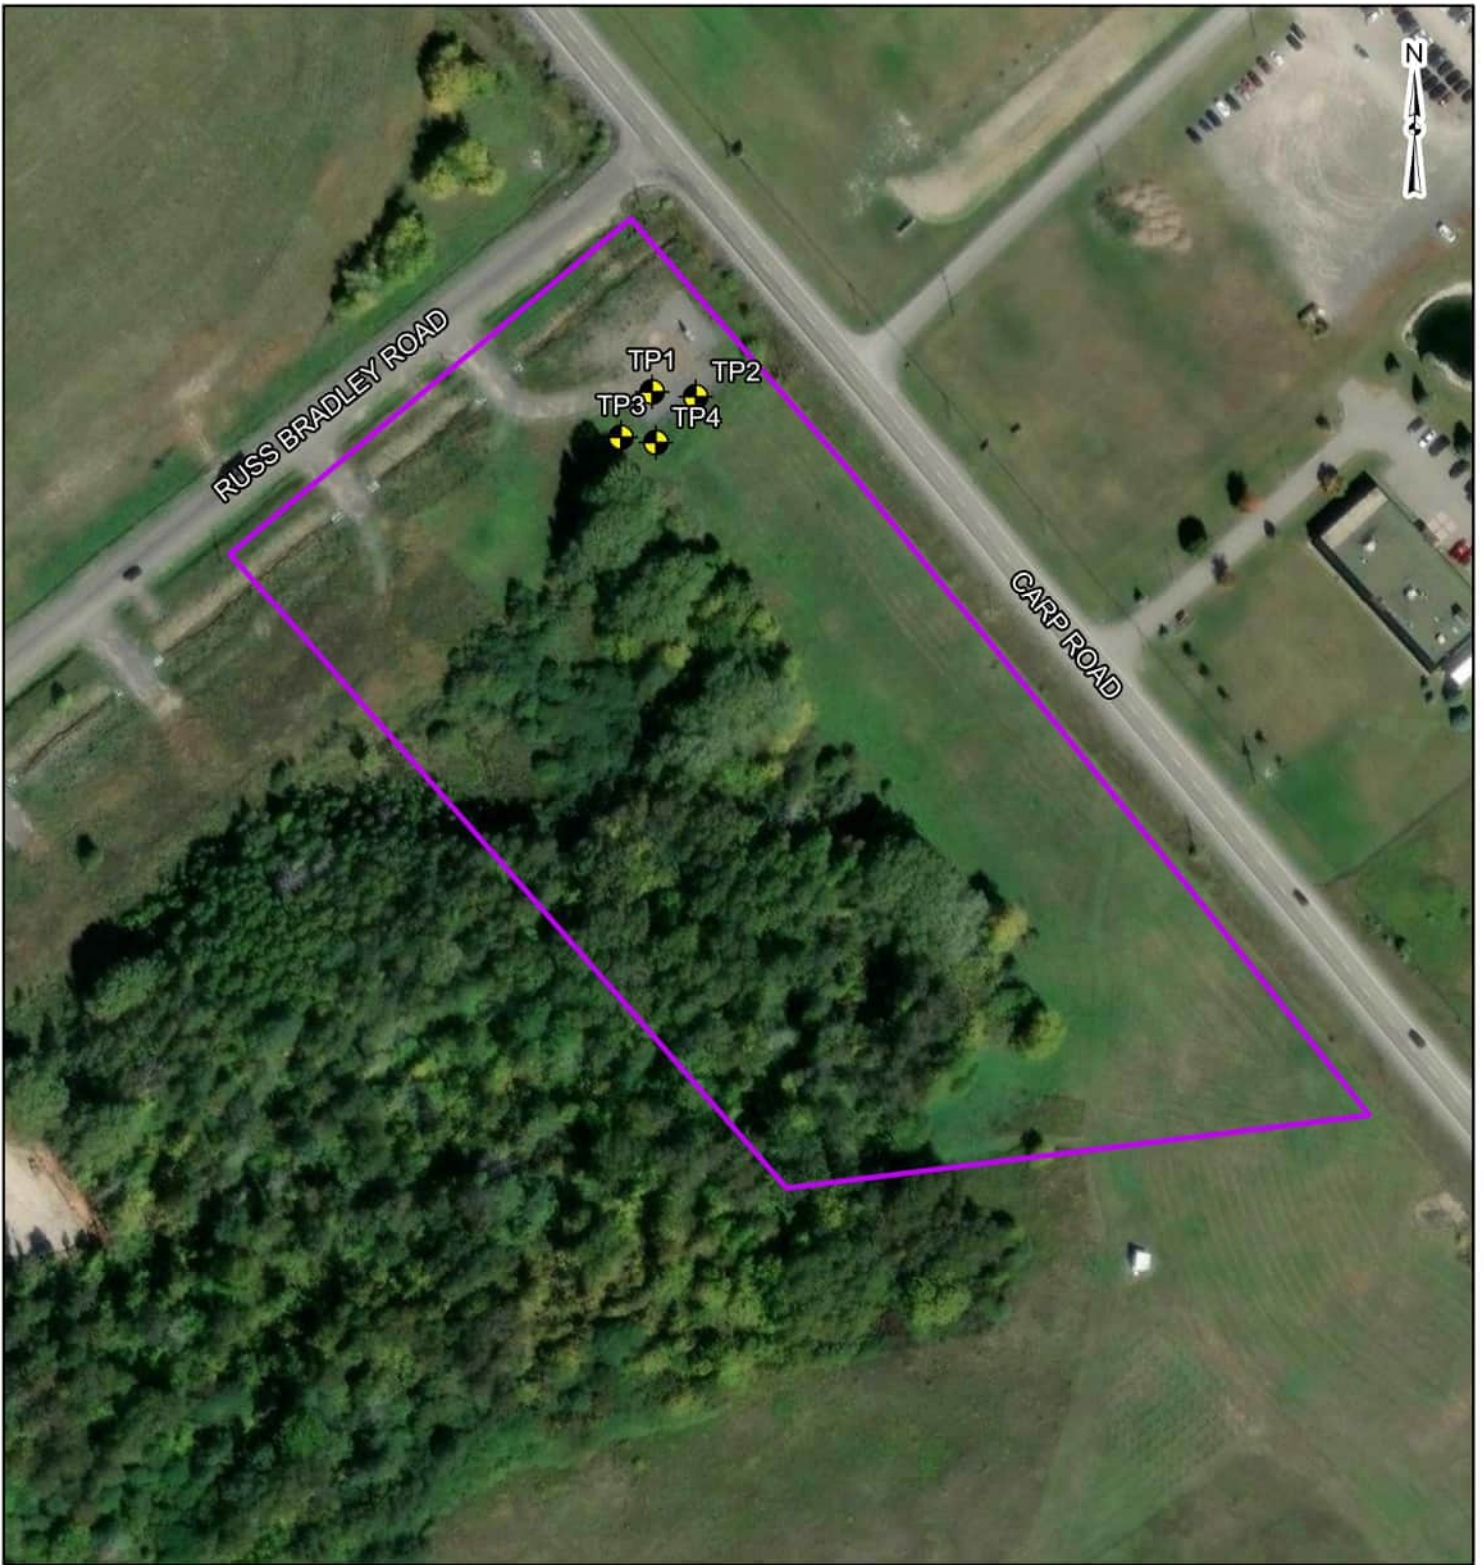
C:\Users\hamed\Documents\Projects\2022\CCO\CCO-22-1643 Trevor Watkins - EIS - 1600_Threats_AirQualityandEnvironmental\CCO-22-1643_MECPWellRecords.mxd

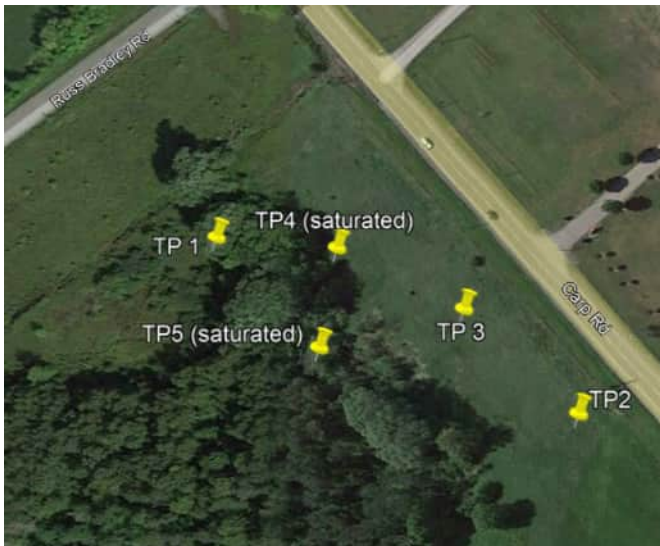
Figure 1 – Guelph Permeameter Test Locations

McIntosh Perry staff completed infiltration testing on June 7, 2022, at the locations shown on Figure 1, below. A Guelph Permeameter (a constant head permeameter used to measure in-situ vertical hydraulic conductivities of soil) was set up in three separate locations (TP1, TP2, TP3) for a total of three double-head infiltration tests. Additional tests were attempted (TP4, TP5) however a majority of the proposed development area was saturated and deemed unsuitable for testing. Test locations were selected based on the permeability of soils and subsequent capacity to complete the infiltration testing. In this case, only one (1) hole (TP1) was completed within the proposed infiltration area, while the remaining (TP2, TP3) were completed in close proximity to Carp Road – outside of the desired infiltration area. Holes were advanced using a hand auger.

As shown, the highest infiltration rate was observed in TP1 at a depth of approximately 0.05 m bgs (approximately 113.85 m asl). The lowest infiltration rate was observed in TP2 at a depth of approximately 0.15 m bgs (approximately 113.75 m asl). These values are generally consistent with the observed stratigraphy, in that fine-grain materials will typically have lower hydraulic conductivity rates.

It is noted that the field infiltration testing for TP2 and TP3 were conducted outside of the proposed infiltration infrastructure area, and are situated in close proximity to Card Road. Based on Site observations from June 7 and August 30, 2022, the property and development area appear to be highly saturated, with many areas of stagnant standing water. In particular, the wooded area of the Site appears to be a local topographic low point, and is not considered suitable for infiltration trenches or galleries in its current state. In several instances where infiltration tests were attempted, excess water logging caused no movement in the water column. As noted above, additional testing was done in subsequent holes TP2 and TP3 within an area closer to Carp Road.
