Phase One Environmental Site Assessment 2885 Carp Road Ottawa, Ontario

Project: 101688.002

Re: Phase One Environmental Site Assessment

Proposed Commercial Development 2885 Carp Road, Ottawa, Ontario

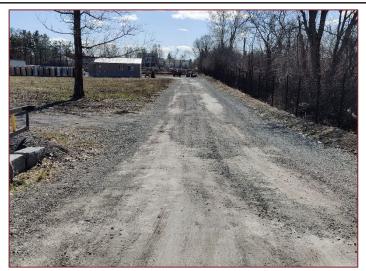
Photograph 1 – View of the Site from Carp Road, looking southwest along the northwest property boundary.

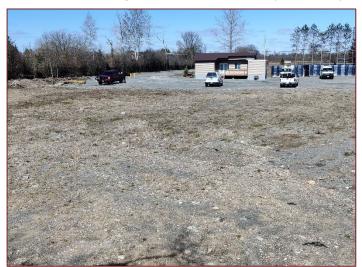
Photograph 3 – View of the Site looking northeast from the southwest boundary.

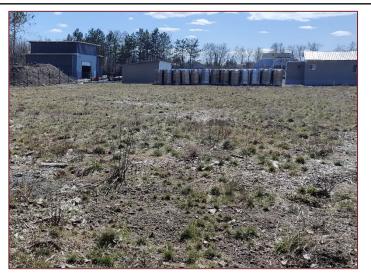
Photograph 2 – View across the northeast portion of the Site looking southwest.

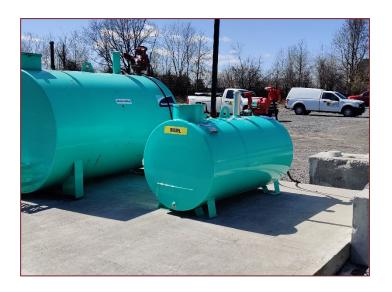
Two aboveground storage tanks (ASTs) were identified on the Site – one 4,550 L tank for gasoline and one 1,550 L tank for diesel. Both tanks were installed less than one year ago and are rented from MacEwan Petroleum. There were no signs of staining on the tanks due to overfilling, nor on the concrete pad underneath the tanks due to leaks. However, the concrete pad on which the tanks were stationed did not have secondary containment.

Photograph 5 – Two aboveground storage tanks along the southeast property boundary of Site.

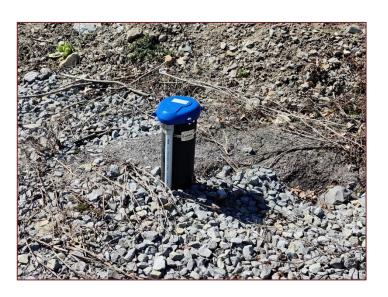
One domestic well was observed on the Site, along the northwest property boundary, located west of the on-site office building.

Photograph 6 – Potable well located west of the on-site office building near the northwest property boundary.
