Project:
RONALD MCDONALD HOUSE
 407 SMYTH ROAD
 OTTAWA., ONTARIO

Drawing:
TREE CONSERVATION REPORT

Scale: 1:400	Date: 20 NOV, 2020
Design By: PG	Drawn By: PG
Project Number: 2060-01	Sheet Number: TCR 1.1

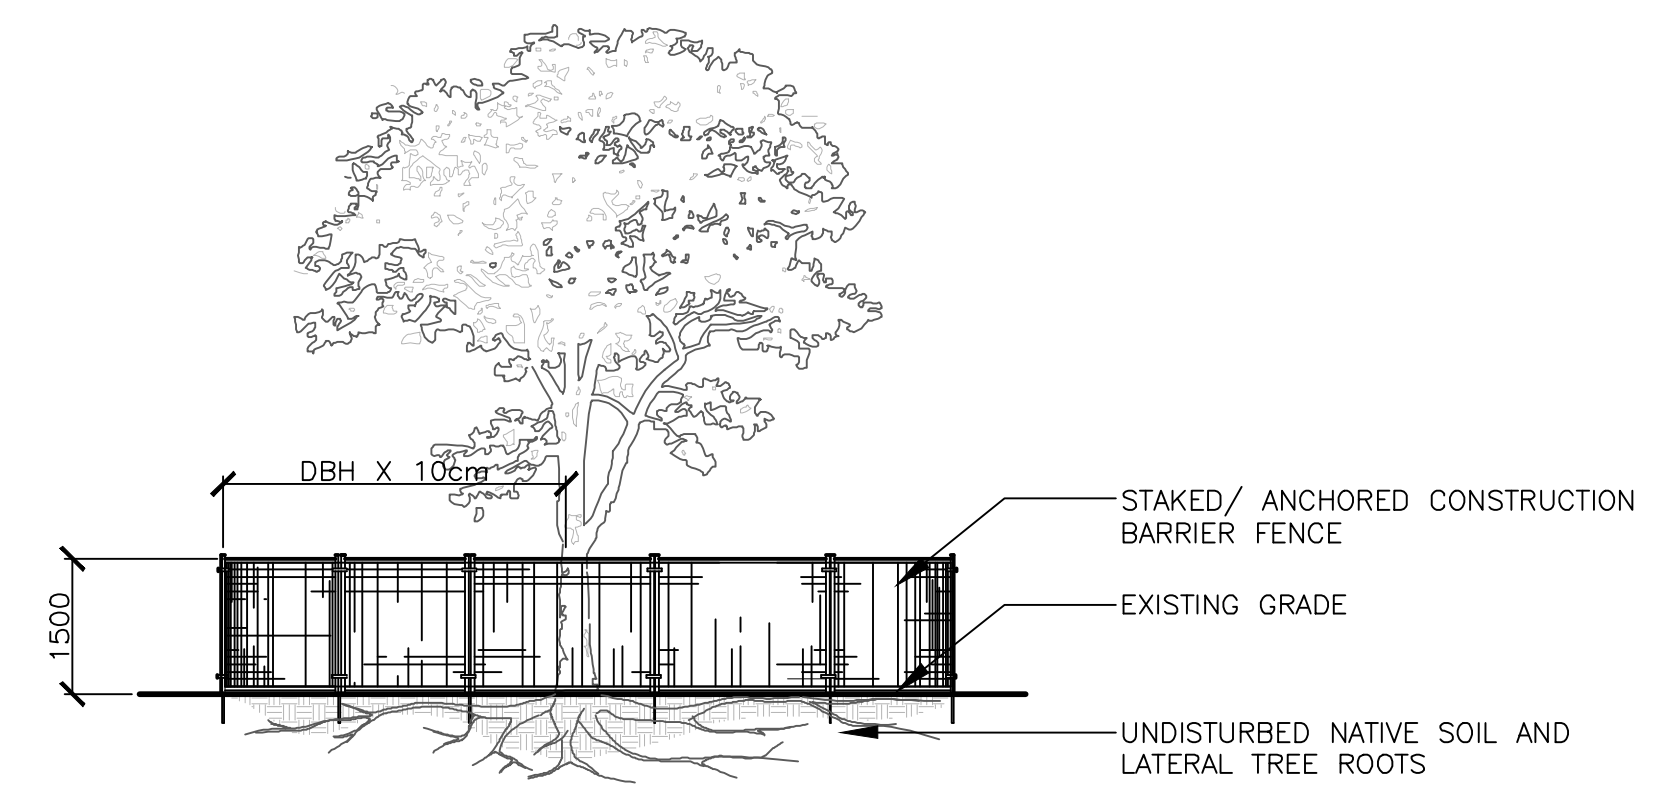
1 TREE PROTECTION FENCING N.T.S.

THE FOLLOWING PROTECTION MEASURES MUST BE IMPLEMENTED FOR RETAINED TREES, BOTH ON SITE AND ADJACENT SITES, PRIOR TO ANY TREE REMOVAL OR SITE WORKS AND MAINTAINED FOR THE DURATION OF CONSTRUCTION ON SITE.

- UNDER THE GUIDANCE OF AN ARBORIST, ERECT A FENCE AT THE CRITICAL ROOT ZONE (CRZ) OF TREES WHERE THE CRZ IS ESTABLISHED AS BEING 10 CENTIMETERS FROM THE TRUNK FOR EVERY CENTIMETER OF TRUNK DIAMETER AT BREAST HEIGHT. THE CRZ IS CALCULATED AS DBH X 10cm.
- DO NOT PLACE ANY MATERIAL OR EQUIPMENT WITHIN THE CRZ OF THE TREE
- DO NOT ATTACH ANY SIGNS, NOTICES OR POSTERS TO ANY TREE
- DO NOT RAISE OR LOWER THE GRADE WITHIN THE CRZ WITHOUT APPROVAL
- TUNNEL OR BORE WHEN DIGGING WITHIN THE CRZ OF A TREE
- DO NOT DAMAGE THE ROOT SYSTEM, TRUNK, OR BRANCHES OR ANY TREE
- ENSURE THAT EXHAUST FUMES FROM ALL EQUIPMENT ARE NOT DIRECTED TOWARDS ANY TREE CANOPY
