Muncaster
Environmental
Planning Inc.

**RE: Natural Environmental Update
1650 Shea Road**

To update our Environmental Impact Statement and Tree Conservation Report of February 25th, 2016, I reviewed the lands associated with 1650 Shea Road and adjacent lands on June 24th, 2022. The field review took place from 06:10 to 07:40 under clear skies with fog patches, a light air, and an air temperature of 16°C. The results of the field review are grouped under three headings; existing tree cover, unevaluated wetlands, and on-site dug channels.

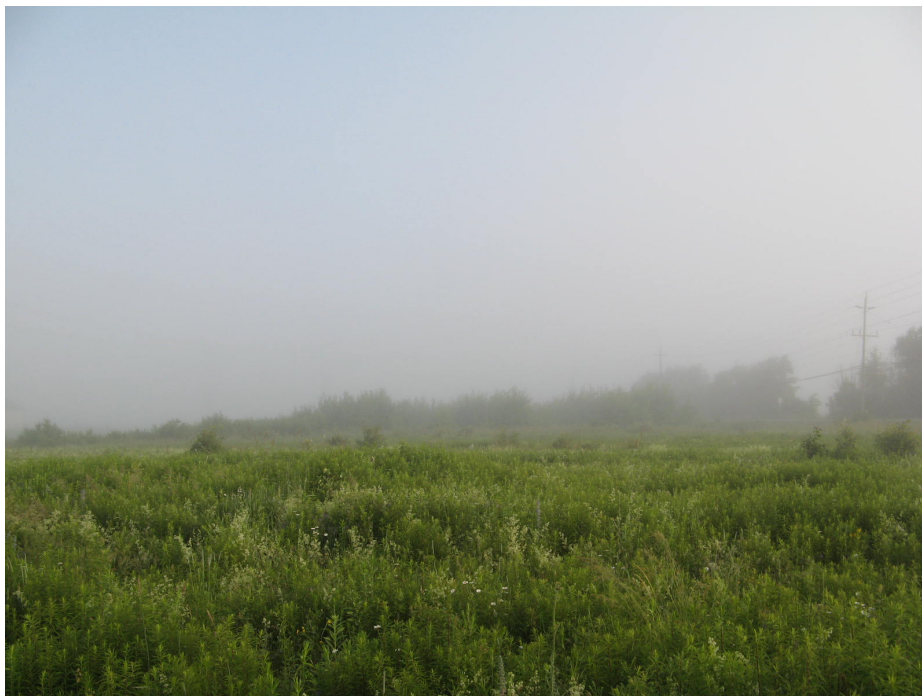
The site has been cleared of trees and grubbed (Photo 1). No trees at least 10cm diameter at breast height (dbh) were observed on the site in June, 2022. The current vegetation on the site would be described as a combination of regenerating cultural meadow (Photo 2) and thicket communities (Photo 3). Regenerating woody vegetation includes areas of trembling aspen stems less than 10cm dbh, with small ash stems also present. Shrubs in the thicket habitat include glossy buckthorn, red raspberry, slender willow, and Bebb's willow.

Photo 2 – Cultural meadow habitat dominates the central and north portions of the 1650 Shea Road lands. View looking north from Cosanti Drive with off-site trees on the north side of Fernbank Road in the background
