JBPA Developments Inc.

**Phase I Environmental Site Assessment Rev 2
12-24 Hawthorne Avenue
Ottawa, Ontario**

CM3 Project SDC1007

February 7, 2023 (Revision 2)

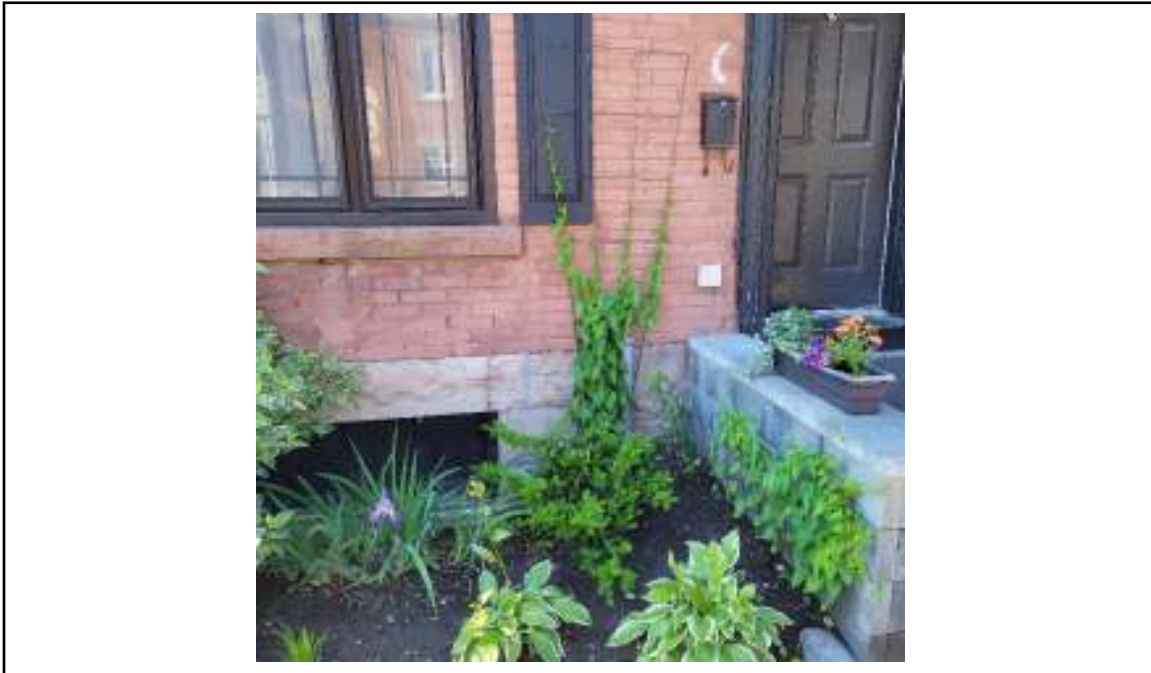
Photograph 5: Looking south at north front wall of 18 Hawthorne, note fill and vent pipes for AST in basement of unit.

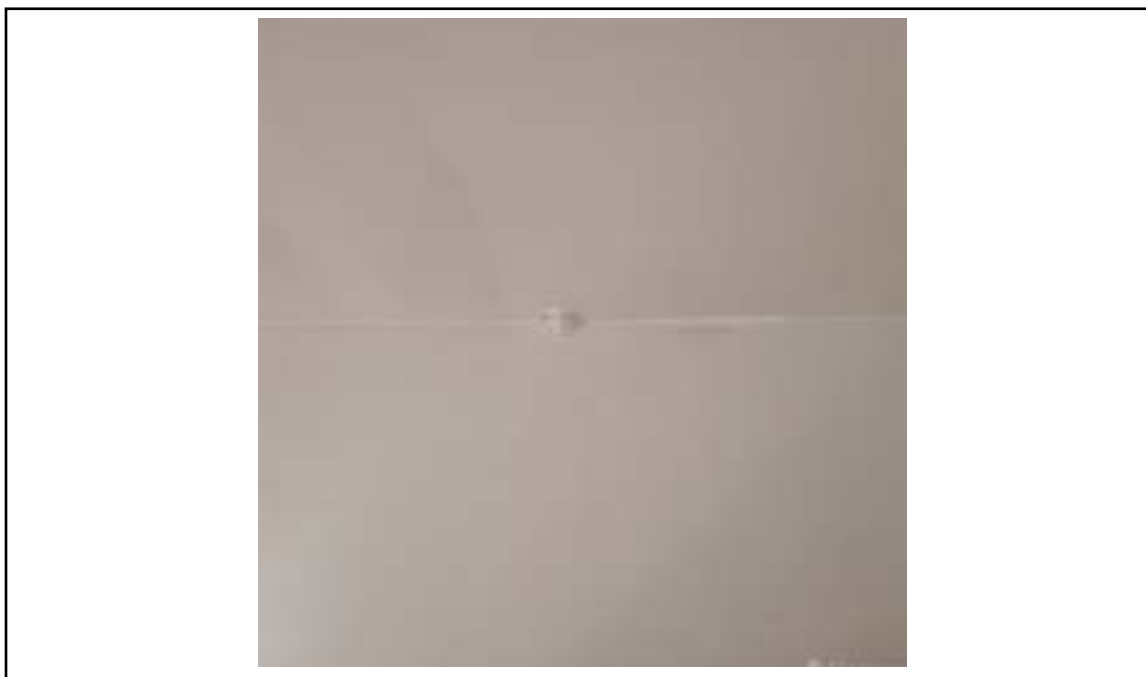
Photograph 9: West wall and ceiling of kitchen in 14 Hawthorne, note main sewer drain in corner of wall/ceiling.

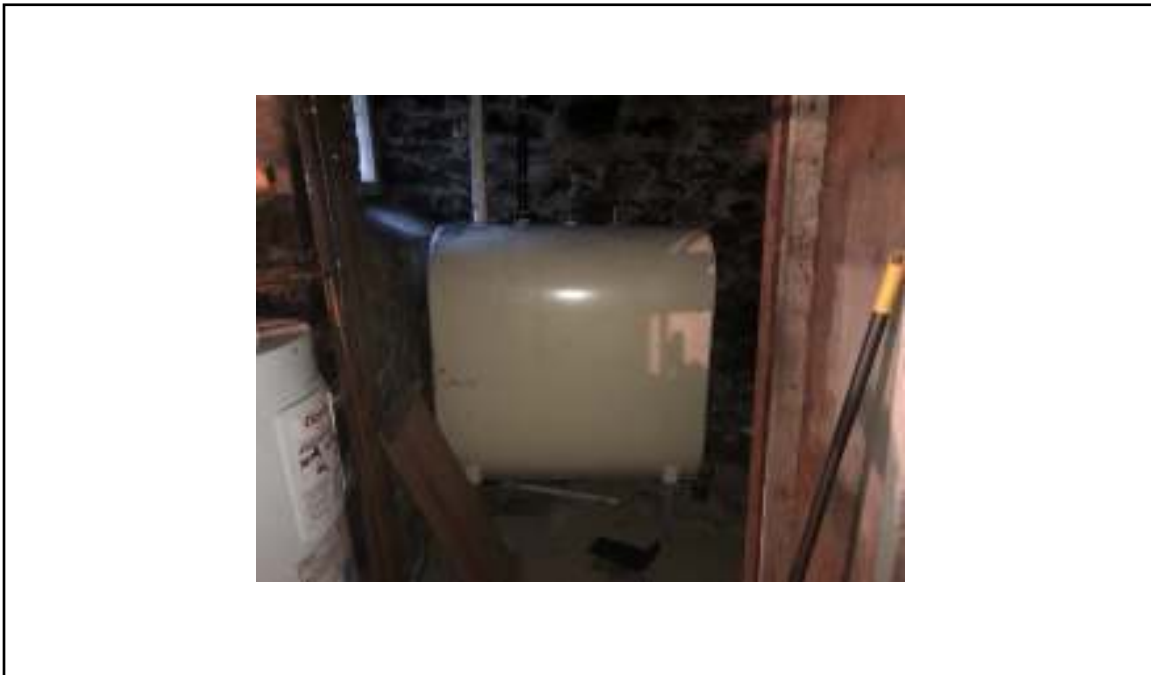
Above ground storage tanks (ASTs), containing fuel oil, were observed in the basement of 12 Hawthorne mid-way along the west wall and in the basement of 18 Hawthorne at the north wall adjacent to the basement window. Based on information provided during the interview, all units were likely heated by fuel oil at one time. Documentation regarding the removal of the tanks from the units 14 and 16 was not available.

Photograph 13: 680 liter fuel oil above ground storage tank in basement of 12 Hawthorne.

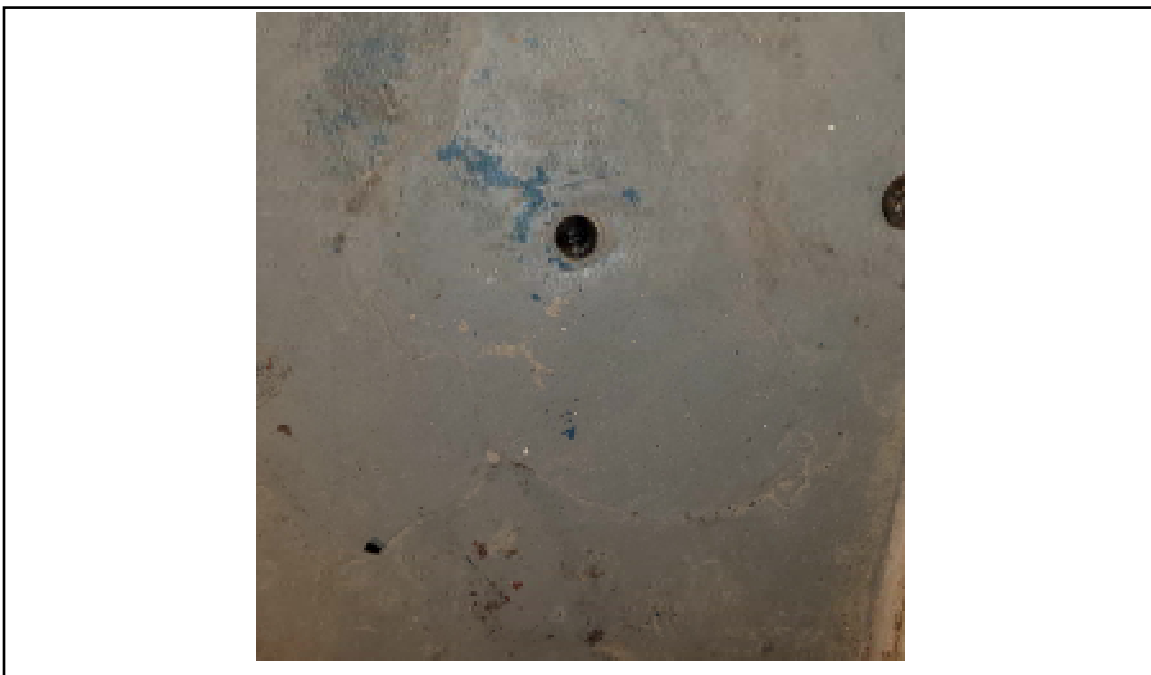
Photograph 16: Floor drain in floor of basement of 16 Hawthorne.

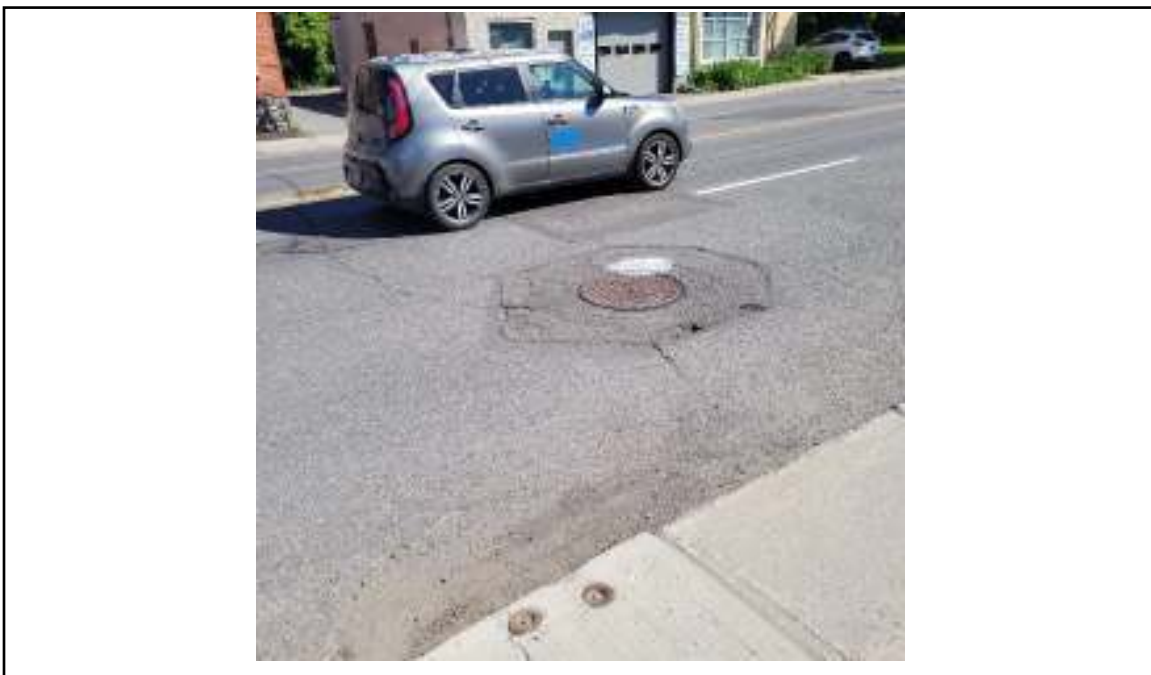
Photograph 26: Storm water manhole on Hawthorne Avenue, water service valves in sidewalk in front of 20 Hawthorne with former automotive service center across street at 25 Hawthorne.

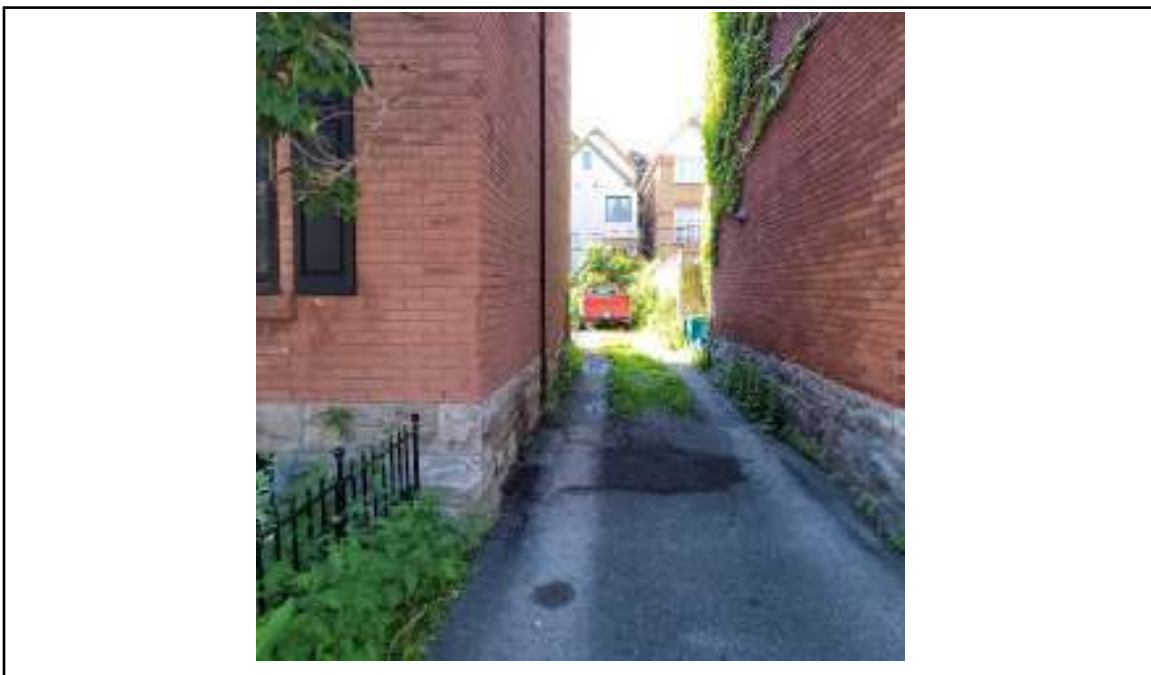
Photograph 30: Looking south from asphalt laneway of 12. Note fill and vent pipes for AST in basement of 12 Hawthorne on brick wall, center of photograph. Off-site property 10 Hawthorne is on left.
