**Preliminary Environmental Impact Study for the Proposed Parking Lot
Expansion at the Ottawa-Carleton Detention Centre, 2244 Innes Road,
Ottawa**

Final Report

December 22, 2022

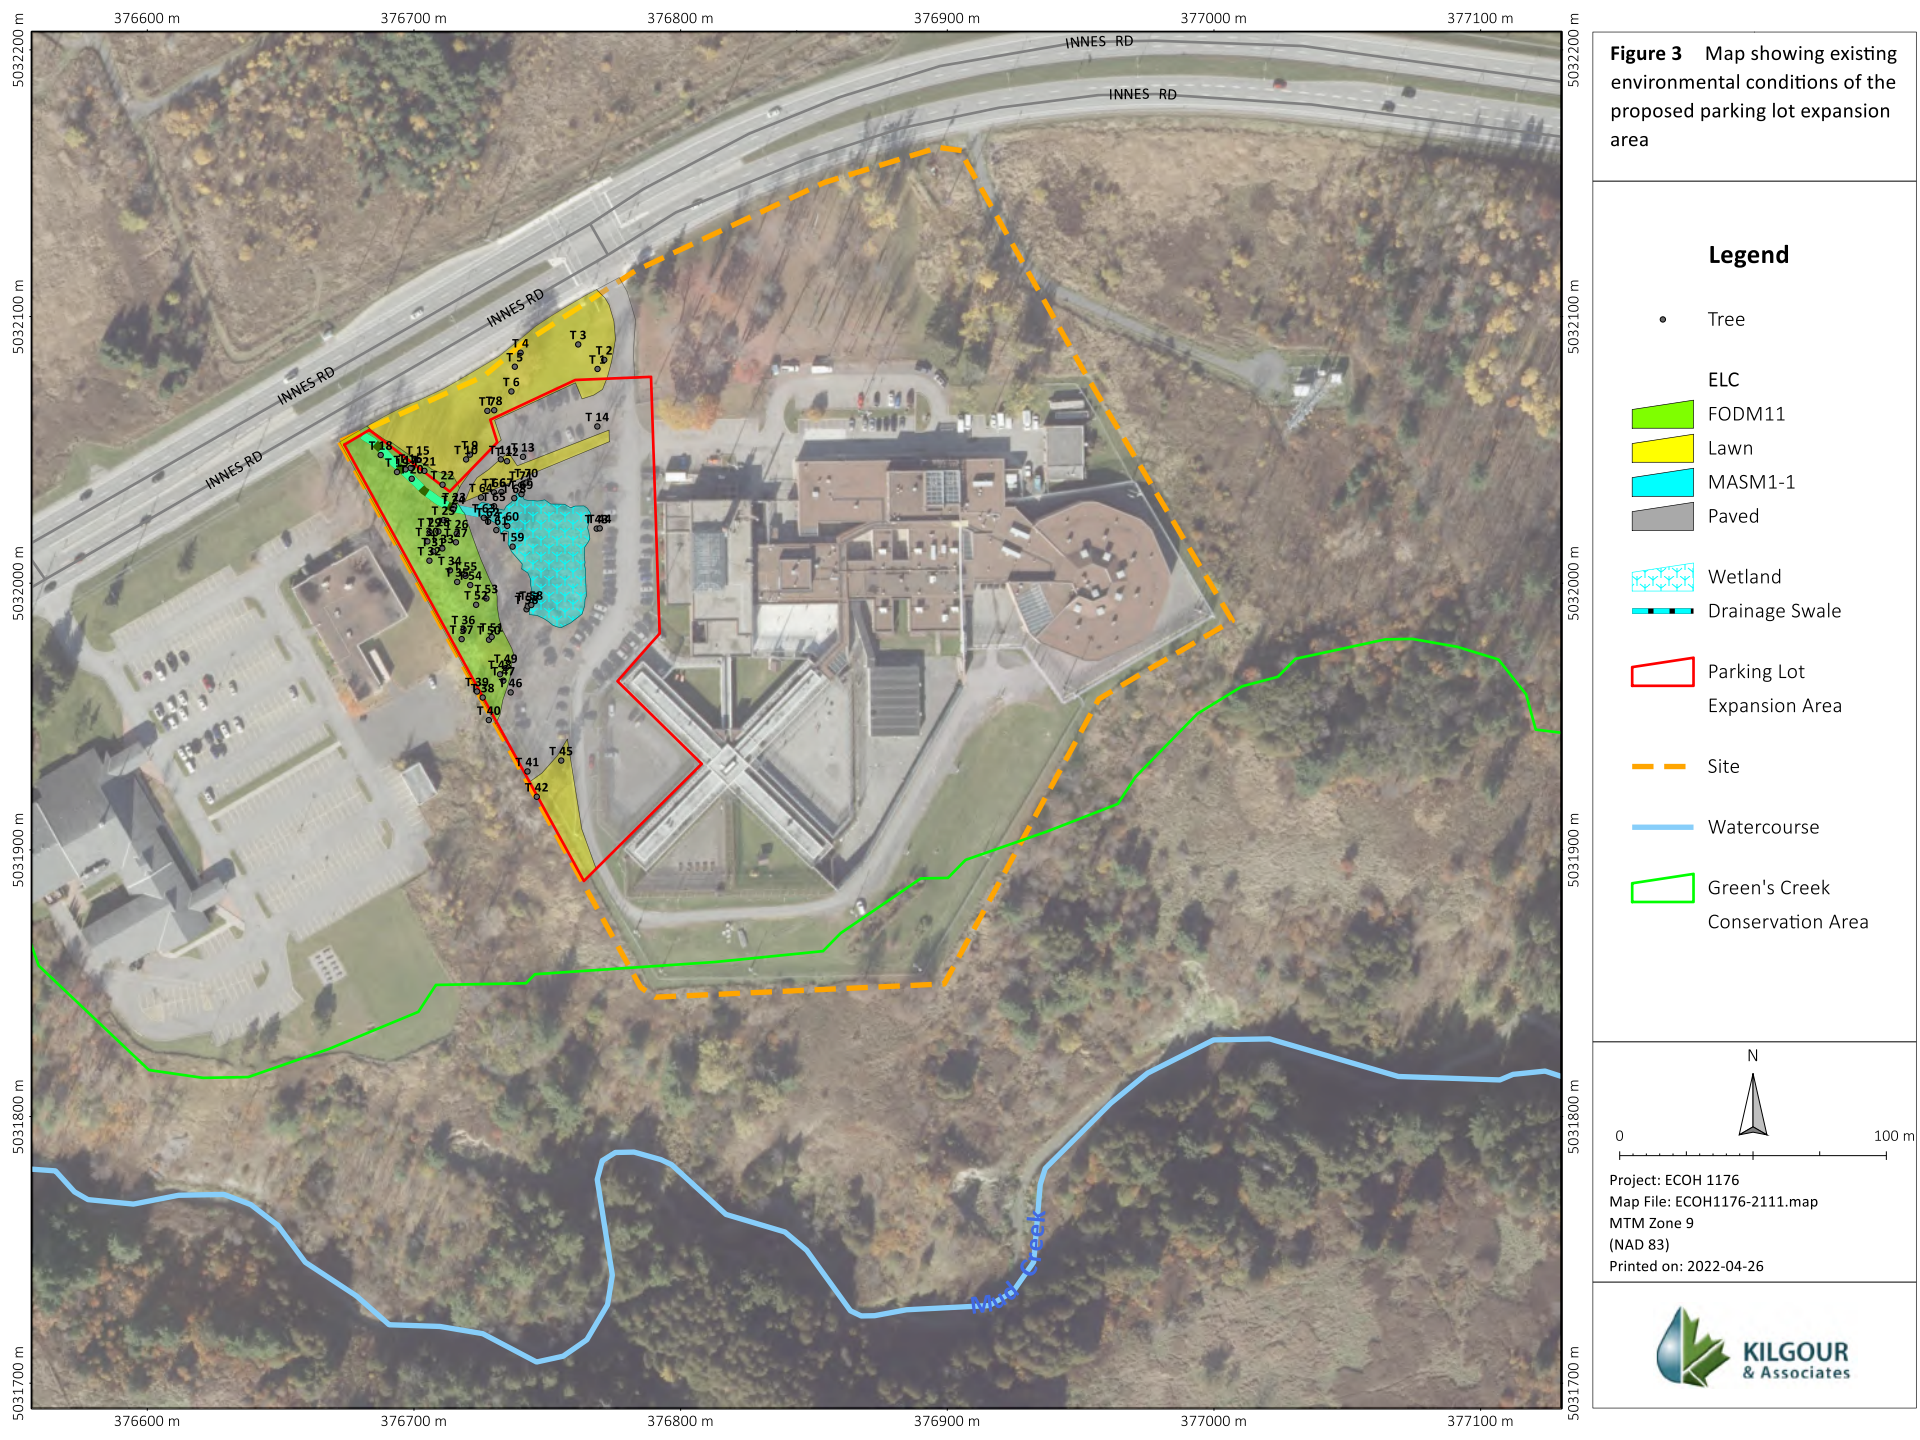
Figure 3 Map showing existing environmental conditions of the proposed parking lot expansion area

Four distinct ELC units (ecosites, vegetation types, or other) were delineated within the proposed parking lot expansion area (Figure 3). Two of the four ELC units are of anthropogenic nature (i.e., open lawn and parking areas) consistent with the lack of natural features in the existing parking lot. The other two ELC units consist of a deciduous hedgerow and a small wetland.

Details from the tree inventory are presented in Appendix E. In general, the parking lot expansion area contains 71 trees with DBH ≥ 10 cm from 11 species (Figure 3), with over 70% of trees observed dominated by two species: Silver Maple and Basswood (Table 1). Fifty-six trees were assessed as “wildlife” trees (Appendix E).

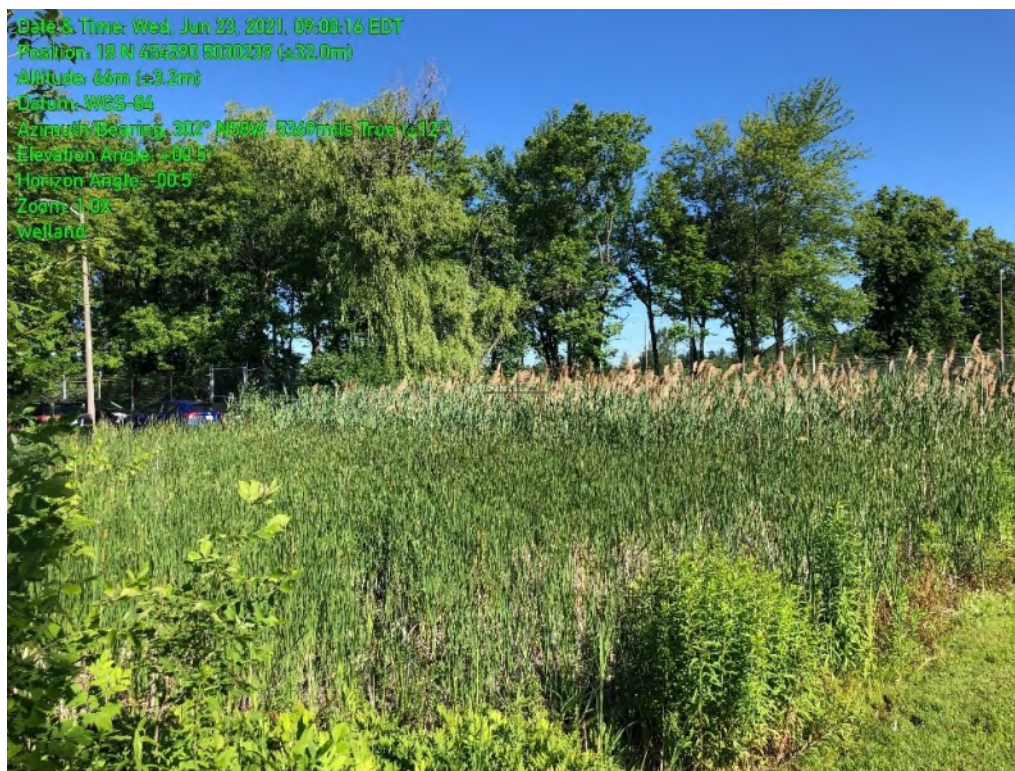
Towards the centre of the existing parking lot is a wet depression approximately 0.1 ha in size that is dominated by emergent wetland vegetation. The northern portion of this feature consists of a dense stand of Common Reed (*Phragmites australis*; an invasive species) while the southern portion is dominated by Common Cattail (*Typha latifolia*; Figure 7). The fringes of this feature are highly disturbed given its location within the existing parking lot. Some edges of the depression contain weeds and invasive species such as Perennial Sow-thistle (*Sonchus arvensis*), Common Buckthorn, and Purple Loosestrife (*Lythrum salicaria*), while other edges consist of mowed lawn and gravel.

Figure 7 Photo of the Cattail Mineral Shallow Marsh Type towards the centre of the existing parking lot on the Site (taken June 23, 2021)

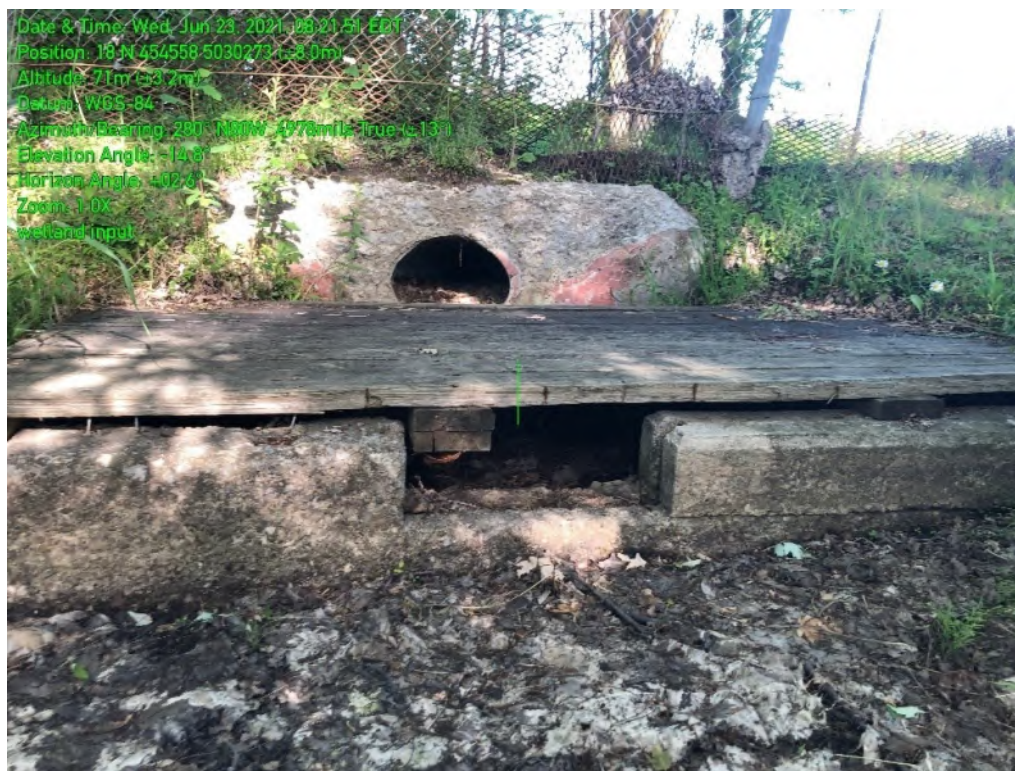
The feature has soils reflective of poor drainage, with approximately 40 cm of organic soils underlain by sand and clay with signs of gley, an indication of prolonged water saturation. The soil surface was dry in the late spring and early summer, suggesting that the water table is rarely or only briefly above the substrate surface in the spring, but with soil water remaining in the rooting zone for most of the growing season. According to Ottawa-Carleton Detention Centre staff, this feature is a result of a pond that was originally dug in the 1970s, which is visible in geoOttawa imagery from 1976 through the early 2000s. Water was held in the pond via a dike (Figure 8) that was eventually released to allow water to drain from the pond, resulting in current shallow marsh conditions. The feature is currently used as a snow management area which would contribute to higher water levels during the spring freshet. Gravel and stumps were observed throughout the feature, likely a result of being pushed in from snow plows.

Figure 8 Photo showing the remnants of a dike in the northwestern portion of the wetland on Site (taken June 23, 2021)

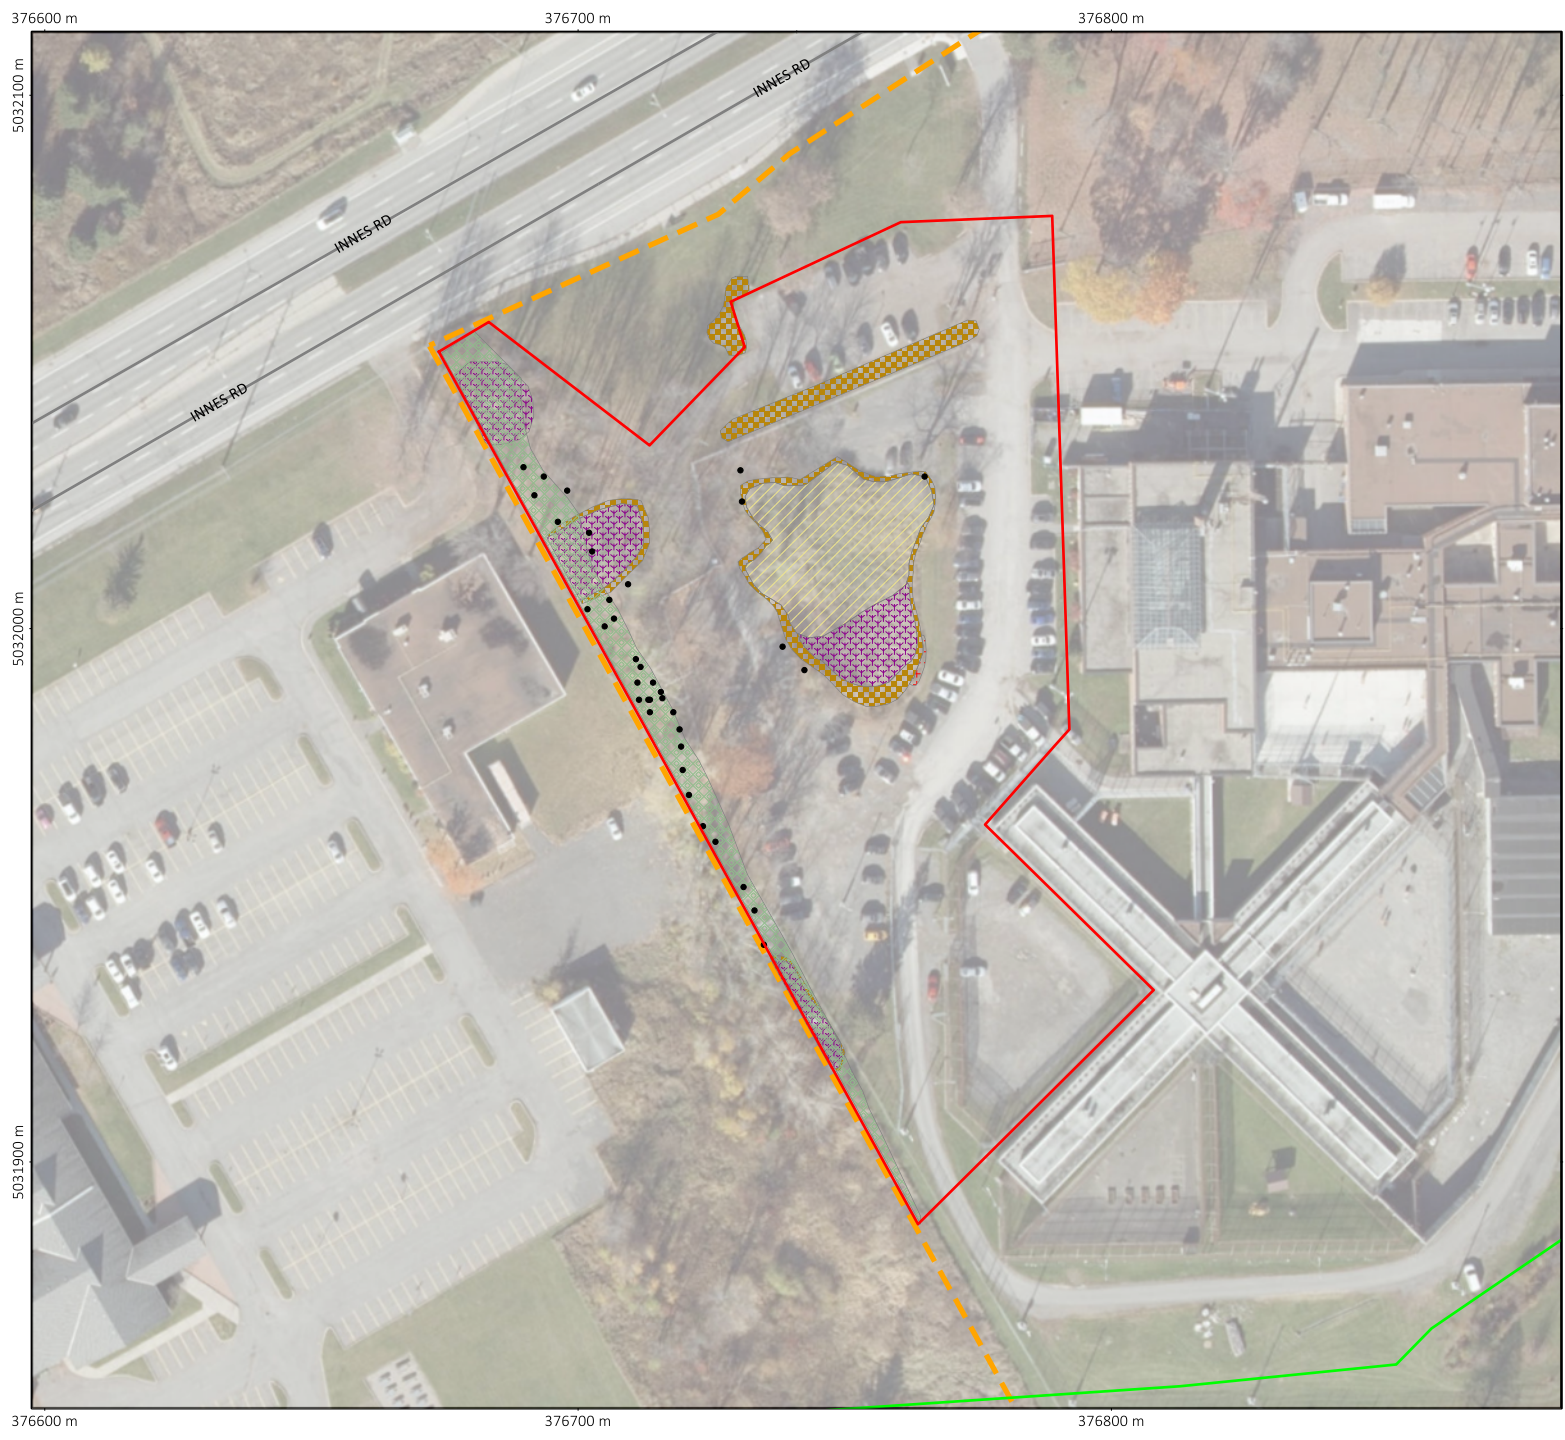
Figure 9 Map showing the distribution of exotic, invasive, and noxious plants in the proposed parking lot expansion area

The proposed parking lot expansion area contained six plant species considered exotic, invasive, or noxious (Figure 9, Table 2).

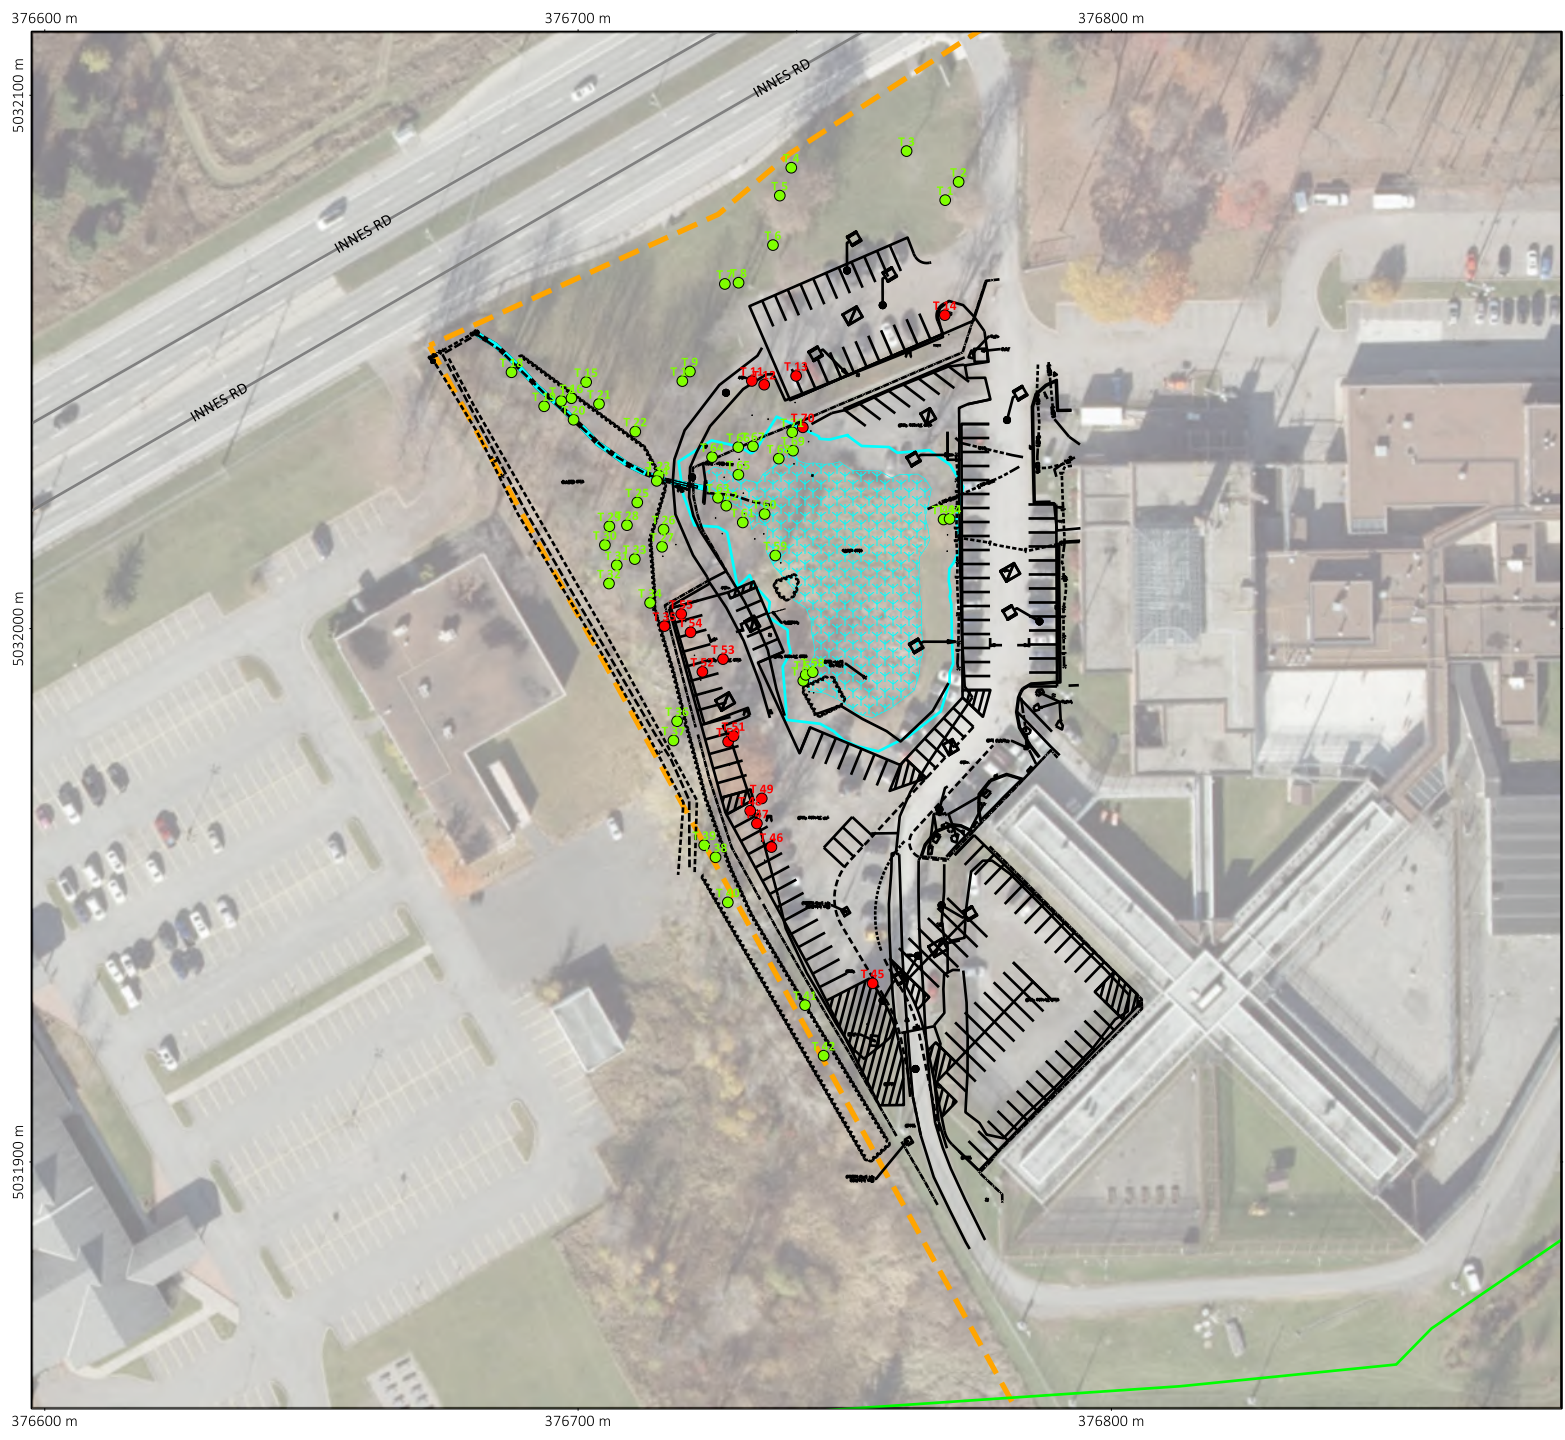
Figure 16 Map showing the proposed parking lot expansion

Stormwater and snow would be managed on-Site in consultation with the NCC and RVCA. Post-development stormwater flow paths will match existing conditions, with existing grades generally being maintained and stormwater continuing to be directed towards the wetland. Stormwater management infrastructure would be improved through a new underground exfiltration storage facility and oil and grit separator downstream of the wetland, upstream of the grate inlet to Mud Creek at Innes Road. The culvert at the downstream end of the wetland will be replaced. The wetland will no longer be used for snow management.

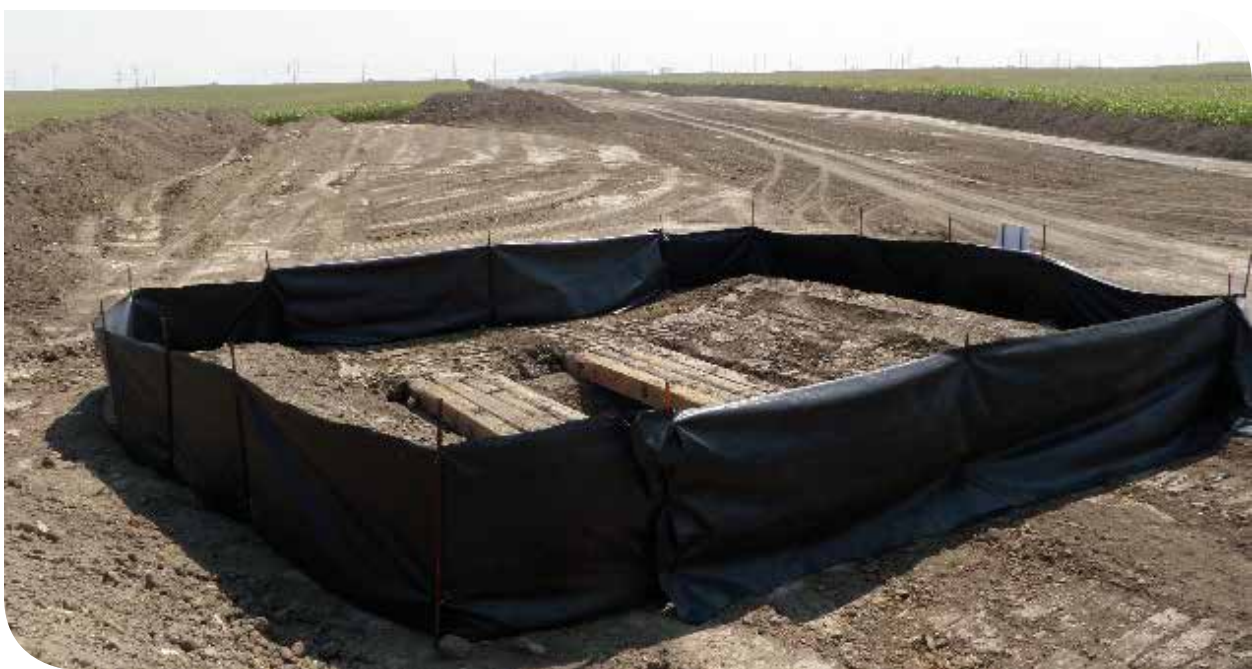
Cleaning station at construction site.

- A pump and high pressure hose OR high pressure water unit
- Minimum water pressure for vehicle cleaning should be at least 90 pounds per square inch. Water can be supplied as high volume/low pressure or low volume/high pressure (NOAA Fisheries Service).
- Air compressor and blower OR vacuum
- Shovel
- Pry bar
- Stiff brush or broom

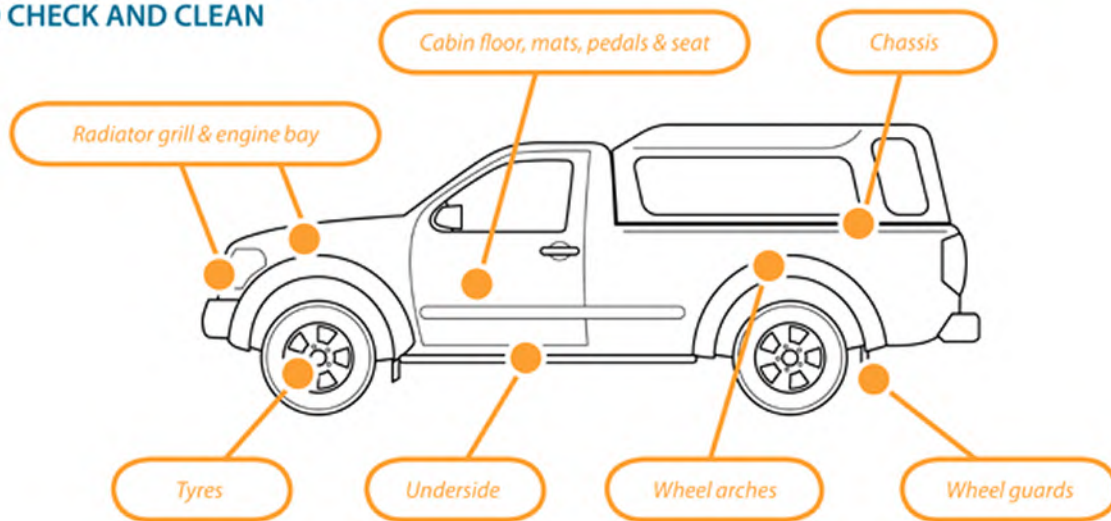
4WD VEHICLE WITH KEY SPOTS TO CHECK AND CLEAN

✓
Cabin	Floor, mats, pedals, seats	
Engine	Radiators, engine bay, grill	
Body	Underside, chassis, crevices, ledges, bumper bars	
Wheels	All wheels (including spare), wheel arches, guards	
Tray	Floor, canopy (if included)

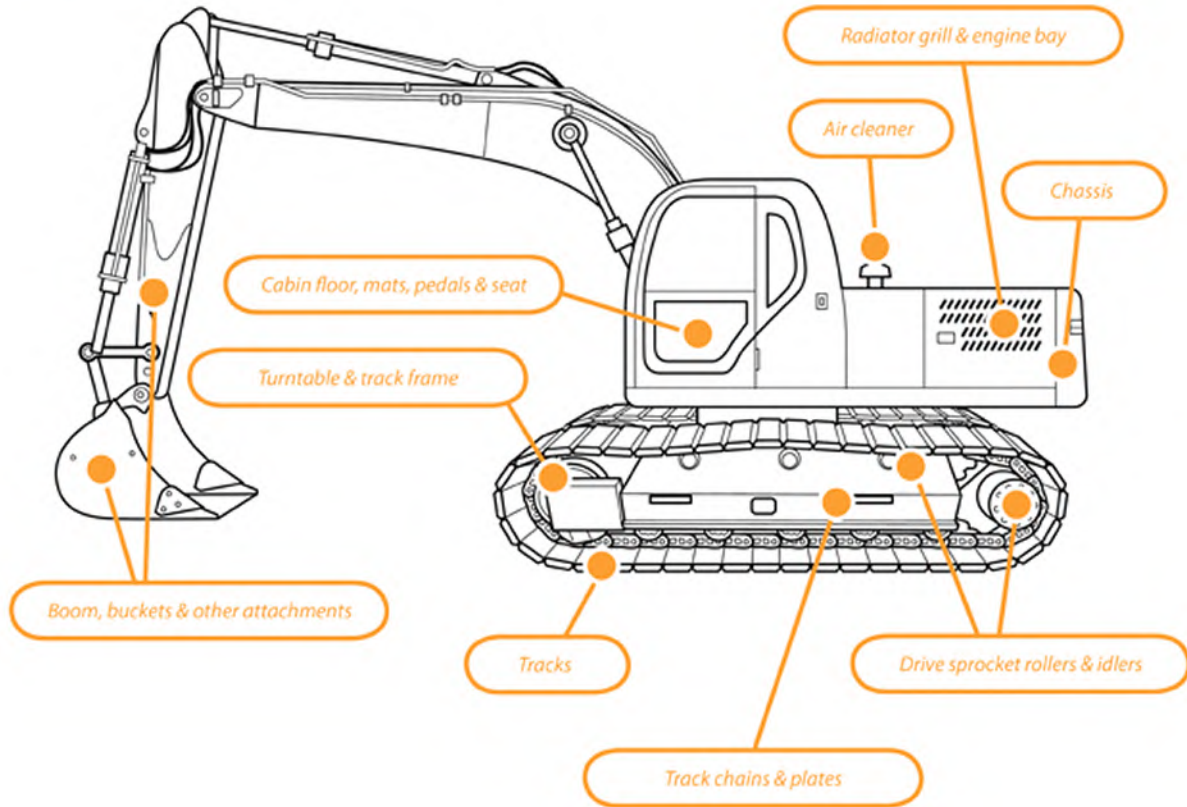
EXCAVATOR WITH KEY SPOTS TO CHECK AND CLEAN

✓
Cabin	Floor, mats, pedals, seats	
Engine	Radiators, engine bay, grill, air cleaner	
Tracks	Tracks, track frame, drive sprocket rollers, idlers	
Body Plates	Plates of cabin	
Body	Ledges, channels	
Bucket		
Booms		
Turret Pivot

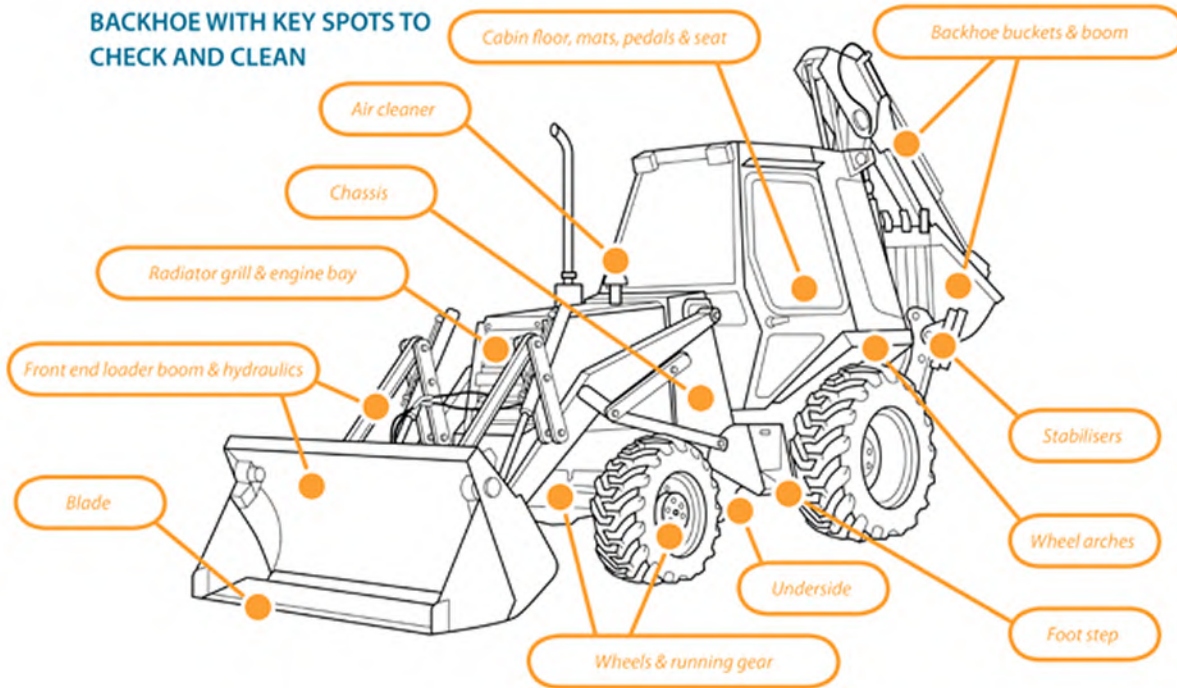
BACKHOE WITH KEY SPOTS TO CHECK AND CLEAN

✓
Cabin	Floor, mats, pedals, seats, foot step	
Engine	Radiators, engine bay, grill, air cleaner	
Wheels	All wheels (including spare), wheel arches, guards	
Front end loader	Blade, hydraulics, booms	
Backhoe	Buckets, boom, hydraulics, stabilisers

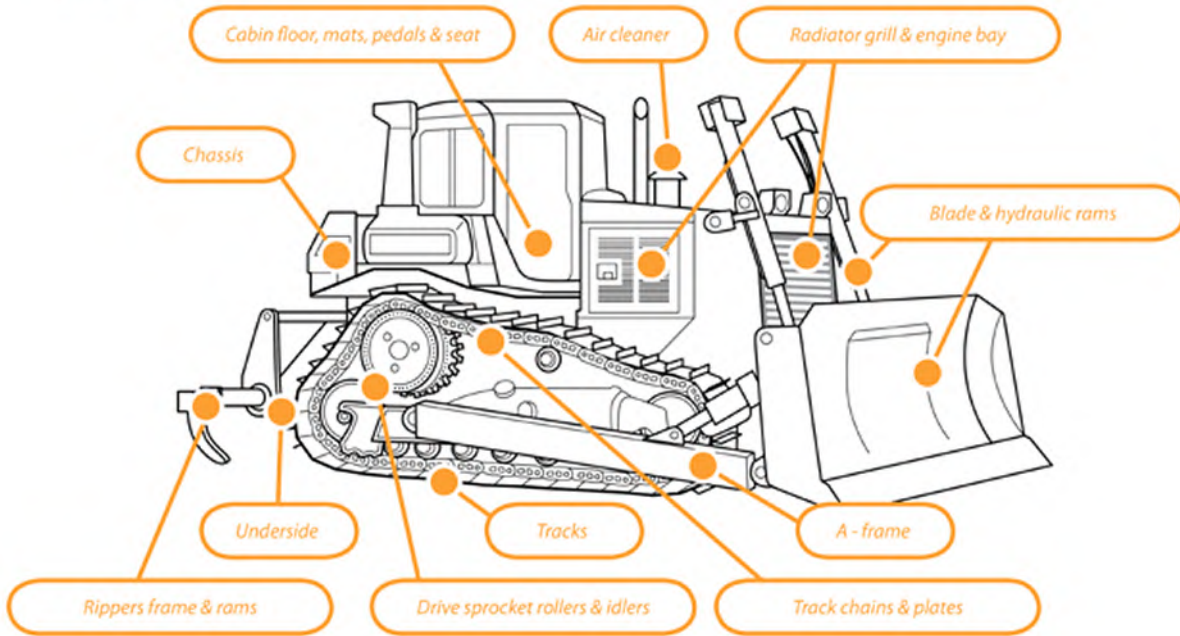
BULLDOZER WITH KEY SPOTS TO CHECK AND CLEAN

✓
Cabin	Floor, mats, pedals, seats	
Engine	Radiators, engine bay, grill, air cleaner	
Tracks	Tracks, track frame, drive sprocket rollers, idlers	
Body Plates	Belly plates, rear plates	
Body	Ledges, channels	
Blade	Pivot points, hydraulic rams, a-frame	
Ripper	Ripper frame, ripper points
