# **1Door4Care: CHEO Integrated Treatment Centre - Geotechnical Investigation Report (Parking Garage)**

Children's Hospital of Eastern Ontario  
Campus 401 and 407 Smyth Road  
Ottawa, Ontario

Infrastructure Ontario Project # 182-OCTC

25 October 2022

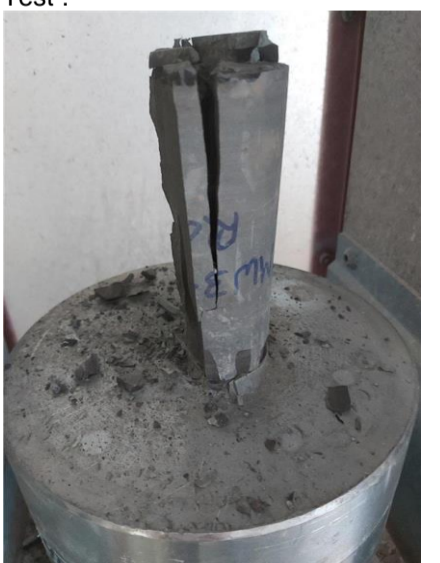
0.15	0.15	0.15	0.15		
Mass : <u>965.2</u> (g) Volume: <u>364718</u> (mm <sup>3</sup> )					
Density : <u>2646</u> (kg/m <sup>3</sup> )					
Moisture Conditions : <u>Dry</u>					
Loading Rate (0.5 to 1.0 MPa / sec) : <u>0.6</u> (MPa/sec)					
Type of Fracture : <u>3</u>					
Test Duration (2-15 Minutes) : <u>3.5</u> (minutes)					
Maximum Applied Load : <u>251.98</u> <input checked="" type="checkbox"/> kN <input type="checkbox"/> lbs					
<b>Compressive Strength :</b> <u>80.8</u> (MPa)	After Test :

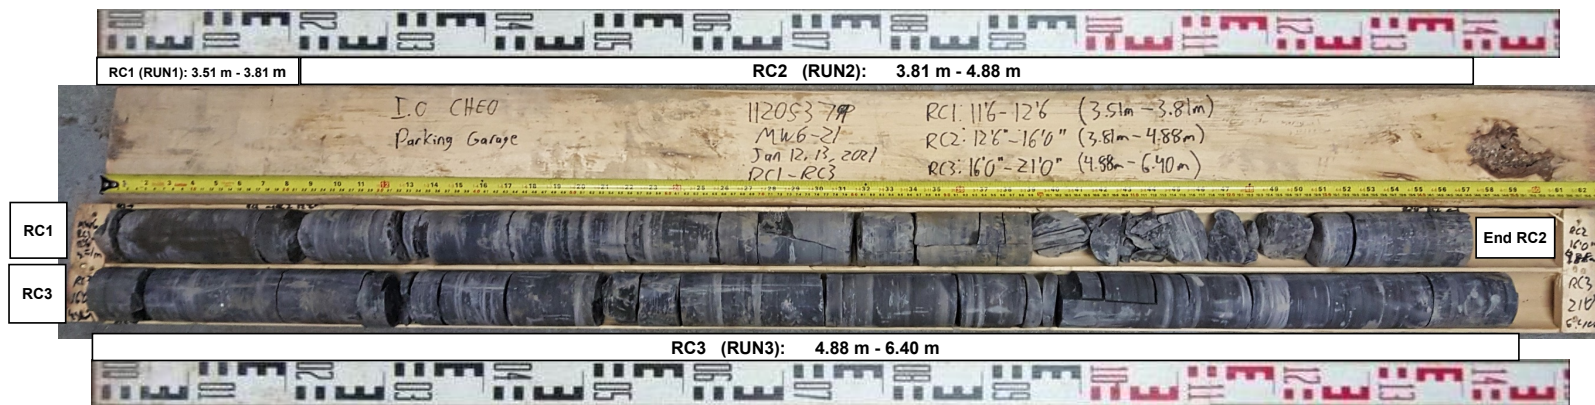
# HQ Rock Core Photo Log MW6-21 (RUN1,RUN2 & RUN3)

RC1 (RUN1): 3.51 m - 3.81 m  
 RC2 (RUN2): 3.81 m - 4.88 m  
 RC3 (RUN3): 4.88 m - 6.40 m

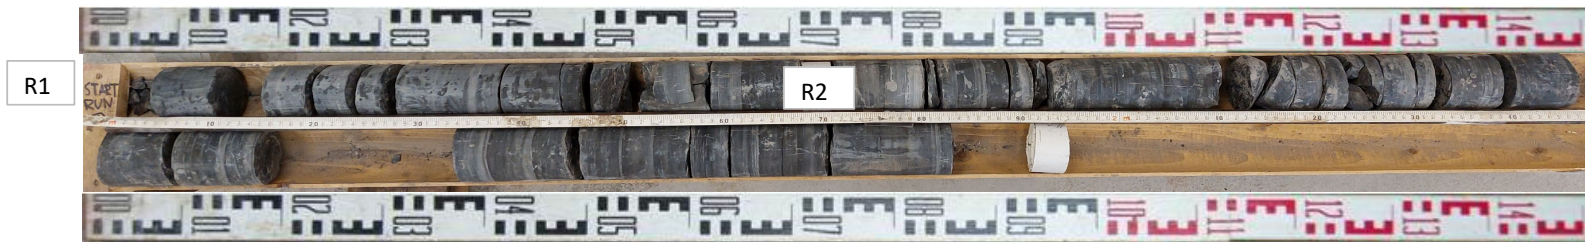
## Rock Core Photo Log BH11-22

R1 (RUN 1): 2.5 m - 3.4 m  
 R2 (RUN 2): 3.4 m - 4.9 m

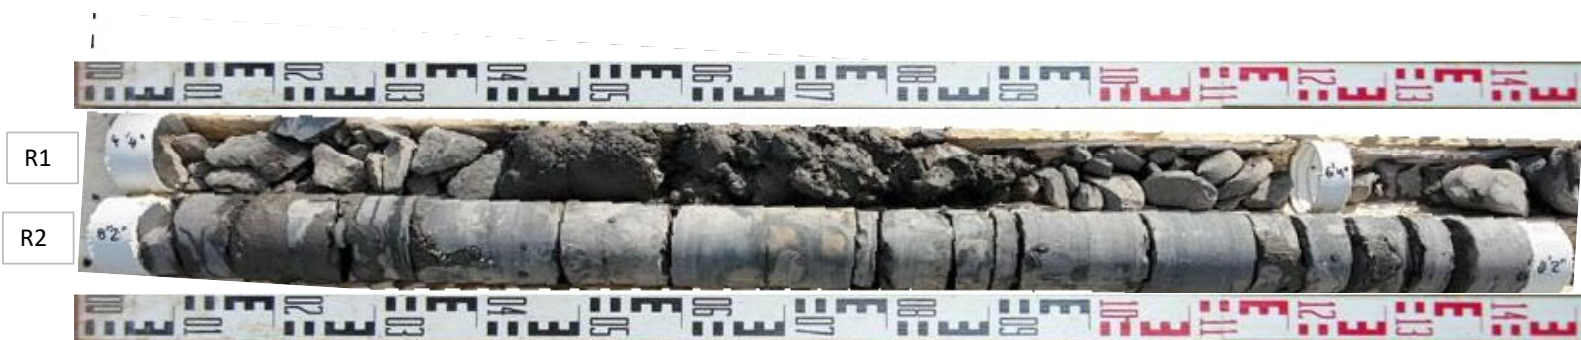
## Rock Core Photo Log BH13

R1 (RUN 1): 1.2 m - 1.9 m  
 R2 (RUN 2): 1.9 m - 3.4 m

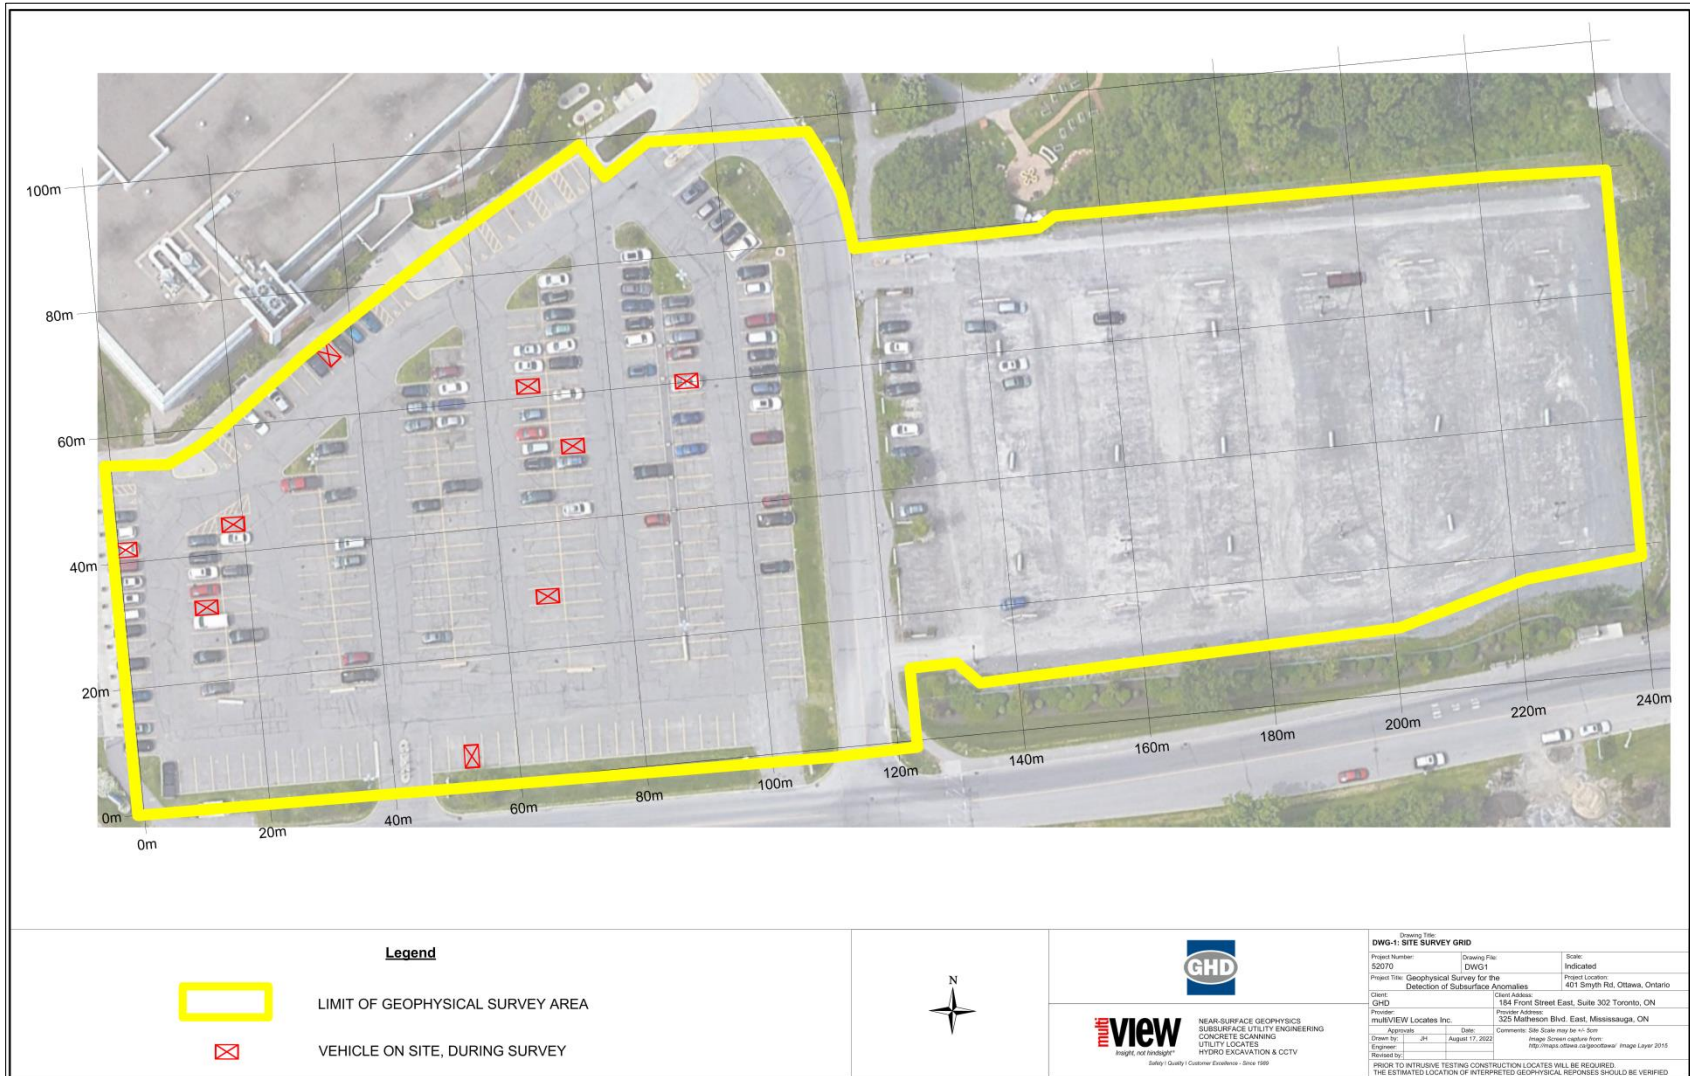
Figure 3-1: Geophysical Survey Area

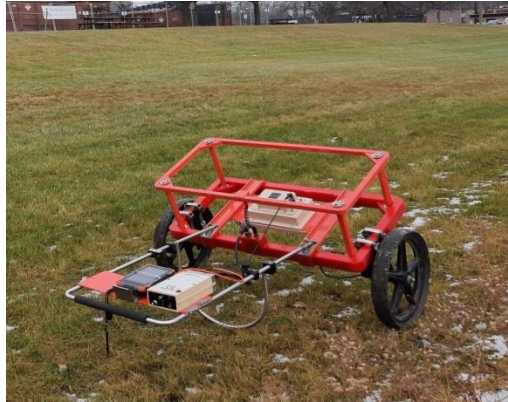
Figure 3-2: Typical TDEM Acquisition System Setup
