ENVIRO-EXPERTS ENVIRONMENTAL SITE ASSESSMENT PHASE I

630, Montreal Road, Ottawa, On

Project 3260

April 4th, 2022

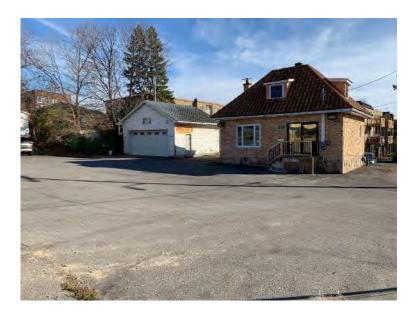
Photograph 1:

North view of onsite buildings, facing southeast

The Site is improved with a two-storey (formerly residential) office building with a basement, and a slab-on-grade auto body garage building. The buildings occupy roughly 15% of the Site area, and Mr. Baroud mentioned the buildings were constructed sometime around the 1940s. There is a small, grassed area south of the office building, and the remainder of the Site is paved. The office building is brick clad, with window-mounted air conditioning equipment and natural gas—fired, forced-air heating.

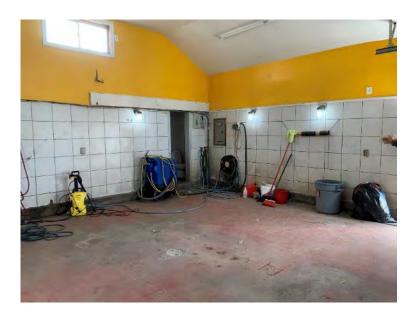
Photograph 4:

Interior of the auto garage with one borehole, one monitoring well, and one out-of-use oil/water separator, facing southwest

One drain was observed in the garage building, as well as one oil/water separator. According to the representative for the previous property owner, the oil/water separator has been cleaned and out-of-use since 2017. PGL was unable to inspect the interior of the oil/water separator. No other pits or underground structures were observed onsite.

One drain was observed in the garage building, connected to the oil/water separator. According to the representative for the previous property owner, the oil/water separator has been cleaned and out-of-use since 2017. PGL was unable to inspect the interior of the oil/water separator. No other pits or drains or sumps were observed onsite.

One drain was observed in the garage building and one oil/water separator, both within the south portion of the building. The installation date of the oil/water separator is unknown, and it is assumed that it was used to capture any liquid spills from within the garage building. The effluent discharge location is unknown, but according to the representative for the previous property owner, the oil/water separator has been cleaned and out-of-use since 2017.

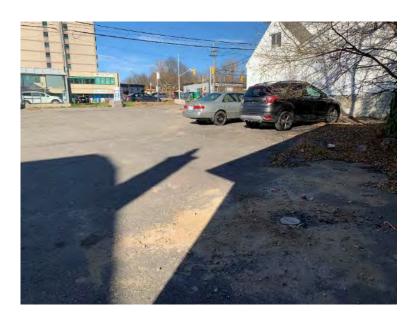
Photograph 6:

Two onsite monitoring wells north and northeast of the garage building, facing northeast

Eight monitoring wells were observed onsite: one inside the auto body garage building; one north of the garage building; one centrally along the east property line; one in the northwest corner of the Site; one centrally along the north property line; and three in the northwest corner of the Site. Listings of these well records were not available through ERIS or on the MECP well records site. It is unclear as to when these wells were installed. PGL did not observe any water supply wells at the Site.

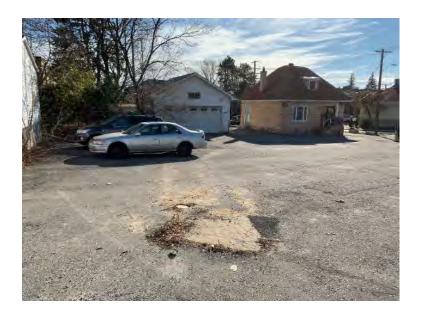
Photograph 7:

One monitoring well in the northeast corner of the Site, facing southwest

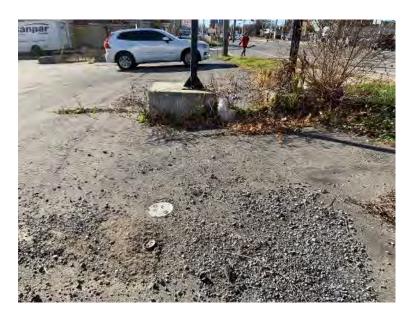
Photograph 8:

One monitoring well centrally along the north property line, facing west

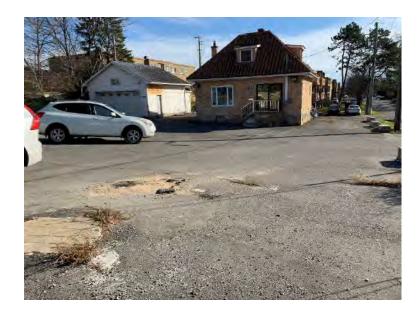
Photograph 9:

Three monitoring wells in the northwest corner of the Site, facing southeast

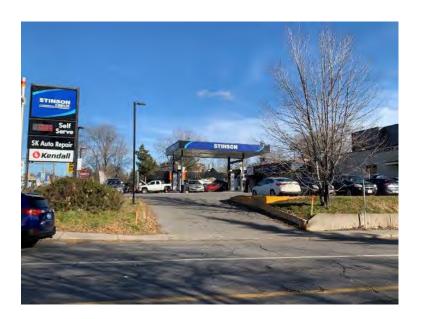
Photograph 10:

Offsite service centre 45m east, facing east

- The LRL 2017 Phase 1 ESA update noted that a gasoline service station was present roughly 45m east of the Site since at least the late 1950s. Due to the distance and inferred upgradient location, the risk for environmental concern to the Site from this gasoline station was considered by LRL to be moderate; and
