**Assessment of Parking Lot  
Subsurface Conditions  
Jabulani Winery and Event Facility  
8005 Jock Trail  
Ottawa, Ontario**

GEMTEC Project: 101593.001

April 25, 2023  
GEMTEC Project: 101593.001

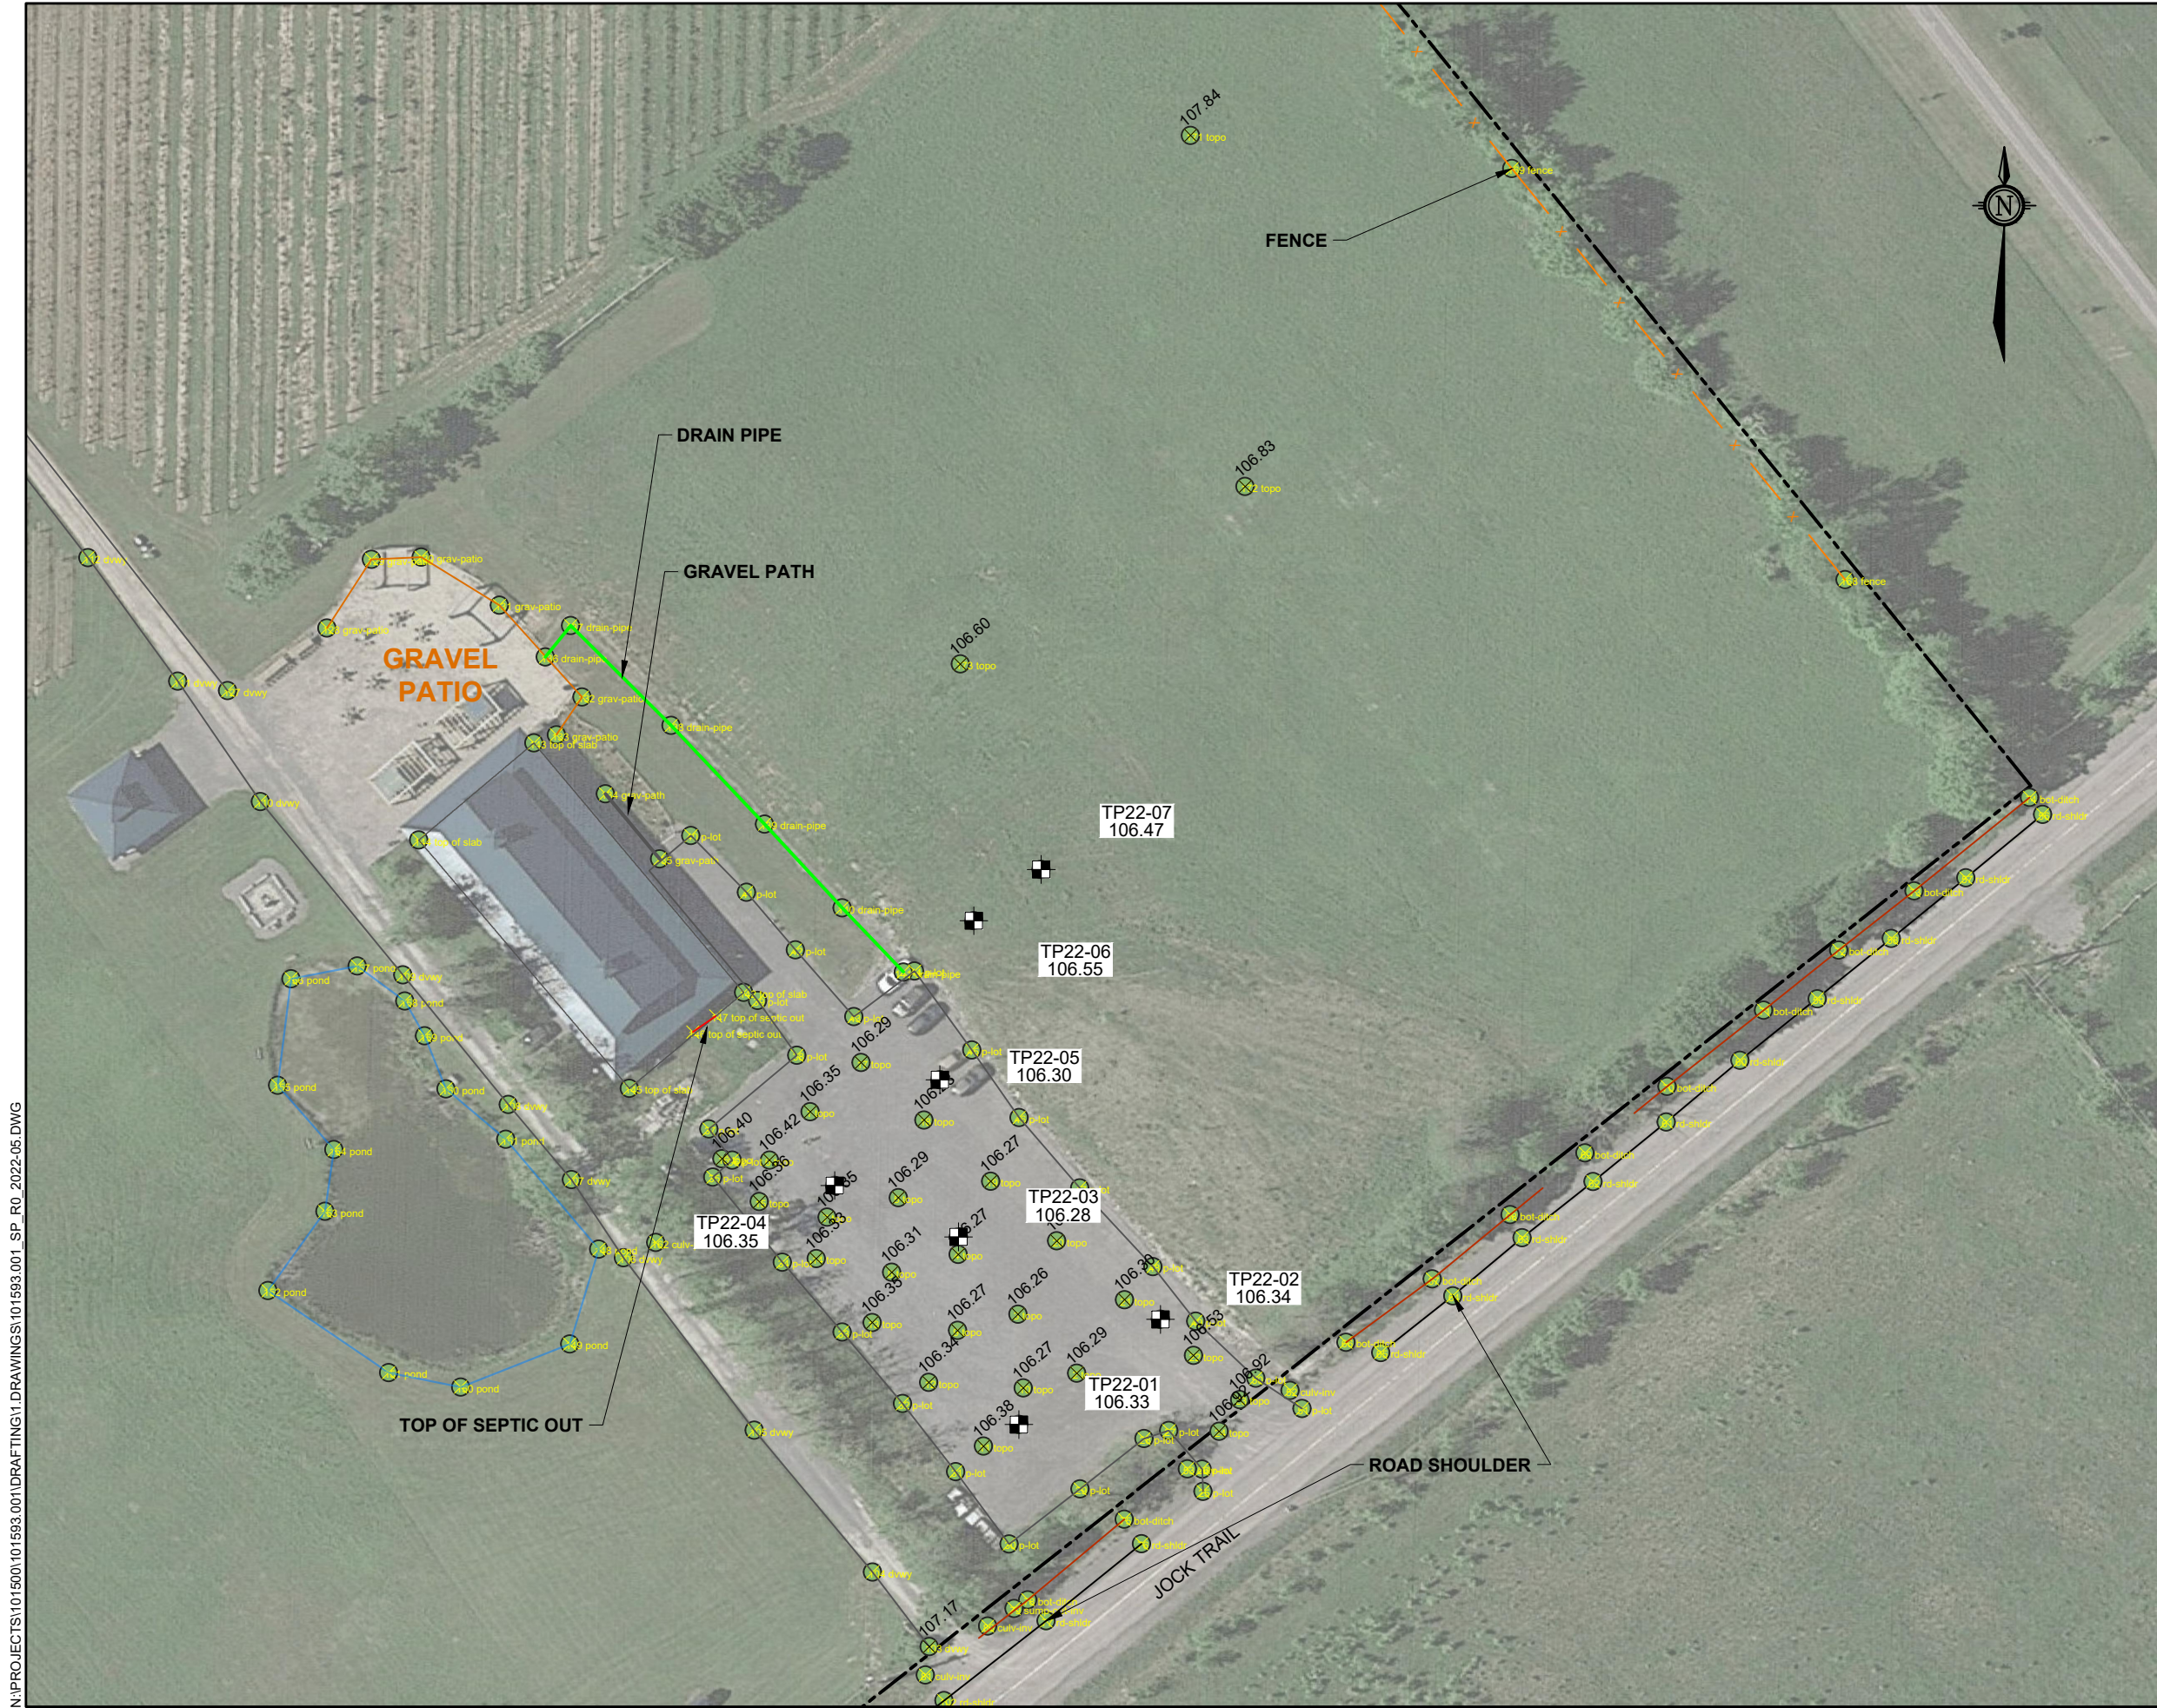
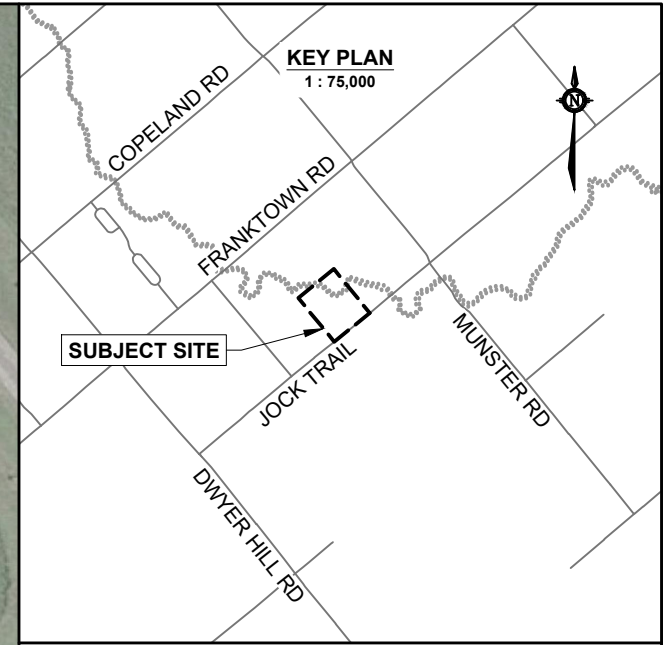
Date	JULY, 2022	Rev.	0	FIGURE 1
------	------------	------	---	----------

The existing parking lot is about 30 by 60 metres, gravel surfaced and was constructed at the same time as the building. Access to the parking lot is by a gravel surfaced roadway connecting to Jock Trail (see attached Site Plan – Figure 1). There are no planned expansions of the existing parking lot.

The results of the test pits are provided on the Record of Test Pit sheets in Attachment A. The approximate locations of the test pits are shown on the Site Plan, Figure 1. The laboratory testing results are provided on the Soils Grading chart, in Attachment B.

The test pit locations were selected by GEMTEC and positioned on site to cover the existing parking lot. The ground surface elevations at the location of the test pits were determined using a global positioning system. The elevations are referenced to geodetic datum (CGVD28) and are considered to be accurate to approximately 2 centimeters.
