**RE: TREE CONSERVATION REPORT FOR 1400–1410 YOUVILLE DRIVE, OTTAWA**

This Tree Conservation Report (TCR) was prepared by IFS Associates Inc. (IFS) on behalf of 2167659 Ontario Inc. in support of the development of 1400-1410 Youville Drive in Orleans. The need for this report is related to trees protected under the City of Ottawa’s Tree Protection By-law (By-law No. 2020-340). The By-law reflects Section 4.8.2. of the City of Ottawa’s Official Plan which calls for the retention of the City’s urban forestry canopy and, in particular, the protection of large, healthy trees.

**Jim Key FIX AUTO**  
 1400 1410 Youville Drive Orleans  
 2167659 Ontario Inc. 1438 Youville Drive, Orleans Ontario, K1C 2X8, 613-841-3099

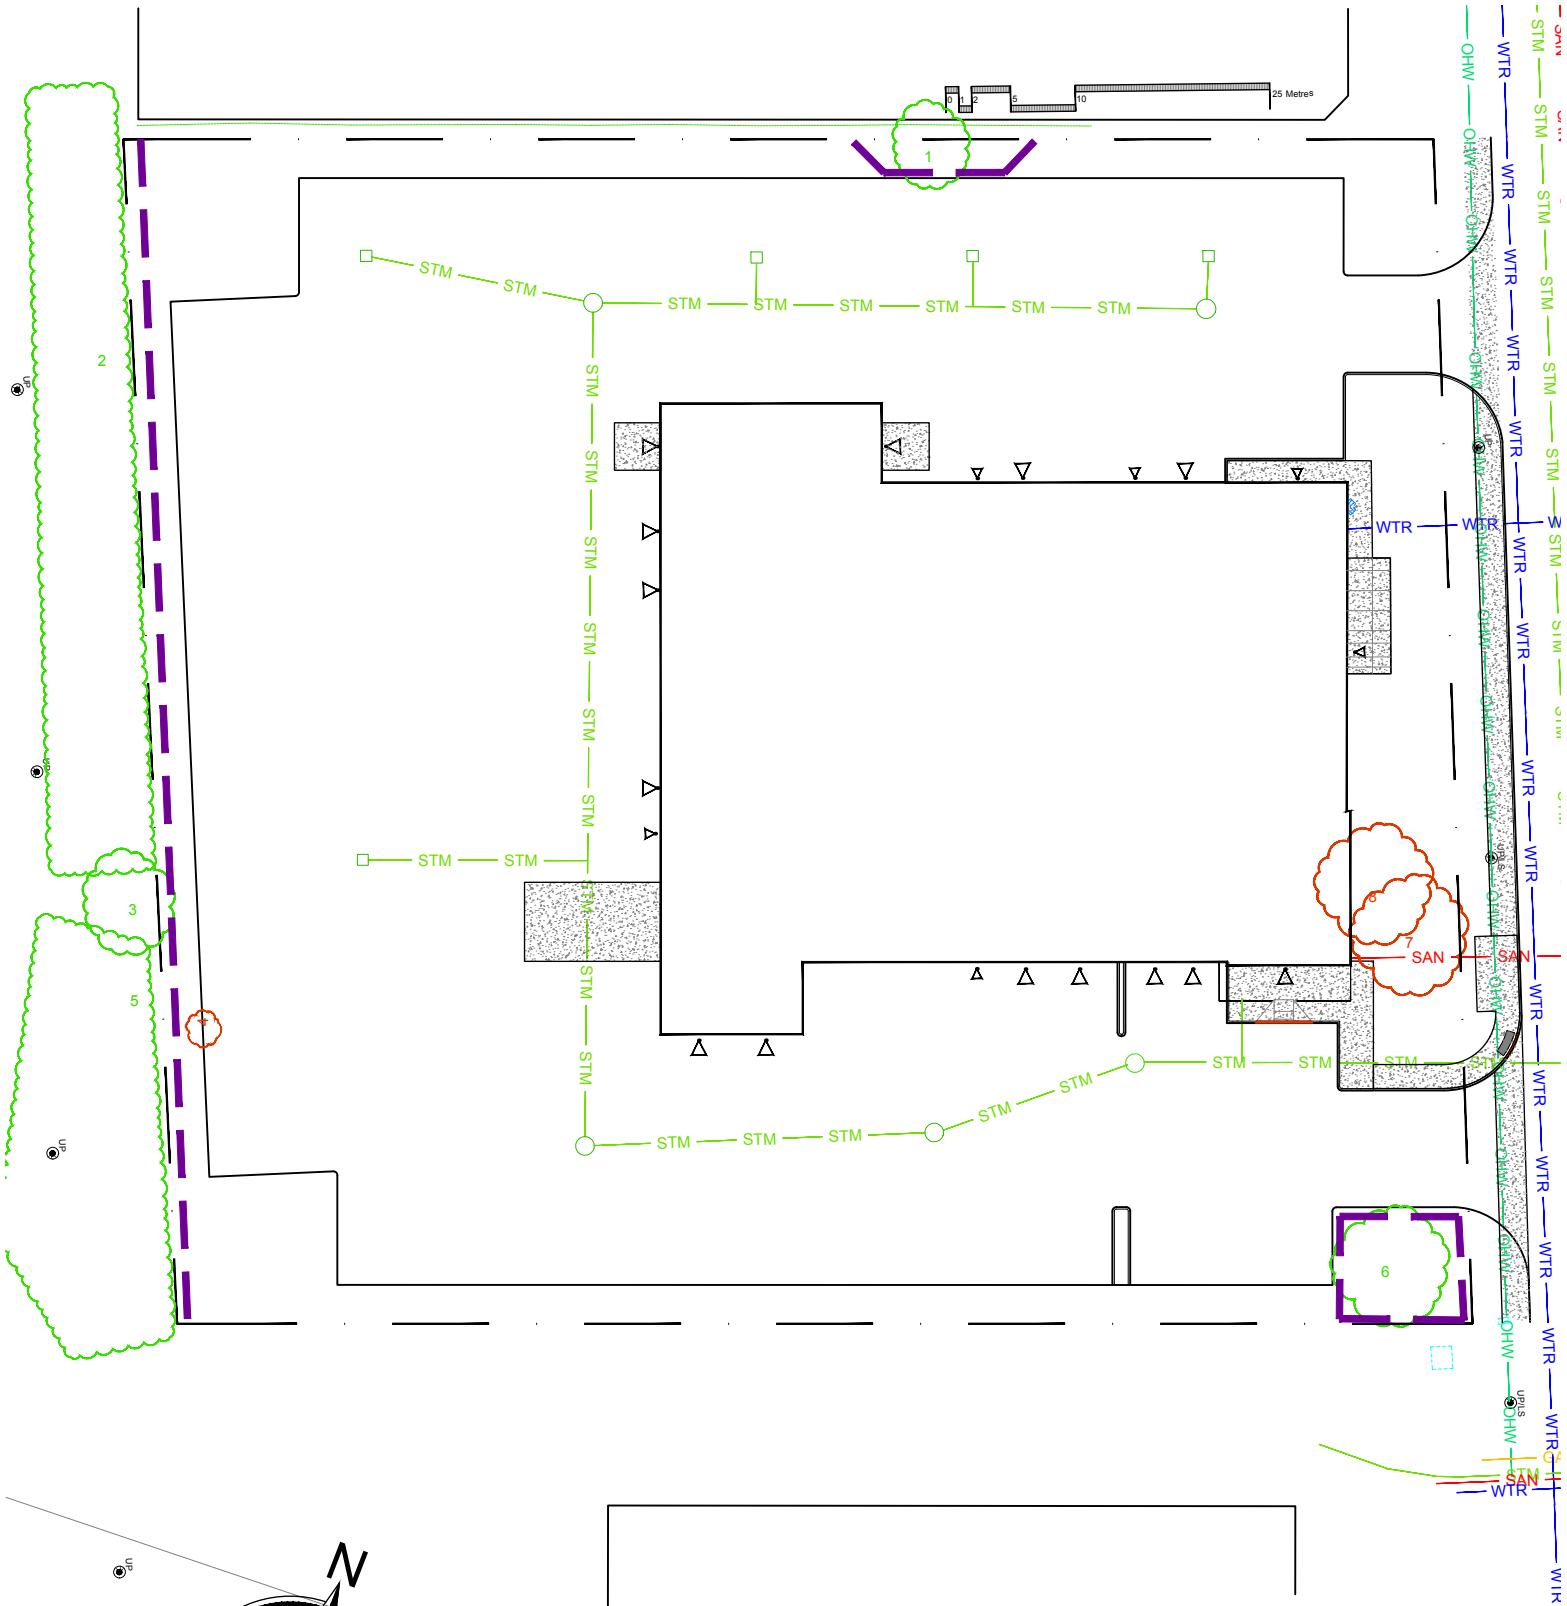
On the Table 1 below details the species, condition, size (diameter) and status of the individual trees on the subject and adjacent private properties. Each of these trees is referenced by the numbers plotted on the tree conservation plan on page 5 of this report.

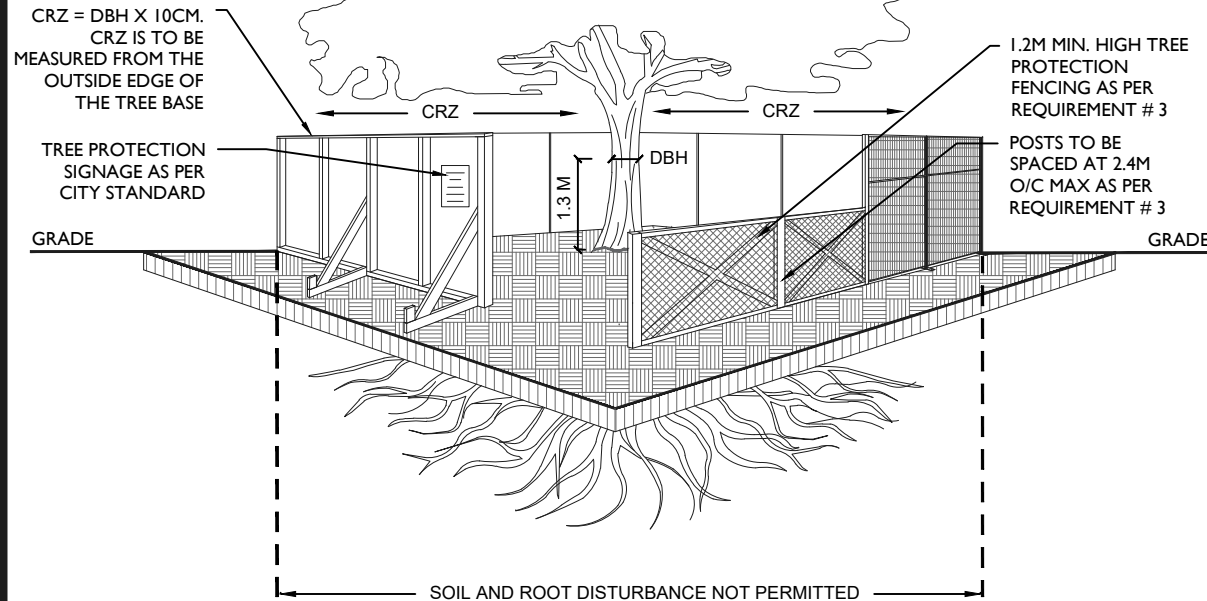
PLAN VIEW

- DO NOT EXTEND HARD SURFACE OR SIGNIFICANTLY CHANGE LANDSCAPING
3. TREE PROTECTION FENCING MUST BE AT LEAST 1.2M IN HEIGHT, AND CONSTRUCTED OF RIGID OR FRAMED MATERIALS (E.G. MODULOC - STEEL, PLYWOOD HOARDING, OR SNOW FENCE ON A 2"X4" WOOD FRAME) WITH POSTS 2.4M APART, SUCH THAT THE FENCE LOCATION CANNOT BE ALTERED. ALL SUPPORTS AND BRACING MUST BE PLACED OUTSIDE OF THE CRZ, AND INSTALLATION MUST MINIMISE DAMAGE TO EXISTING ROOTS. (SEE DETAIL)

1. PRIOR TO ANY WORK ACTIVITY WITHIN THE CRITICAL ROOT ZONE (CRZ = 10 X DIAMETER) OF A TREE, TREE PROTECTION FENCING MUST BE INSTALLED SURROUNDING THE CRITICAL ROOT ZONE, AND REMAIN IN PLACE UNTIL THE WORK IS COMPLETE.

2. UNLESS PLANS ARE APPROVED BY CITY FORESTRY STAFF, FOR WORK WITHIN THE CRZ:
  - DO NOT PLACE ANY MATERIAL OR EQUIPMENT - INCLUDING OUTHOUSES;
  - DO NOT ATTACH ANY SIGNS, NOTICES OR POSTERS TO ANY TREE;

- DO NOT RAISE OR LOWER THE EXISTING GRADE;
  - TUNNEL OR BORE WHEN DIGGING;
  - DO NOT DAMAGE THE ROOT SYSTEM, TRUNK, OR BRANCHES OR ANY TREE;
  - ENSURE THAT EXHAUST FUMES FROM ALL EQUIPMENT ARE NOT DIRECTED TOWARD ANY TREE CANOPY.

4. THE LOCATION OF THE TREE PROTECTION FENCING MUST BE DETERMINED BY AN ARBORIST AND DETAILED ON ANY ASSOCIATED PLANS FOR THE SITE ( E.G. TREE CONSERVATION REPORT, TREE INFORMATION REPORT, ETC). THE PLAN AND CONSTRUCTED FENCING MUST BE APPROVED BY CITY FORESTRY STAFF PRIOR TO THE COMMENCEMENT OF WORK.

5. IF THE FENCED TREE PROTECTION AREA MUST BE REDUCED TO FACILITATE CONSTRUCTION, MITIGATION MEASURES MUST BE PRESCRIBED BY AN ARBORIST AND APPROVED BY CITY FORESTRY STAFF. THESE MAY INCLUDE THE PLACEMENT OF PLYWOOD, WOOD CHIPS, OR STEEL PLATING OVER THE ROOTS FOR PROTECTION OR THE PROPER PRUNING AND CARE OF ROOTS WHERE ENCOUNTERED.

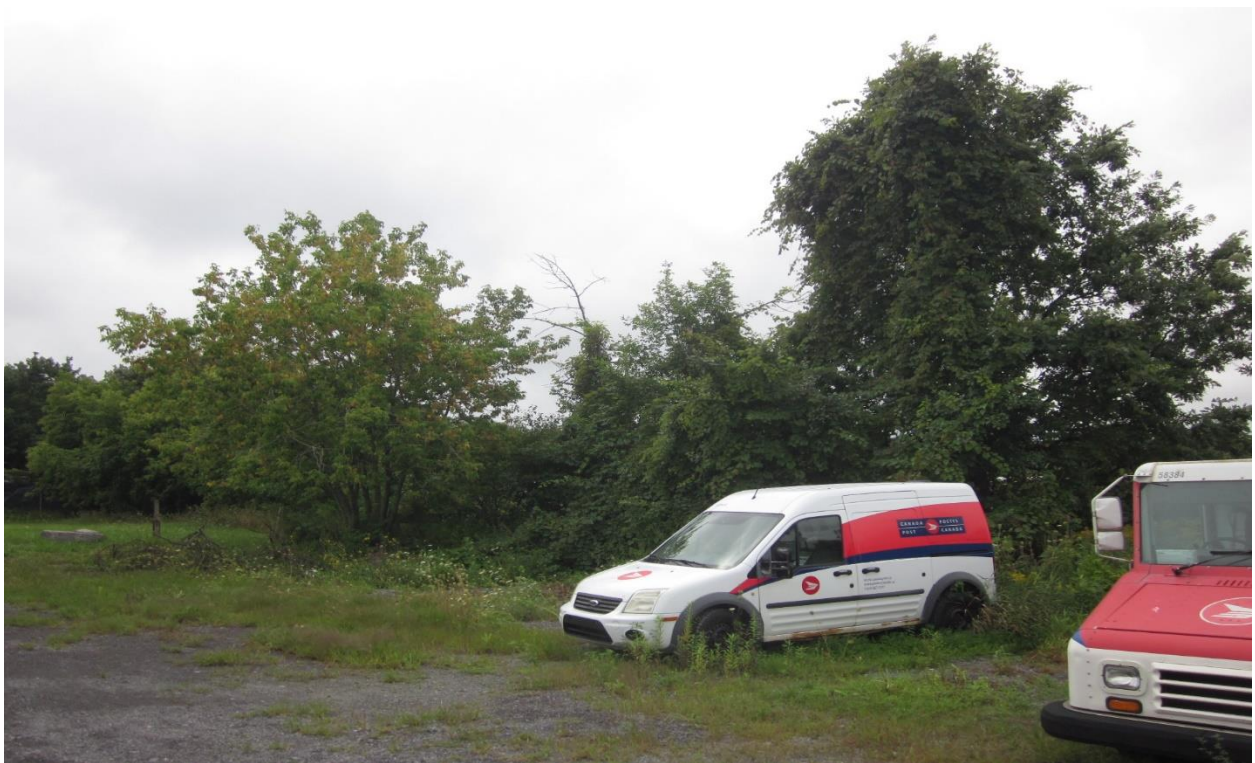
Tree No.	Tree Species	Ownership	DBH <sup>1</sup> (cm)	Tree Condition; Age Class; Condition Notes; Species Origin & <b>Preservation Status</b> (to be removed or preserved and protected)
1	White elm ( <i>Ulmus americana</i> )	Private	30	Good; mature; upright pedestal with multiple leaders arising at 4m – broad crown; no outward signs of Dutch elm disease ( <i>Ophiostoma novo-ulmi</i> ); native species; <b>to be preserved and protected</b>
2	Poplar ( <i>Populus</i> spp.) & Ash ( <i>Fraxinus</i> spp.)	Neighbour	10-15 approx.	Poor; maturing line of trees – ash originating from seed, poplar from root sprouts; ash dead due to emerald ash borer ( <i>Agrilus planipennis</i> ); all trees covered in dense vine growth ( <i>Vitis</i> spp.); native species; <b>to be preserved and protected</b>
3	Bur oak ( <i>Quercus macrocarpa</i> )	Neighbour	+/-35	Fair; mature; single upright main stem; crown covered in dense vine growth ( <i>Vitis</i> spp.); native species; <b>to be preserved and protected</b>

4	Manitoba maple ( <i>Acer negundo</i> )	Private	11 avg.	Fair; maturing; eight divergent stems from grade – possible coppice growth; broad dense crown; naturalized species; <b>to be removed</b> (conflicts with construction of proposed parking lot)
5	Manitoba maple ( <i>Acer negundo</i> )	Neighbour	10-20 approx.	Fair; maturing line of trees; all originated from seed; most multi-stemmed from grade; naturalized species; <b>to be preserved and protected</b>
6	Colorado spruce ( <i>Picea pungens</i> )	Private	42	Good; mature; crown raised to 3.5m above sign; epicormic growth regenerating along bole; good crown density, annual growth increment and needle colour; introduced species; <b>to be preserved and protected</b>
7	Colorado spruce ( <i>Picea pungens</i> )	Private	47	Good; mature; co-dominant stems at 2m – mildly divergent; lower crown asymmetric towards southeast due to influence of tree #8; good crown density, annual growth increment and needle colour; introduced species; <b>to be removed</b> (conflicts with service installation)

Picture 2. Trees #3, neighbouring grouping of trees (right) and #4 private Manitoba maple (left) at 1400-1410 Youville Drive
