Phase I Environmental Site Assessment

3130 Woodroffe Avenue
Ottawa, Ontario

September 15, 2015

Report: PE3632-1

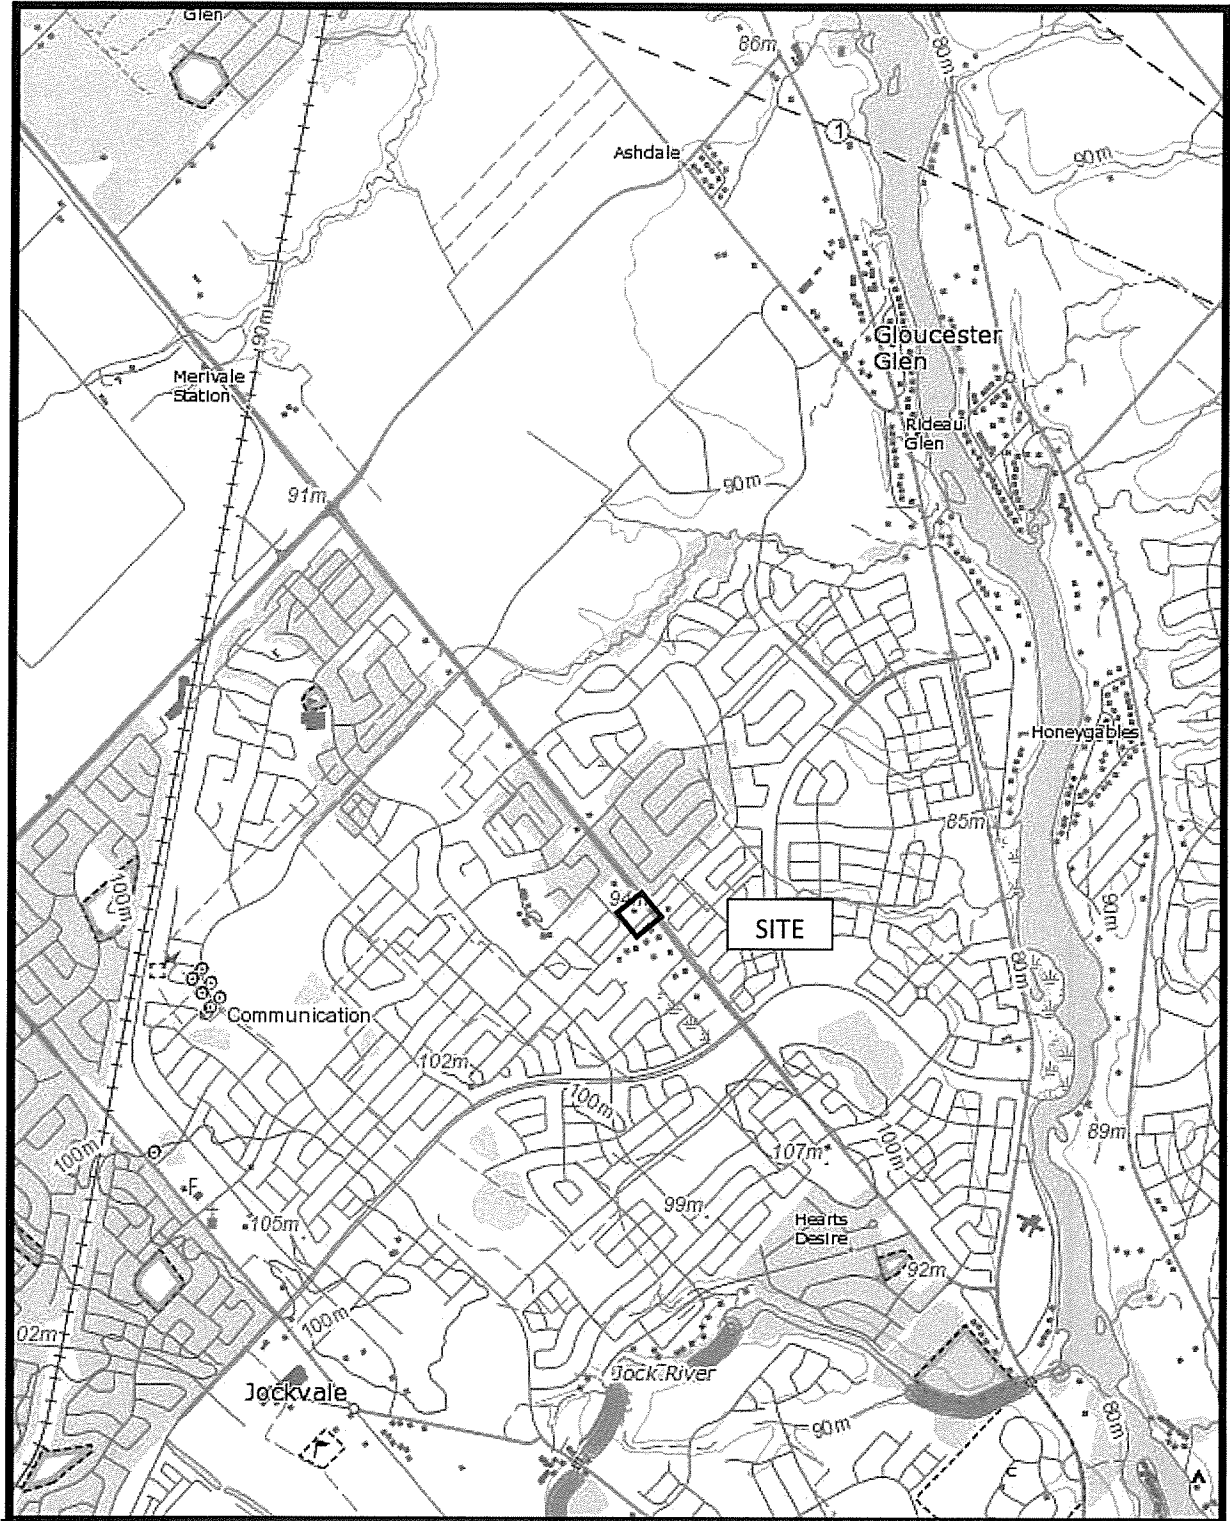
FIGURE 2

Topographic information was obtained from Natural Resources Canada – The Atlas of Canada website. The topographic maps indicate that the elevation of the subject site is approximately 94 m ASL, and that the regional topography in the general area of the site slopes downward to the east to northeast, towards the Rideau River. An illustration of the referenced topographic map is presented on Figure 2 – Topographic Map, appended to this report.

TOPOGRAPHIC MAP

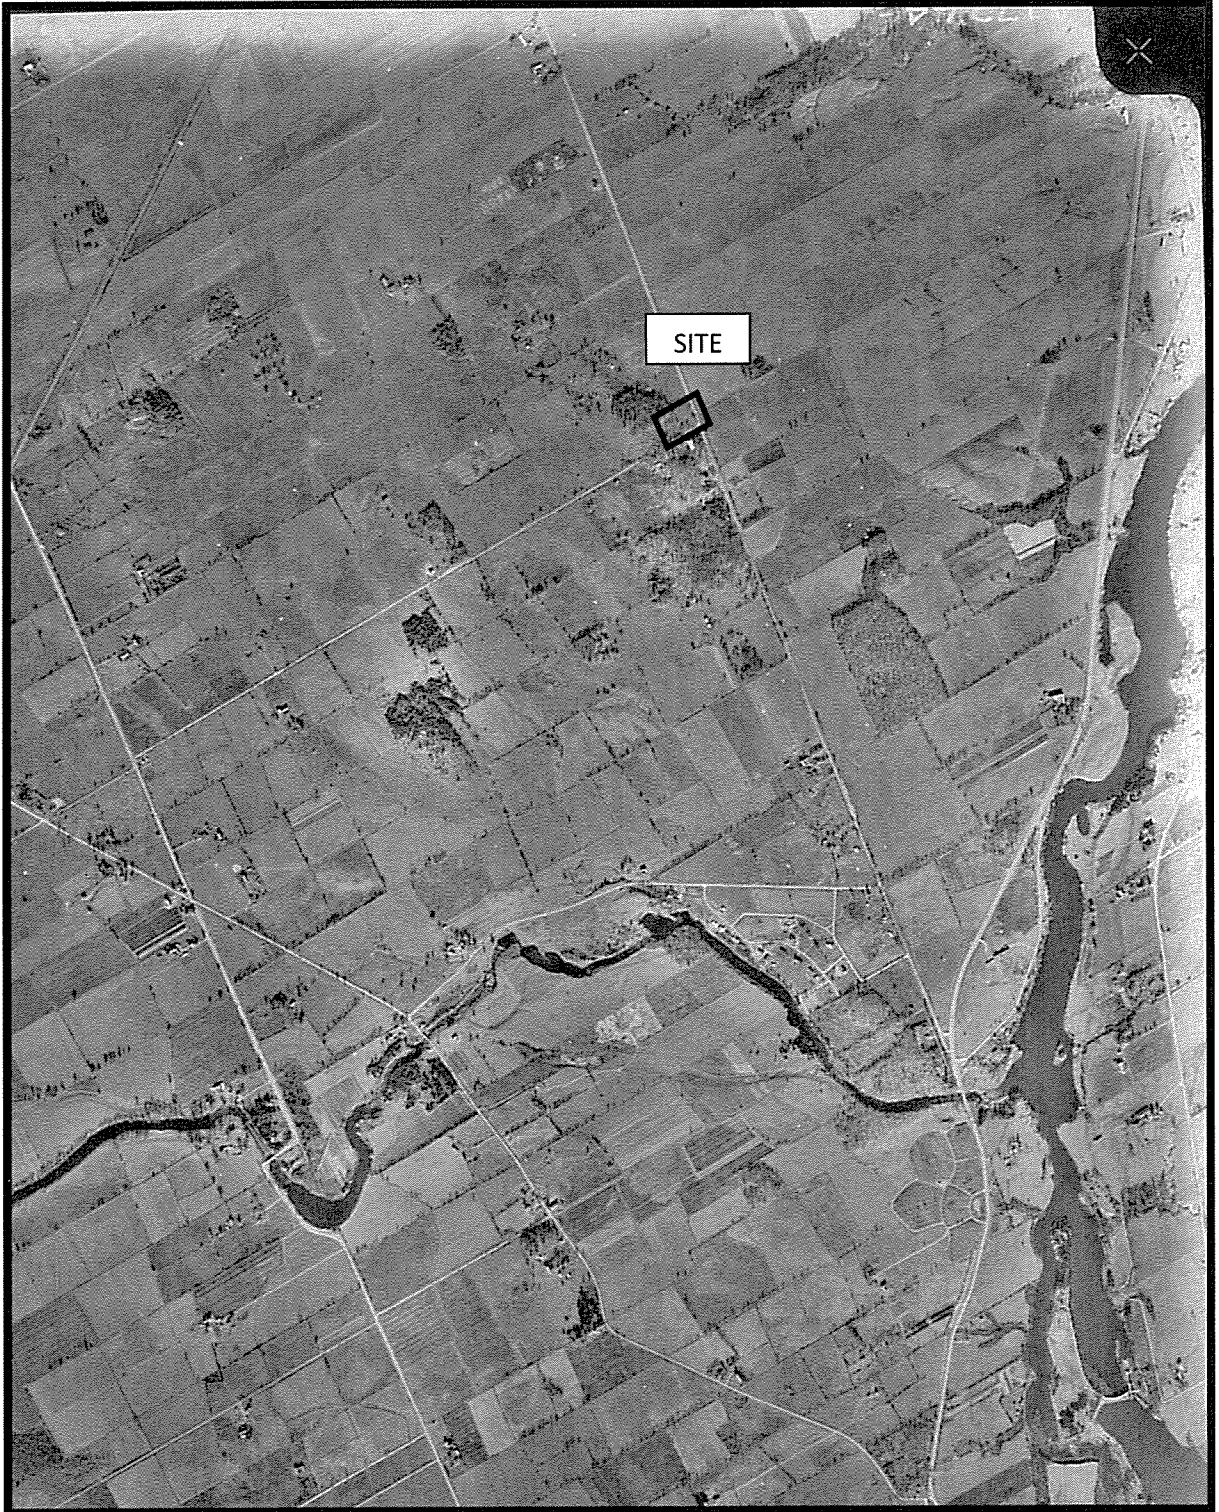
AERIAL PHOTOGRAPH
1960

| 1960 | The subject site appears to be vacant grass land with sparse trees. Woodroffe Avenue is present to the east of the subject site and Deerfox Drive is present to the south of the subject site. A few residential dwellings are present across Deerfox Drive, to the south of the subject site. Neighbouring lands consist of vacant or agricultural fields. A small forested area is located northwest of the subject property. |

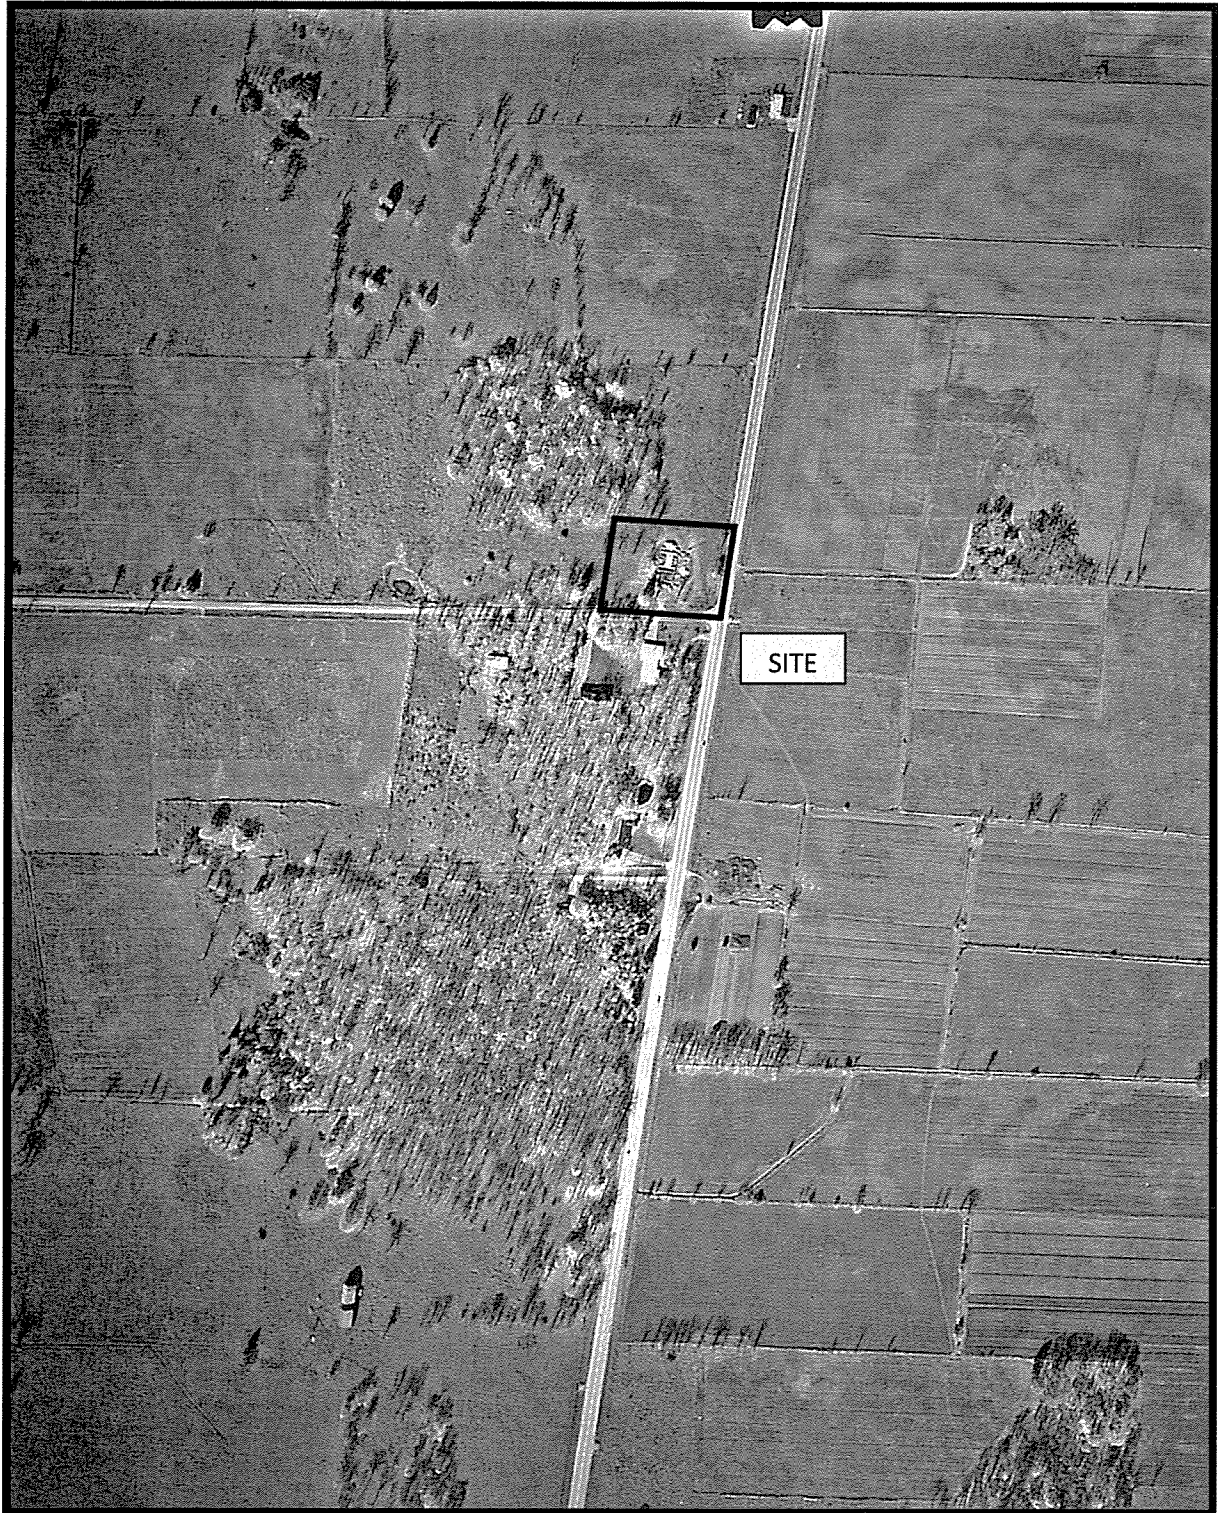
AERIAL PHOTOGRAPH
1968

| 1968 | The subject building appears to be under construction in the aerial photograph. No apparent changes have been made to the neighbouring properties. |

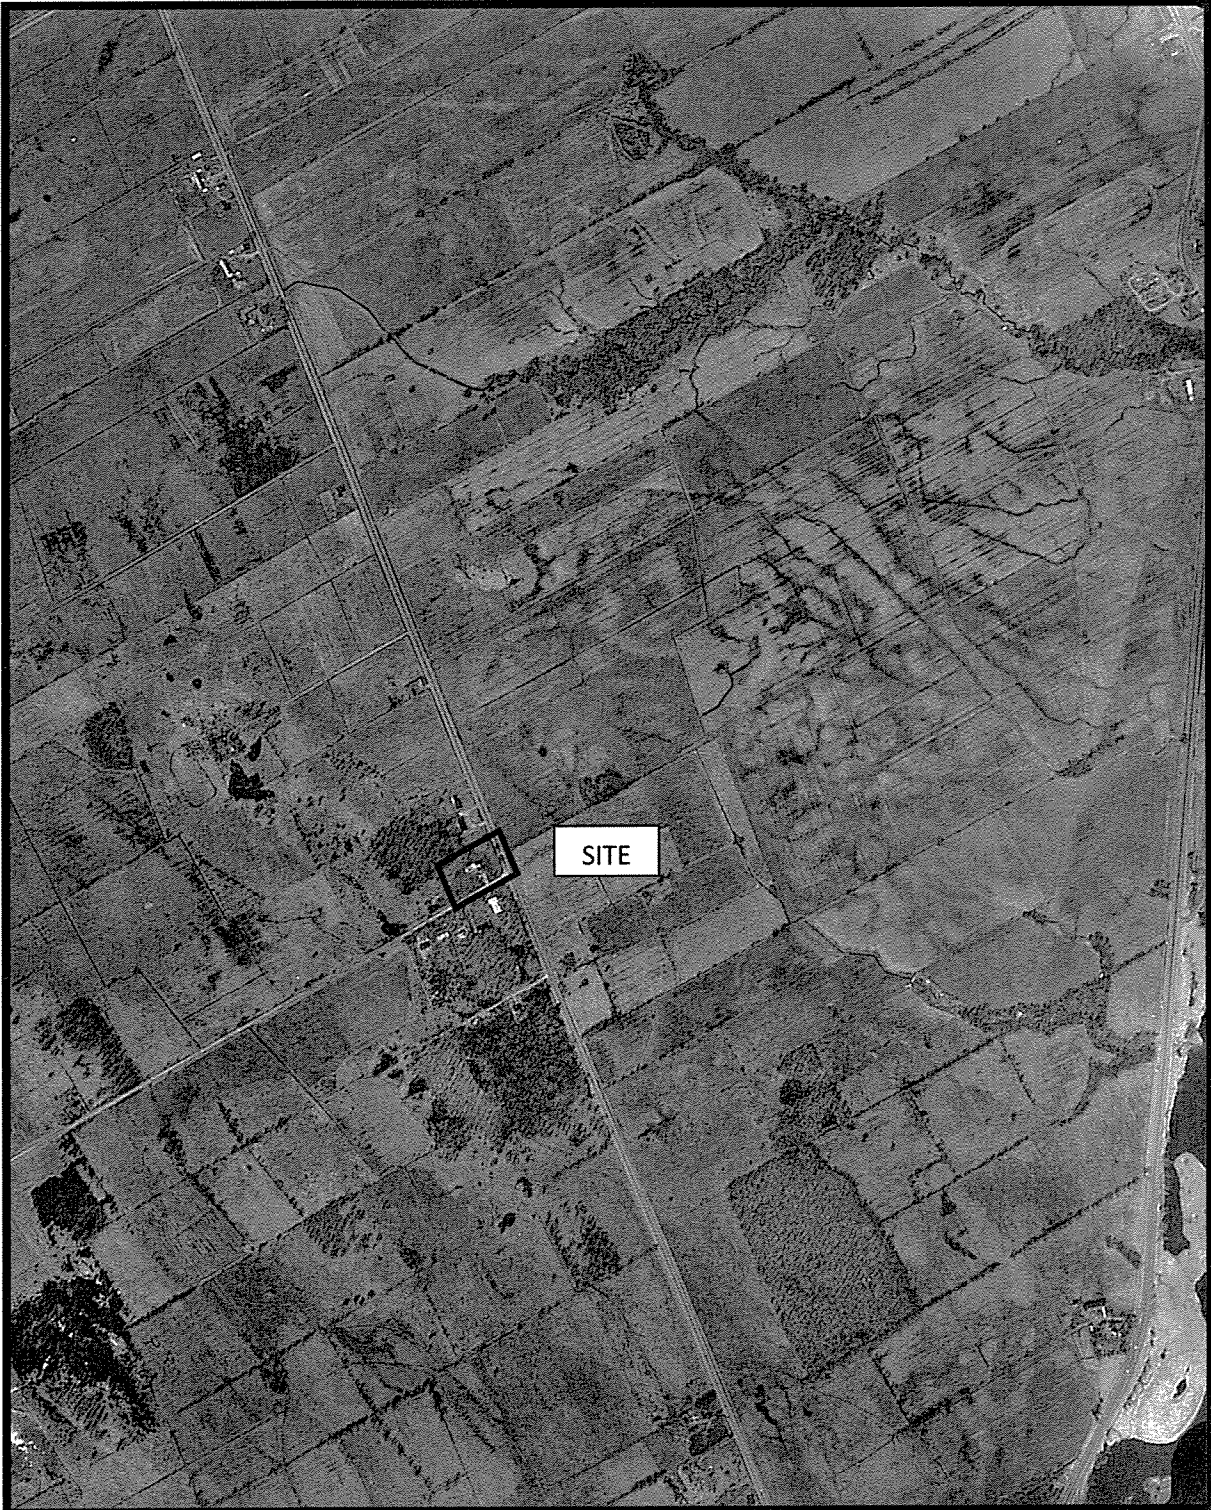
AERIAL PHOTOGRAPH
1973

- 1973 The subject property appears to be occupied by the present day residential structure. Residential dwellings are present on the west side of Woodroffe Avenue, to the north of the subject site and an increased number of residential dwellings are present along the south side of Deerfox Drive to the southwest.

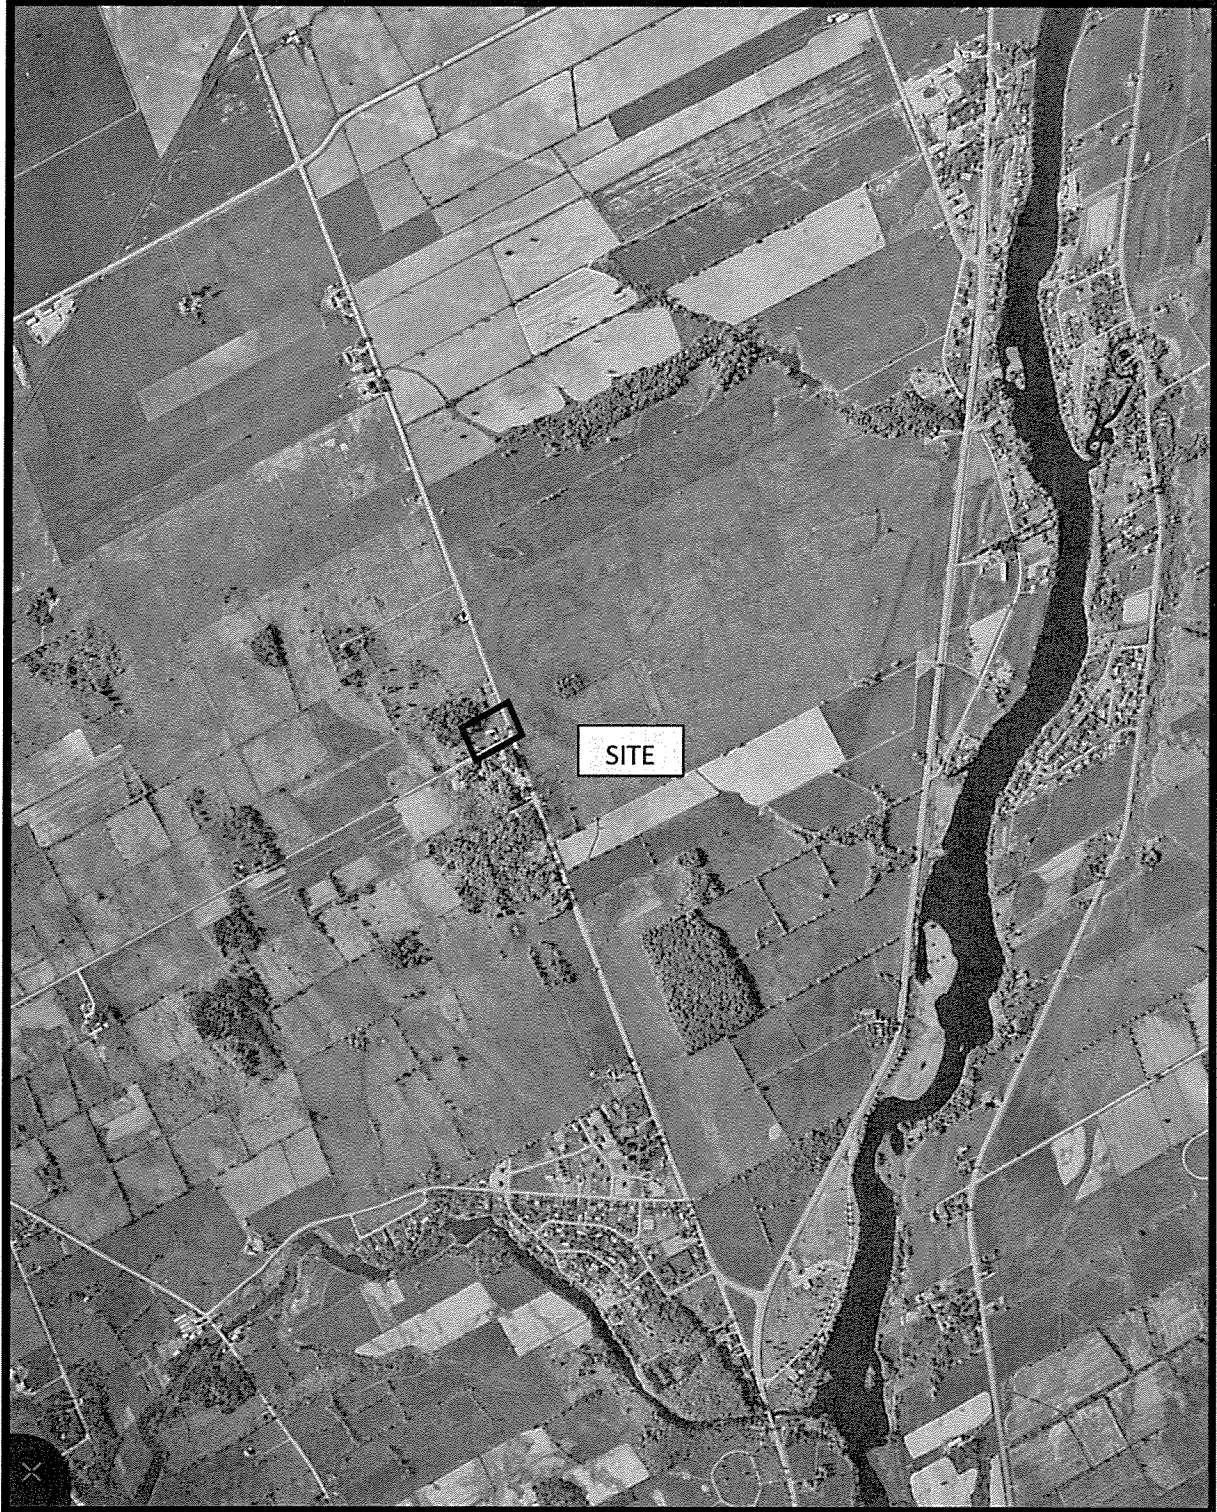
AERIAL PHOTOGRAPH
1979

- 1979 No significant changes appear to have been made to the subject or the neighbouring properties.
- 1989 A pool is present on the west side of the residence on the subject site. A residential dwelling has been constructed on the property immediately north of the subject site. No other significant changes have been made to the subject or neighbouring properties.

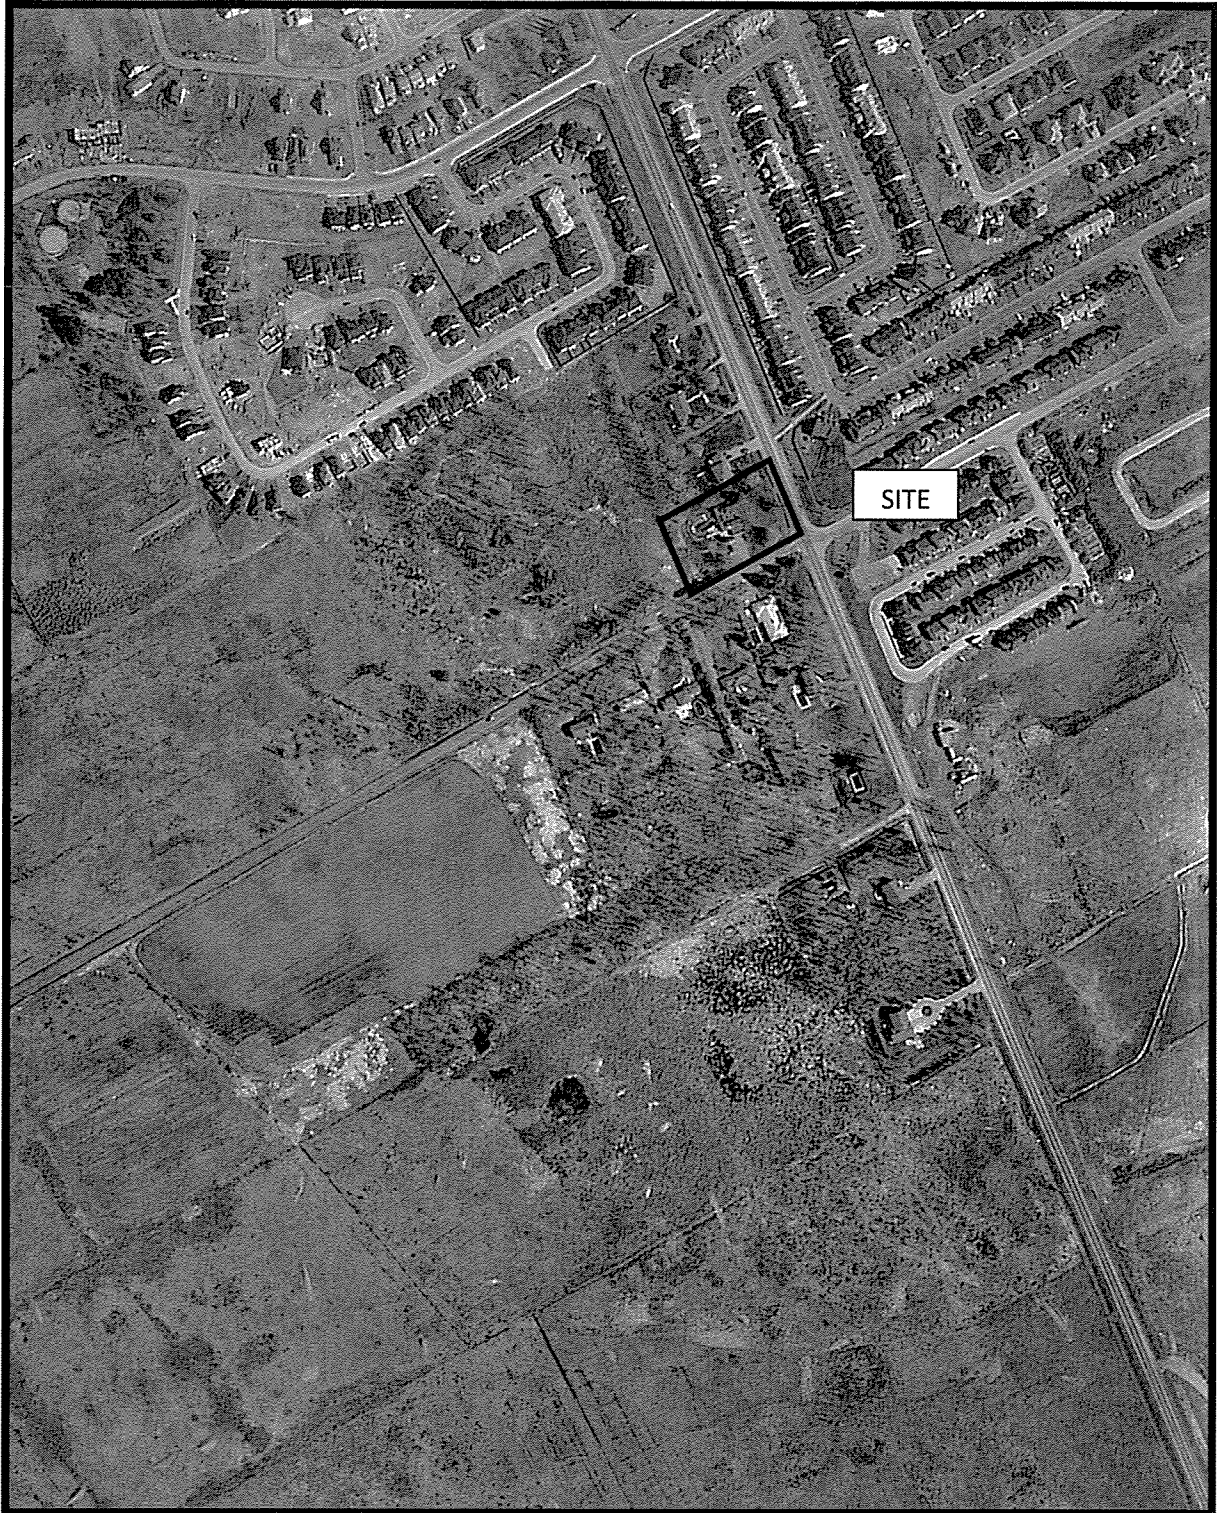
AERIAL PHOTOGRAPH
1995

- 1995 No apparent changes have been made to the subject site. Stoneway Drive has been completed further to the east of the subject site. Residential development is present and is expanding further to the east and north of the subject site.
