## **Phase II – Environmental Site Assessment**

360 Laurier Avenue W.

Prepared for CLV Group Developments Inc.

Report: PE5833-2

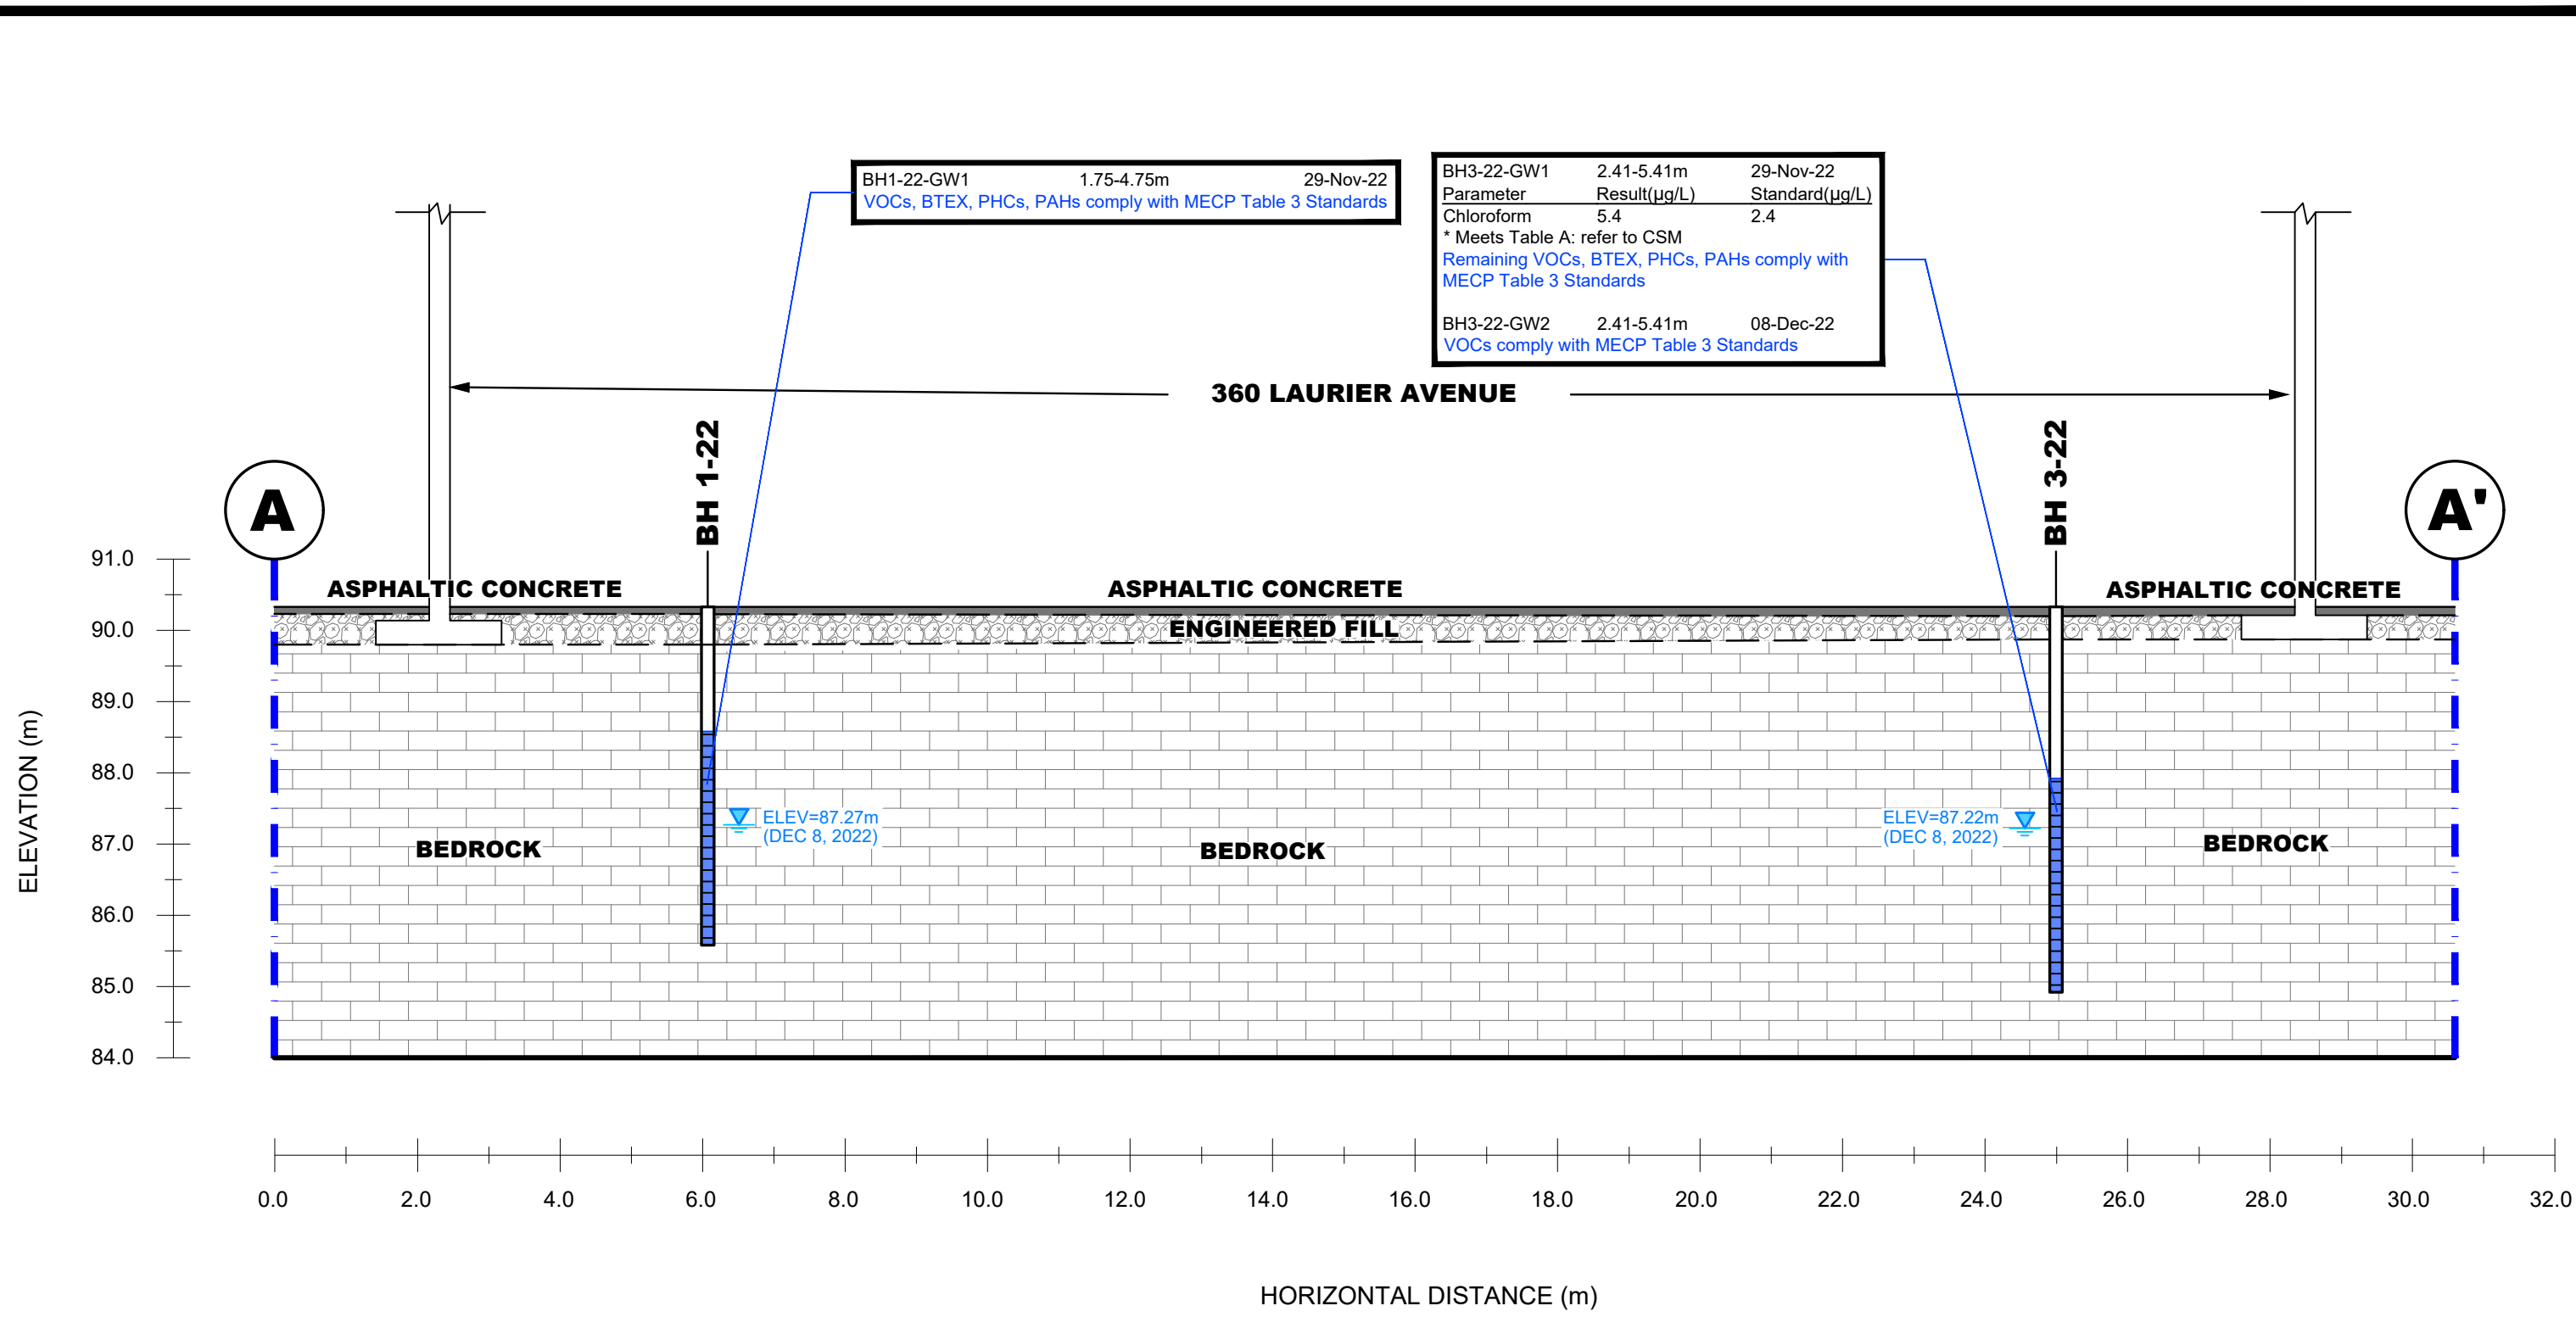
Title: **CROSS SECTION A-A' - GROUNDWATER**

BH3-22-GW1	2.41-5.41m	29-Nov-22
Parameter	Result(µg/L)	Standard(µg/L)
Chloroform	5.4	2.4
* Meets Table A: refer to CSM		
Remaining VOCs, BTEX, PHCs, PAHs comply with MECP Table 3 Standards		
BH3-22-GW2	2.41-5.41m	08-Dec-22
VOCs comply with MECP Table 3 Standards

**GROUNDWATER RESULT COMPLIES WITH THE MECP TABLE 3 STANDARDS**

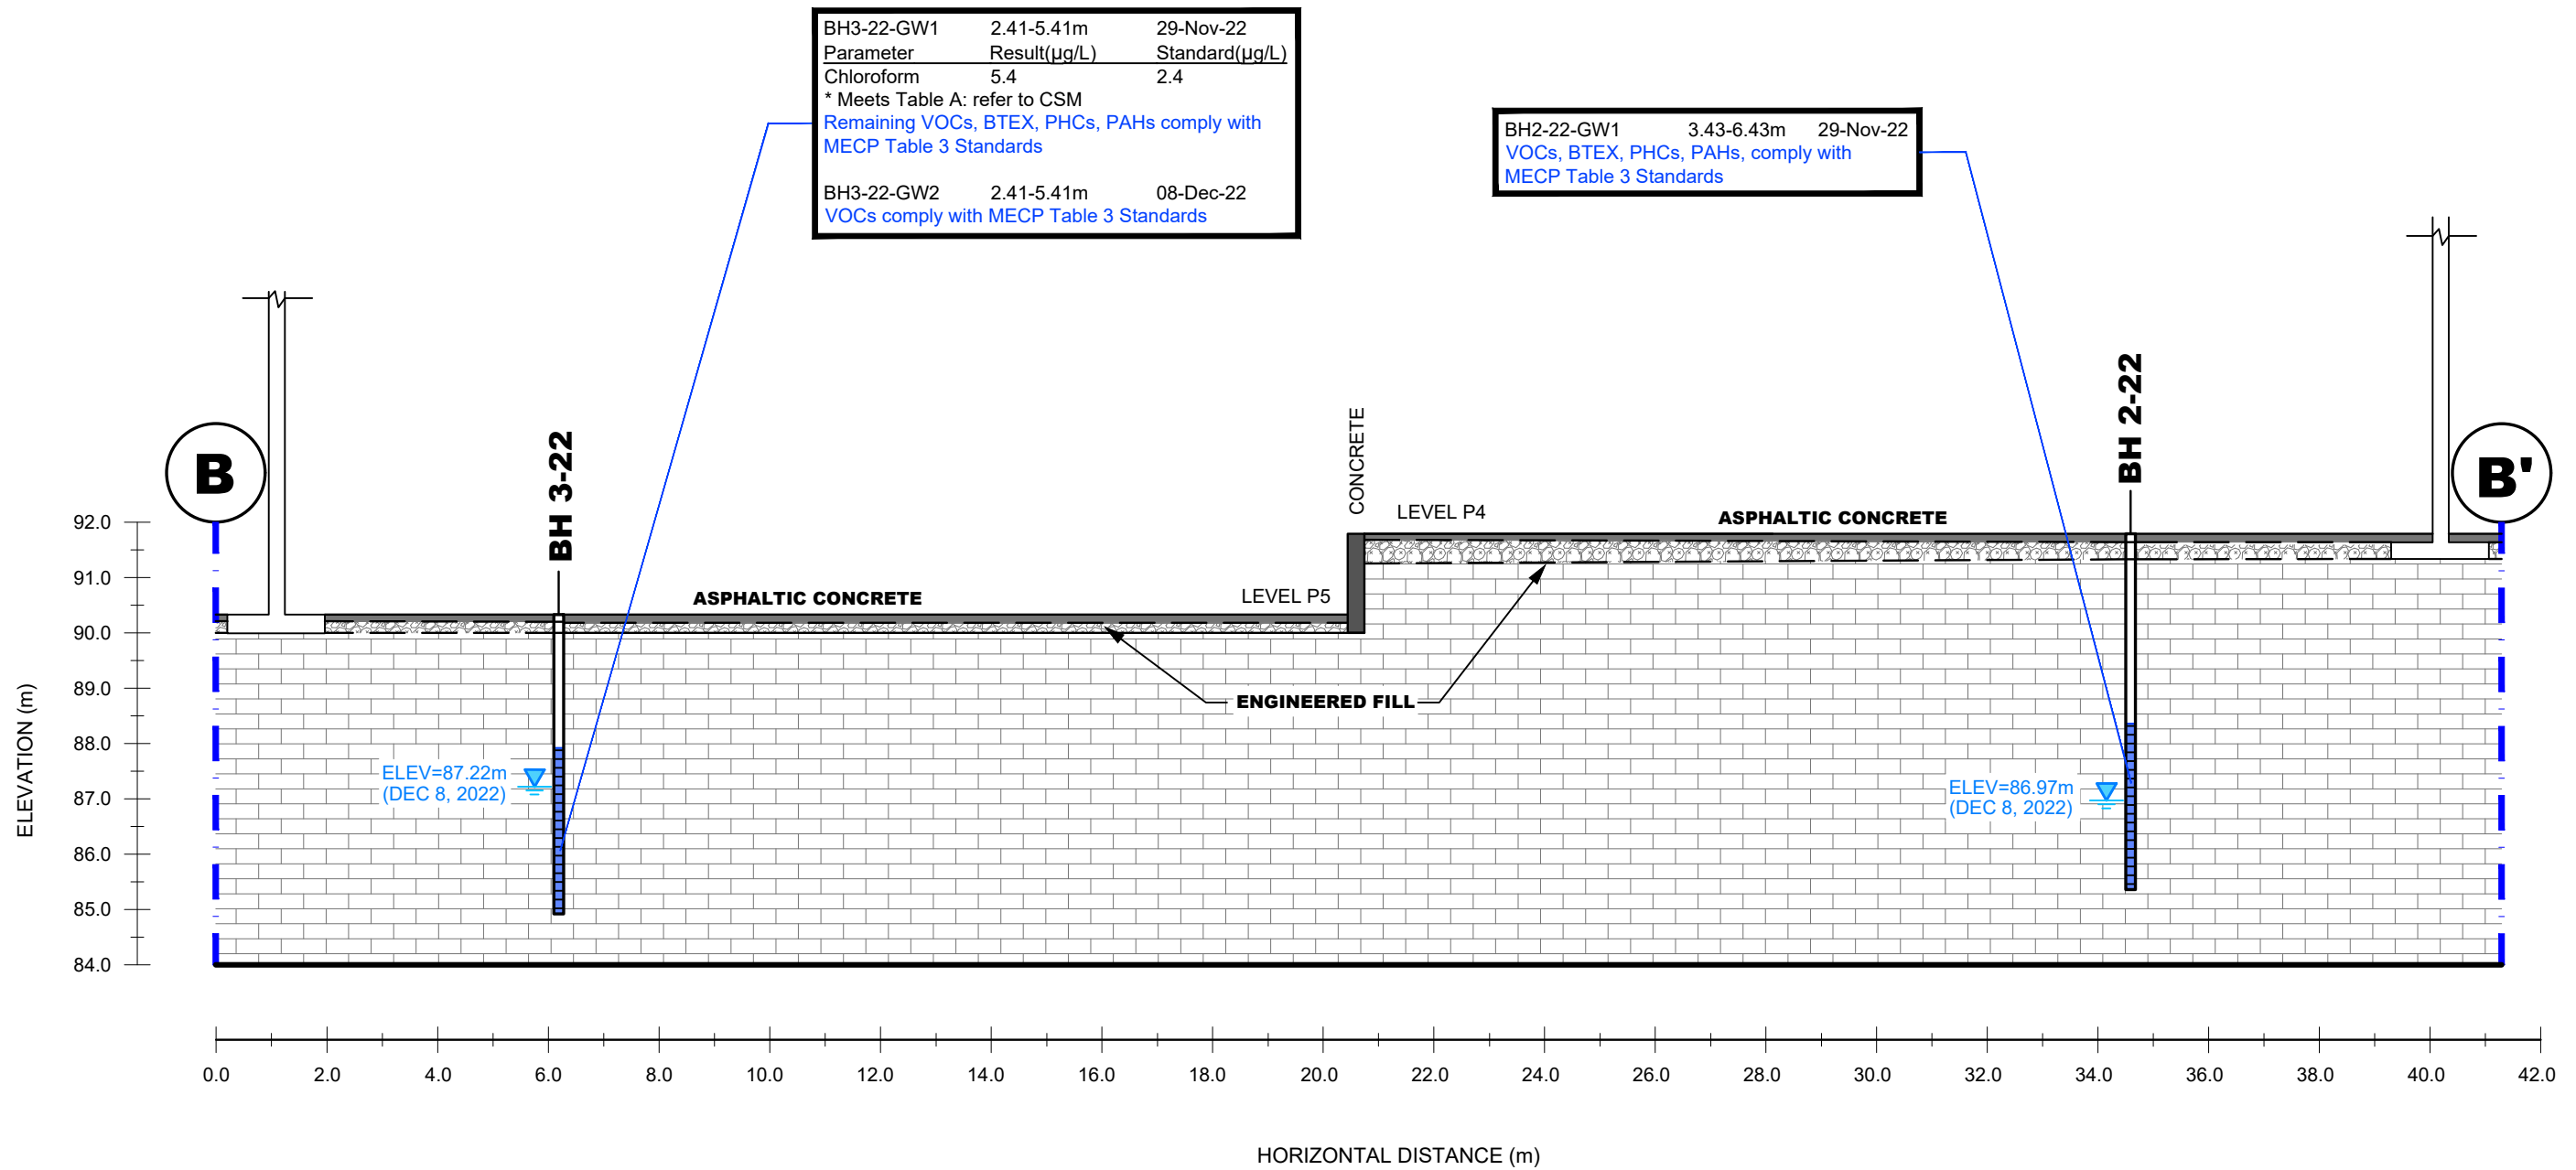
**GROUNDWATER RESULT COMPLIES WITH THE MECP TABLE 3 STANDARDS**
