**RE: 3040 and 3044 Innes Road – Proposed Apartment Building
Tree Conservation Report and Environmental Impact Statement - Updated**

**3040 & 3044 Innes Road
Blackburn Hamlet, City of Ottawa**

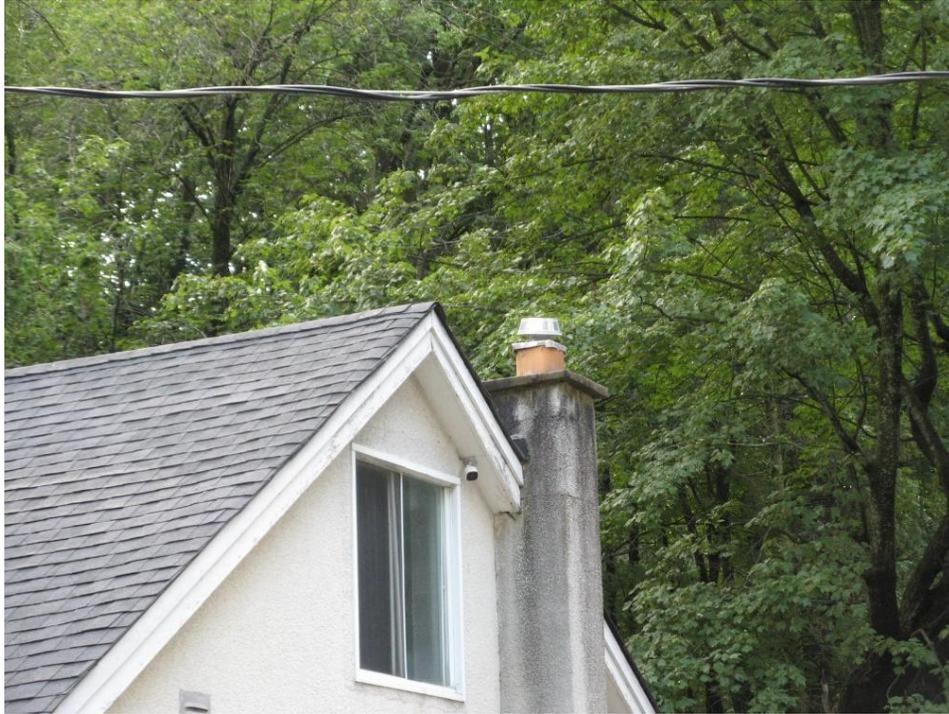
Photo 1 – Chimneys on the residences (this example is 3044 Innes Road) are vented, preventing potential chimney swift access. View looking southeast

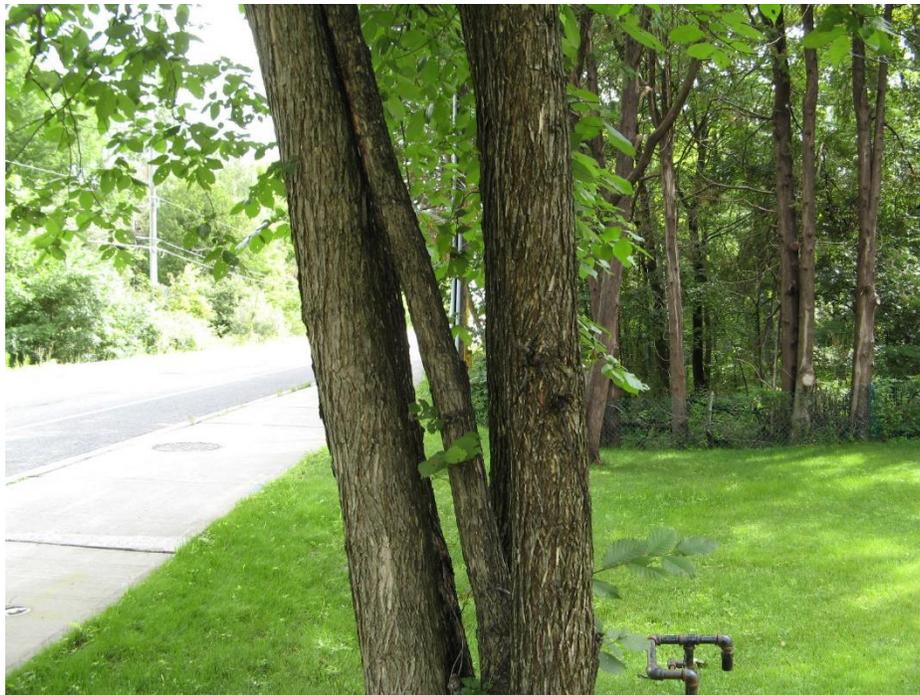
There are several trees along the periphery of 3044 Innes Road. Starting in the north portion, south of Innes Road, a coppice white elm with the largest stems up to 20cm diameter at breast height (dbh) are south of the sidewalk north of 3044 Innes Road (Photo 2). Several white cedars between 10cm and 30cm dbh are along the east fence line (Photo 5). The north cedars and the coppice white elm are on City property. These trees appear to be in generally good condition, with good leaf-out and minimal trunk damage, though many of the cedars have been extensively pruned.

Photo 2 – Coppice white elm and manicured lawn in the front (north) portion of 3044 Innes Road. Note elm is likely on City property but is planned to be retained. View looking east

Trees that appear to be all or in part on City land on the south side of Innes Road include a 35cm dbh basswood to the north of 3040 Innes Road and coppice white cedars with individual stems up to 28cm dbh and smaller coppice white elms with individual stems up to 20cm dbh to the north of 3044 Innes Road. These trees appear to be in generally good condition, with good leaf-out and minimal trunk damage. Some stems in the multi-stem trees have been removed. It is anticipated that the east City-owned trees (the coppice white cedars with individual stems up to 28cm dbh and smaller coppice white elms with individual stems up to 20cm dbh) can be retained, but the west City-owned 35cm dbh basswood will likely need to be removed due to the proximity of the north edge of the underground parking in this area.

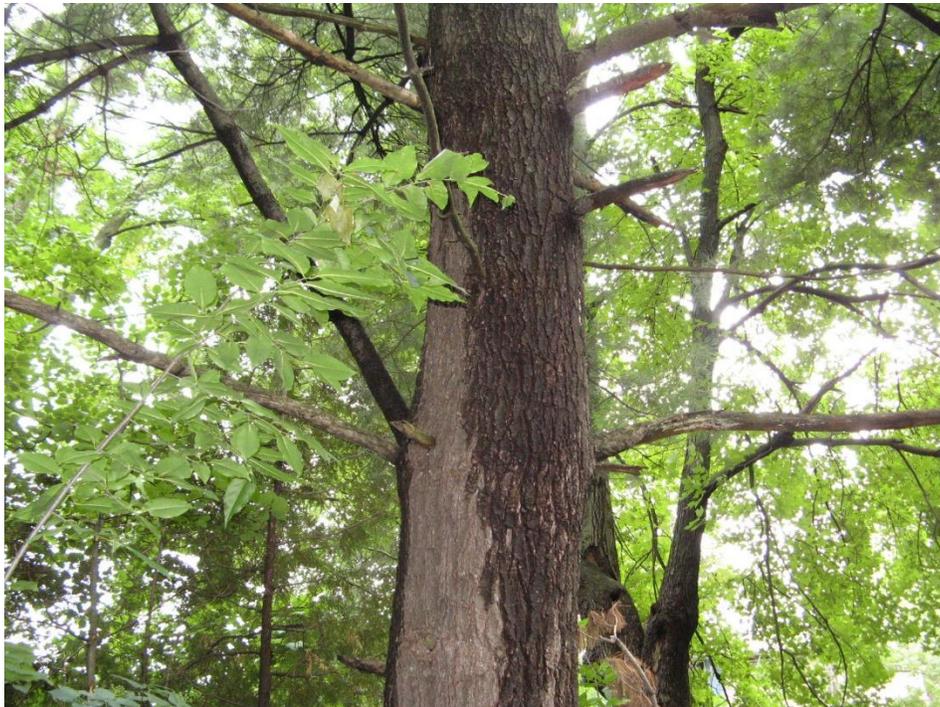
Photo 4 – Mature white pine in the southwest portion of 3044 Innes Road. View looking west

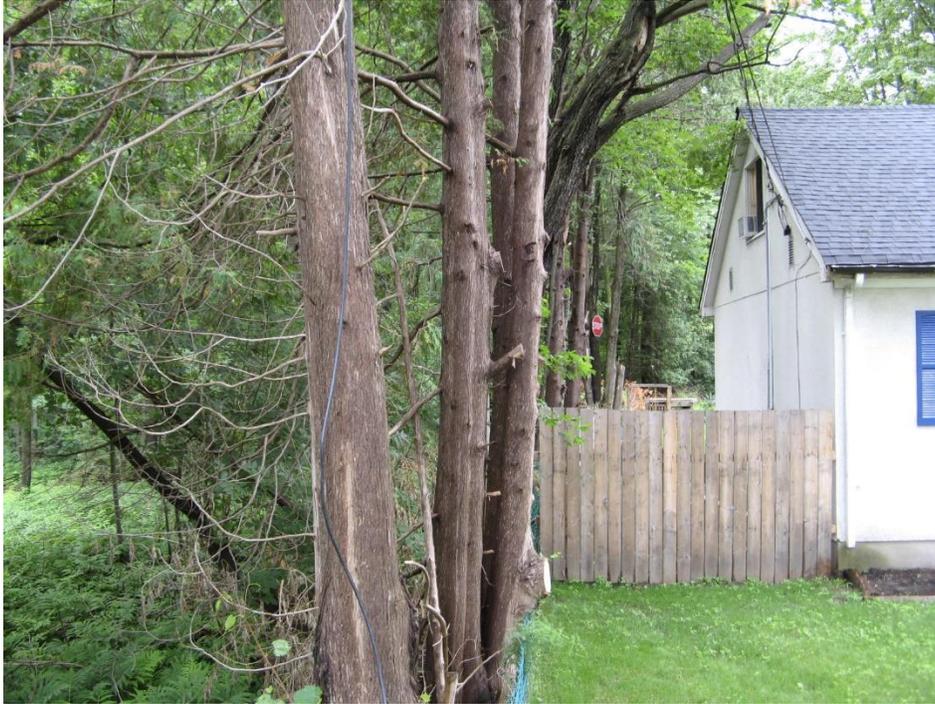
Photo 5 – White cedars along the east fenceline of 3044 Innes Road, south of Innes Road. Front cedars are on City property but will be retained. View looking south.

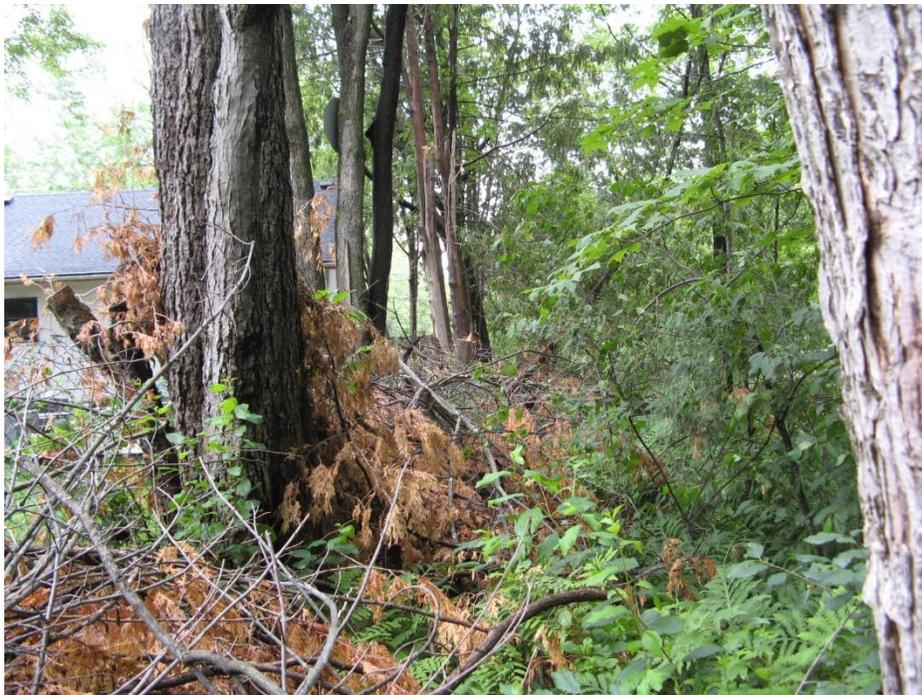
In addition to the white cedars described above, several trees are along the east property line. These include a 48cm dbh sugar maple, a coppice sugar maple with stems up to 30cm dbh, and three red maples (18cm, 20cm, and 50cm dbh) (Photo 6).

Photo 6 - Maples and cedars along the south portion of the east fenceline of 3044 Innes Road. In forefront is mature sugar maple east of site with critical root zone extending onto the site. View looking north

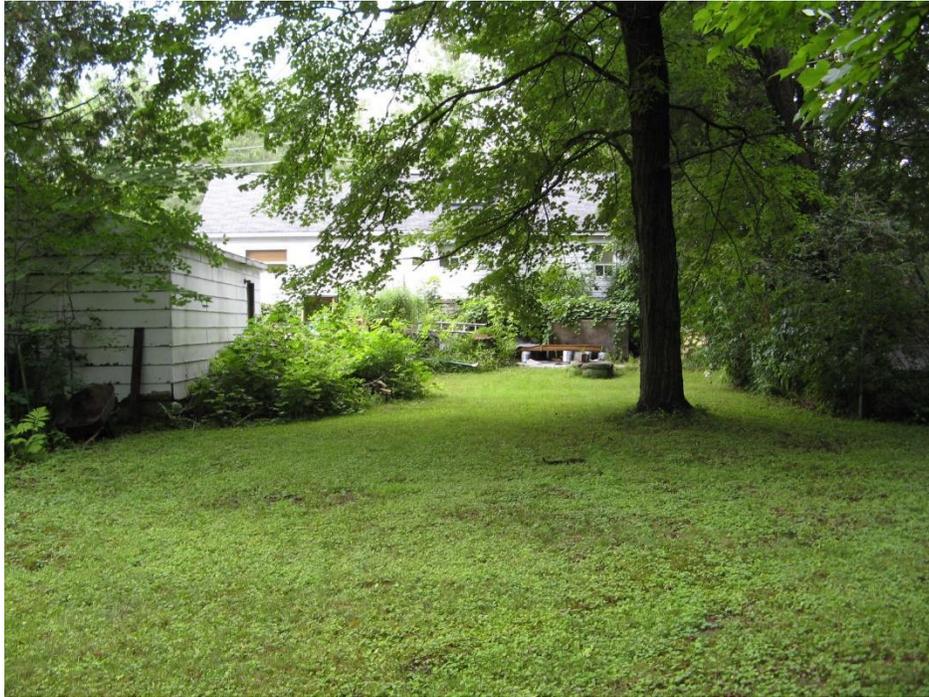
The rear yard of 3040 Innes Road is also a cultural meadow of mowed grassed areas, with three mature red maples (Photo 7). The northern maple (60cm dbh) has been pruned and appeared to be in poor condition with reduced leaf-out. The other two maples (60cm and 75cm dbh) appear to be in better condition. A 22cm dbh Scot's pine is adjacent to the south maples, with a 40cm dbh white cedar and a dead 30cm dbh green ash in the central-west portion of the rear yard.

Photo 7 – Manicured lawn and one of the mature red maples in the south half of 3040 Innes Road. View looking north

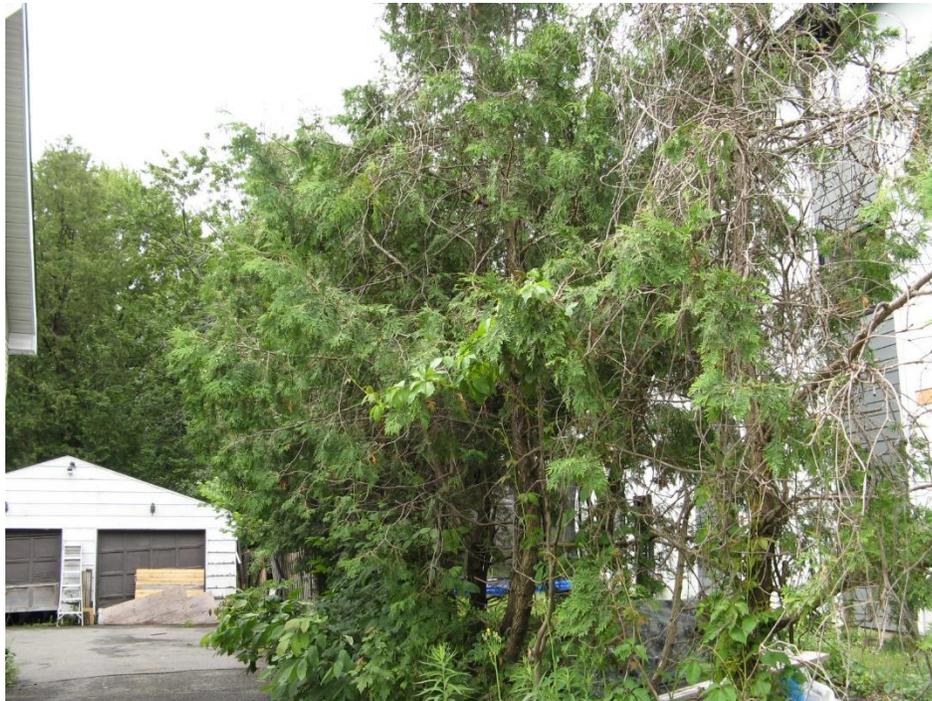
A coniferous hedgerow of ten white cedars between 18cm and 32cm dbh are along the common property line between 3040 and 3044 Innes Road (Photo 8). A 30cm dbh white elm is also in this area, along with a 60cm dbh red maple. The red maple had major trunk damage but the leaf-out was generally good. Grey dogwood, common buckthorn, glossy buckthorn, and regenerating ash are also among and adjacent to the cedar hedgerow. The invasive garlic mustard is common in this area.

Photo 8 – White cedars between 3040 and 3044 Innes Road. View looking south

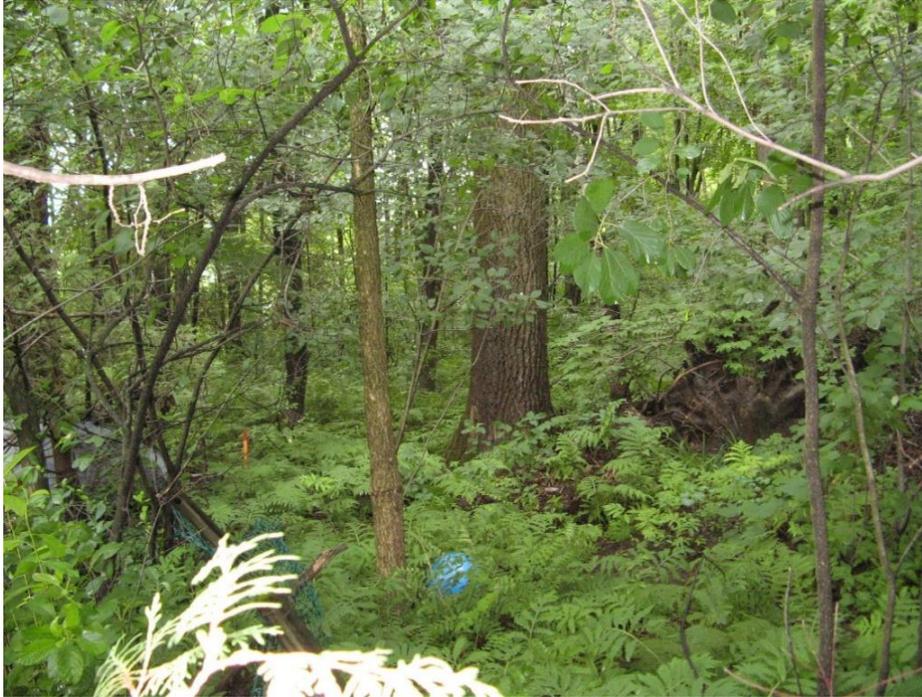
There are no co-owned trees or trees immediately to the south of the site with critical root zones that extend onto the site except an 80cm dbh eastern cottonwood 2.25 metres to the south of the southeast site corner (Photo 9, Tree D on Map 2) and a 55cm dbh twin-stem immediately south of the fence line in the southwest portion of 3040 Innes Road (Tree E on Map 2). The cottonwood appeared to be in poorer condition with reduced leaf-out. The maple to the west appeared to be in better condition, with a few of the maple branches extending north of the tree, overhanging the south edge of 3040 Innes Road.

*Photo 9 - Mature eastern cottonwood to the south of the southeast corner of the site (note stake).
View looking east*

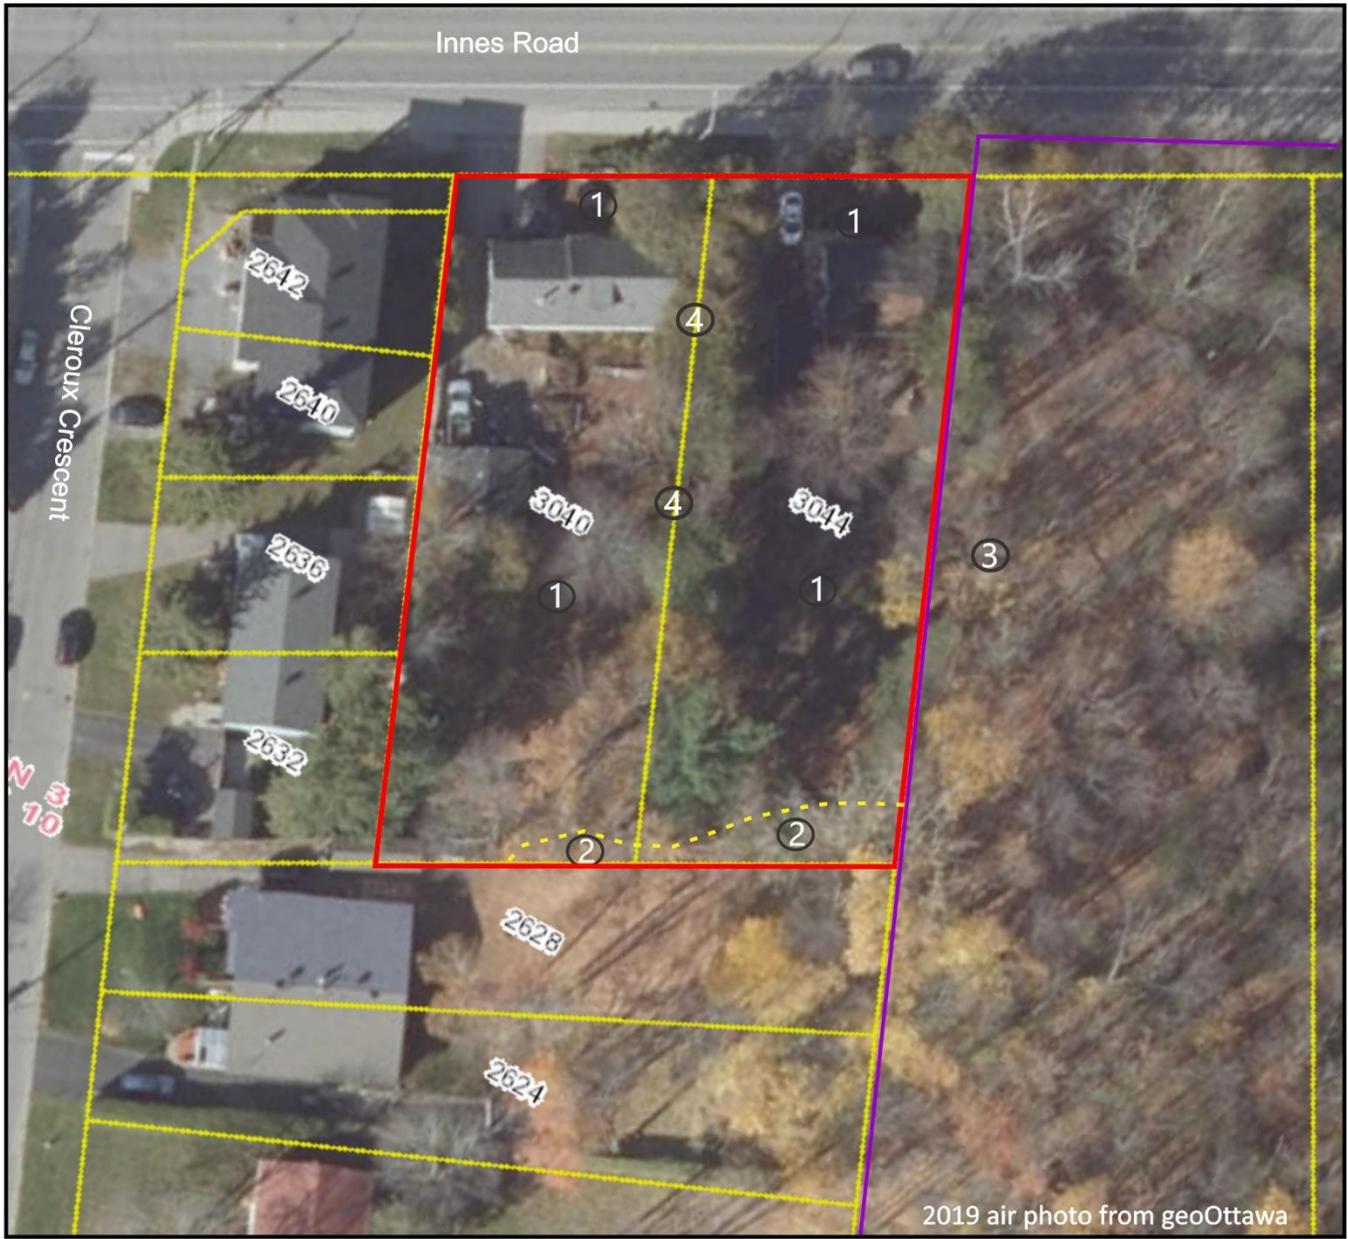
Map 1

EXISTING VEGETATION

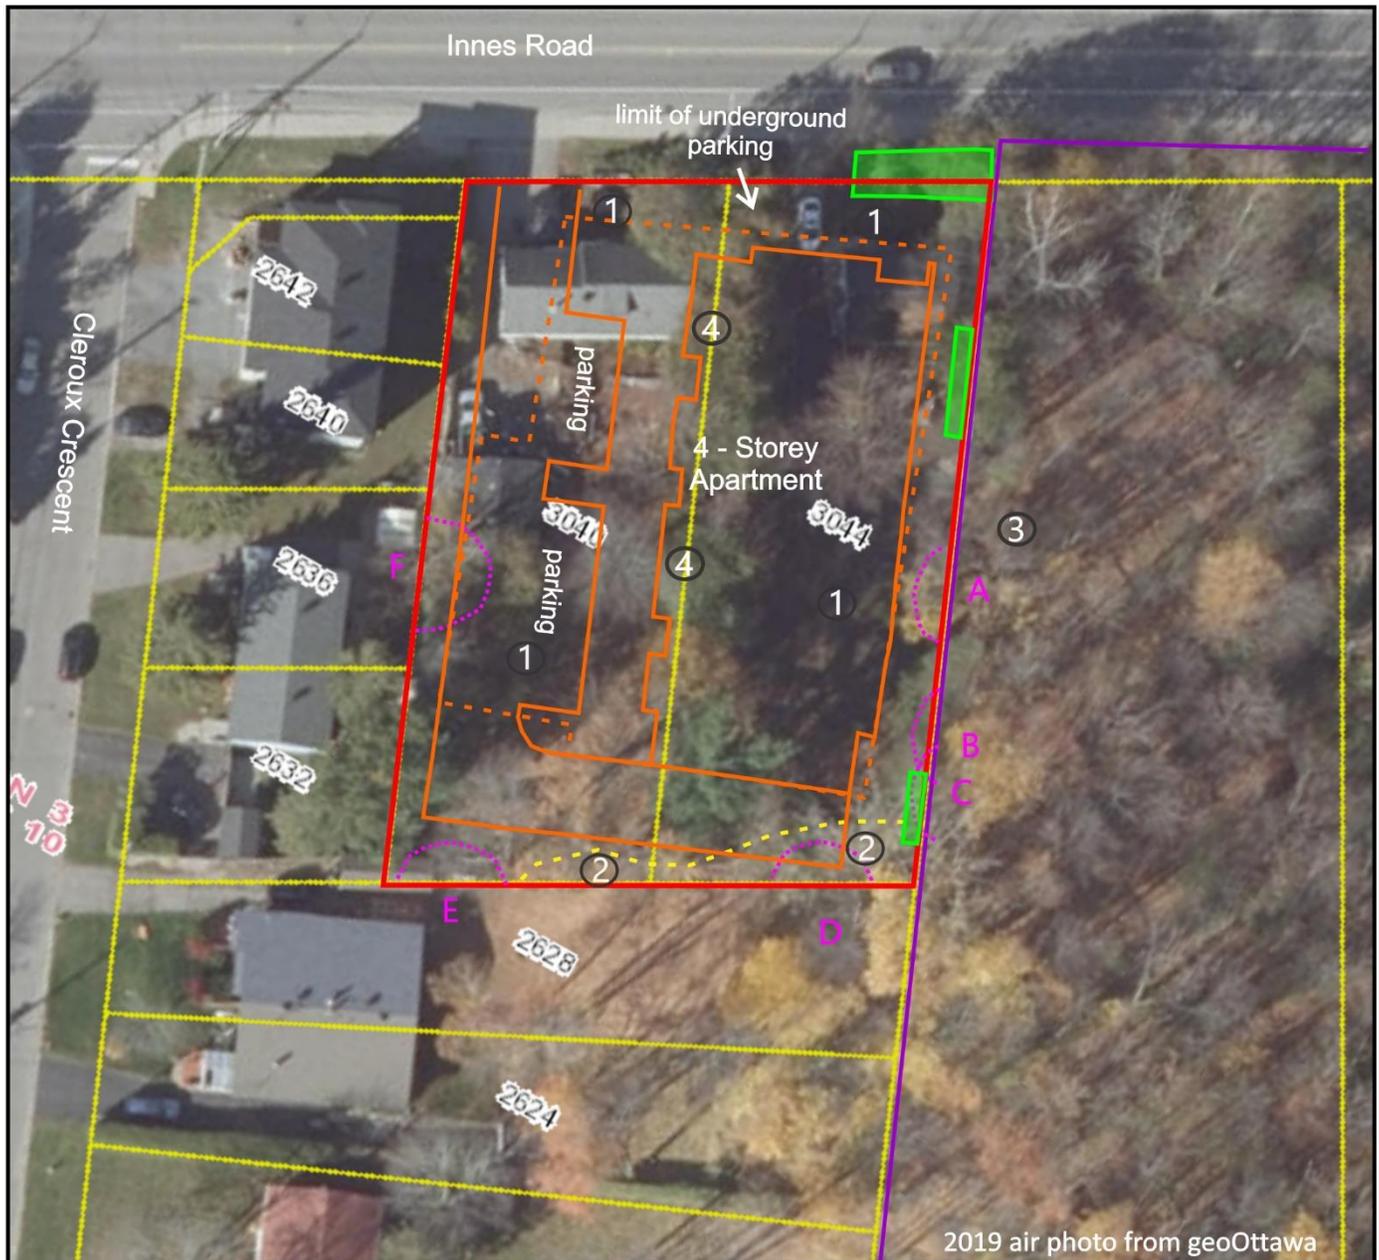
Map 2

Potential tree retention is shown with a green lens on Map 2. Due to the building footprint and grading requirements, tree retention appears to be limited to portions of the north and east edges.

The following Table 1 summarizes the adjacent trees with critical root zones (crz) extending onto the site. The tree letter corresponds to the letters on Map 2:

PROPOSED CONSERVED VEGETATION

2. Trees to be retained are to be protected with sturdy temporary fencing at least 1.3 metres in height installed from the tree trunk a distance of ten times the retained tree's diameter where possible. Locations of the tree preservation fencing are shown on the Landscape Plan by Lashley + Associates (revised October 26, 2022). Signs, notices, or posters are not to be attached to any tree. No grading, heavy machinery traffic, stockpiling of material, machinery maintenance and refueling, or other activities that may cause soil compaction are to occur within three metres of the critical root zone of the trees to be retained and protected. The root system, trunk, or branches of the trees to be retained are to be protected and not damaged. If any roots of trees to be retained are exposed during site alterations, the roots shall be immediately reburied with soil or covered with filter cloth, burlap or woodchips and kept moist until the roots can be buried permanently. A covering of plastic should be used to retain moisture during an extended period when watering may not be possible. Any roots that must be cut are to be cut cleanly to facilitate healing and as far from the tree as possible. Overhanging branches from retained trees, including those adjacent to the site, that may be damaged during construction are to be pruned by a qualified arborist prior to construction. Exhaust fumes from all equipment during construction will not be directed towards the canopy of the adjacent retained trees.

3. Where the critical root zones (ten times the trunk diameter) of the adjacent trees extend onto the site, where possible tree protection fencing as described above is to be installed along the outer edge of the root zone. Smaller roots are to be cut cleanly on an angle or kept moist until they can be backfilled if applicable. As indicated in Table 1 above, where there is the potential for significant damage to the critical root zones of adjacent trees the adjacent landowners are to be consulted and as required the removed tree replaced with new plantings of native tree species in locations approved by the adjacent landowner. Recommended native species for planting include a mix of coniferous and deciduous species such as sugar maple, red maple, basswood, red oak, tamarack, white pine, and white spruce, along with nannyberry, elderberry, and native dogwood shrubs. Sourcing native species from local seed sources is strongly recommended to ensure adaptability and longevity;
