**3440 Frank Kenny Road
Navan, Ontario**

Fisheries Impact Assessment

**October 2016
(Updated March 2022)**

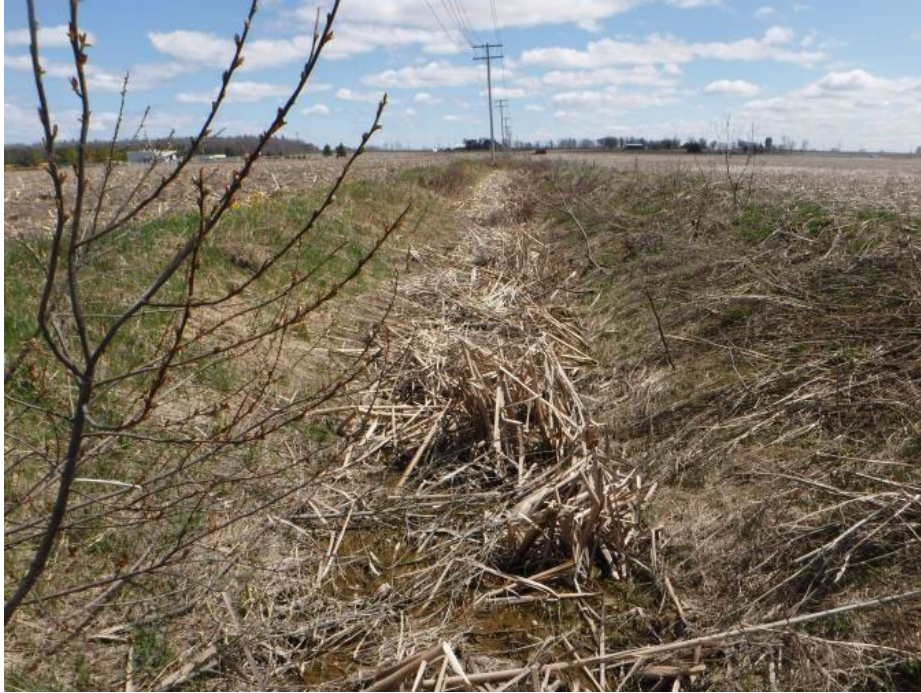
Station 1 was 55 m in length. The average channel width was 2.0 m and the average bankfull depth was 21 cm. During the spring there was a limited amount of water which provided a wetted width of 1.2 m and average water depth of 5 cm (2-14 cm). The entire tributary was dry during the summer visit. When water was present, the habitat type consisted of a glide.

The substrate consisted of fines. The in-water cover consisted of aquatic vegetation. The aquatic vegetation species included: broad-leaved cattail, reed canary grass and algae. This station had no canopy cover present. There were no signs of erosion.

The top of the banks were fully vegetated with herbaceous vegetation and the occasional woody species. The most common species were: reed canary grass, goldenrod, colt's foot, Manitoba maple, willow and red-osier dogwood. The buffer between the crops and the channel was about 3 m on both banks.

On the May 5th visit, due to shallow water, no electrofishing could be completed. Instead, a dip net was used to sample the areas containing some water. The effort was approximately 20 dips. No fish were observed or captured. On the August 19th visit, there was no water to sample.

Photo 1: Station 1 looking upstream from the downstream end (May 5, 2016)

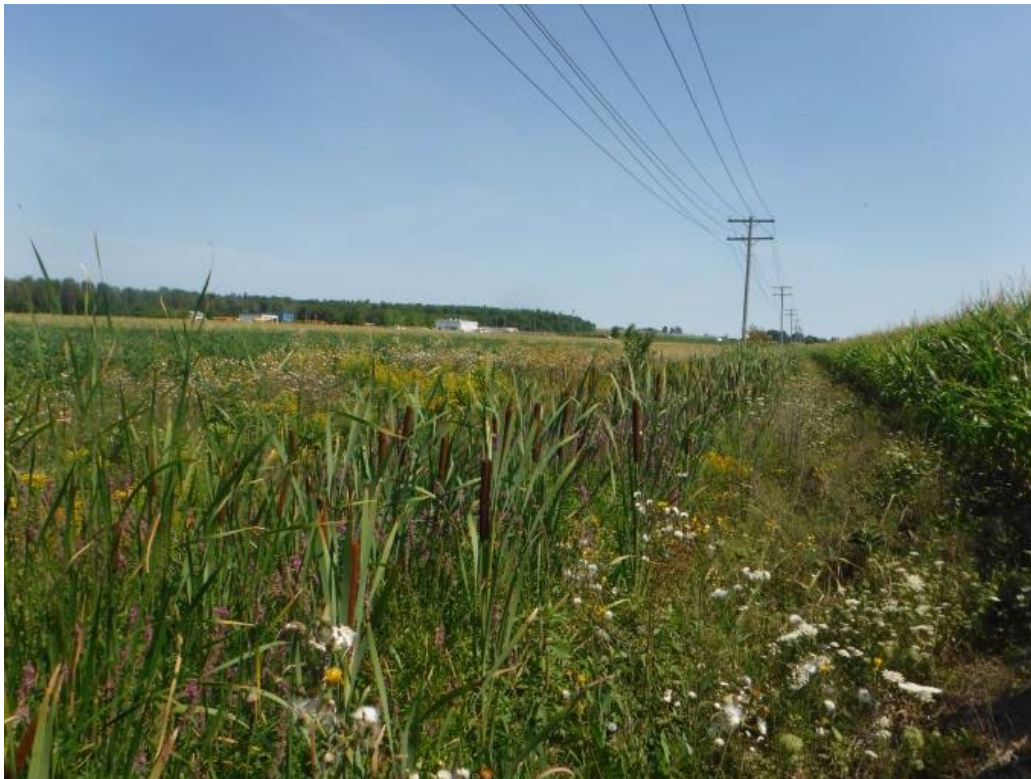
Flow from this unnamed drain eventually reaches Bear Brook (about 6.5 km downstream from the subject lands). Tributary 1 was an agriculture feature with a straight channel that flowed in an east to west direction. The Tributary along the Site's boundary was dry in the spring and summer. Surface water was not present until roughly 190 m downstream of the southwest corner of the site. This was originated from tile drains (Figure 3). No water was present anywhere during the summer visit.

Photo 2: Station 1 looking downstream from the upstream end (August 19, 2016)

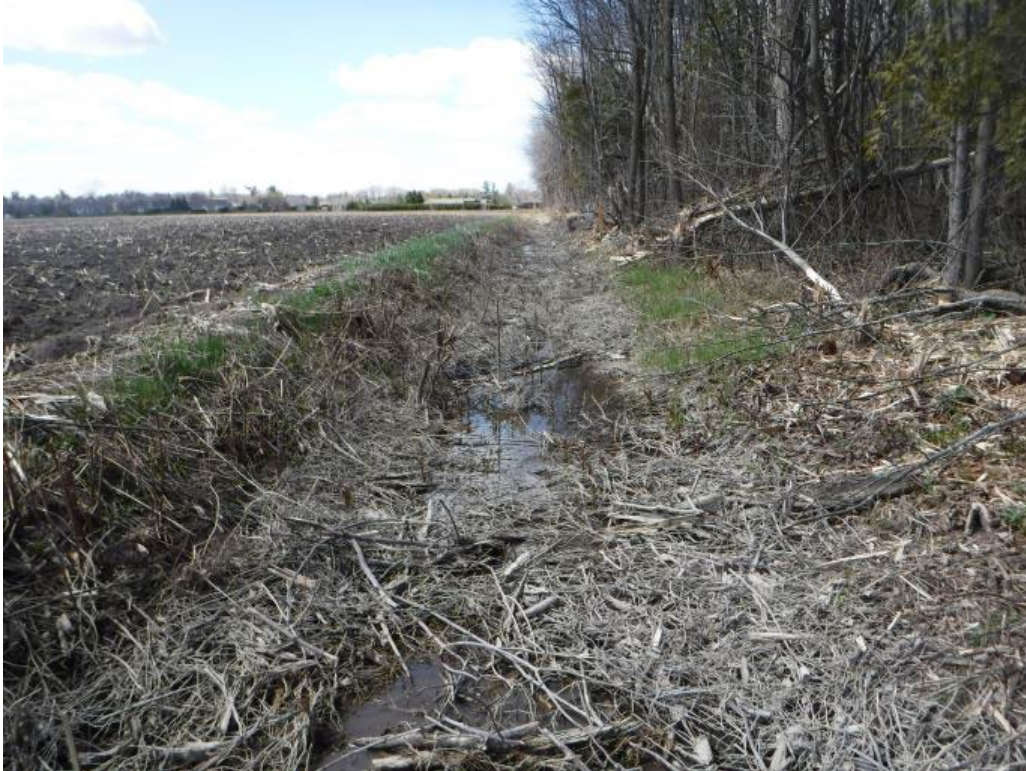
Station 2 was located on northern portion of the subject lands and was 47 m in length. The average channel width was 2.3 m and the average bankfull depth was 24 cm. During the spring there was little water. At that time the average wetted width was 1.6 m and the average water depth of 6 cm (range 3-14 cm). The spring habitat consisted of a glide.

The substrate consisted of fines. The in-water cover consisted of small woody debris and a small amount of aquatic vegetation. The aquatic vegetation species included: reed canary grass and purple loosestrife. This station had moderate canopy cover. There were no signs of erosion noted.

The top of the banks were fully vegetated with herbaceous vegetation and the occasional woody species. The most common species were: reed canary grass, goldenrod, colt's foot, red-osier dogwood, Manitoba maple, willow, trembling aspen, American elm and white cedar. There was a 2 m buffer between the cropped land and the agricultural field (cropped) to the south.

On the May 5th visit, due to shallow water, no electrofishing could be completed. Instead, a dip net was used to sample the areas containing some water. The effort was approximately 50 dips. Only one creek chub (58 mm) and one brook stickleback (55 mm) were captured. One additional brook stickleback was observed.

Photo 3: Station 2 looking downstream from the upstream end (May 5, 2016)

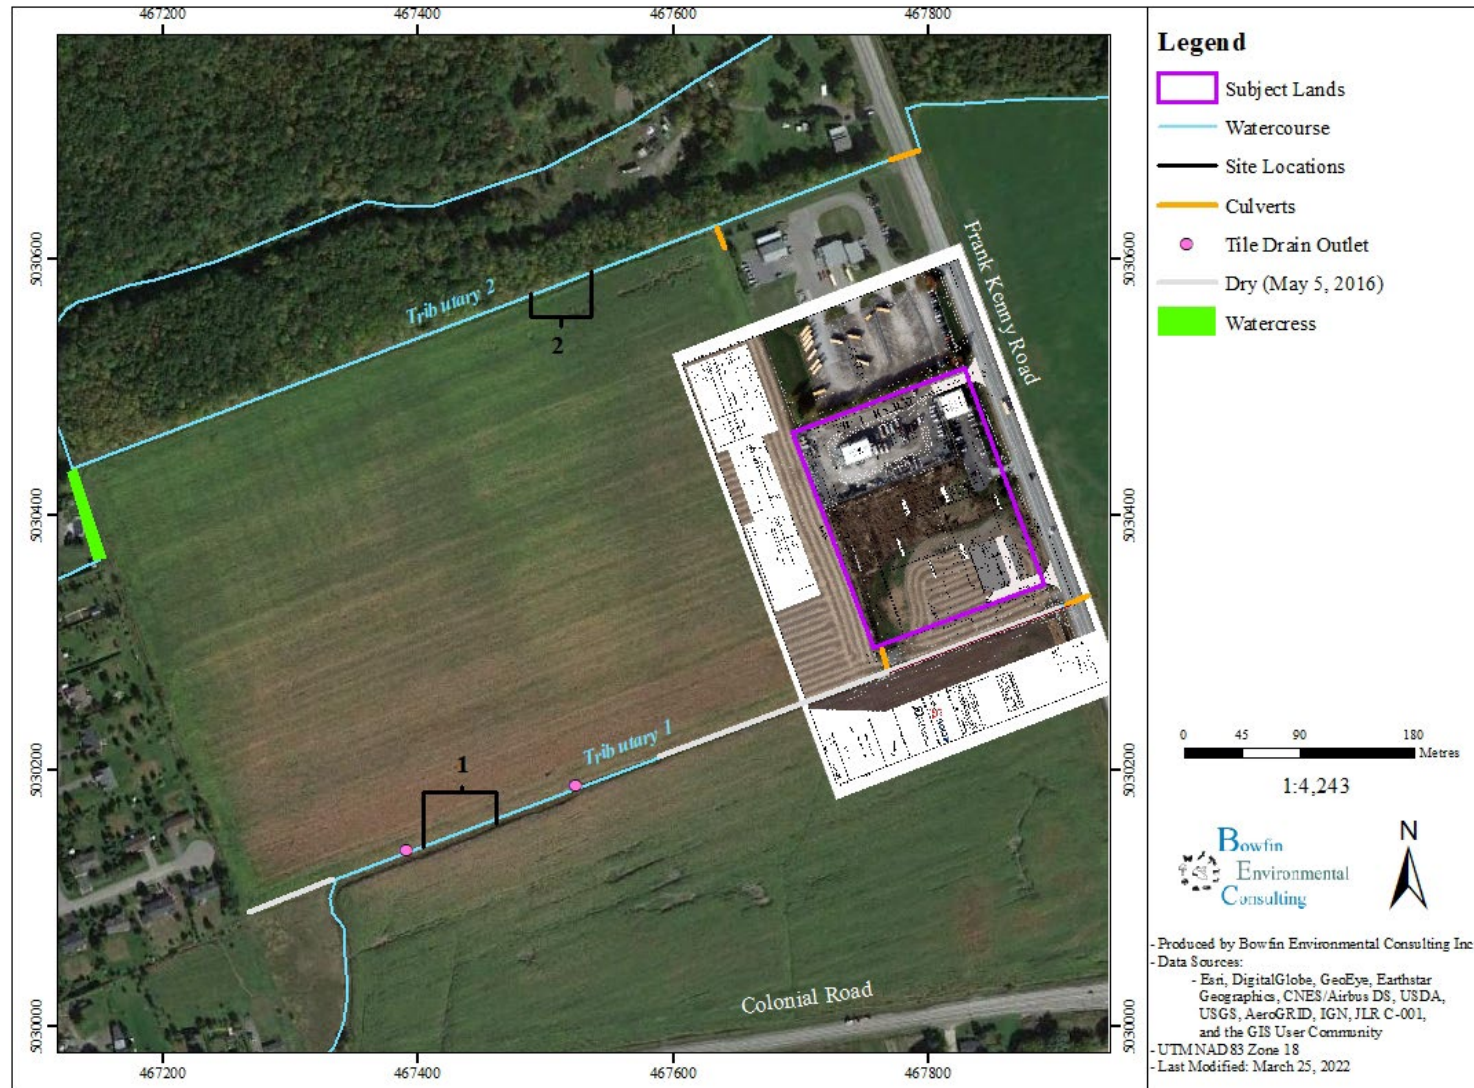
Figure 3: Summary of Findings

Tributary 1 did not provide any direct fish habitat along the site. Any direct habitat would have been further than 190 m downstream of the southwest corner of the site and ephemeral in nature. In 2016, the portion of the feature along the site did not contribute downstream flow apart from possible snowmelt as the feature was dry. This feature provided no to indirect fish habitat within

the study area and is anticipated to provide direct fish habitat much further downstream (>190 m from the site).

Tributary 2 provides seasonal fish habitat to common forage fish. The watercress noted downstream on Tributary 2 is suggestive of groundwater upwellings.
