Phase II Environmental Site Assessment

368 Tweedsmuir Avenue
Ottawa, Ontario

November 4, 2021

Report: PE5429-2

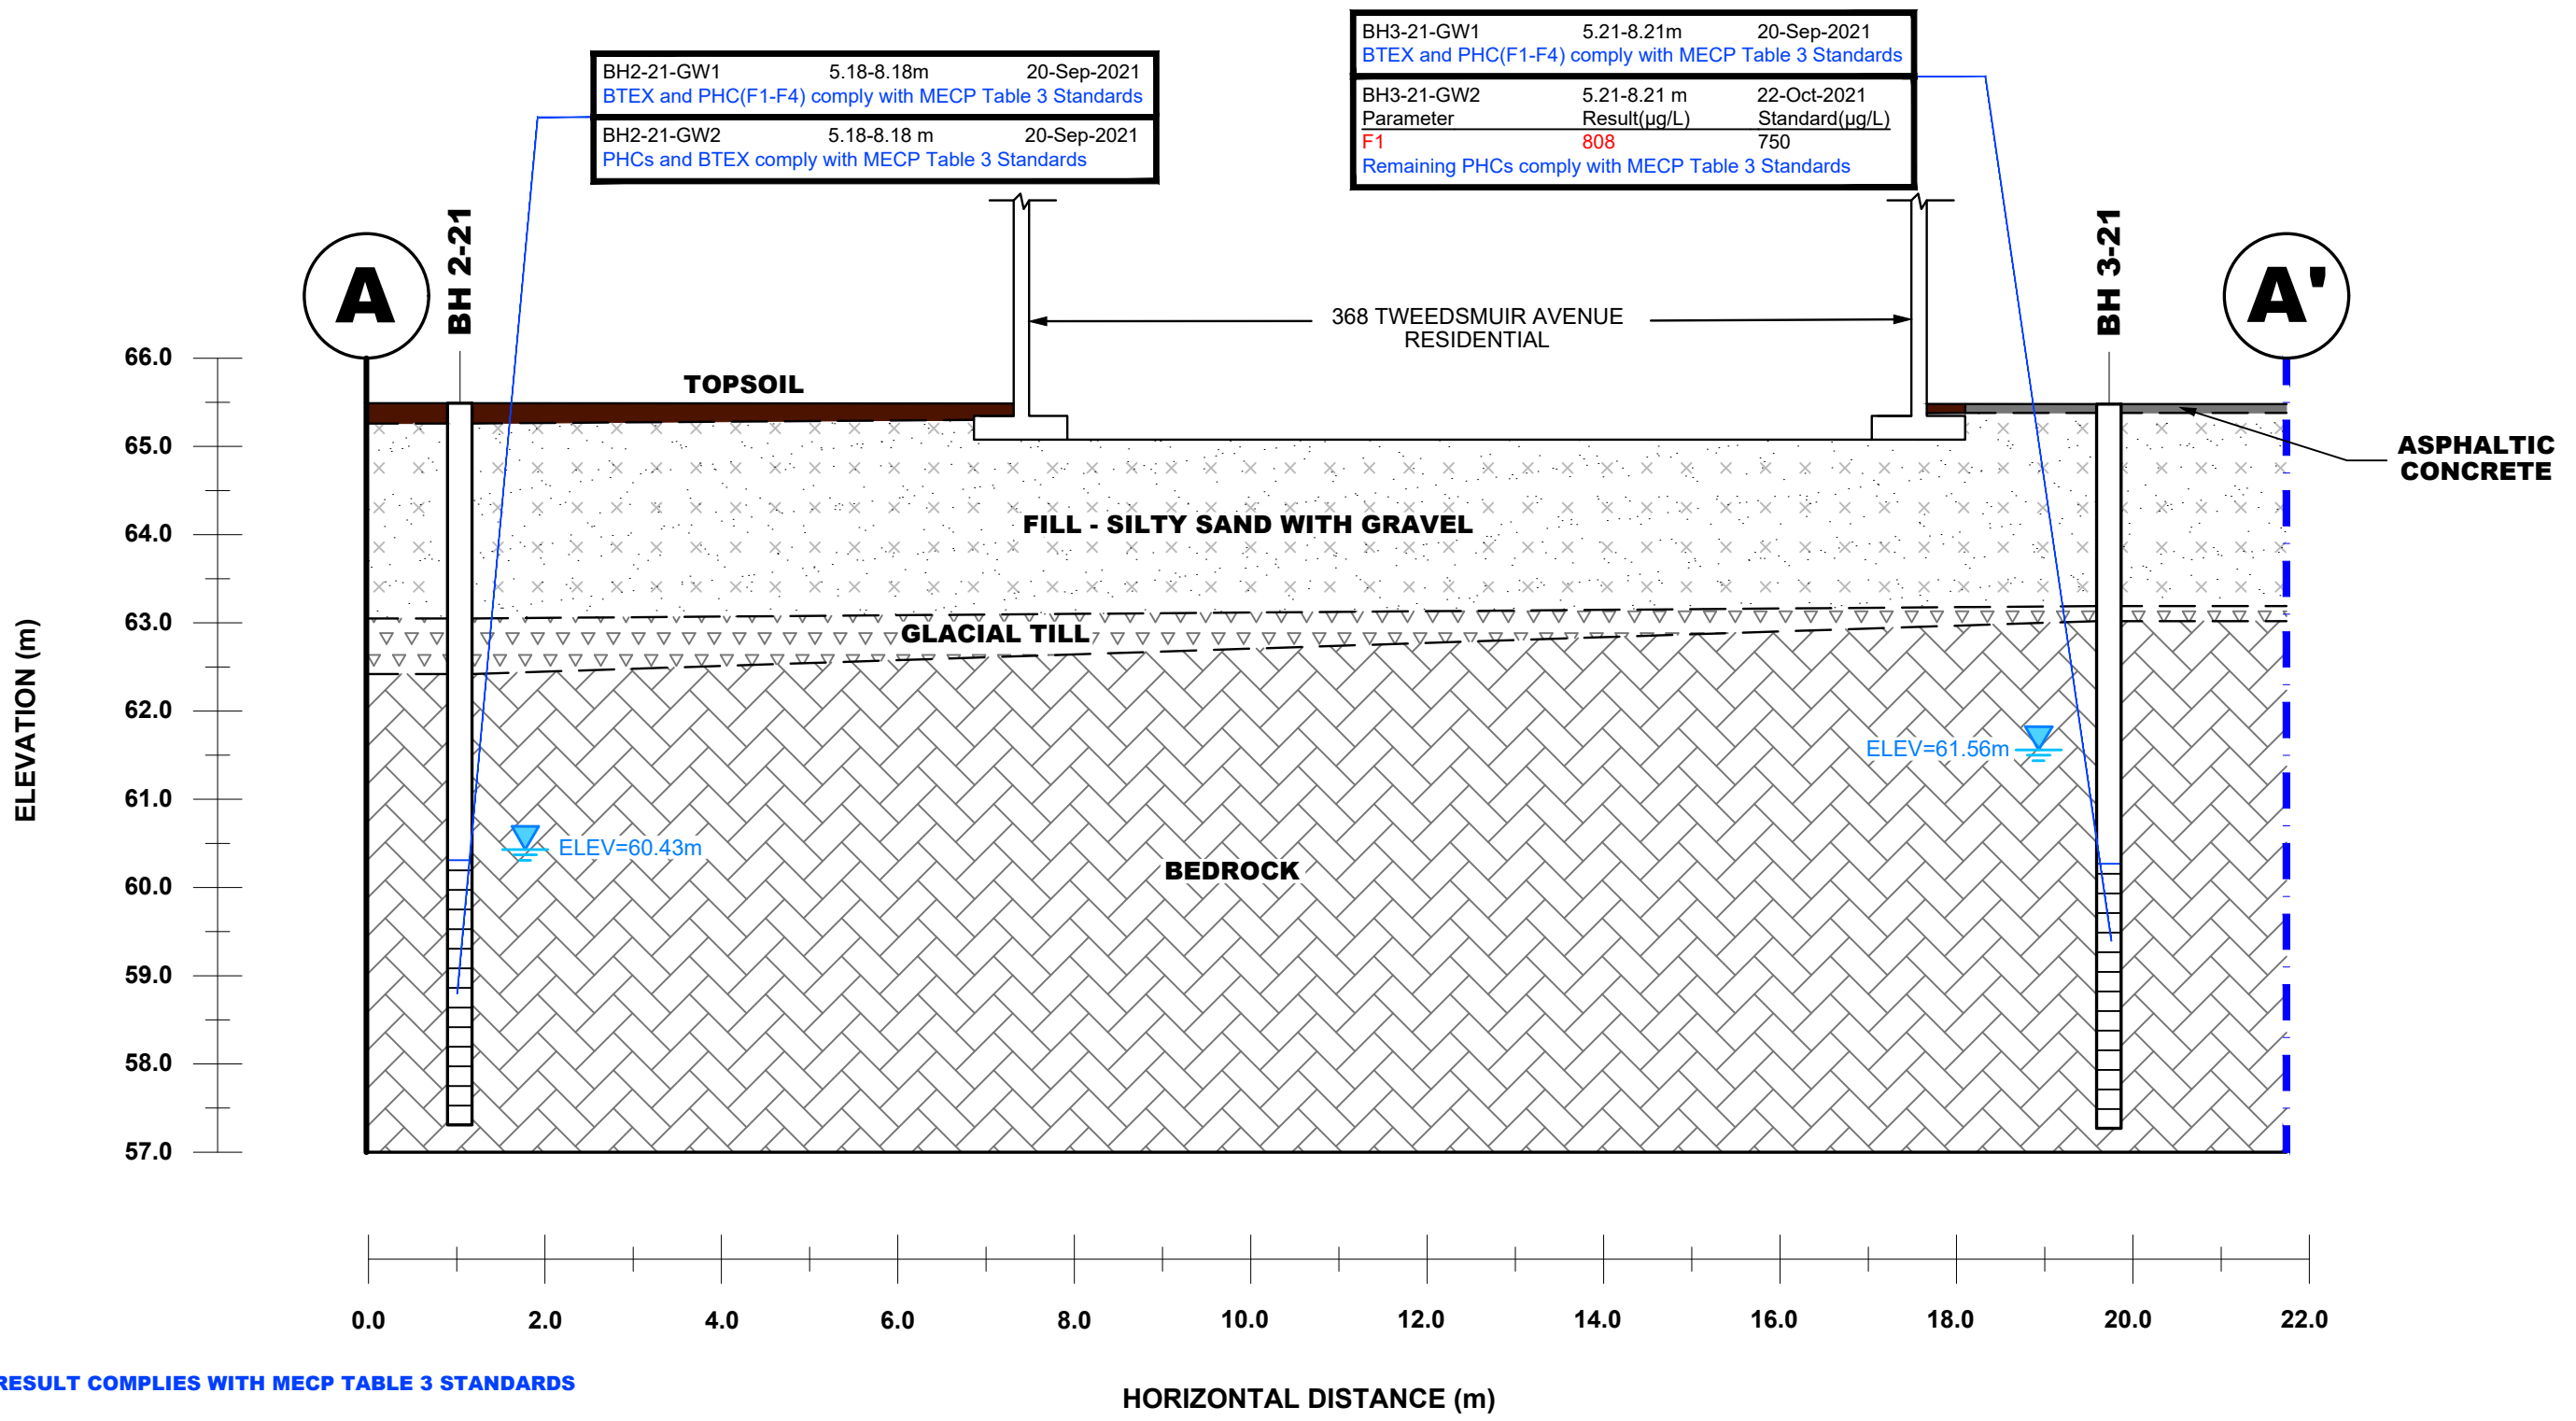
HONEY CONSTRUCTION
PHASE II - ENVIRONMENTAL SITE ASSESSMENT
368 TWEEDSMUIR AVENUE
OTTAWA, ONTARIO
Title: **CROSS SECTION A-A' - GROUNDWATER (BTEX, PHCs)**

BH2-21-GW1	5.18-8.18m	20-Sep-2021
BTEX and PHC(F1-F4) comply with MECP Table 3 Standards		
BH2-21-GW2	5.18-8.18 m	20-Sep-2021
PHCs and BTEX comply with MECP Table 3 Standards

BH3-21-GW1	5.21-8.21m	20-Sep-2021
BTEX and PHC(F1-F4) comply with MECP Table 3 Standards		
BH3-21-GW2	5.21-8.21 m	22-Oct-2021
Parameter	Result(µg/L)	Standard(µg/L)
F1	808	750
Remaining PHCs comply with MECP Table 3 Standards
