## MEMO

**TO:** Josiane Gervais, P.Eng – Project Manager, Infrastructure Approvals  
**FROM:** Kimberley Hunton, P.Eng.  
**SUBJECT:** 1083 Merivale Road – Transportation Safety Memo  
**DATE:** January 19, 2022

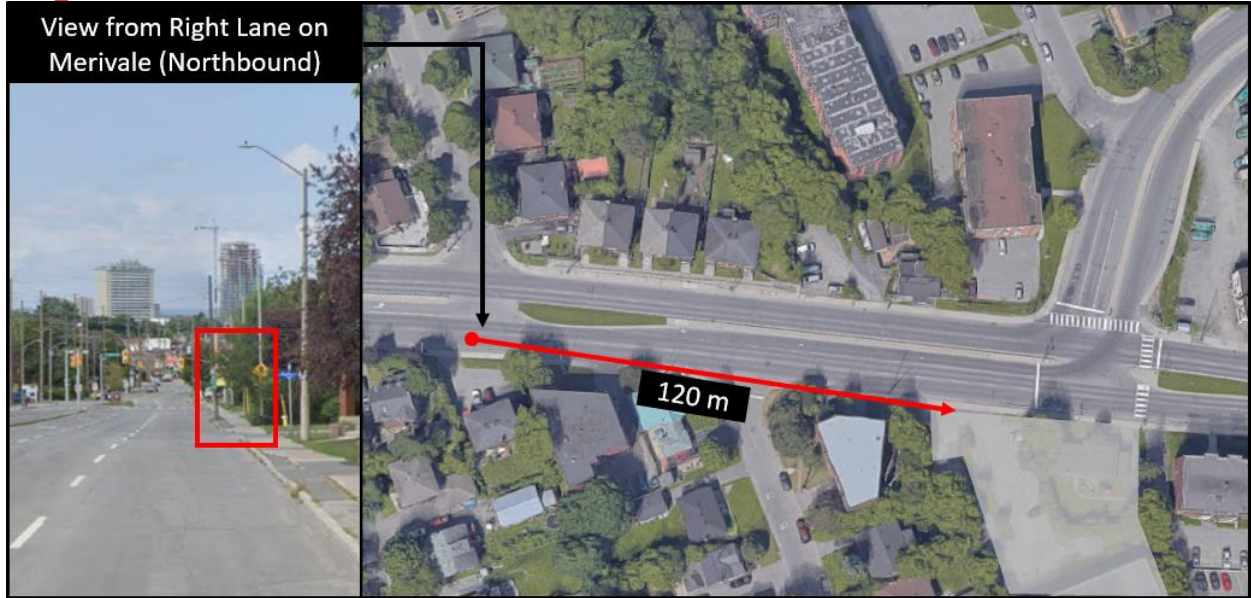
Finally, the 2017 Transportation Association of Canada (TAC) Geometric Design Guide for Canadian Roads requires a sight distance for right-turns from a minor road of 120 m for a single-unit vehicle along a road with a design speed of 50 km/h. From our desktop review of the access, see **Figure 2**, there appear to be no sightline issues.

Figure 2: Desktop Sightline Review

The AutoTurn analysis indicated that both MSUs and Fire Trucks will be able to manoeuvre the right-in/right-out access along Merivale Road without issue. The desktop sightline review indicated that there are no obstructions within the line of sight for exiting trucks turning back on to Merivale Road.

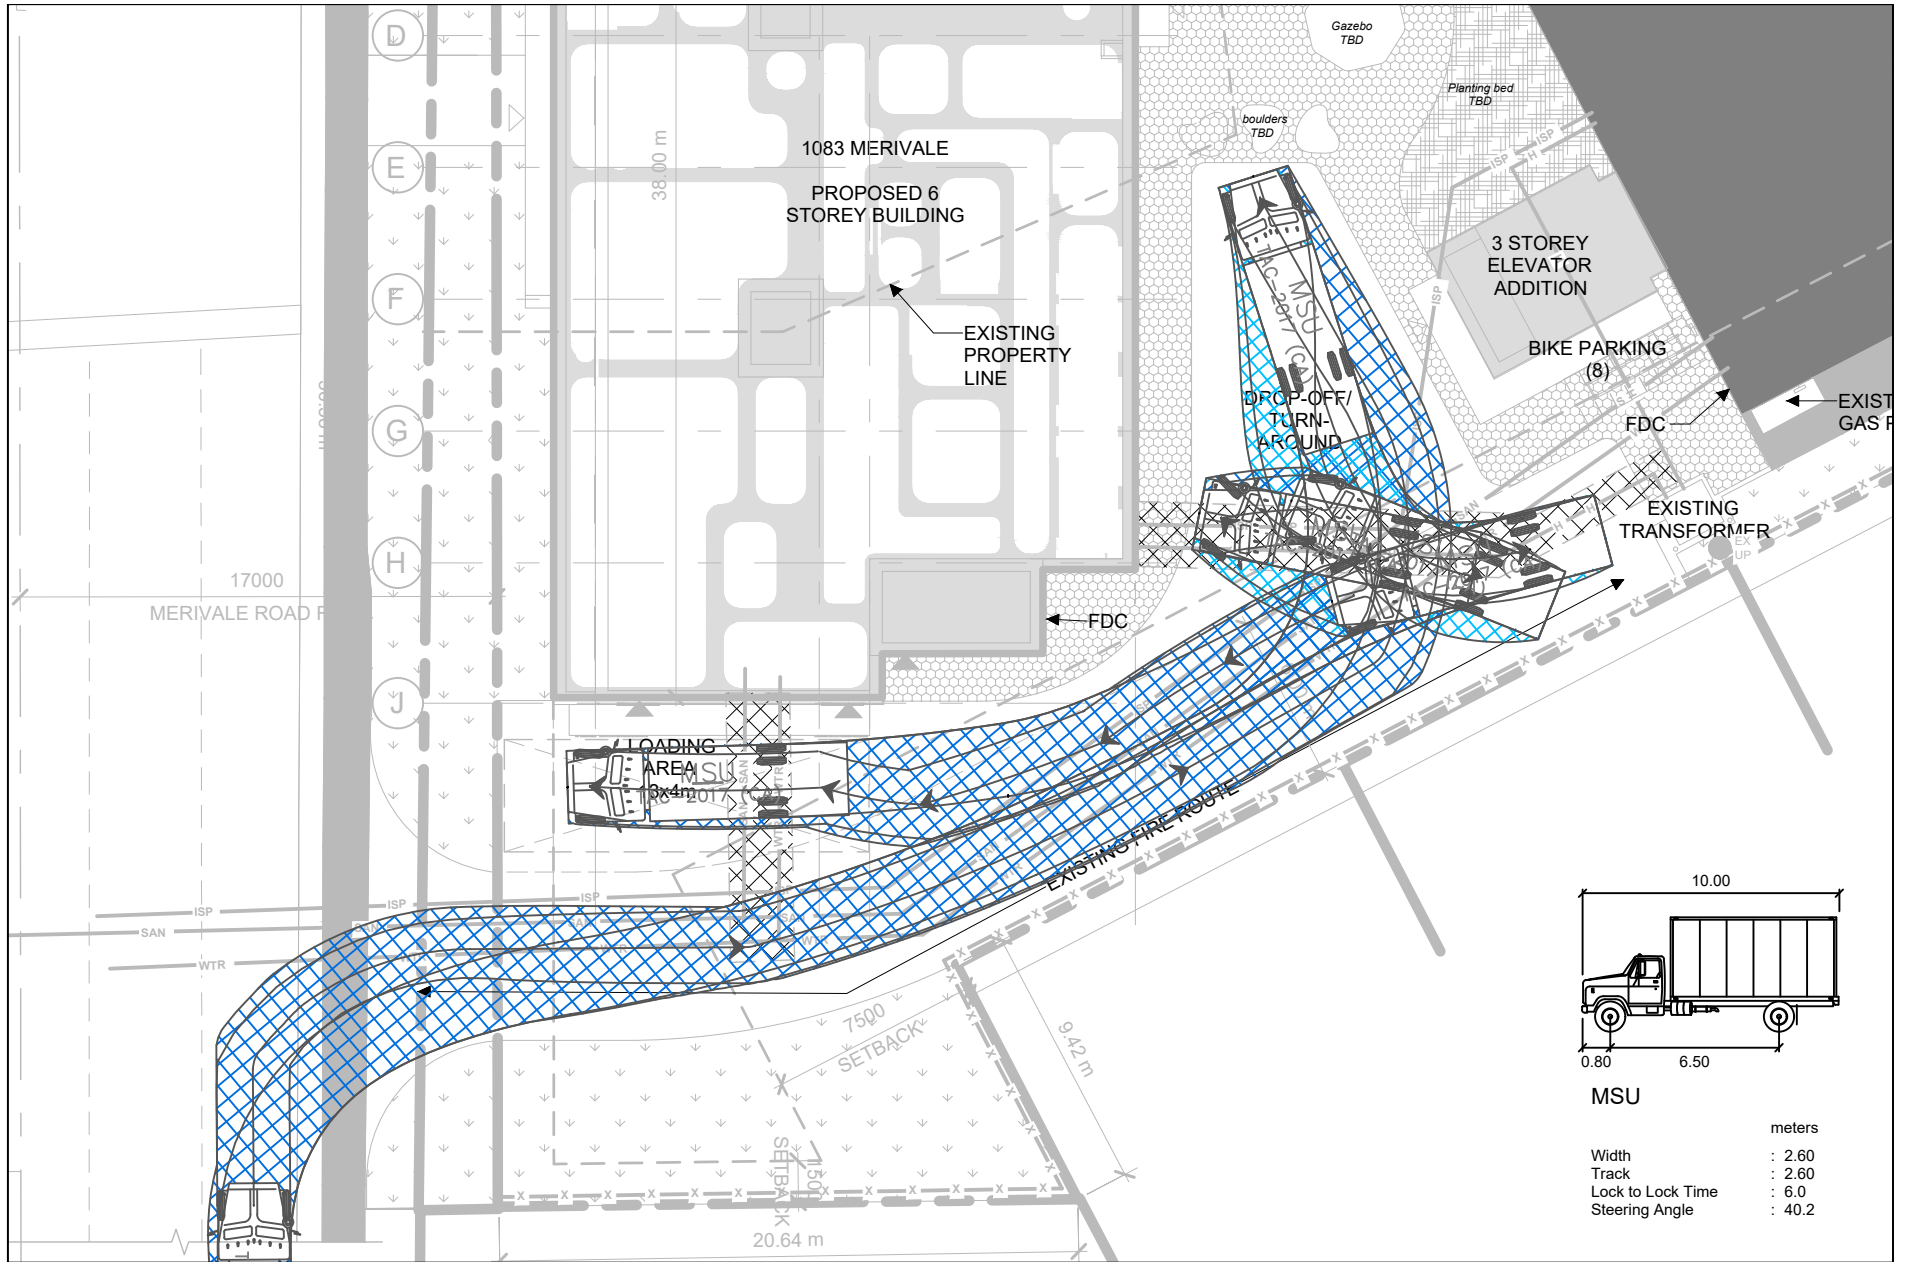
## Appendix D - Figure 1 MSU (Inbound) Turning Model 1083 Merivale Road - Transportation Safety Review

The proposed development and its existing driveway are located just south (less than 5m) of the Merivale/Kirkwood intersection. The truck loading area, as shown on the proposed site plan, will be accessible via the Merivale driveway. Additionally, the Merivale Road access would be a fire access route. An AutoTurn analysis for the anticipated delivery vehicles (MSU) and Fire Trucks was carried out is attached as **Appendix D**. The MSU is able to safely turn around within the site thereby not requiring any reverse movements within the public right of way. The fire truck is capable of turning into the site; the fire access route is less than 90m long on the site and therefore per Ontario Building Code (Section 3.2.5.6), there is no requirement for the fire truck to be able to turn around within the site. A fire truck on departure would reverse back out to Merivale Road, however this is done with flagging operations by the firefighters.

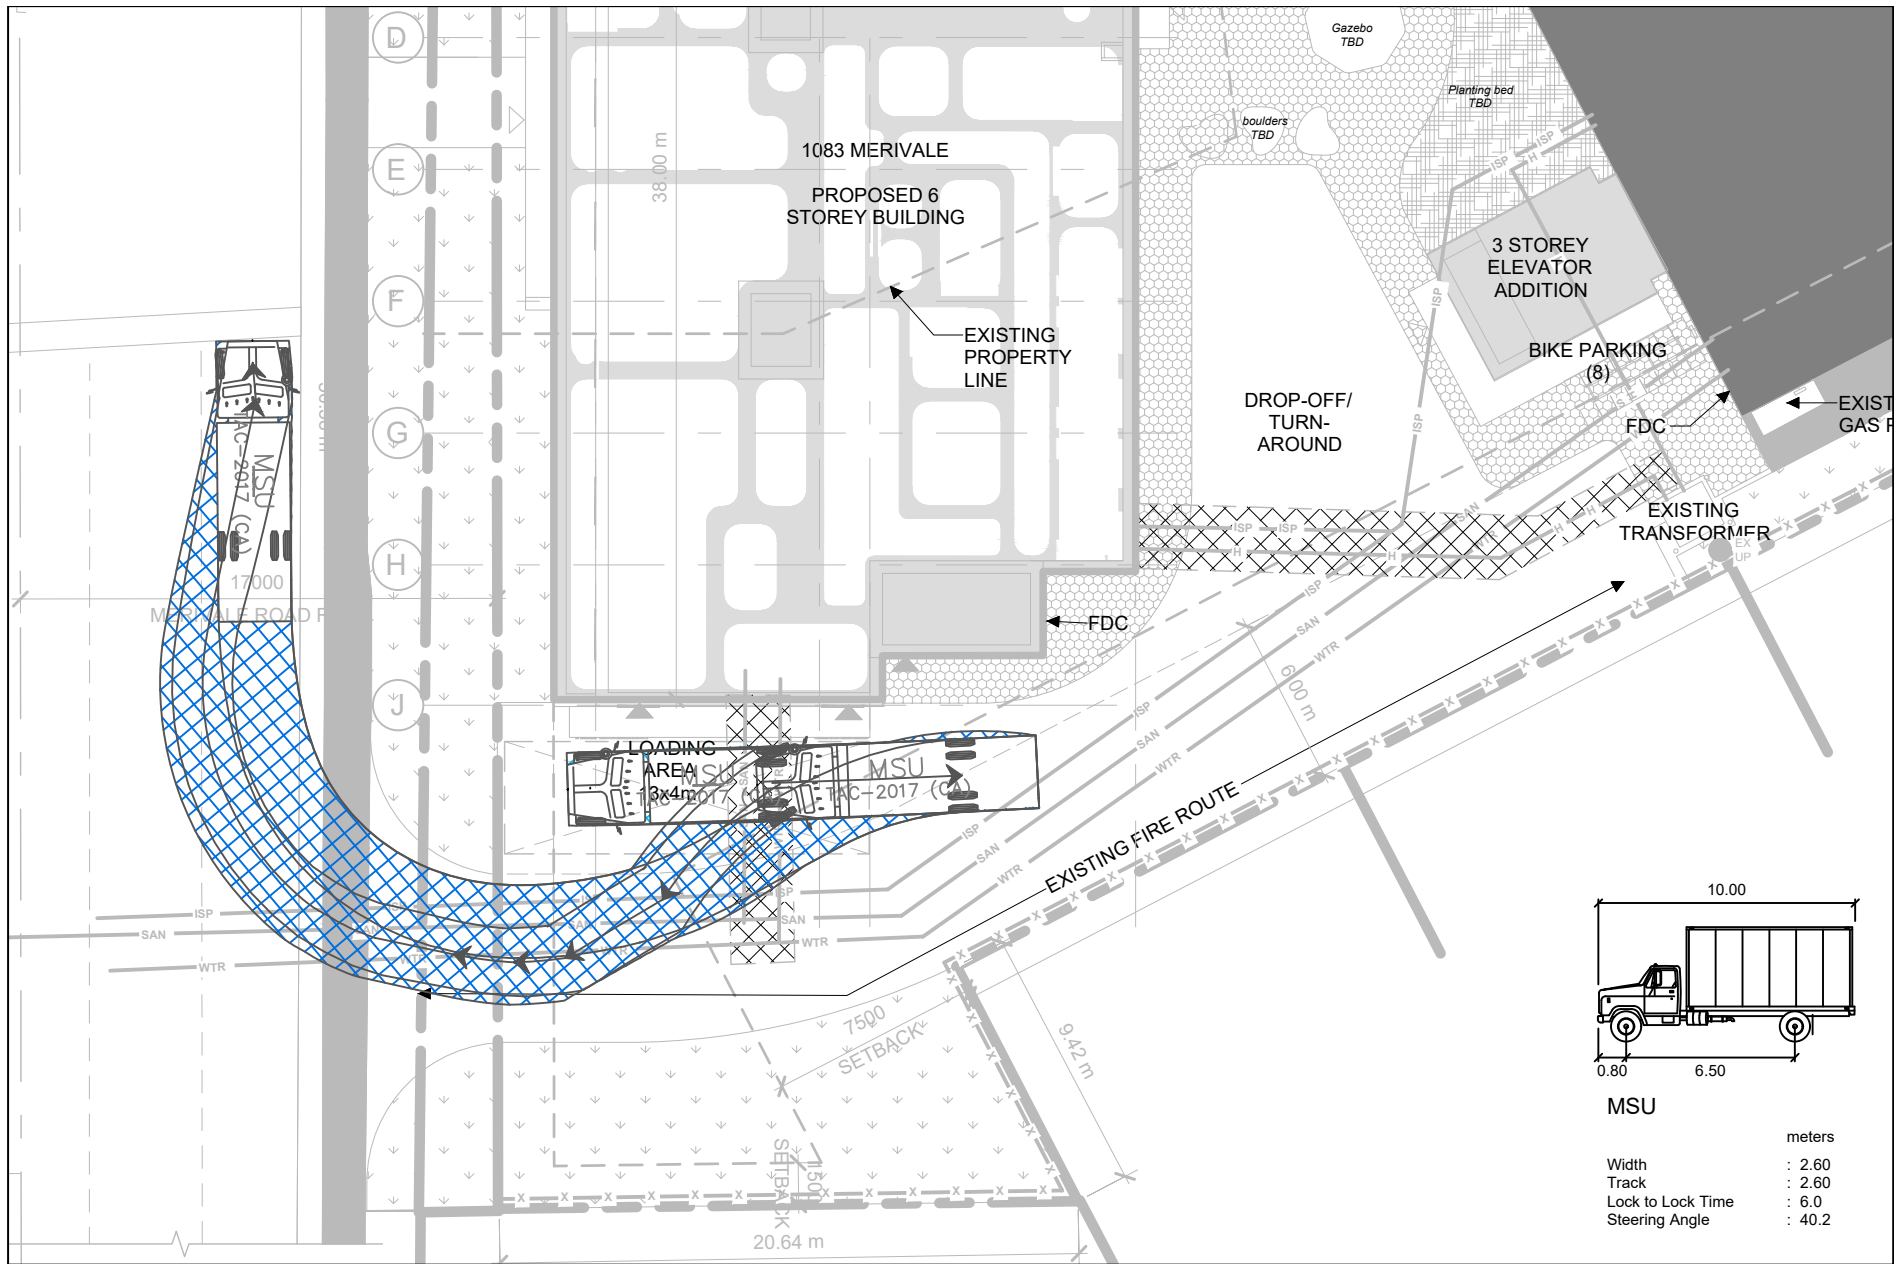
# Appendix D - Figure 2 MSU (Outbound) Turning Model 1083 Merivale Road - Transportation Safety Review

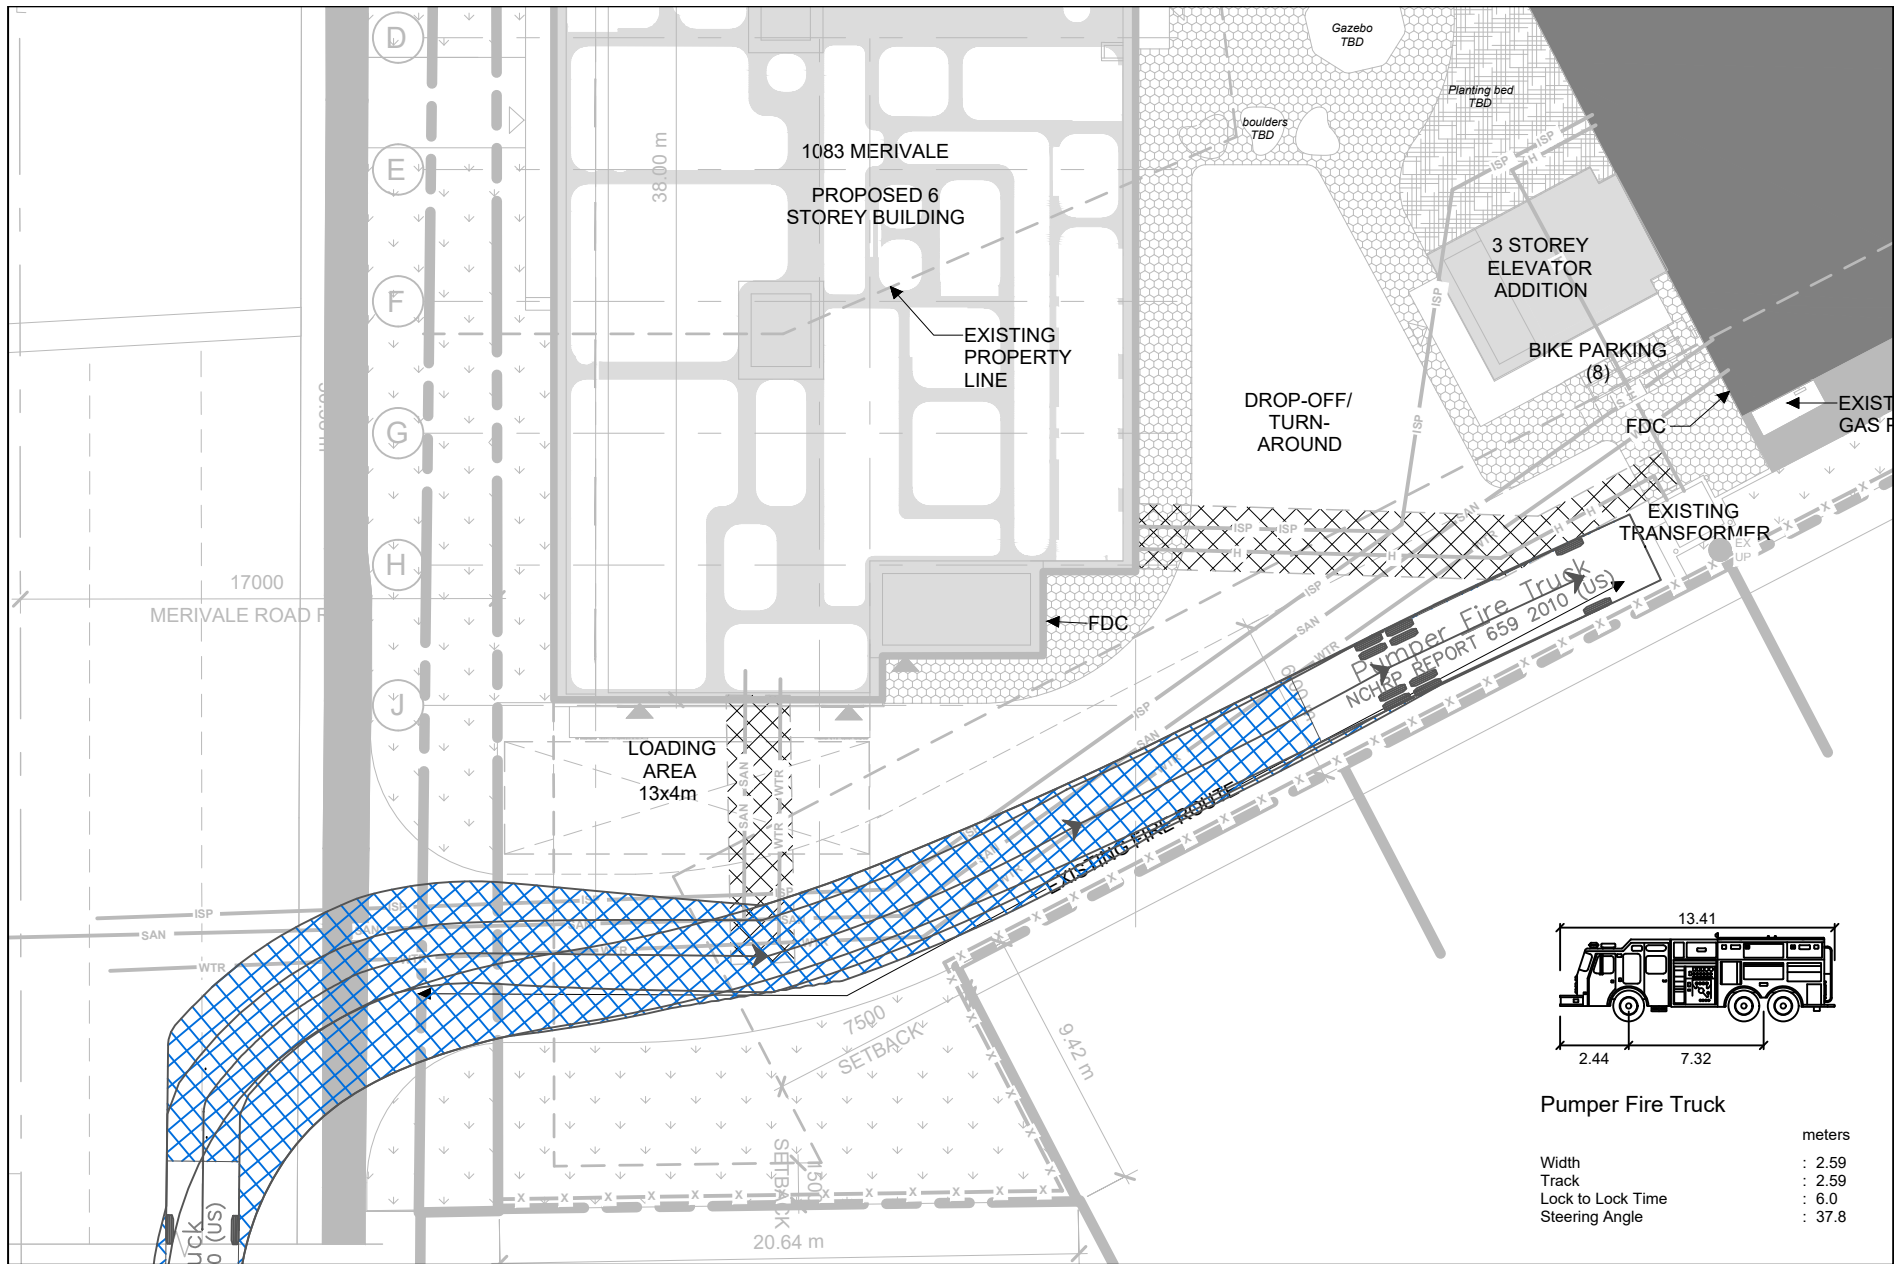
# Appendix D - Figure 3 Fire Truck (Inbound)Turning Model 1083 Merivale Road - Transportation Safety Review
