Tree Conservation Report

5646/5650 Manotick Main St.
Manotick, ON K4M 1B3

May 4, 2023

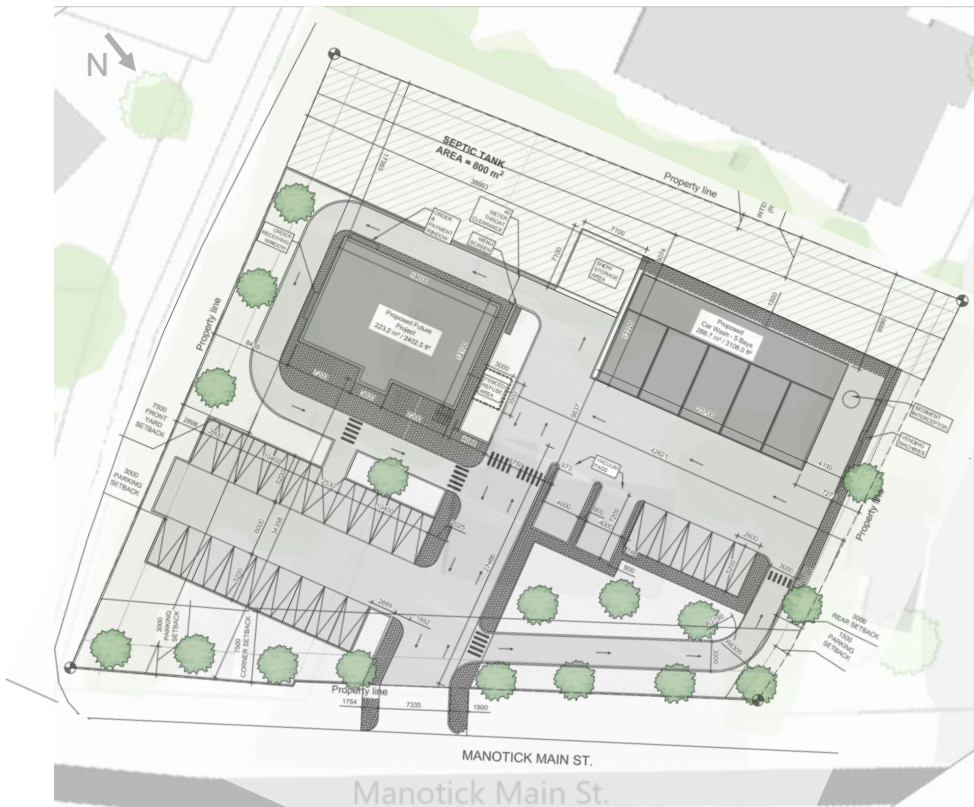
Map #2: Overlay of development plans onto area map.

Trees to be planted

As a significant amount of canopy and screening between the commercial property and existing residential properties is to be removed, trees should be planted as replacement in these areas particularly, as well as in front of the property.
