# Geotechnical Investigation – Slope Stability Analysis

150 Kanata Avenue & 1200 Canadian Shield Avenue,  
Kanata, Ontario

June 26, 2023

Pinchin File: 290435.003

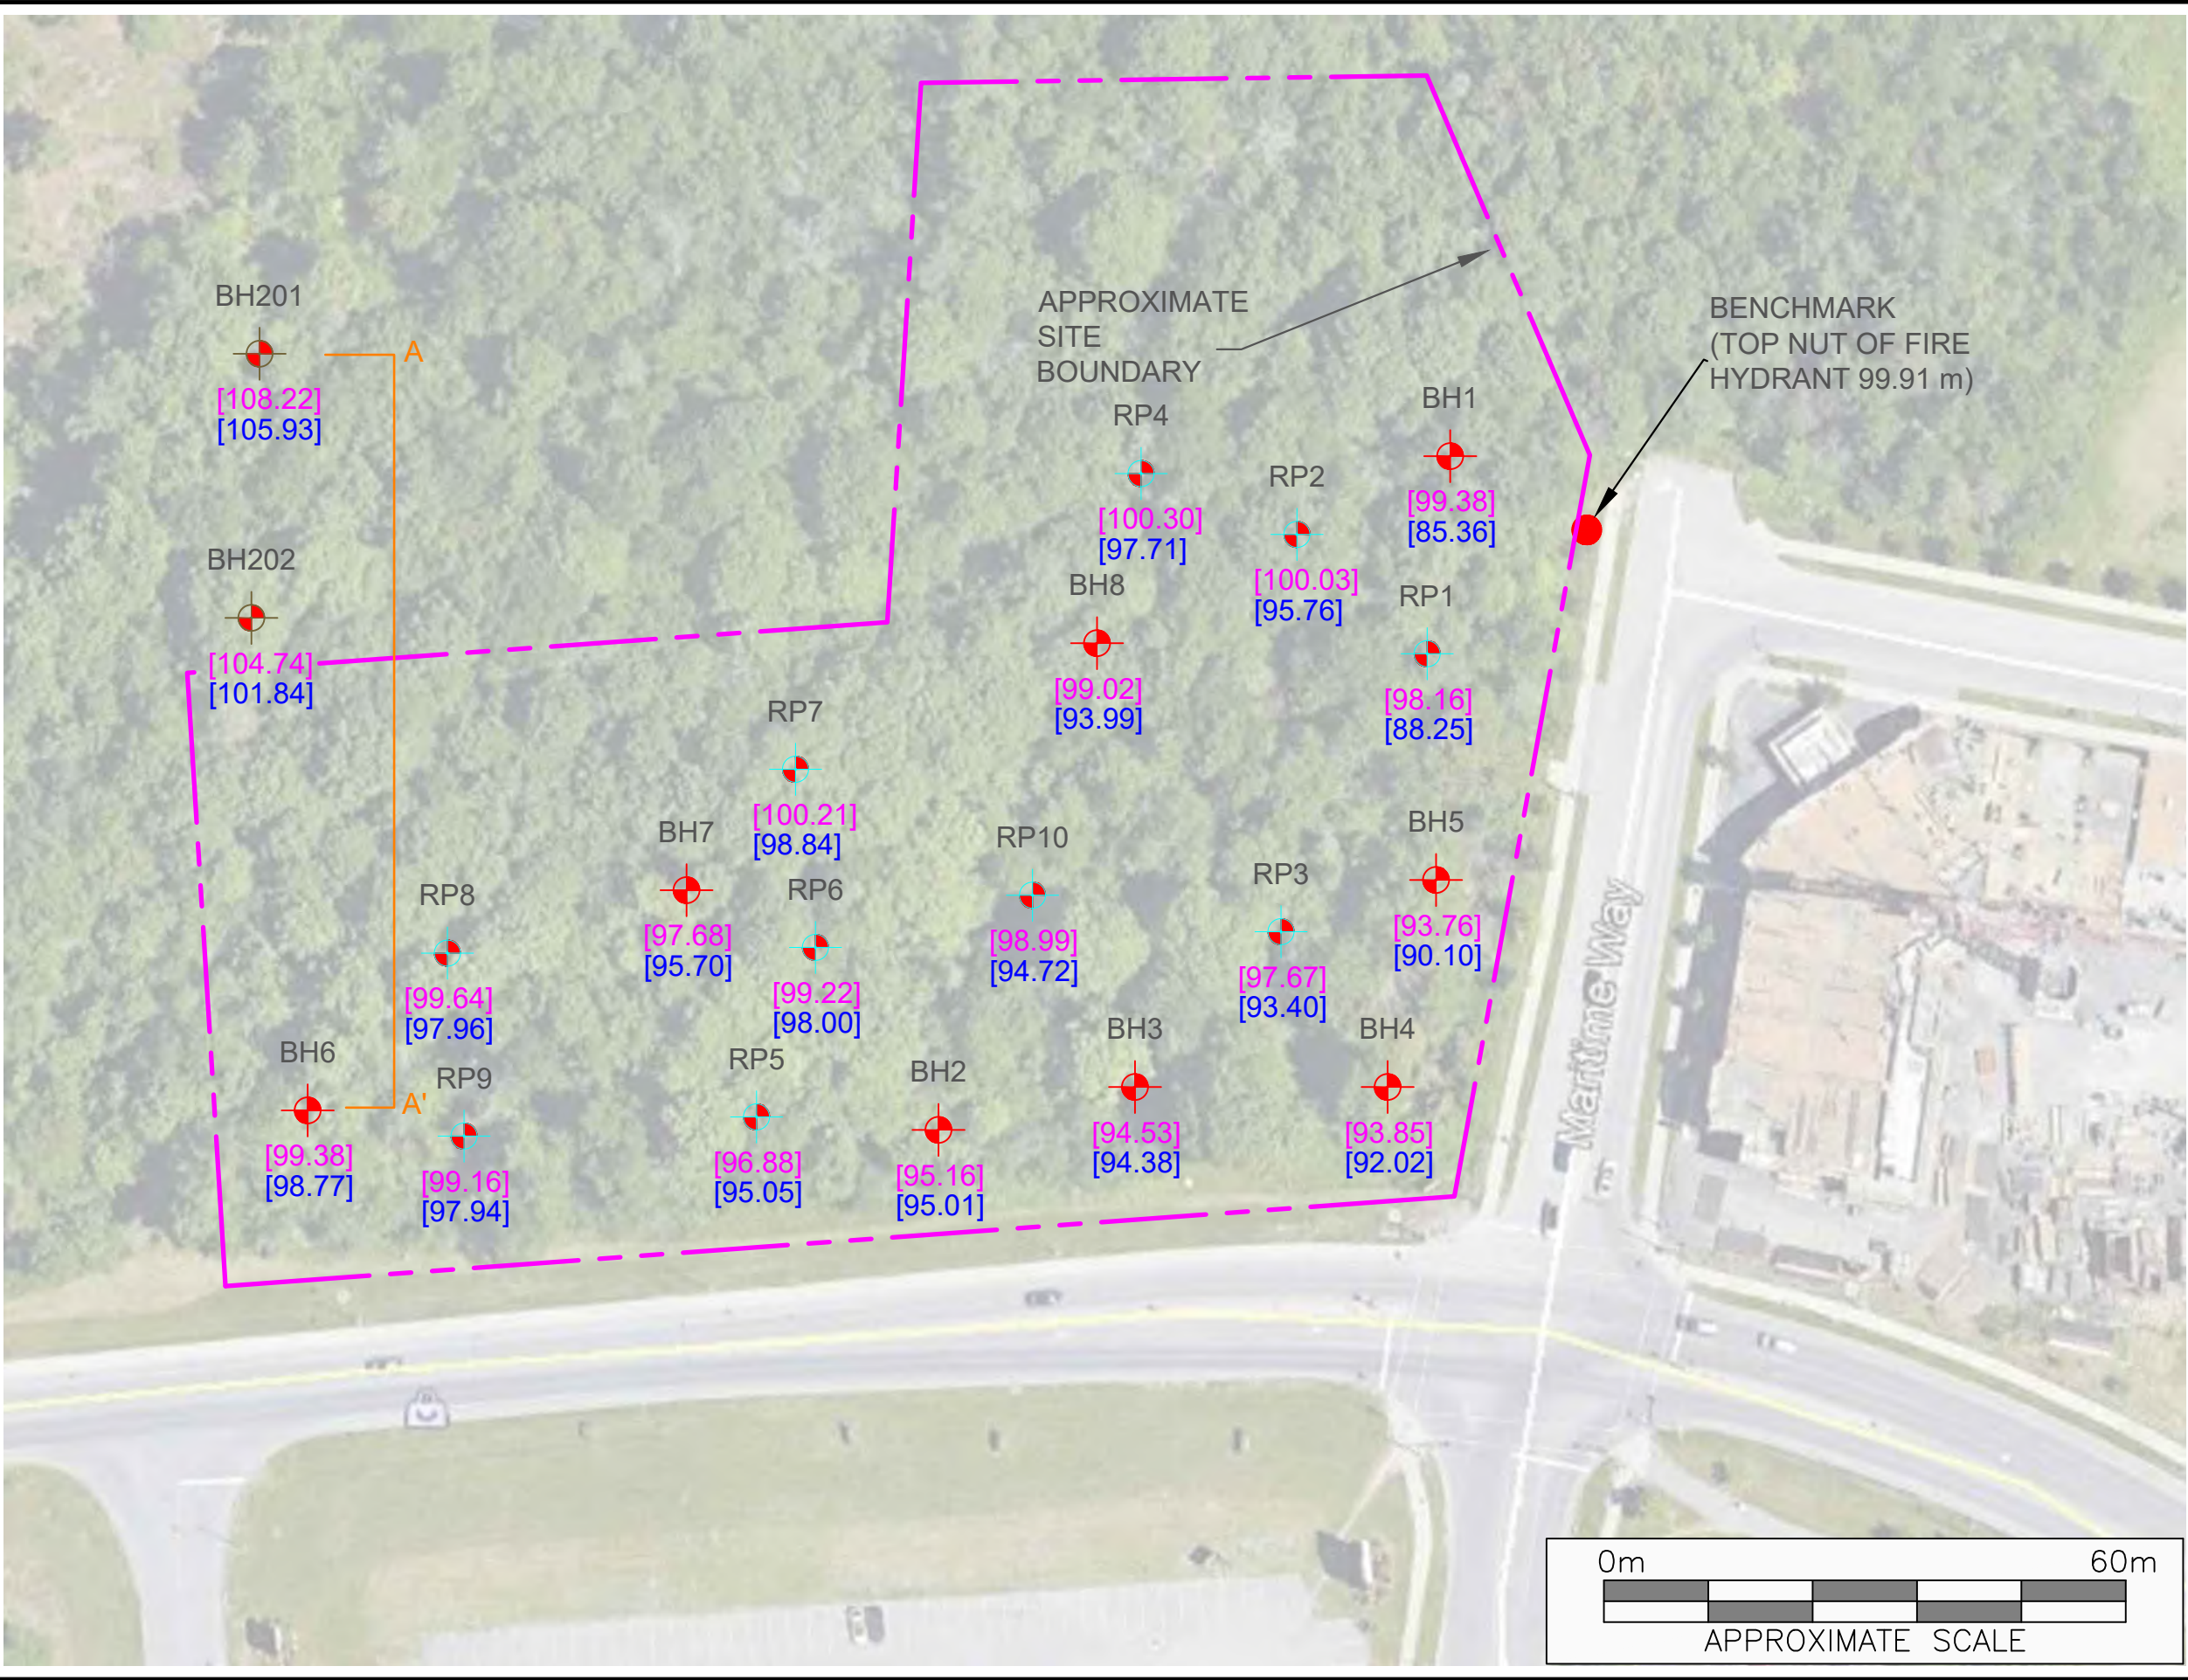
FIGURE NO.  
3

The following subsections contain a discussion of Pinchin’s Slope Stability Analysis in accordance with the Ministry of Natural Resources and Forestry (MNR) Guidelines. The slope stability analysis was completed for both the existing conditions as well as the proposed conditions. One representative slope cross section (cross section A-A’) was analyzed for each condition, through the highest and steepest portion of the embankment. The locations of the slope cross sections are illustrated on Figures 2 (existing conditions) and 4 (proposed conditions). A simplified cross-section of the soil stratigraphy for both the existing conditions and proposed conditions are shown on Figures 3 and 5, respectively.

The results of the analysis indicate that the cross-section profiles have factors of safety against slope failure of 2.47 (existing) and 2.21 (proposed). The factors of safety are closely related to the shallowness of the slope, strength of the soil, and absence of groundwater. The results of the slope stability analysis are included on Figures 3 (existing) and 5 (proposed).

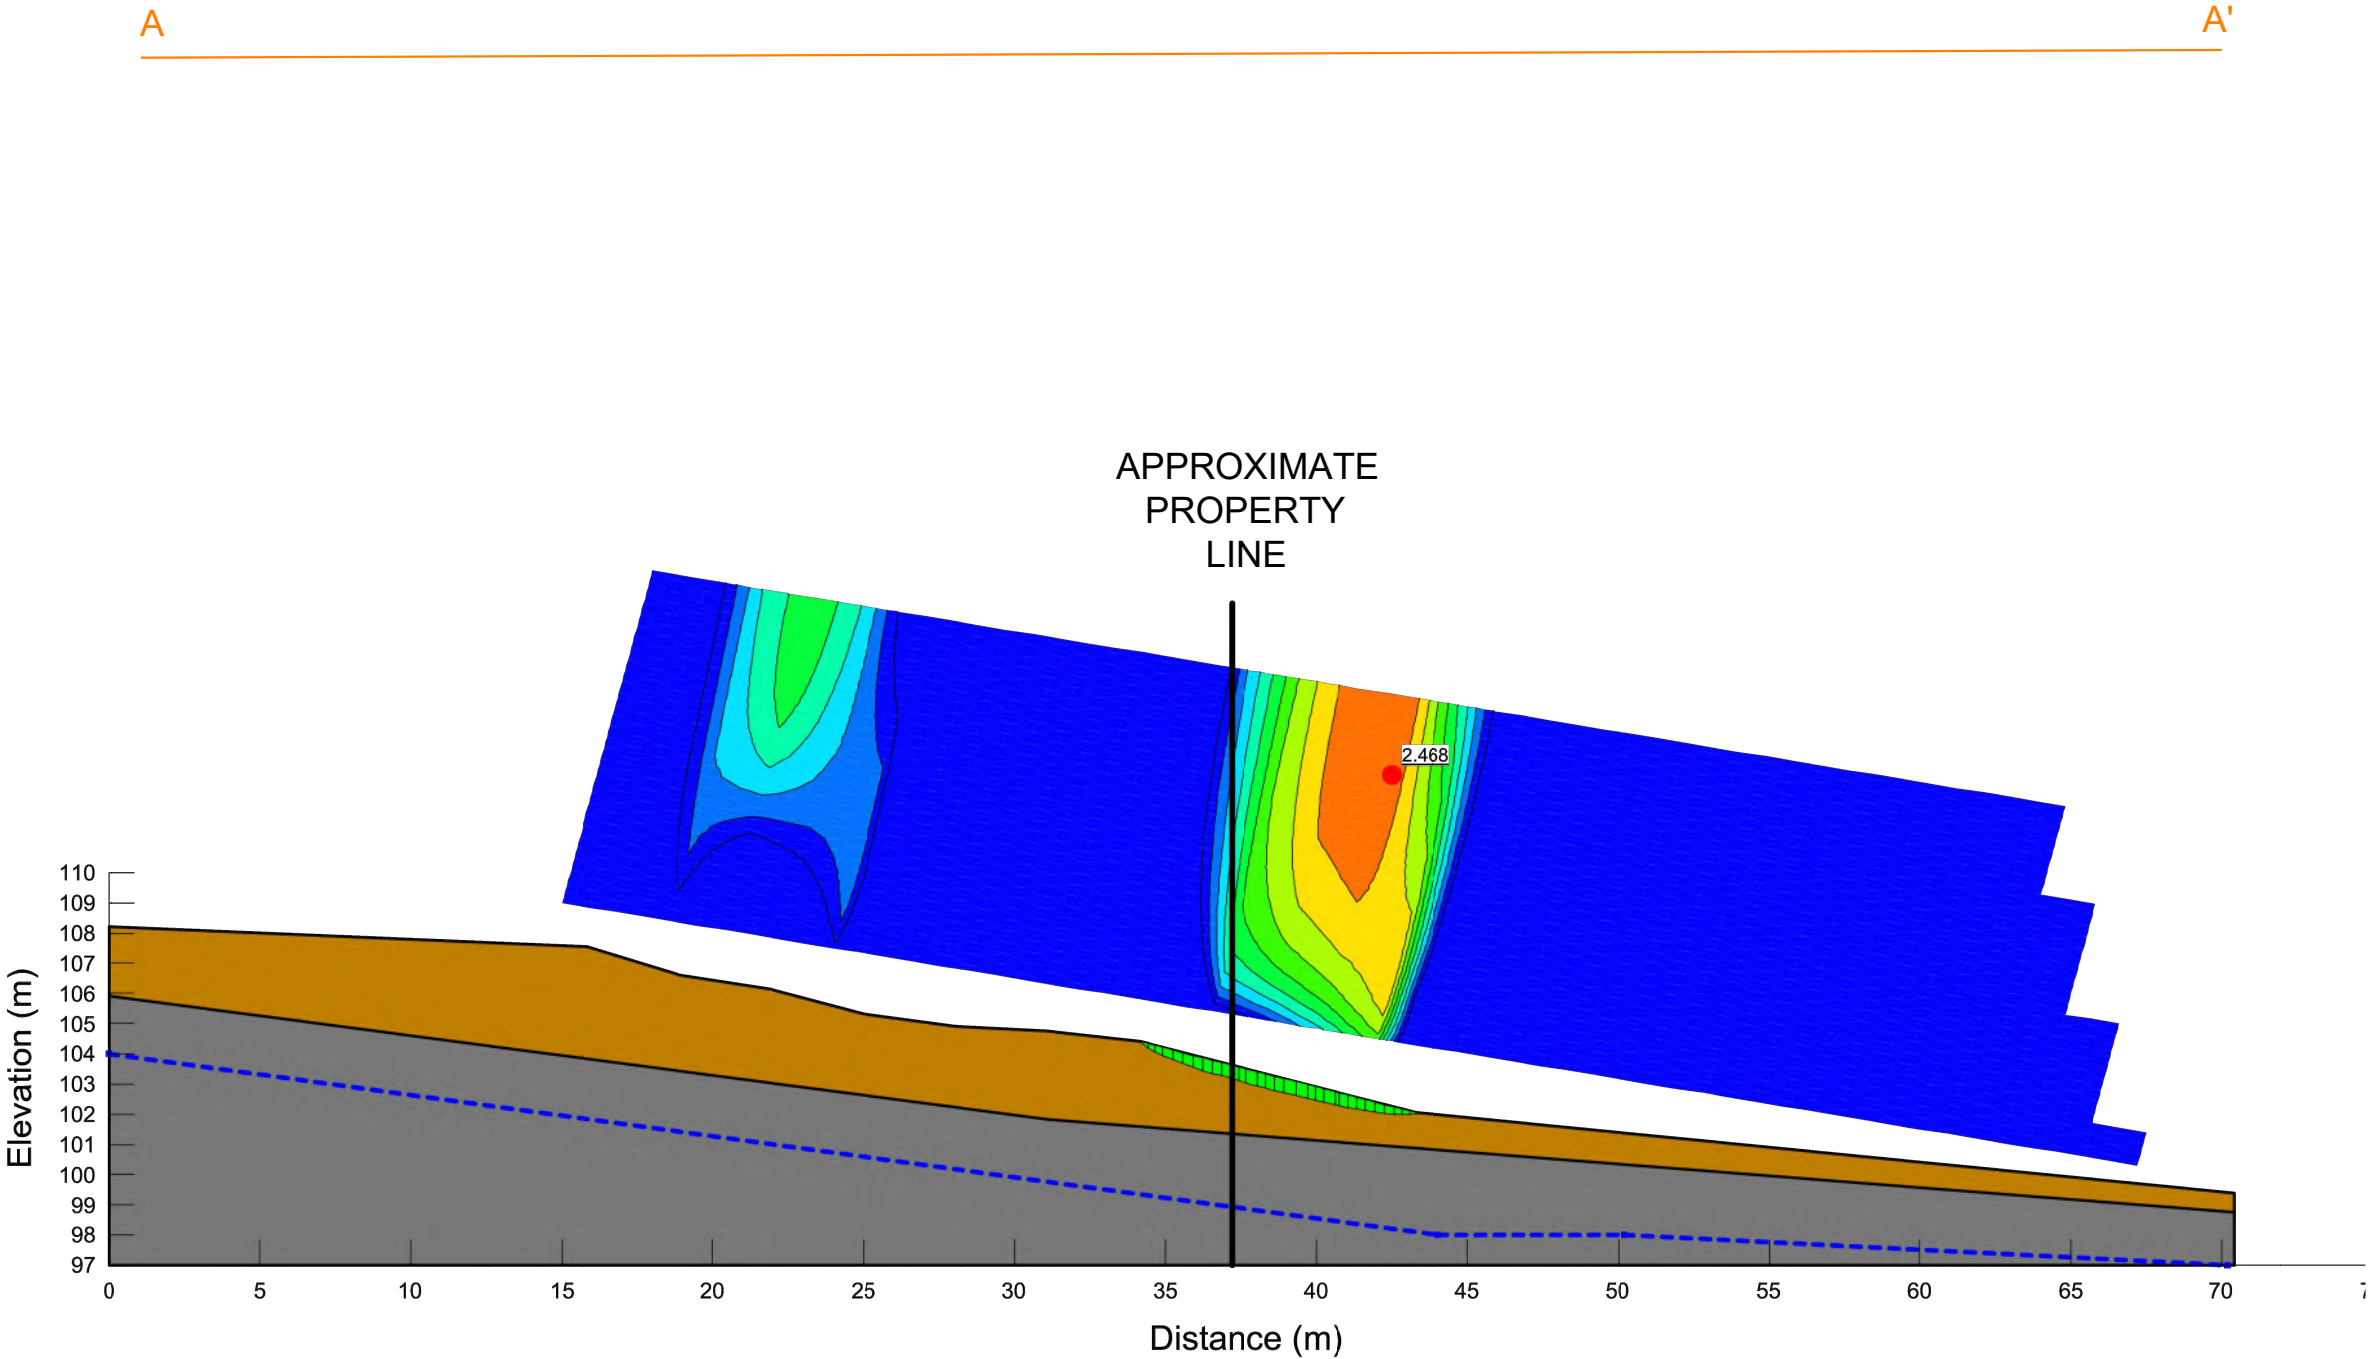
| Color | Name | Model | Unit Weight (kN/m³) | Effective Cohesion (kPa) | Effective Friction Angle (°) | Piezometric Line |
| Grey | Bedrock | Bedrock (Impenetrable) | | | | 1 |
| Orange | Glacial Till - Sand & Silt | Mohr-Coulomb | 20 | 0 | 32 | |

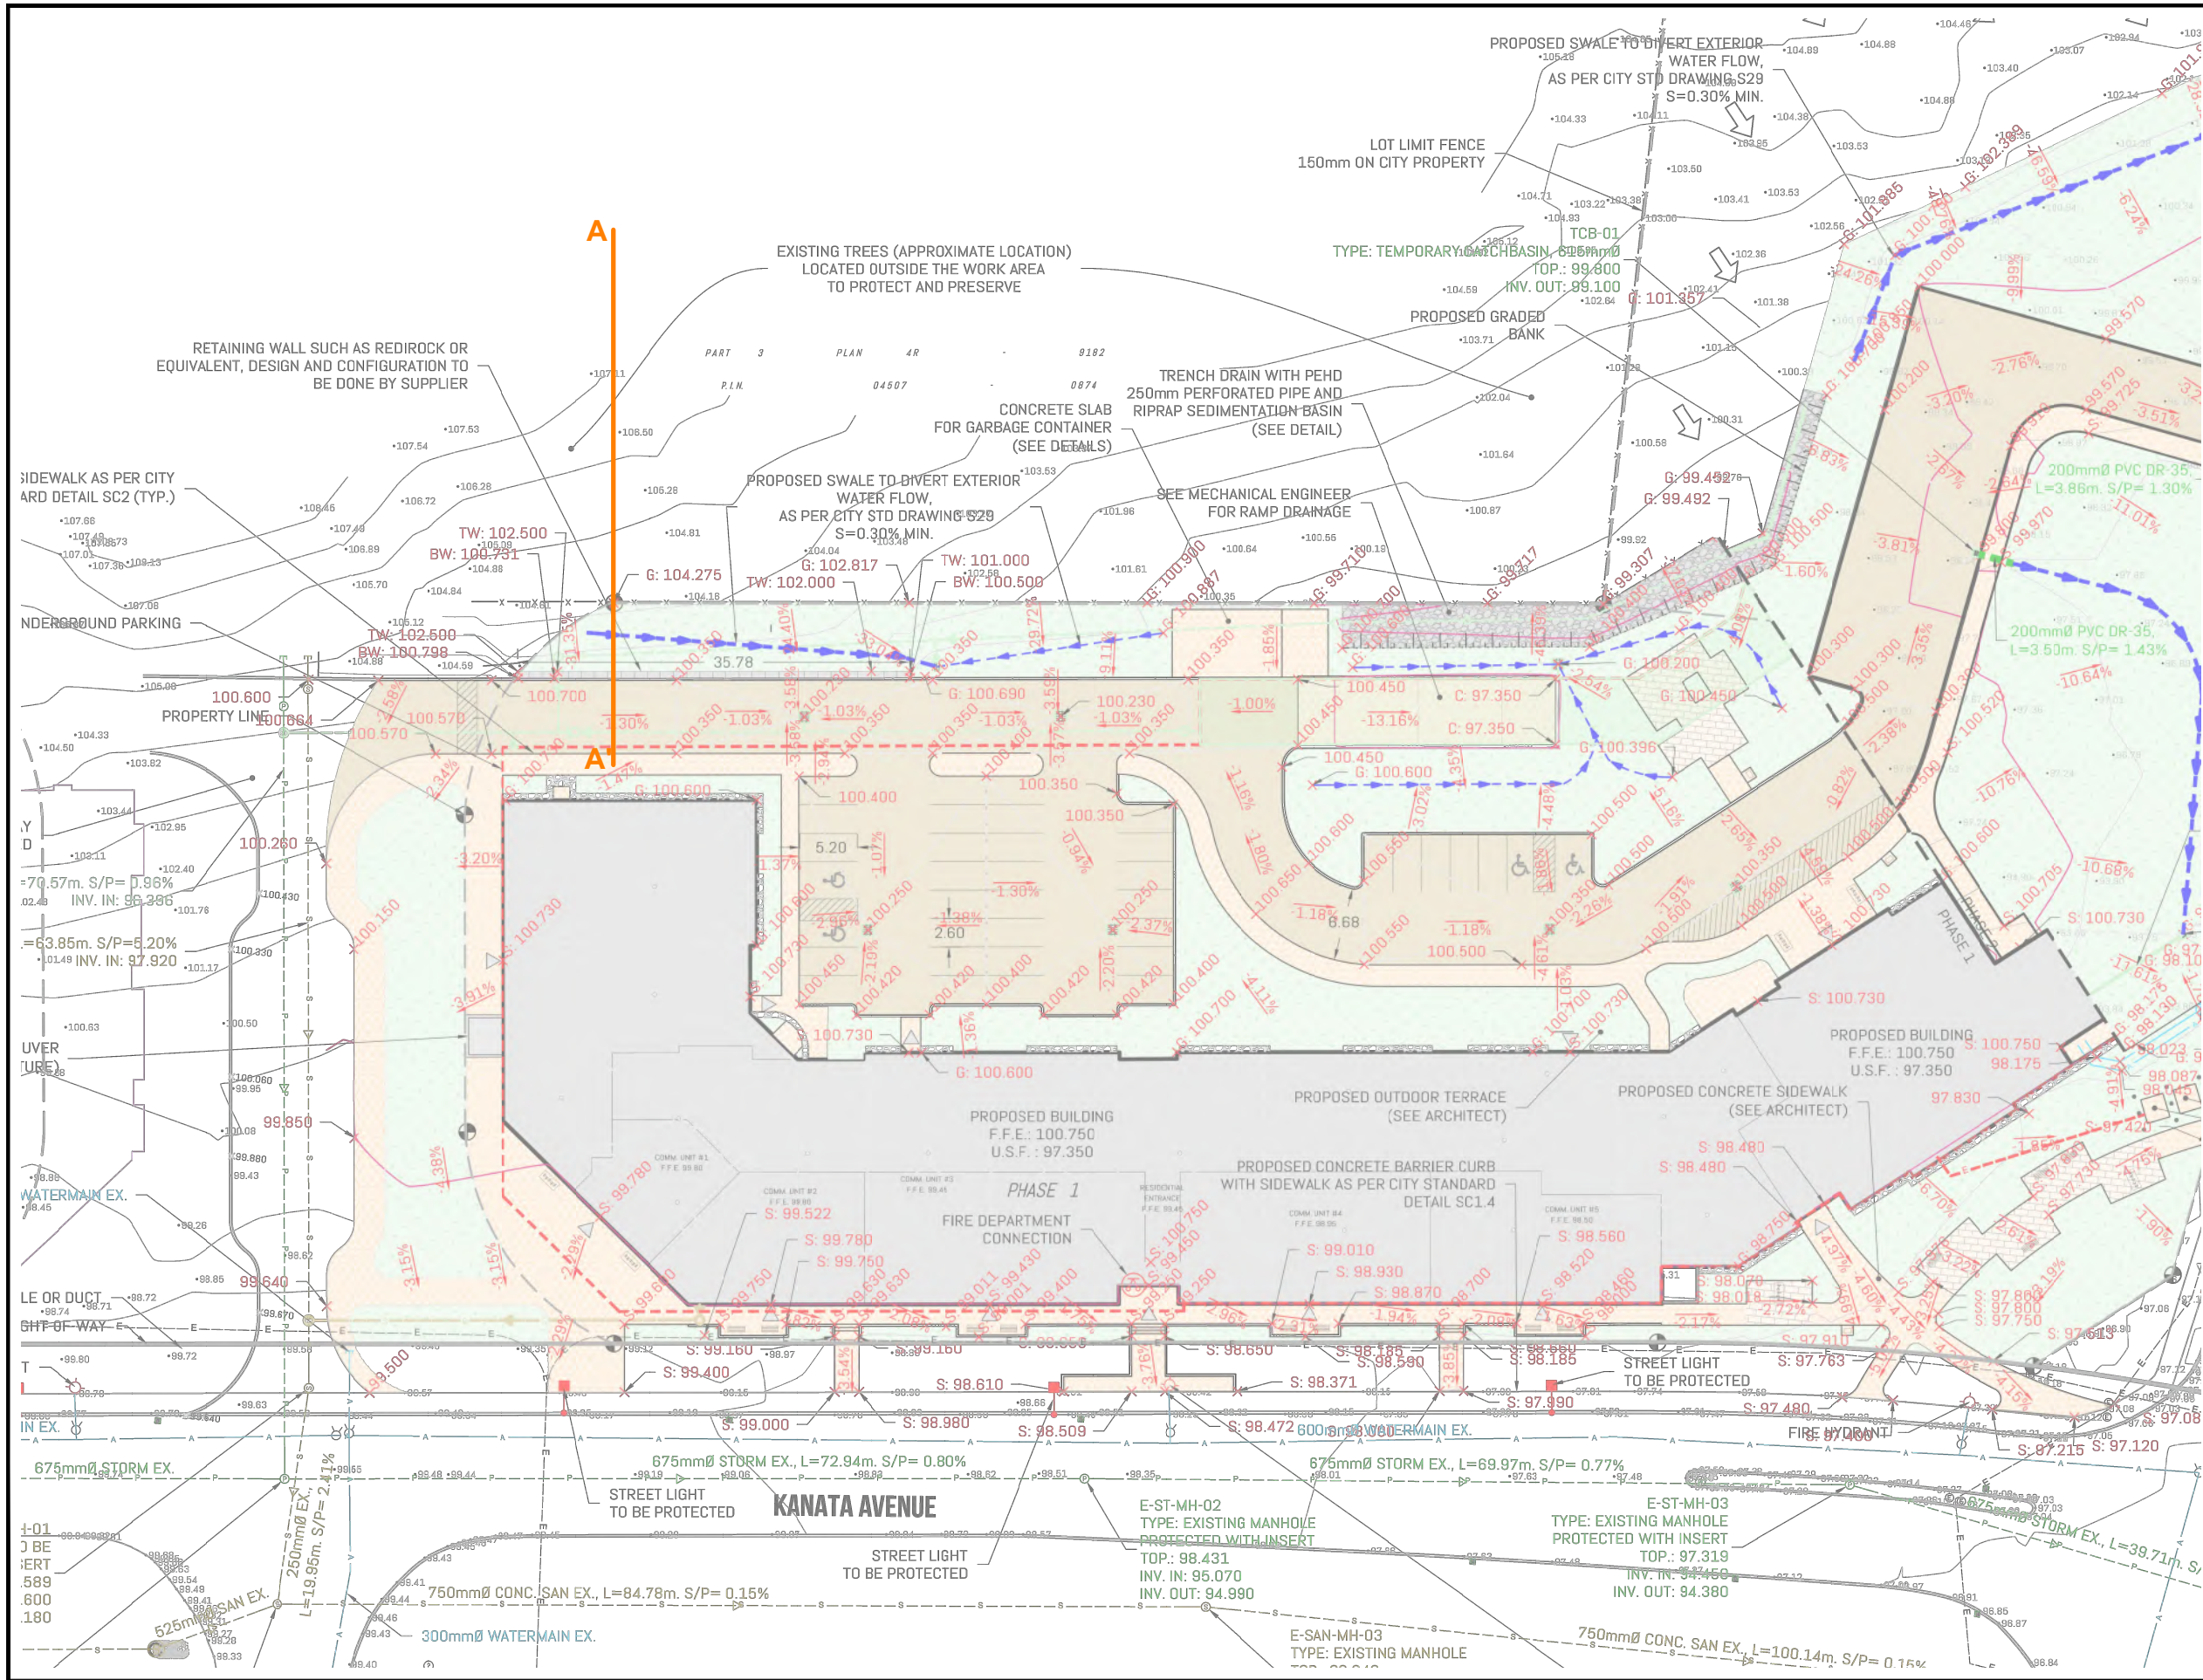
FIGURE NO.  
4

Figure 4 – Proposed Site Grading Plan and Cross Section A – A' Location

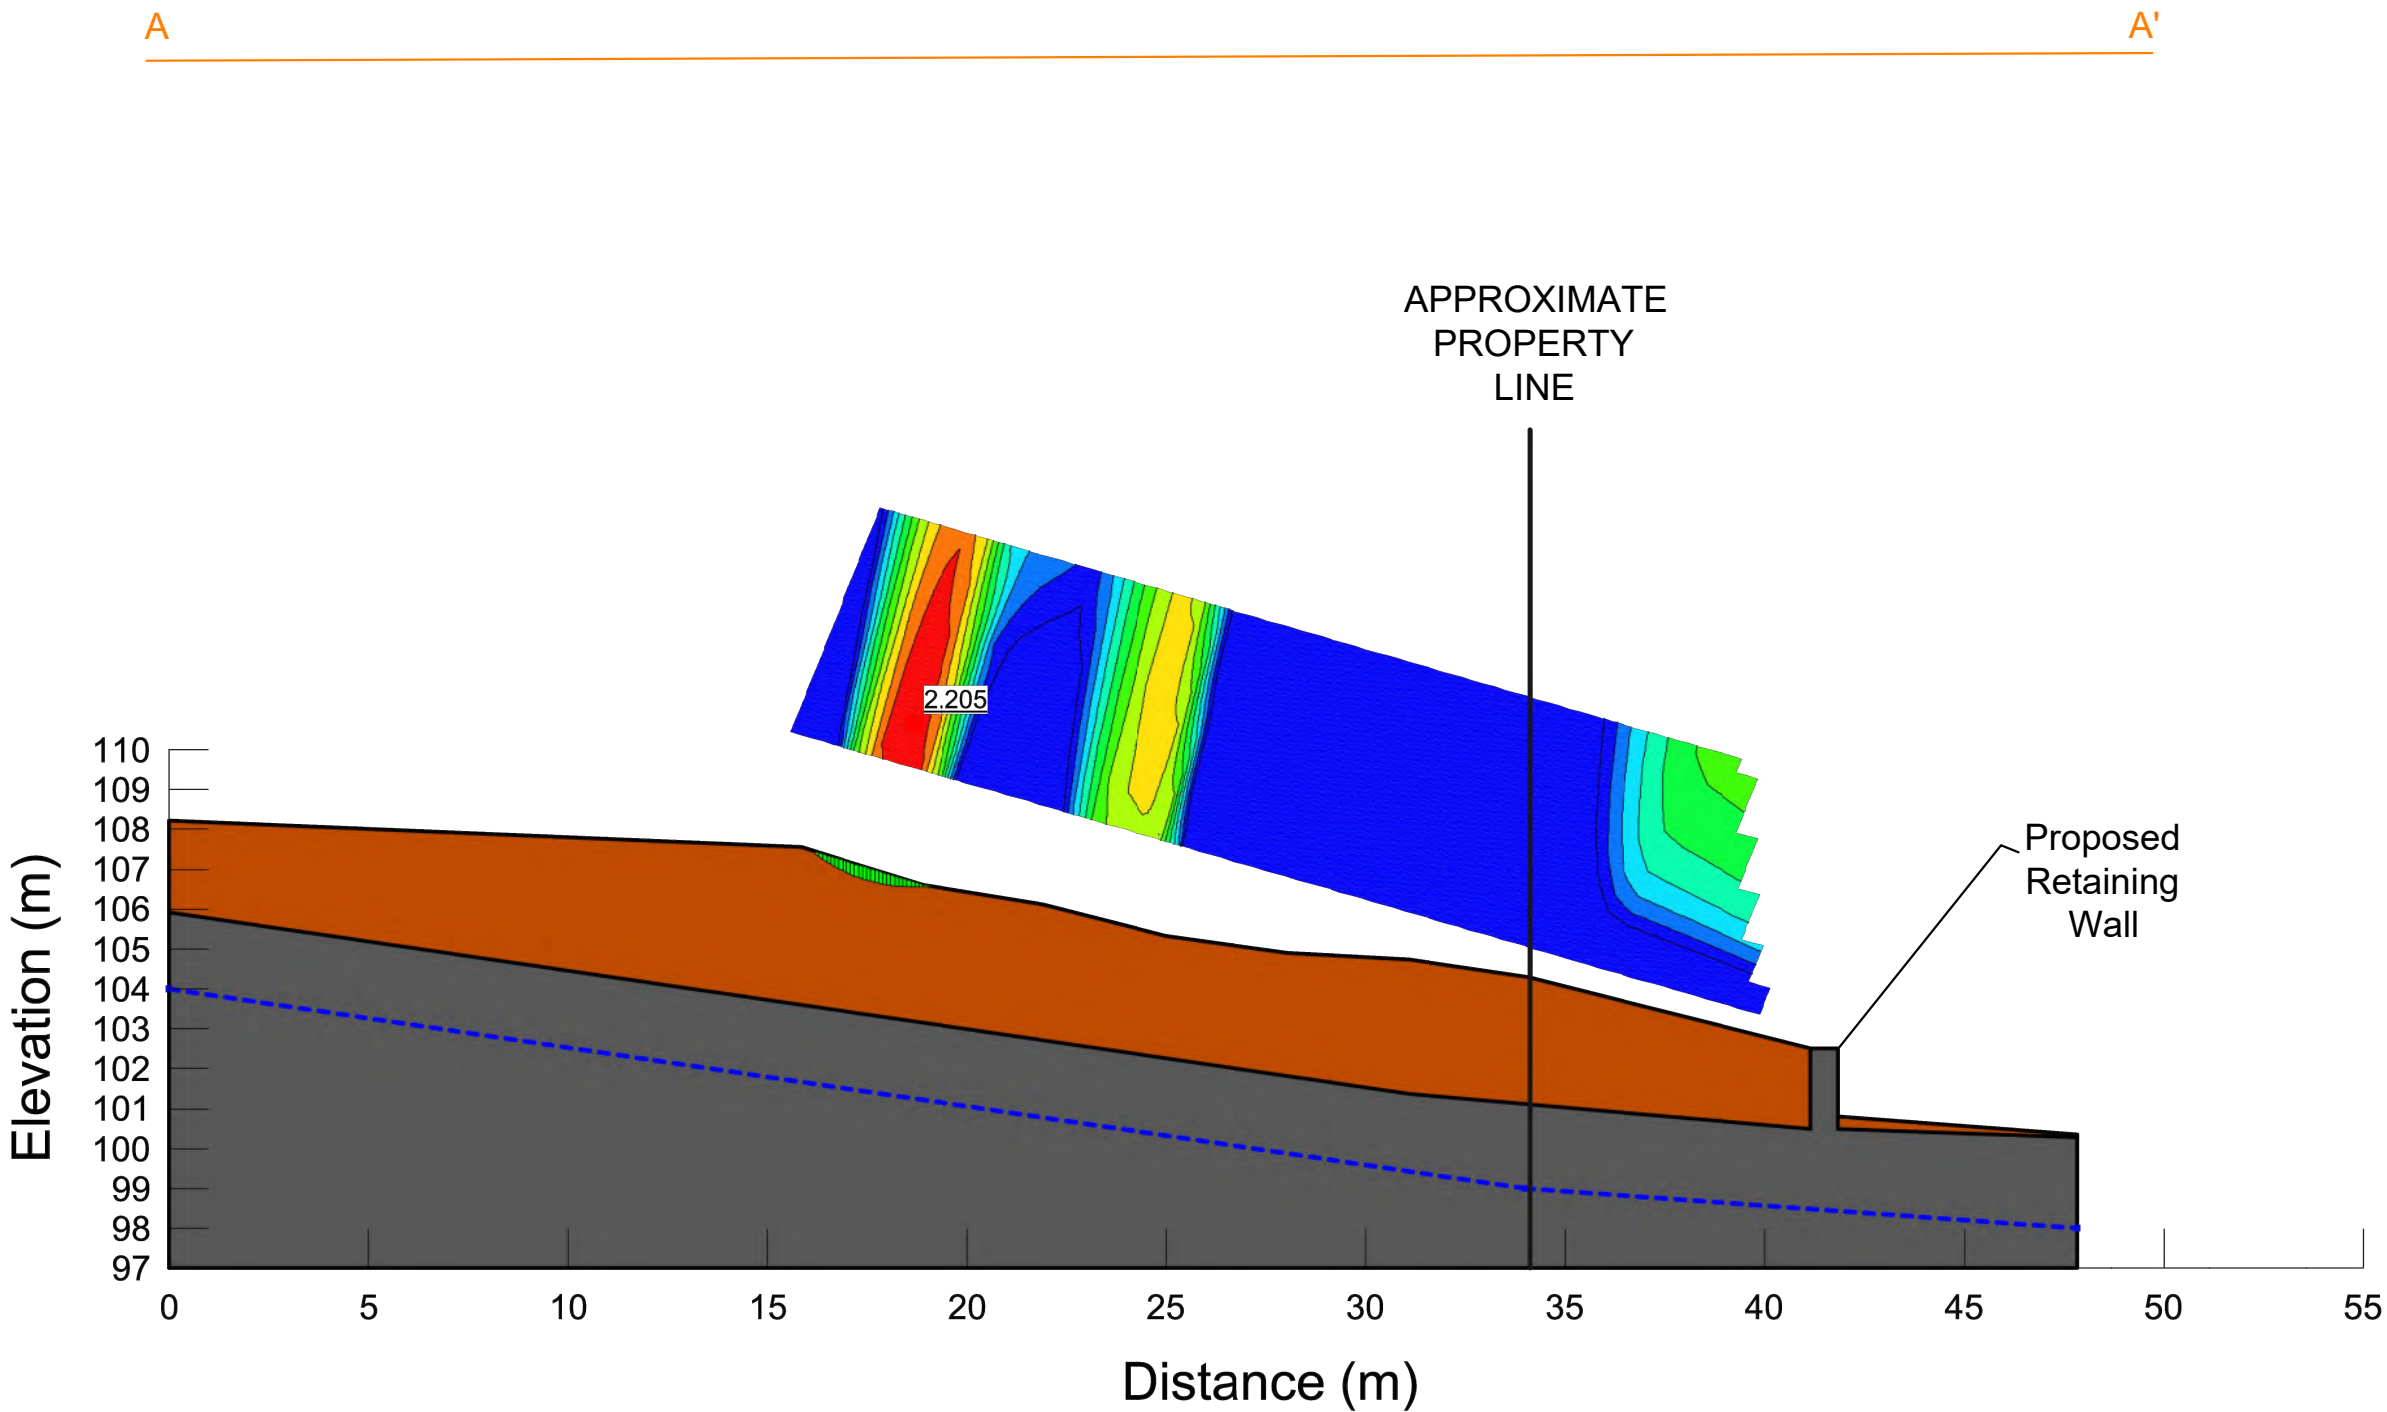
| Color | Name | Model | Unit Weight (kN/m³) | Effective Cohesion (kPa) | Effective Friction Angle (°) | Piezometric Line |
| <div></div> | Bedrock | Bedrock (Impenetrable) | | | | 1 |

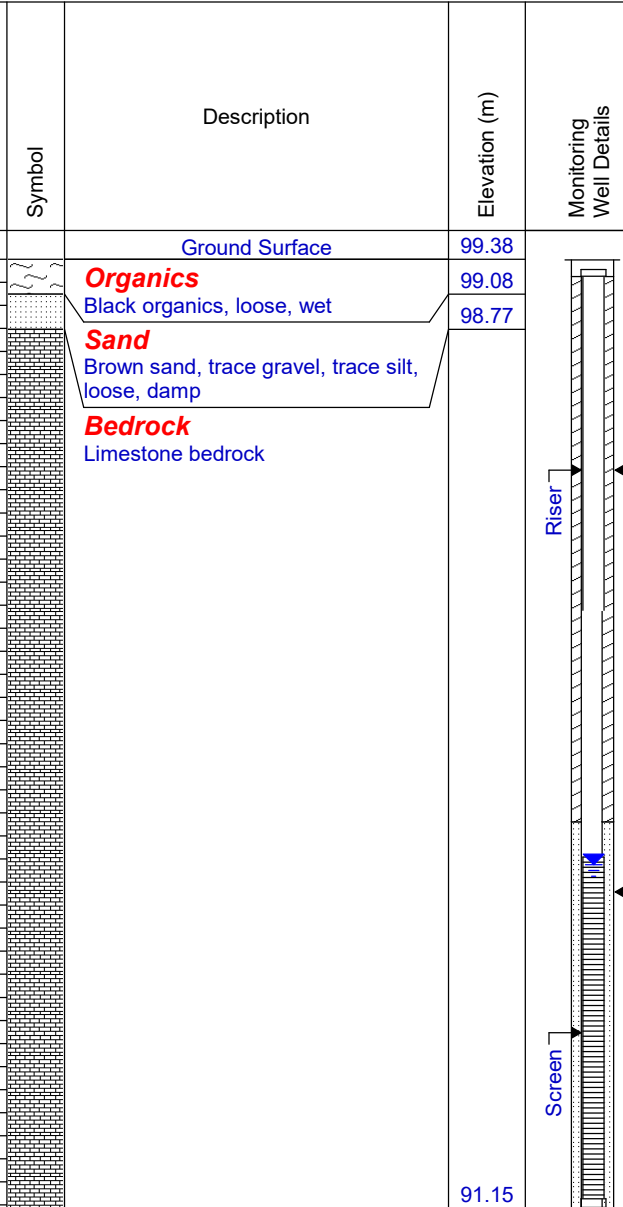
# Log of Borehole: BH6

Refusal was encountered on probable bedrock in each borehole between approximately 2.3 and 2.9 mbgs. It is noted that no bedrock cores were advanced during the current investigation to confirm the presence of bedrock or to evaluate the Rock Quality Designation (RQD); however, bedrock was confirmed via rock coring within Boreholes BH4 and BH6, as well as Rock Probes RP1 and RP9, which were advanced for the Pinchin 2023 Report. It is noted that Borehole BH6 was advanced at the approximate bottom of the existing slope; as such, the information obtained from this borehole was used to aid in completing the slope stability analysis. The bedrock core recovered from within Borehole BH6 consisted of an upper layer of sandstone bedrock overlying granitic bedrock. A copy of the borehole log for Borehole BH6 is included in Appendix II.
