Phase I – Environmental Site Assessment

140 Lusk Street
Ottawa, Ontario

April 12, 2022

Report: PE5694-1

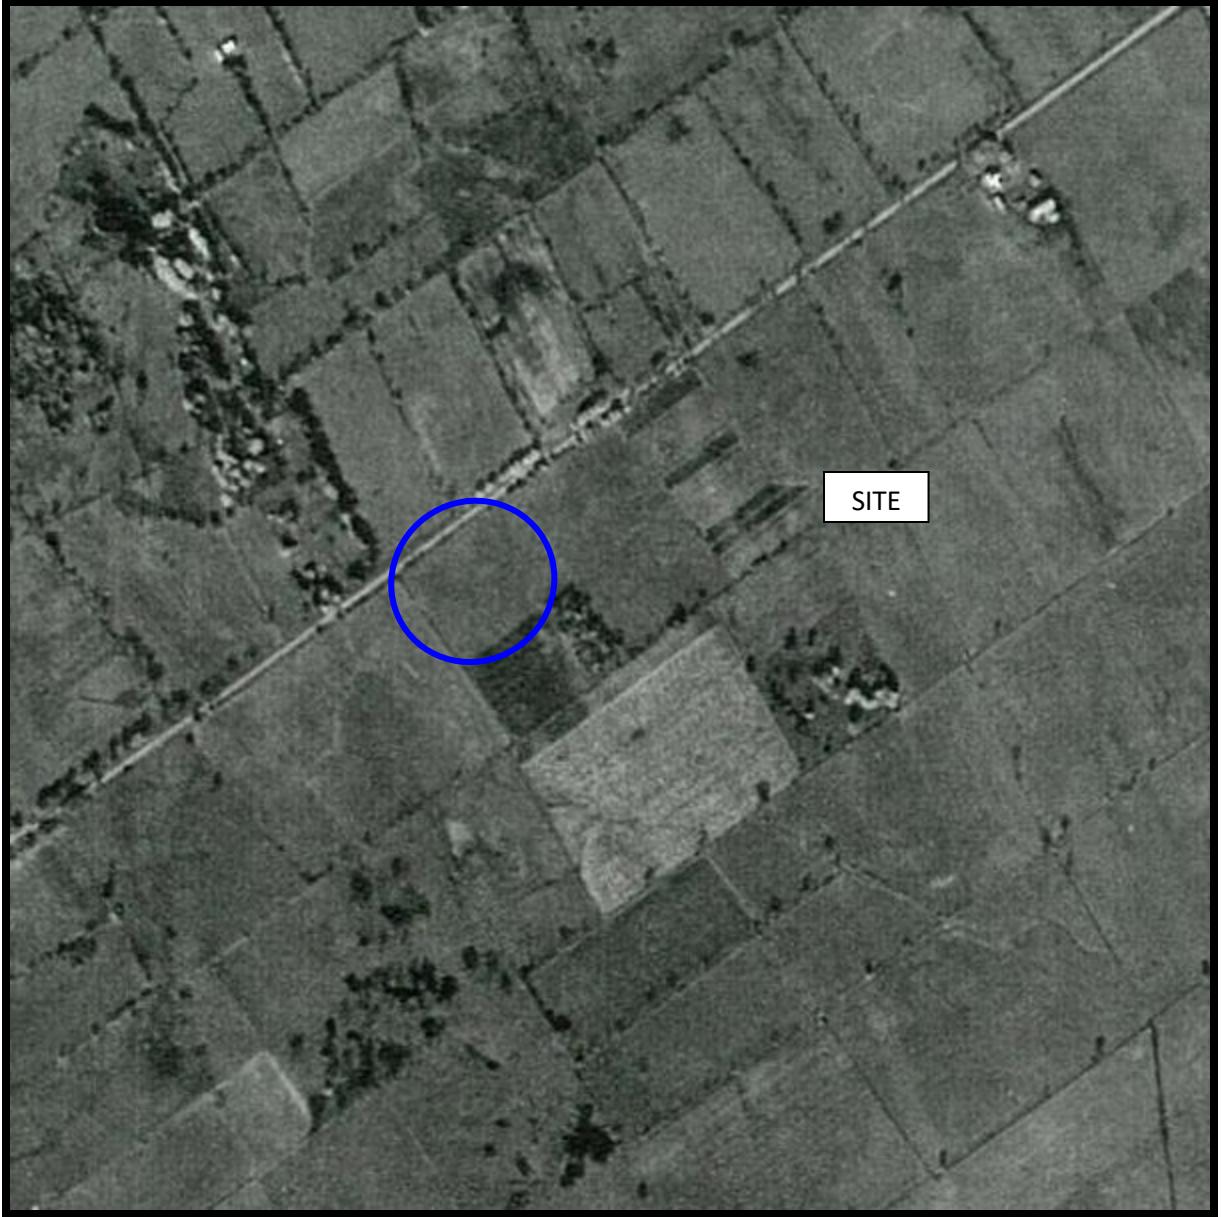
AERIAL PHOTOGRAPH
1945

| 1945 | The subject and surrounding properties appear to be vacant and used for agricultural purposes. A treed area is present to the southeast of the site. Fallowfield Road is present to the north of the site. |

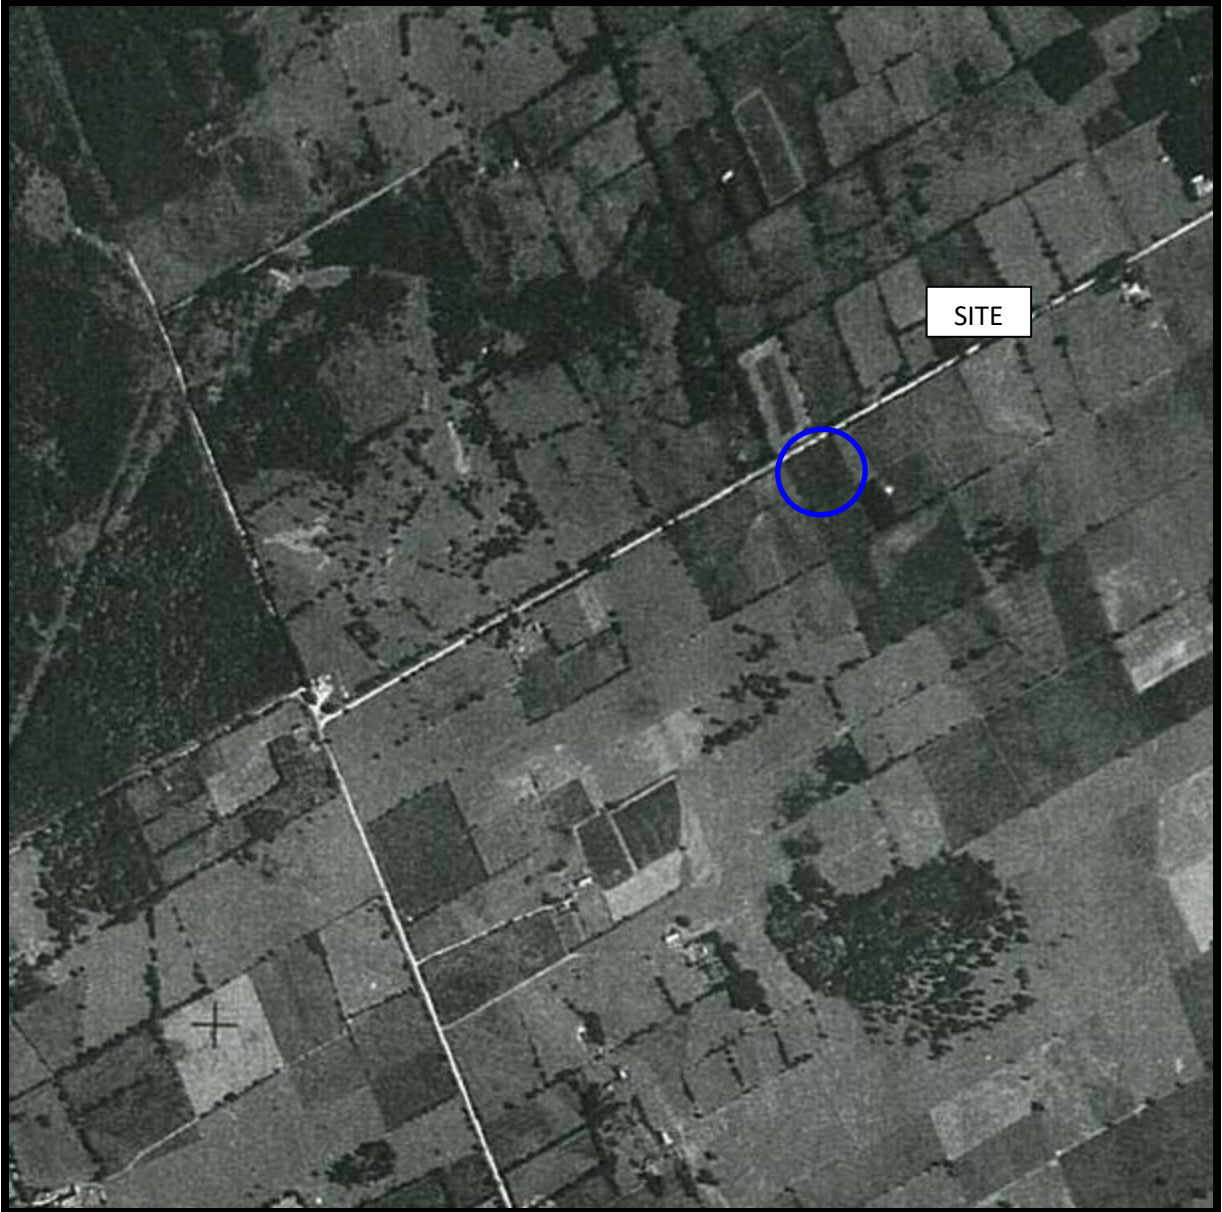
AERIAL PHOTOGRAPH
1955

| 1955 | No significant changes have been made to the subject site or neighbouring properties. |

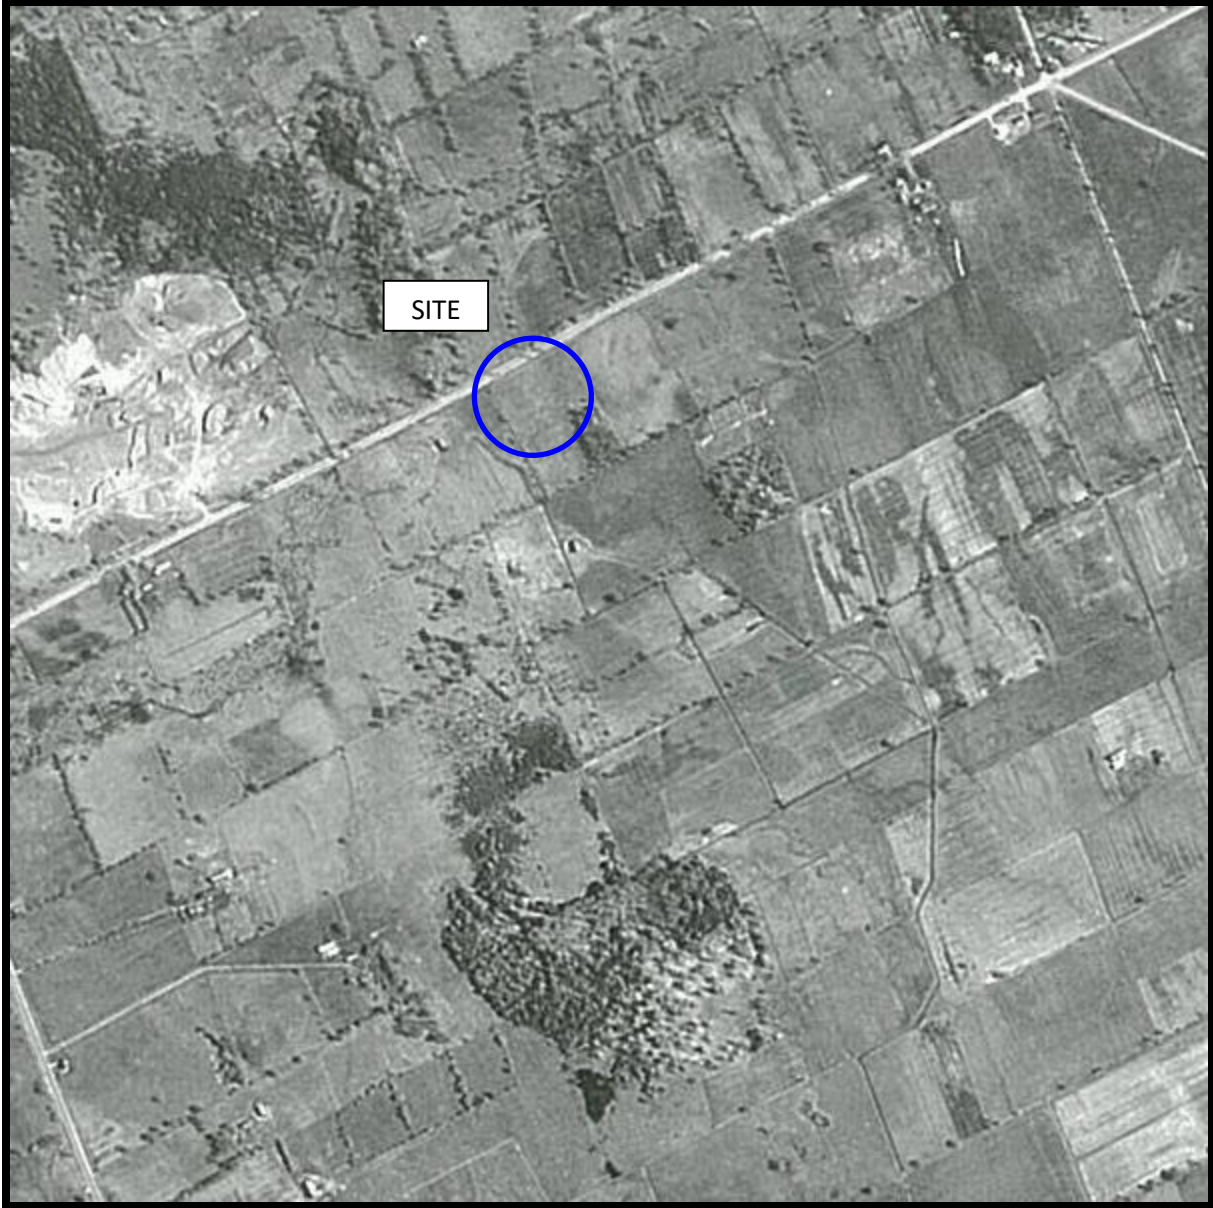
AERIAL PHOTOGRAPH
1963

| 1963 | No significant changes have been made to the subject site or neighbouring properties. |

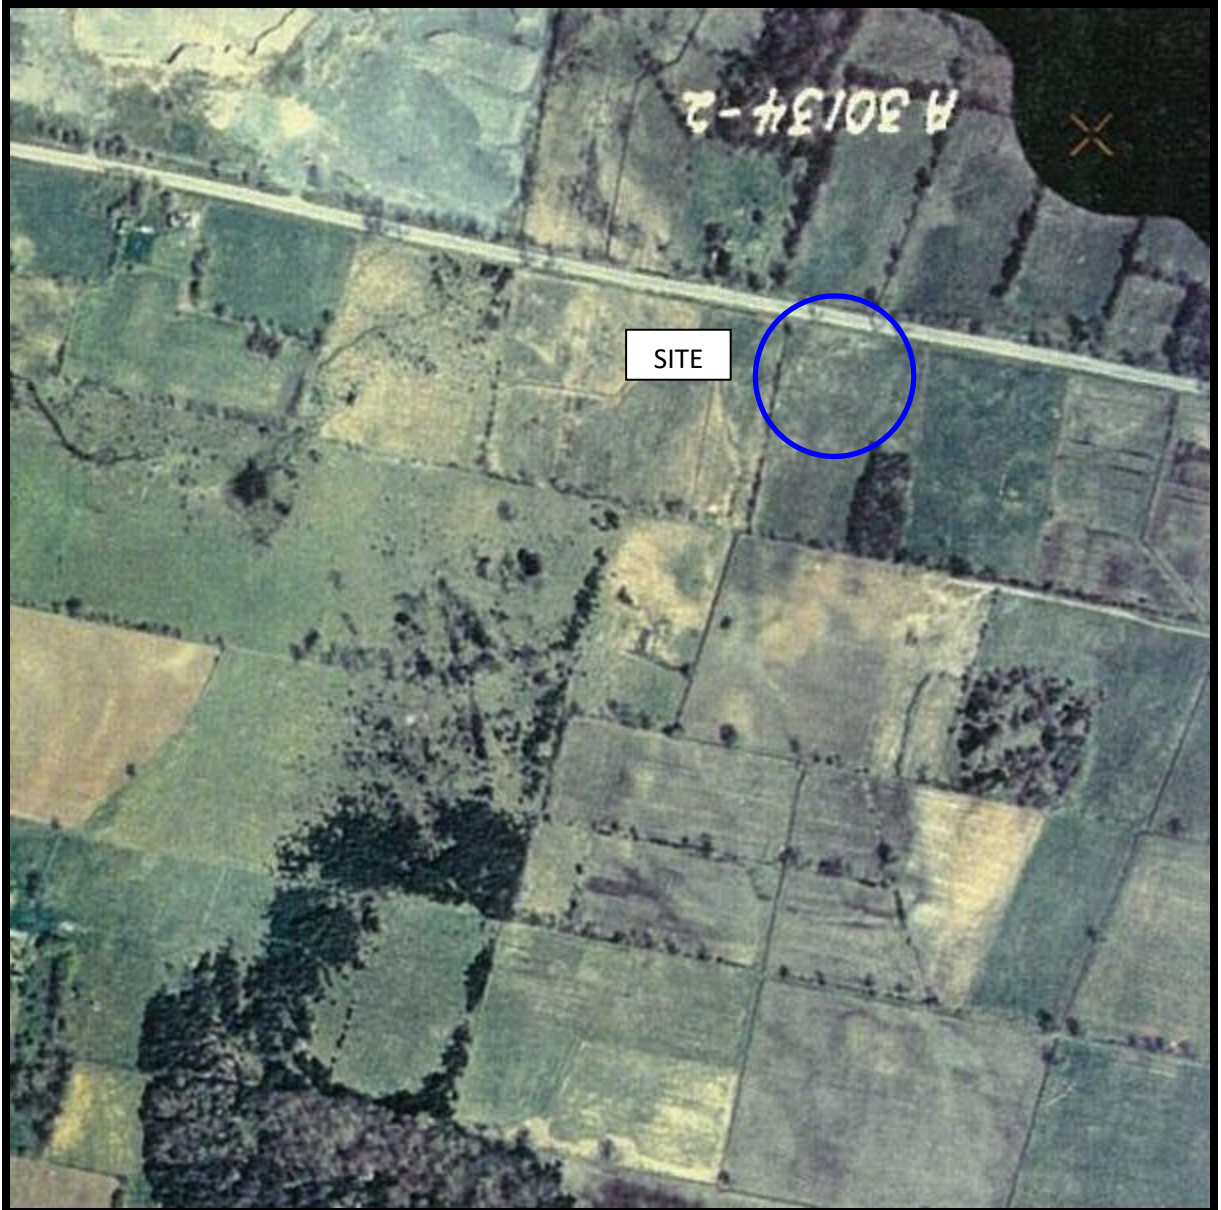
AERIAL PHOTOGRAPH
1968

| 1968 | No significant changes have been made to the subject site or neighbouring properties. |

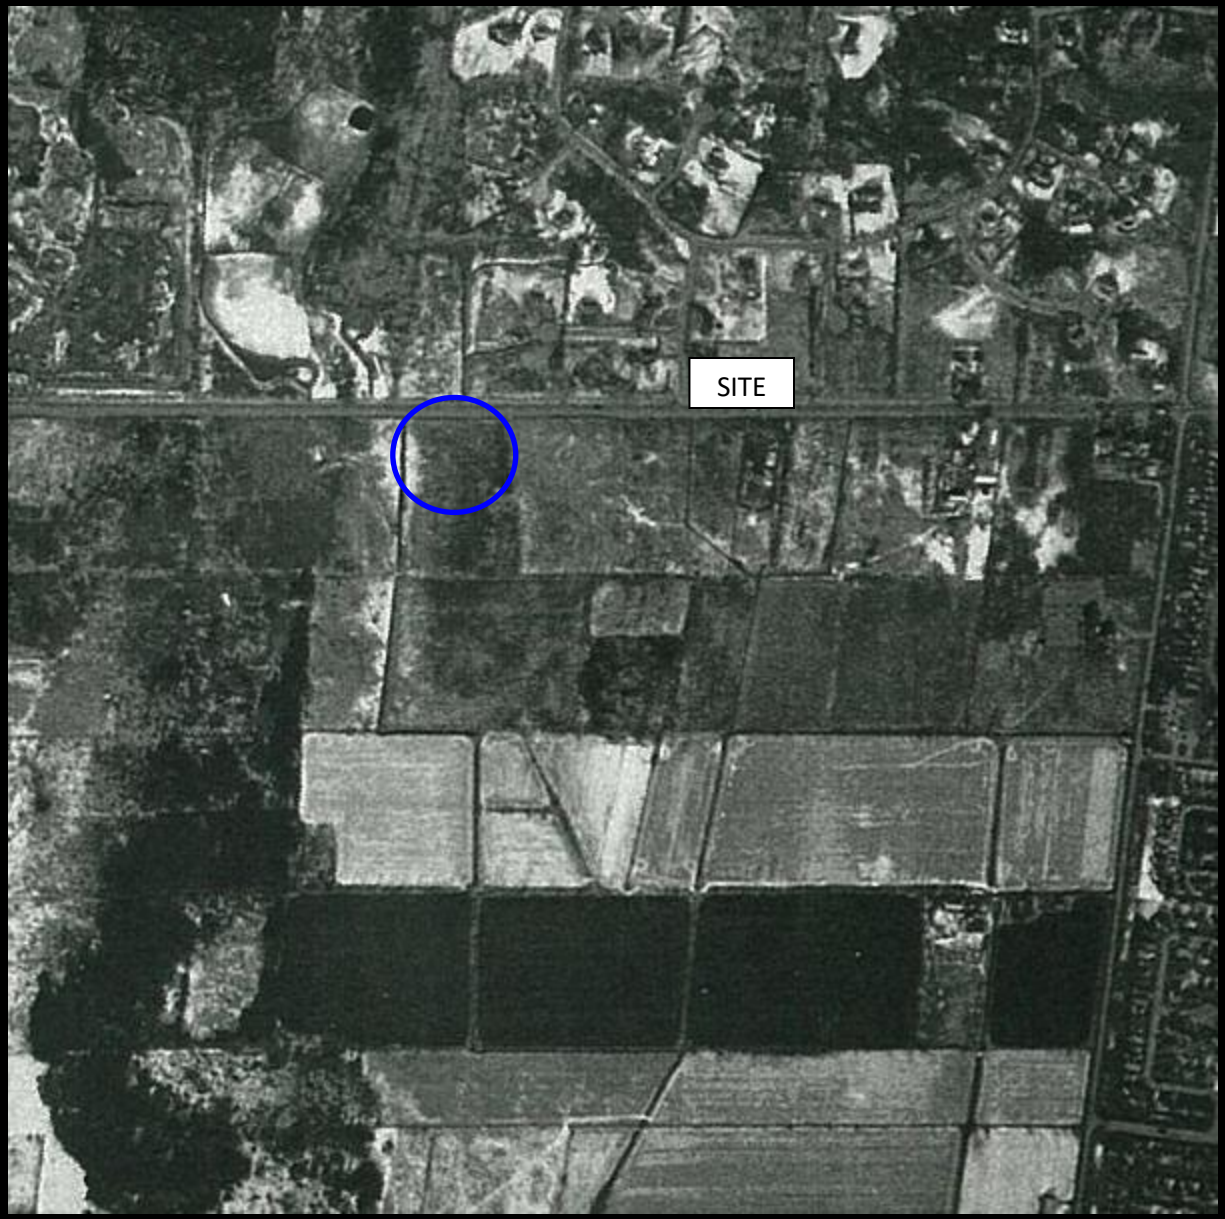
AERIAL PHOTOGRAPH
1988

| 1988 | Residential development is apparent to the north of Fallowfield Road and further east of the site. No significant changes have been made to the subject site or neighbouring properties to the south and west. |

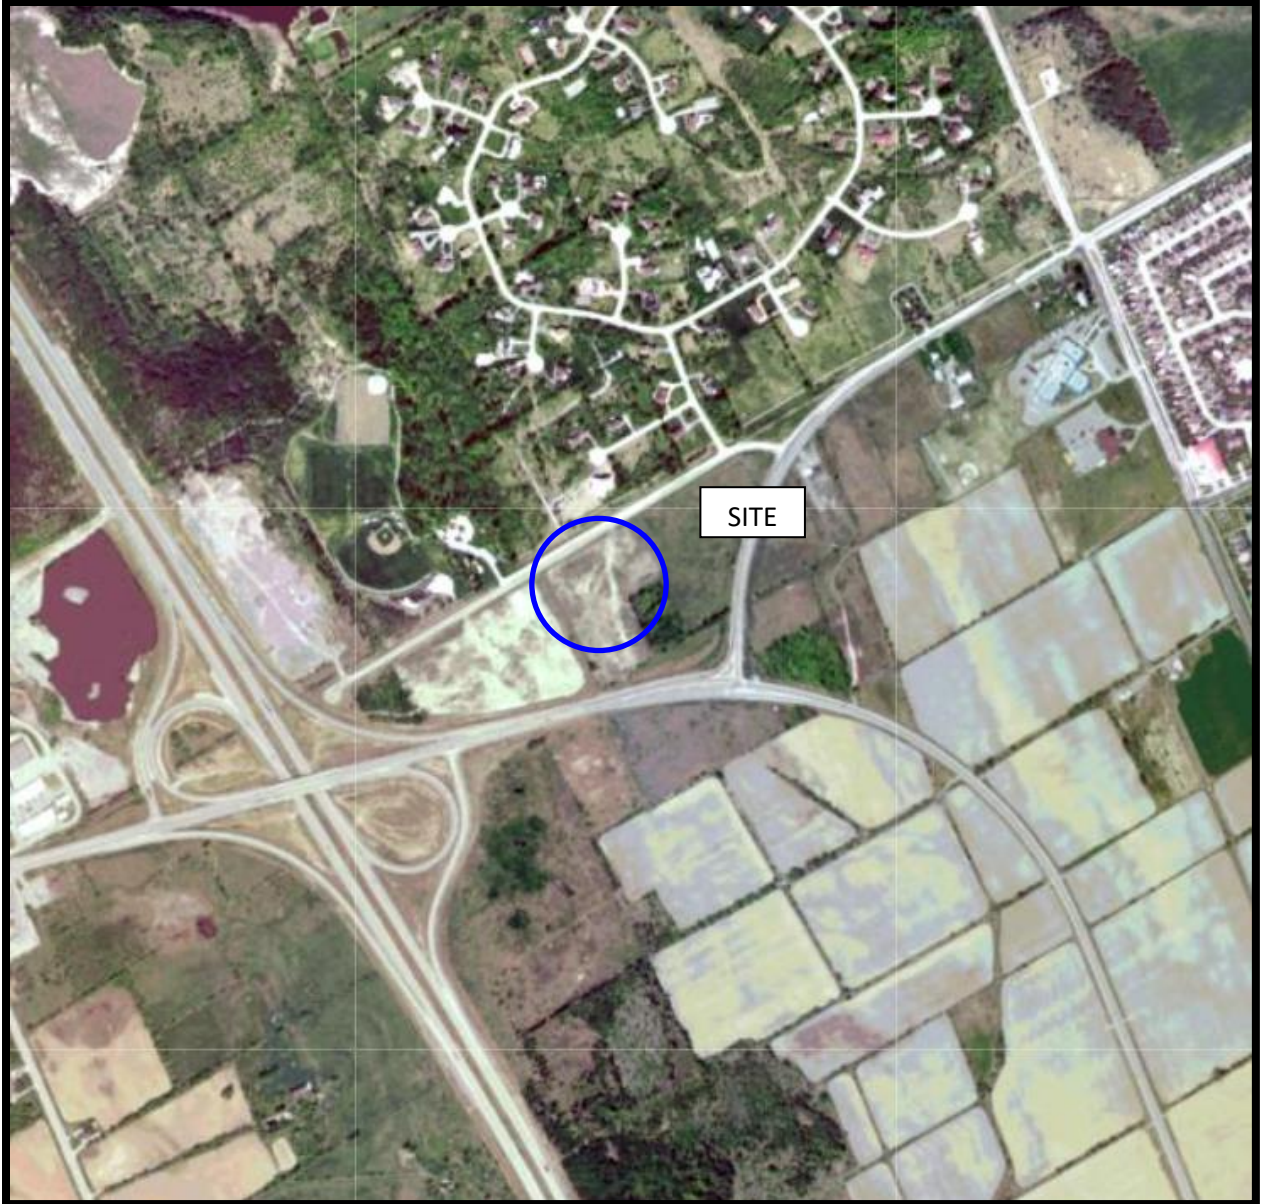
AERIAL PHOTOGRAPH
1999

| 1999 | Highway 416 was constructed further to the west of the subject site which resulted in the realignment of Fallowfield Road and Strandherd Drive. O'Keefe Drive is now present to the north of the subject site. Fill material has been placed on the subject site and the adjacent properties to the east, south and west. Additional residential development to the north has been constructed. |

Based on the findings of the Phase I - ESA, the subject site has received a significant quantity of imported fill material of unknown quality. It is recommended that a fill quality assessment be conducted for the subject site to assess the quality of the fill and determine any impact on future site development.

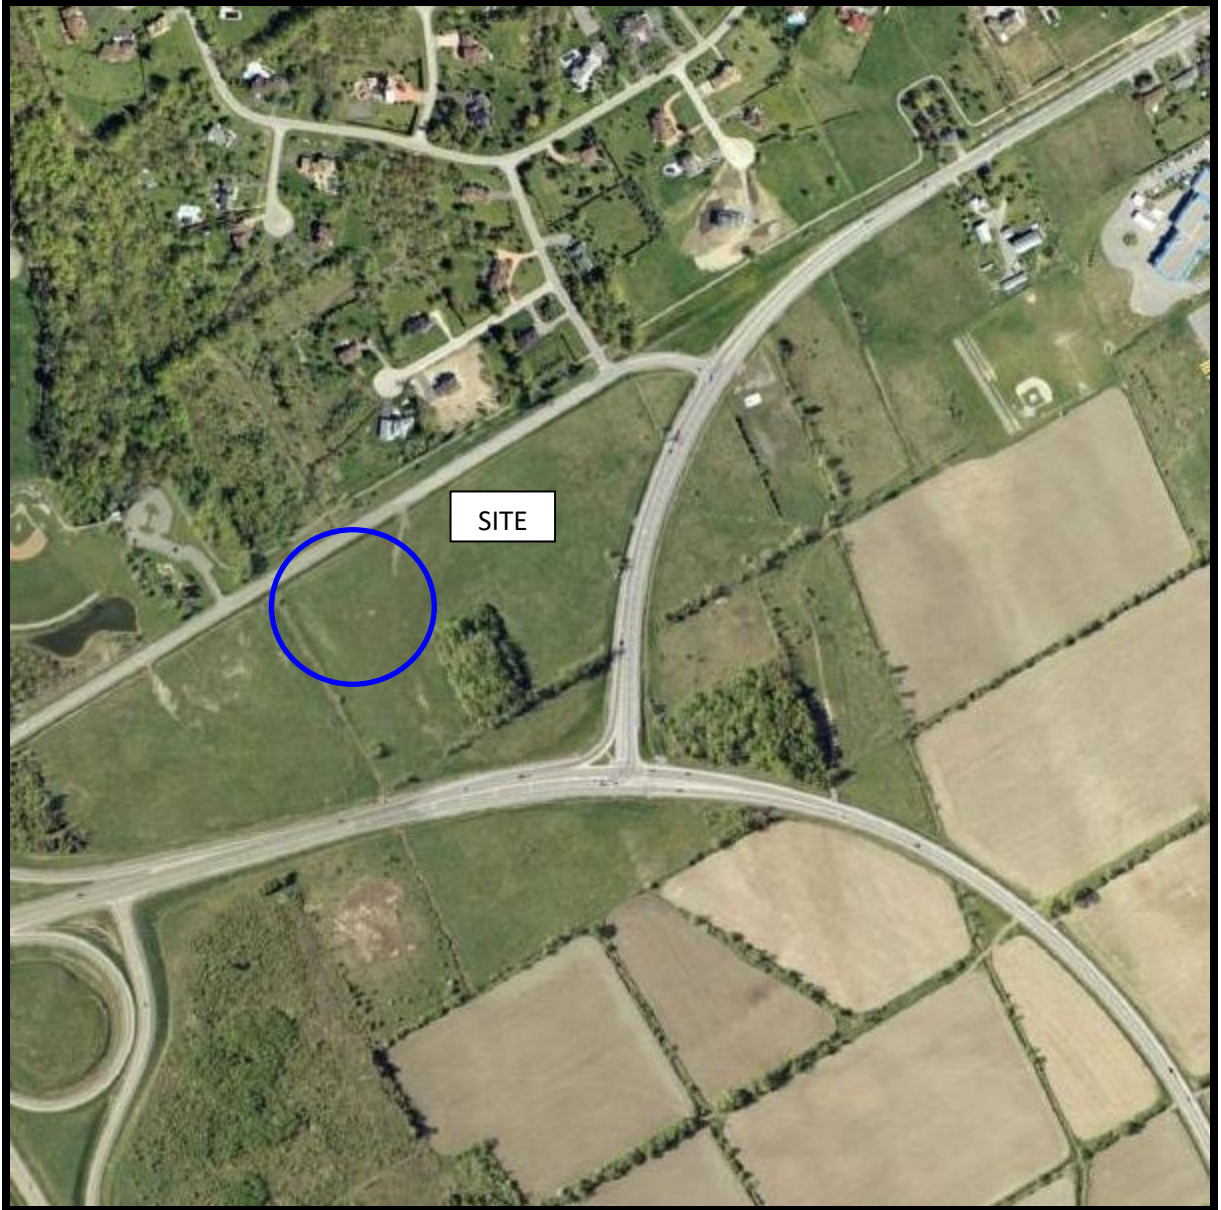
AERIAL PHOTOGRAPH
2002

| 2002 | Increased residential development is apparent to the north of O'Keefe Drive. The subject site appears vacant grassland. No significant changes have been made to the neighbouring properties. |

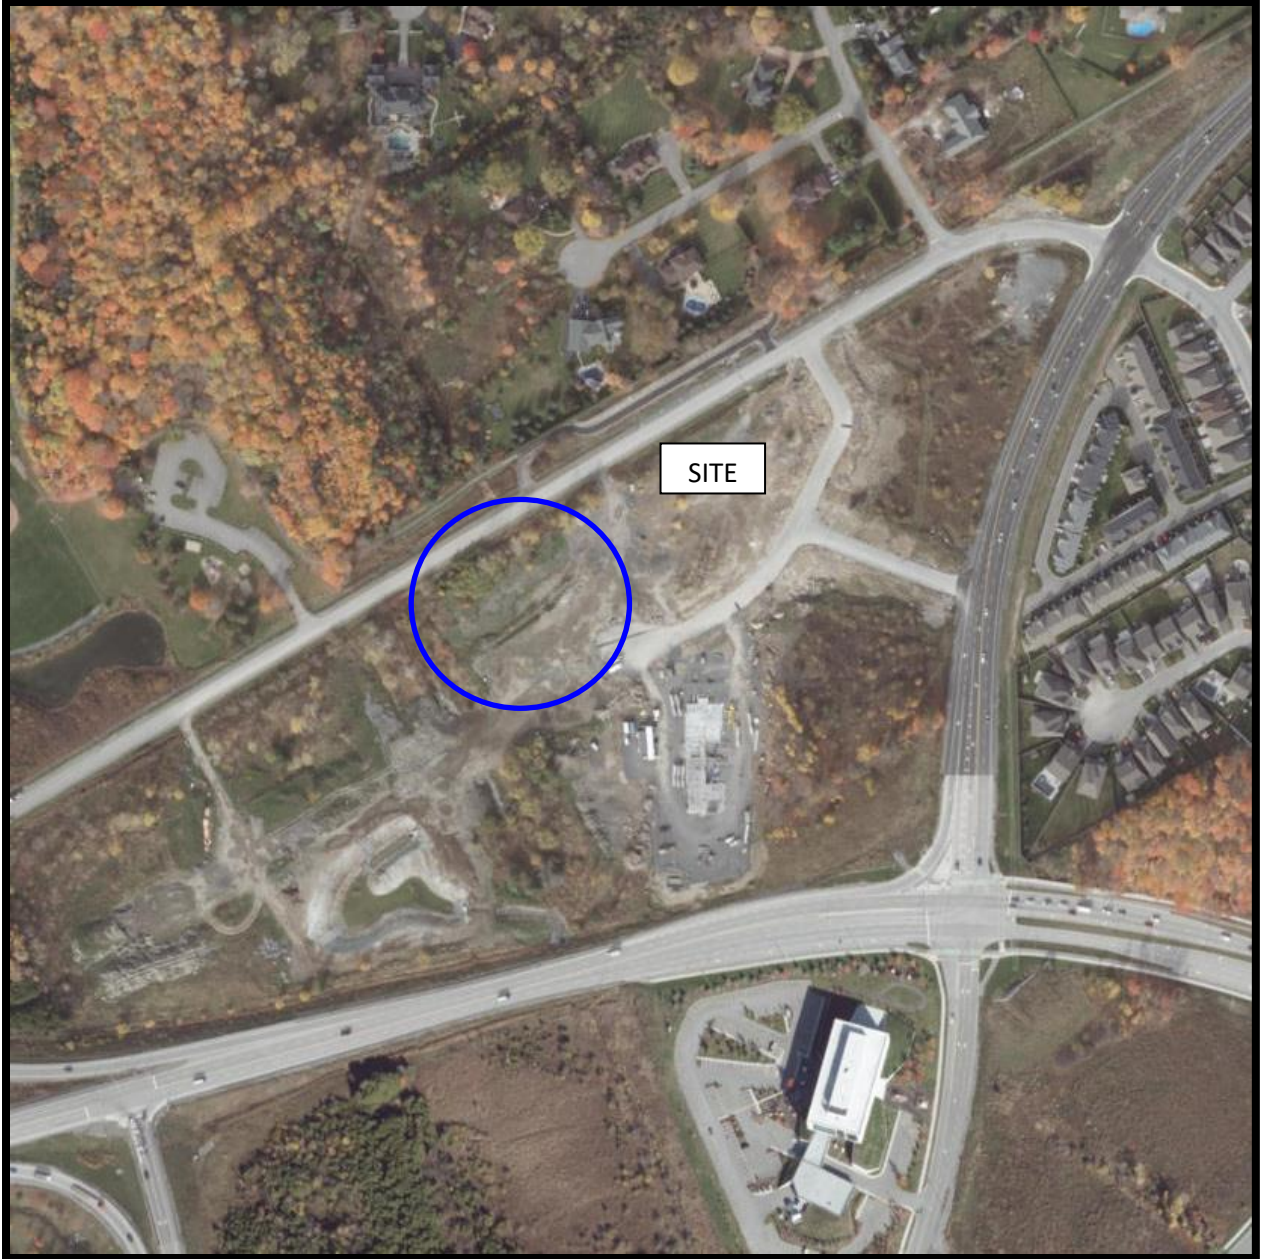
AERIAL PHOTOGRAPH
2019

2019 (City of Ottawa) Additional fill placement has occurred on site. Lusk Street is now present, while a commercial building is under construction to the southeast. A stormwater management pond appears to have been constructed to the southwest of the subject site. Residential development has been constructed further to the east and a commercial building has been constructed further to the south.
