**PATERSON
GROUP**

Phase II Environmental Site Assessment

150 and 160 Laurier Avenue
Ottawa, Ontario

Report: PE4822-2
October 25, 2022

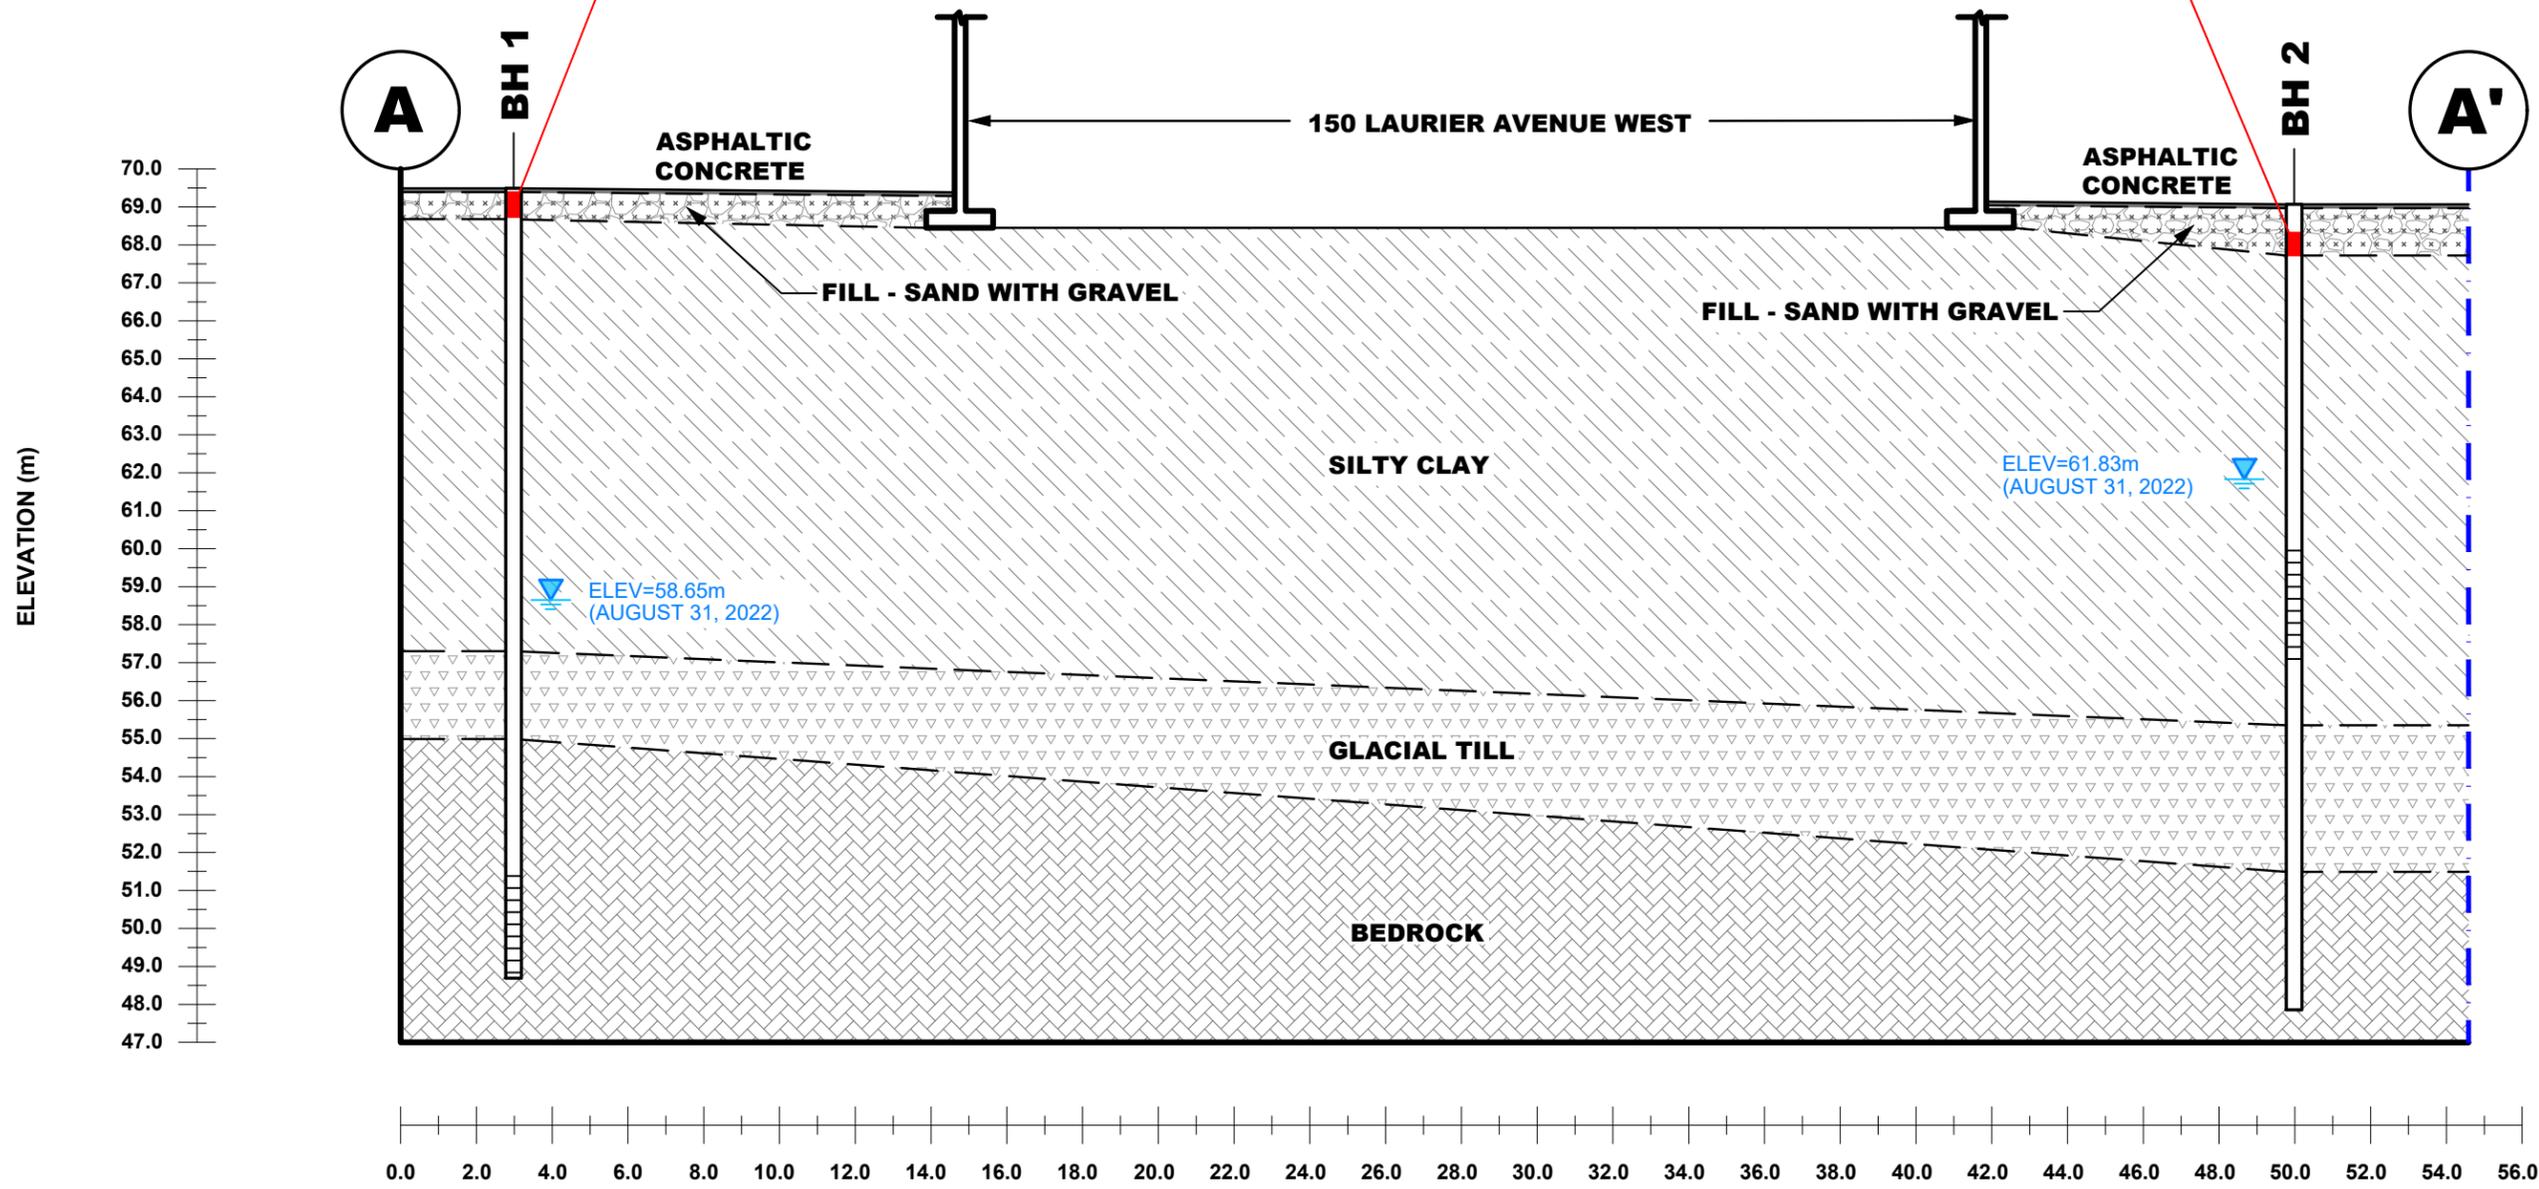
BH1-AU1	0.10-0.76m	09-JAN-2020
Parameter	Result(µg/g)	Standard(µg/g)
Lead	277	120
Remaining Metals, CrVI and Mercury comply with the MECP Table 3 Standards

BH2-SS2	0.76-1.37m	13-JAN-2020
Parameter	Result(µg/g)	Standard(µg/g)
Mercury	0.8	0.27
Vanadium	88.8	86
Remaining Metals and CrVI comply with the MECP Table 3 Standards

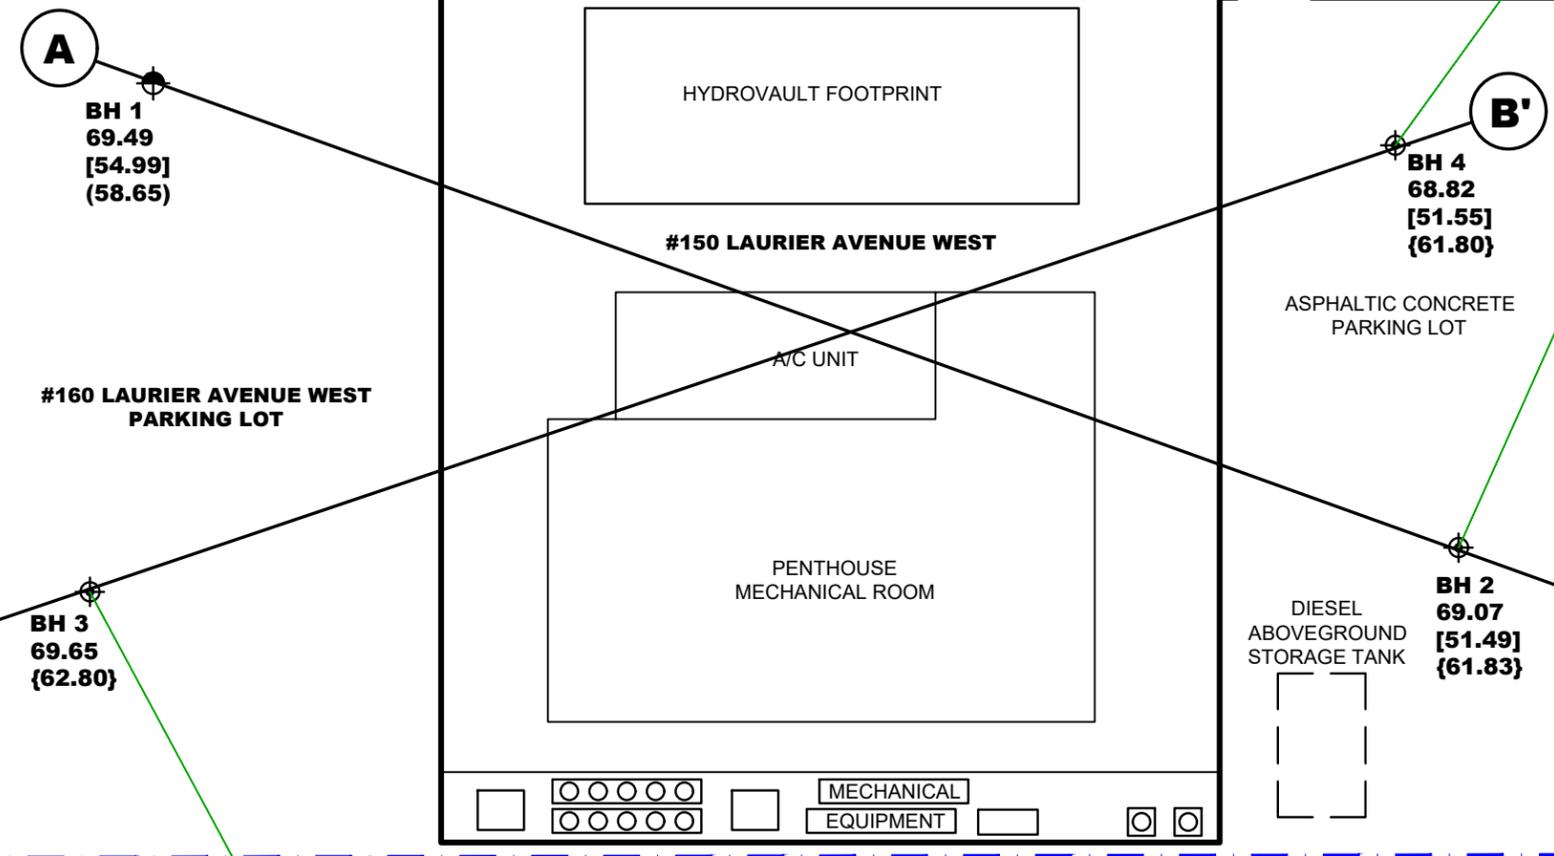
Scale:	1:250	Date:	10/2022
Drawn by:	YA	Report No.:	PE4822-2
Checked by:	JD	Dwg. No.:	PE4822-5
Approved by:	MSD	Revision No.:

BH2-SS8 7.62-8.23m 13-JAN-2020
 VOCs and PHCs comply with the MECP Table 3 Standards

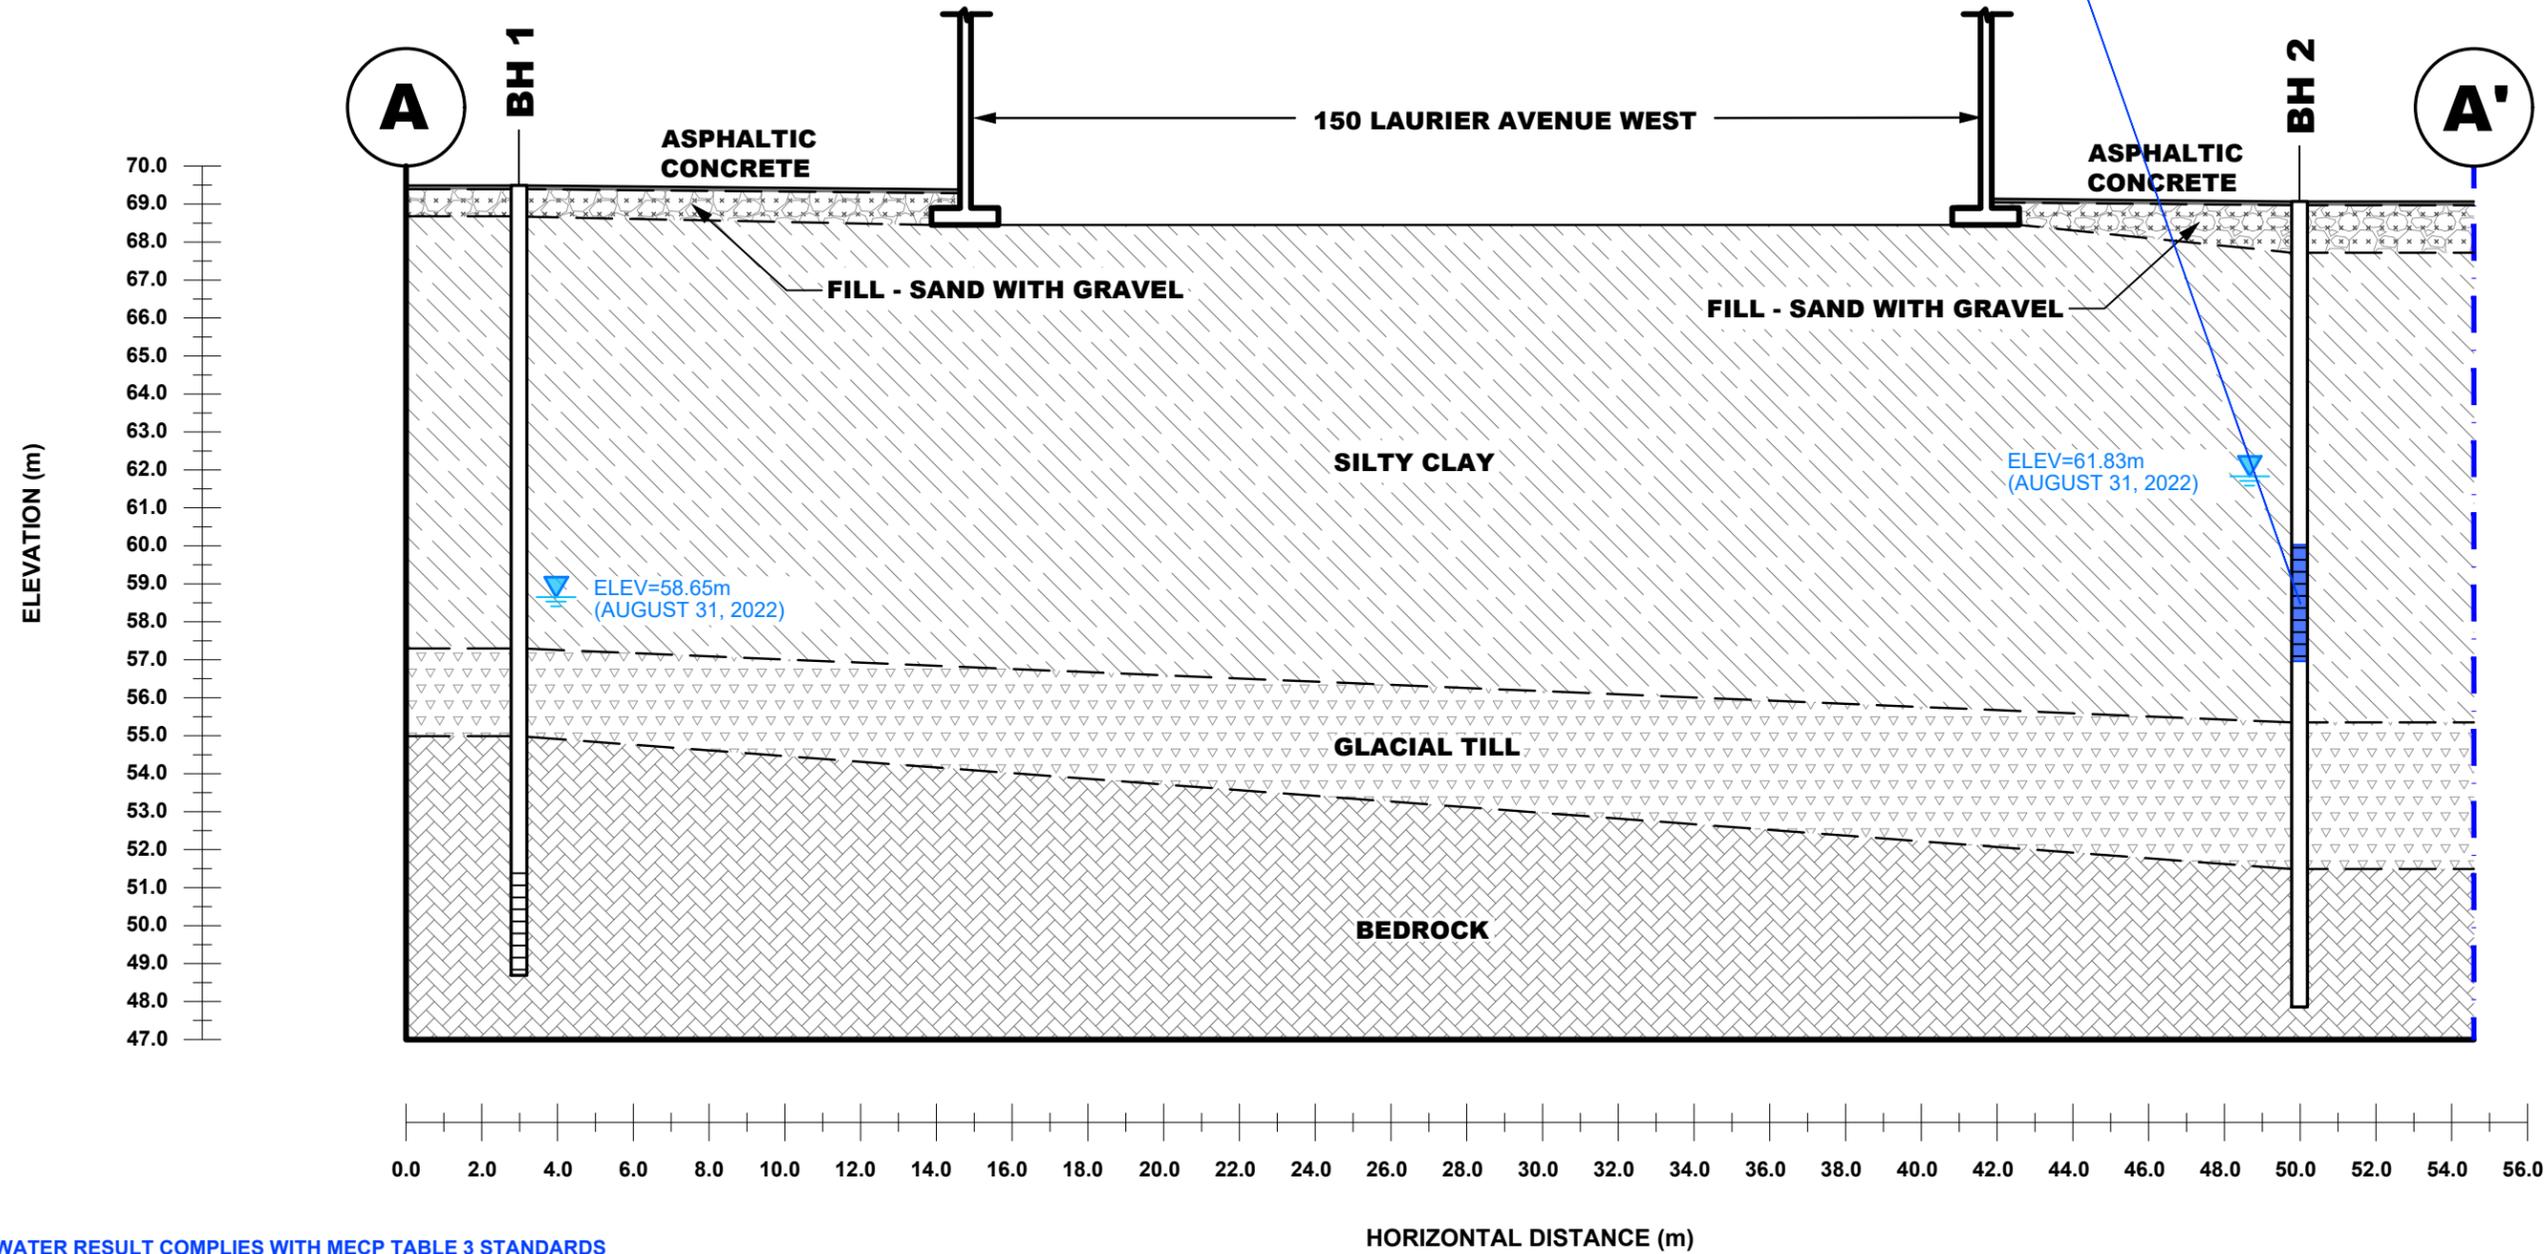
Scale:	AS SHOWN	Date:	10/2022
Drawn by:	YA	Report No.:	PE4822-2
Checked by:	JD	Dwg. No.:	PE4822-6A
Approved by:	MSD	Revision No.:

BH2-GW	9.04-12.11m	31-AUG-2022
Metals, CrVI and Mercury comply with the MECP Table 3 Standards		
BH2-GW	9.04-12.11m	31-AUG-2022
VOCs and PHCs comply with the MECP Table 3 Standards		
BH2-GW	9.04-12.11m	31-AUG-2022
PAHS comply with the MECP Table 3 Standards

Title: **CROSS SECTION A-A' - GROUNDWATER**
(METALS, CrVI, MERCURY, PCBs, VOCs, PHCs, PAHs)

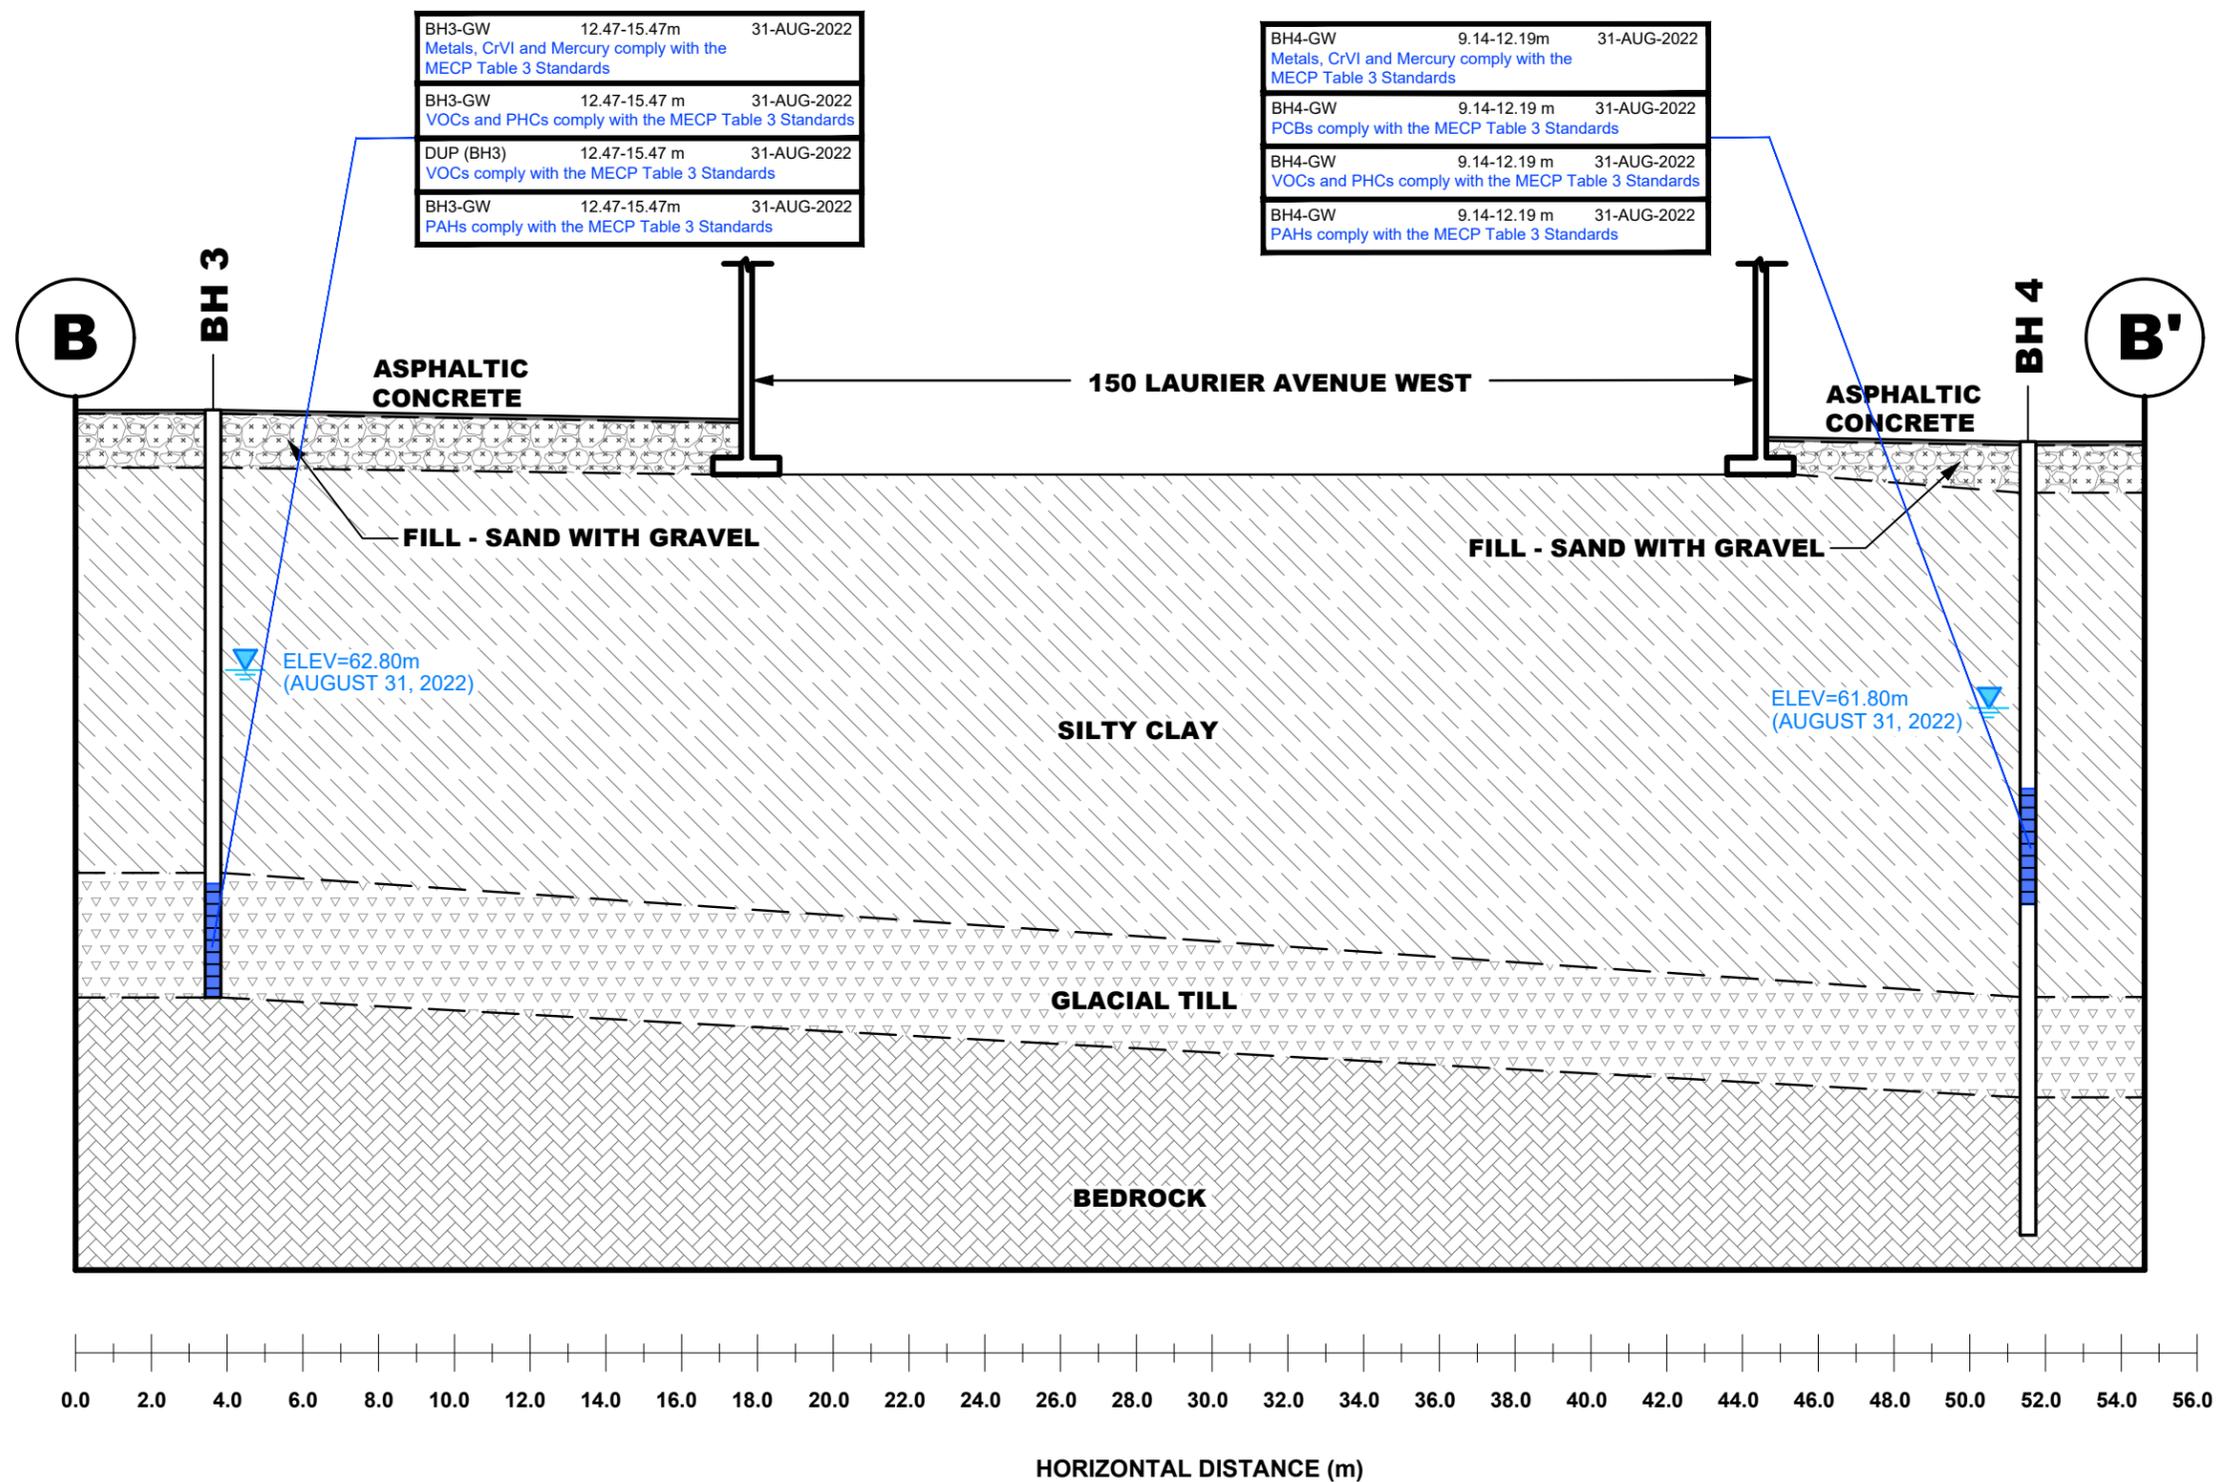
JADCO CORPORATION
PHASE II - ENVIRONMENTAL SITE ASSESSMENT
150 AND 160 LAURIER AVENUE WEST
 OTTAWA, ONTARIO
 Title: **CROSS SECTION B-B' - GROUNDWATER**
(METALS, CrVI, MERCURY, PCBs, VOCs, PHCs, PAHs)

BH3-GW	12.47-15.47m	31-AUG-2022
Metals, CrVI and Mercury comply with the MECP Table 3 Standards		
BH3-GW	12.47-15.47 m	31-AUG-2022
VOCs and PHCs comply with the MECP Table 3 Standards		
DUP (BH3)	12.47-15.47 m	31-AUG-2022
VOCs comply with the MECP Table 3 Standards		
BH3-GW	12.47-15.47m	31-AUG-2022
PAHs comply with the MECP Table 3 Standards

BH4-GW	9.14-12.19m	31-AUG-2022
Metals, CrVI and Mercury comply with the MECP Table 3 Standards		
BH4-GW	9.14-12.19 m	31-AUG-2022
PCBs comply with the MECP Table 3 Standards		
BH4-GW	9.14-12.19 m	31-AUG-2022
VOCs and PHCs comply with the MECP Table 3 Standards		
BH4-GW	9.14-12.19 m	31-AUG-2022
PAHs comply with the MECP Table 3 Standards
