Phase I - Environmental Site Assessment

201 Friel Street
Ottawa, Ontario

Ottawa Community Housing Corporation

Report: PE4033-1

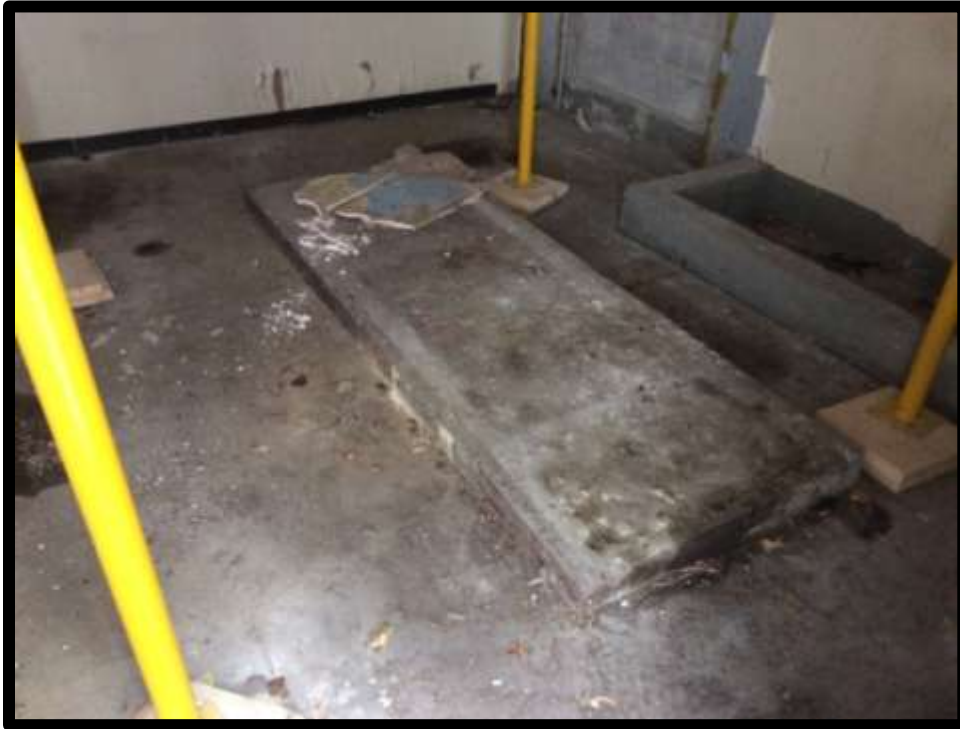
Photograph 1: View of former generator room. The concrete slab and berm are evidence of the former generator and tank locations. Concrete was observed to be in good condition with minimal staining.

Patched holes (evidence of vent/fill lines) were noted on the western wall of the garage, at the former generator room. No staining was observed around the exterior of the former generator room. The former generator room contained a concrete lip, considered to formerly house an interior aboveground storage tank (AST) and an elevated concrete pad, considered to be the former location of the

diesel generator. The concrete floor in the former generator room appeared to be in good condition with very little staining. No concerns were identified with regard to the former use of the former standby diesel generator system at the subject property.

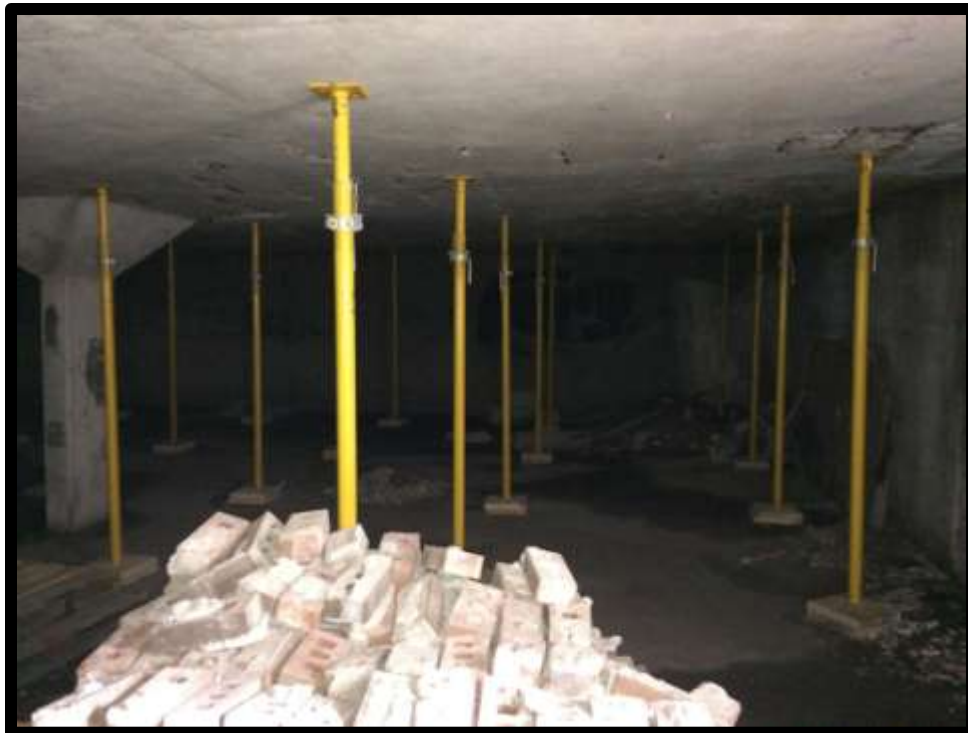
Photograph 2: View of interior of lower portion of the parking structure, facing east from the western portion of the structure. Some debris and bricks are present in the foreground.

At the time of the site visit, the garage was condemned and slated for demolition. Supplemental support of the upper level was provided by an array of jackposts in the lower level. Piles of brick and some building materials were observed in the stored in lower level.

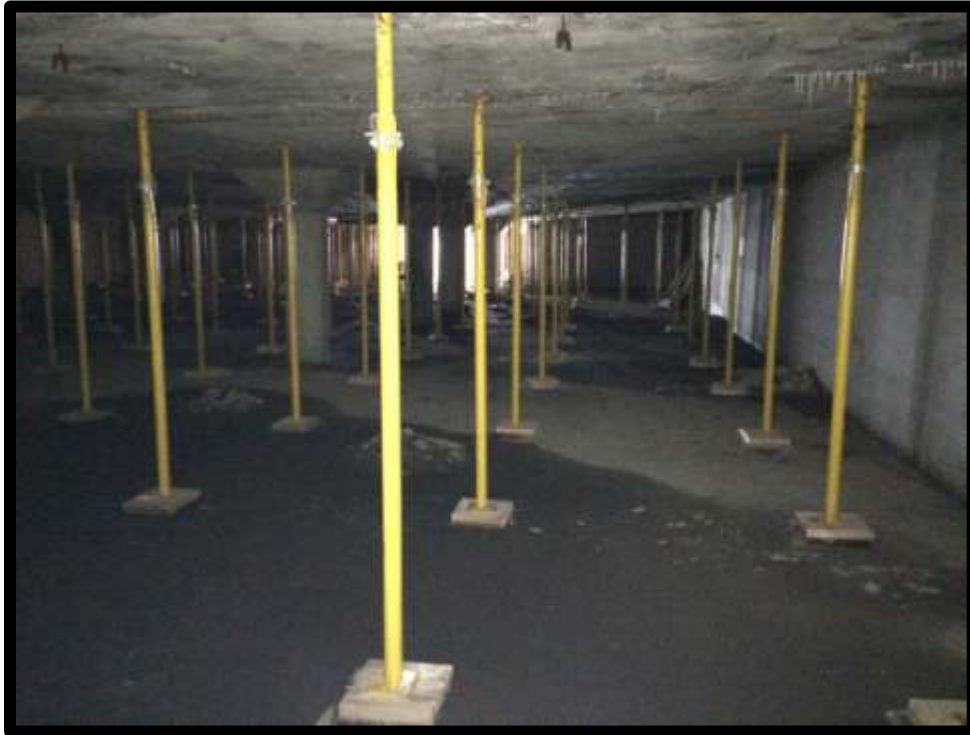
Photograph 3: View of the interior of the lower level of the parking structure. Facing west from the eastern end of the structure.

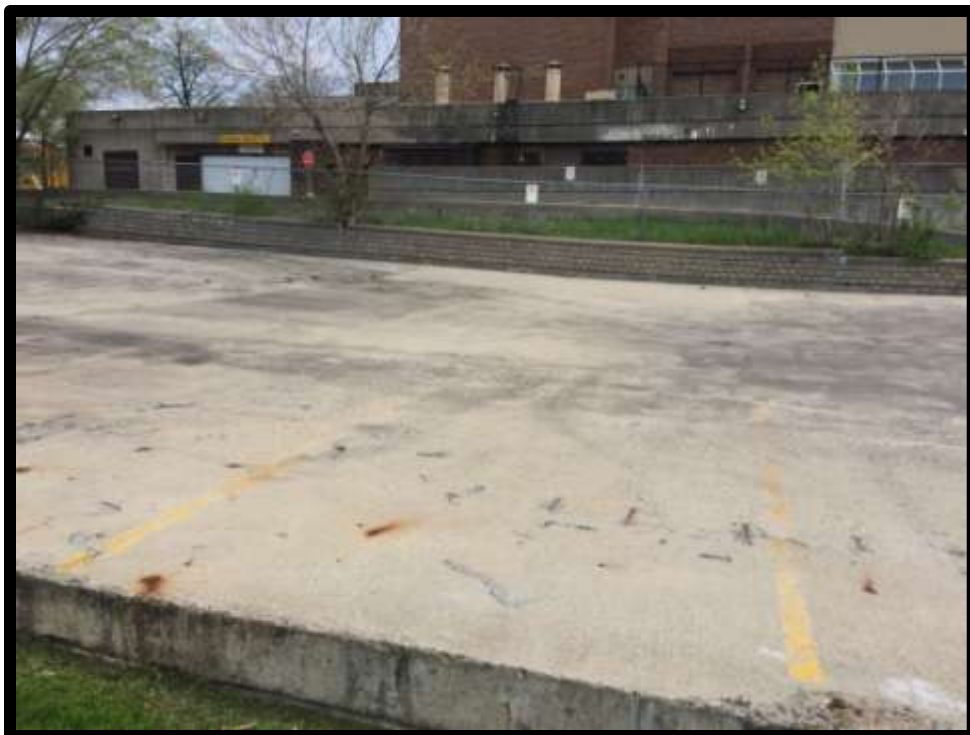
Photograph 4: View of upper level of the parking structure, facing south from the north side of the property.

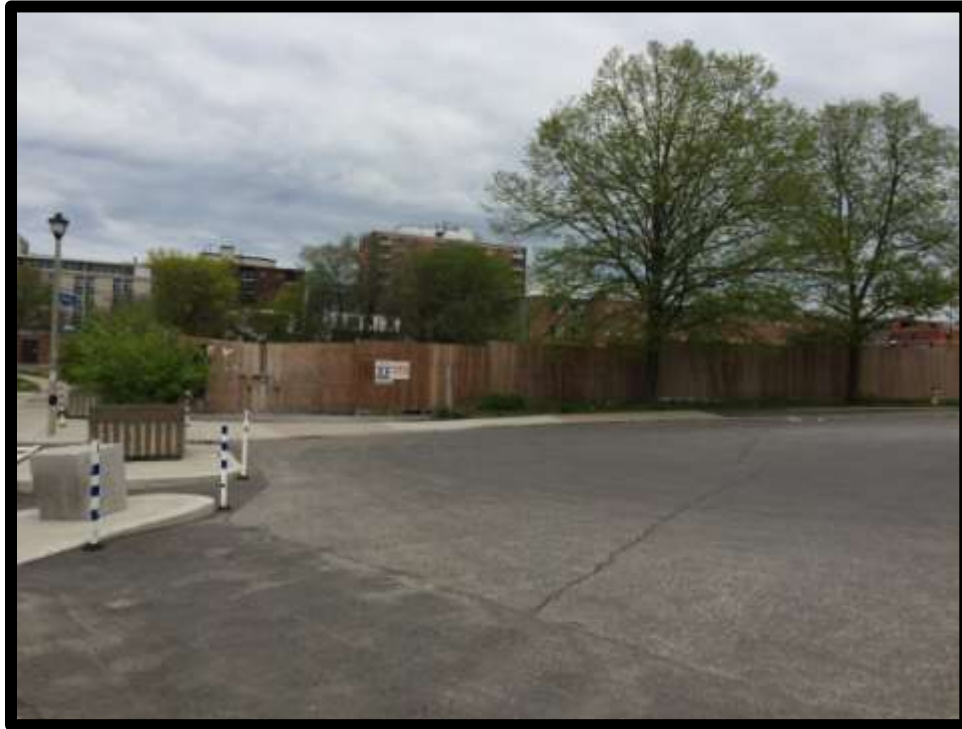
Photograph 5: View of neighbouring property to the west, across Chapel Street. The property is undergoing redevelopment.

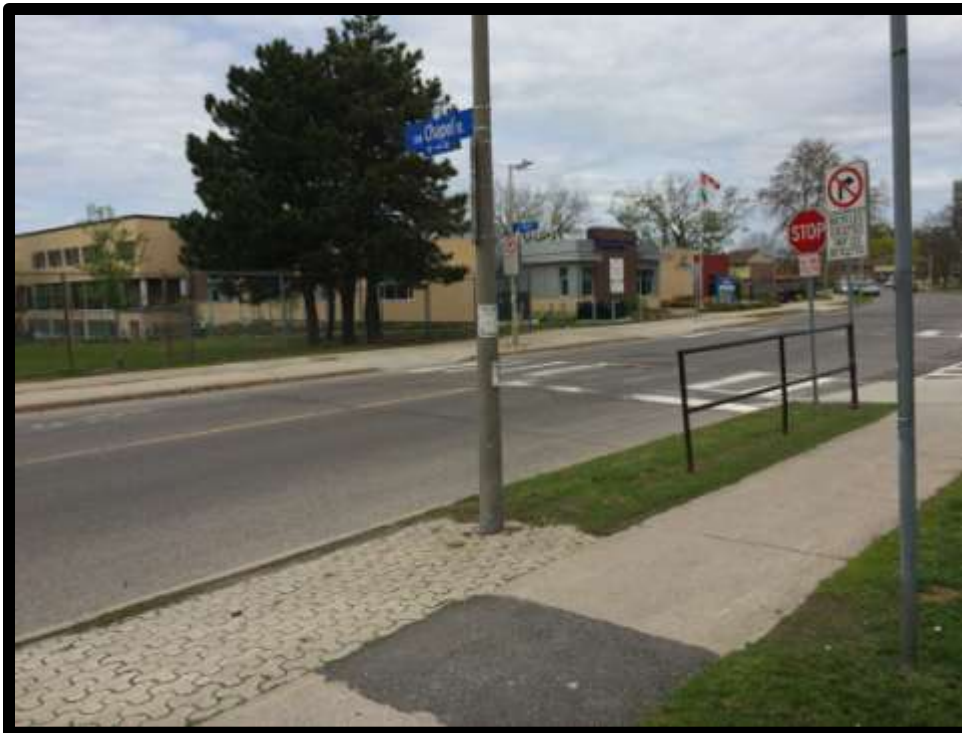
Photograph 6: View of neighbouring properties to the northeast, occupied by school buildings.

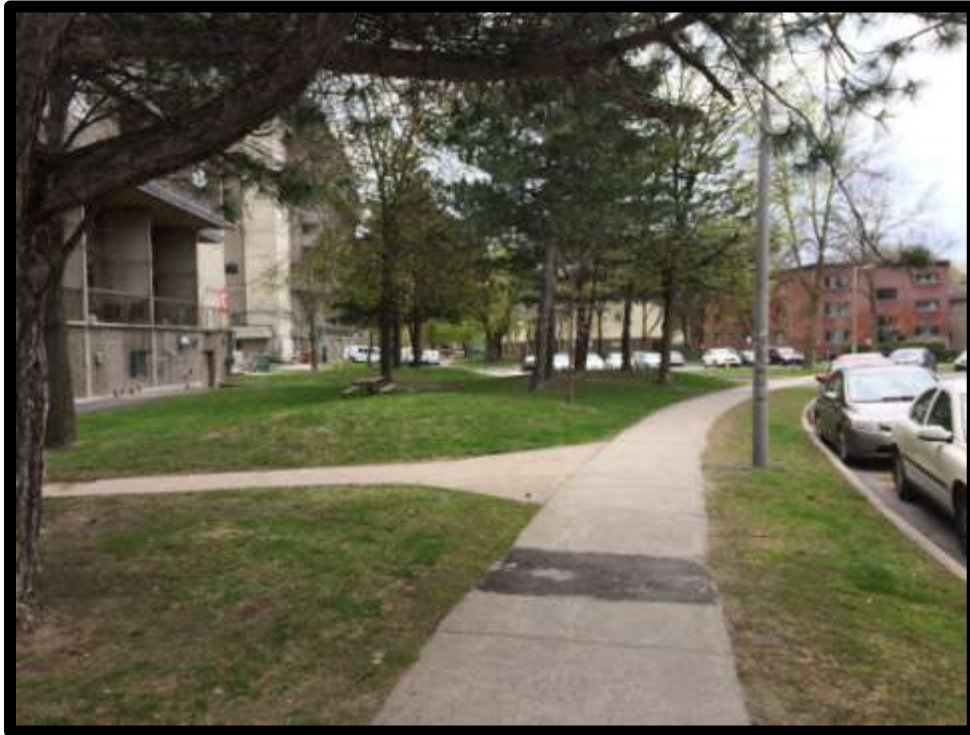
Photograph 7: View of neighbouring properties to the west, from the northwest corner of the property. Neighbouring properties are occupied by residential apartments and townhomes further to the northwest.

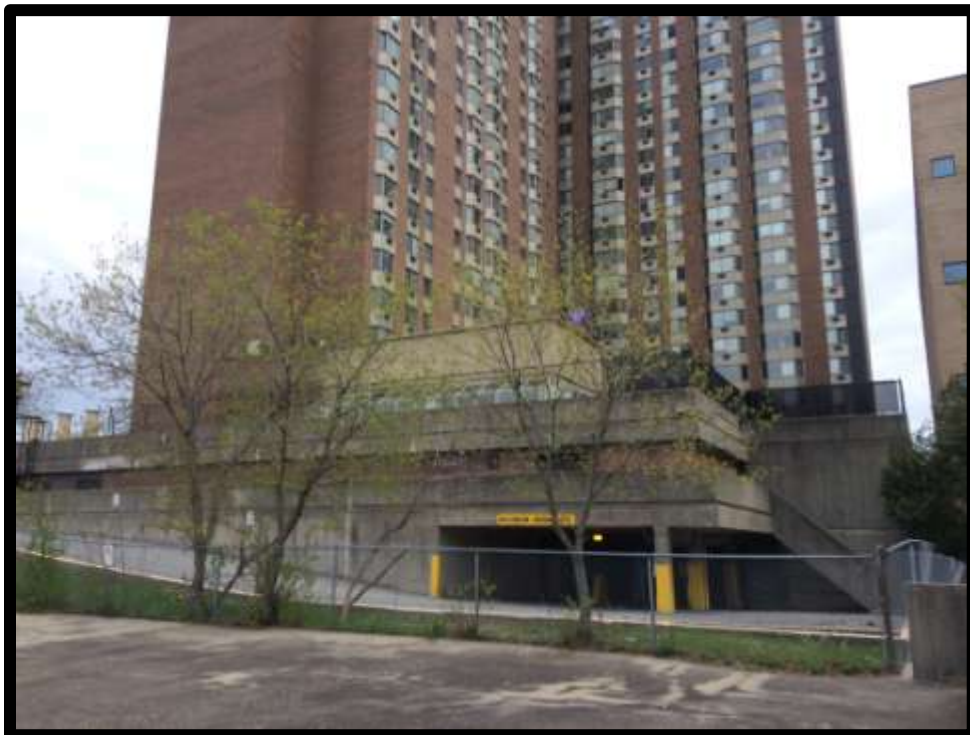
Photograph 8: View of neighbouring property to the south, occupied by a residential apartment tower with an underground parking structure.
