Muncaster
Environmental
Planning Inc.

**RE: 1540 Star Top Road, Gloucester
Environmental Impact Study**

ENVIRONMENTAL IMPACT STATEMENT

**1540 Star Top Road
Gloucester, City of Ottawa**

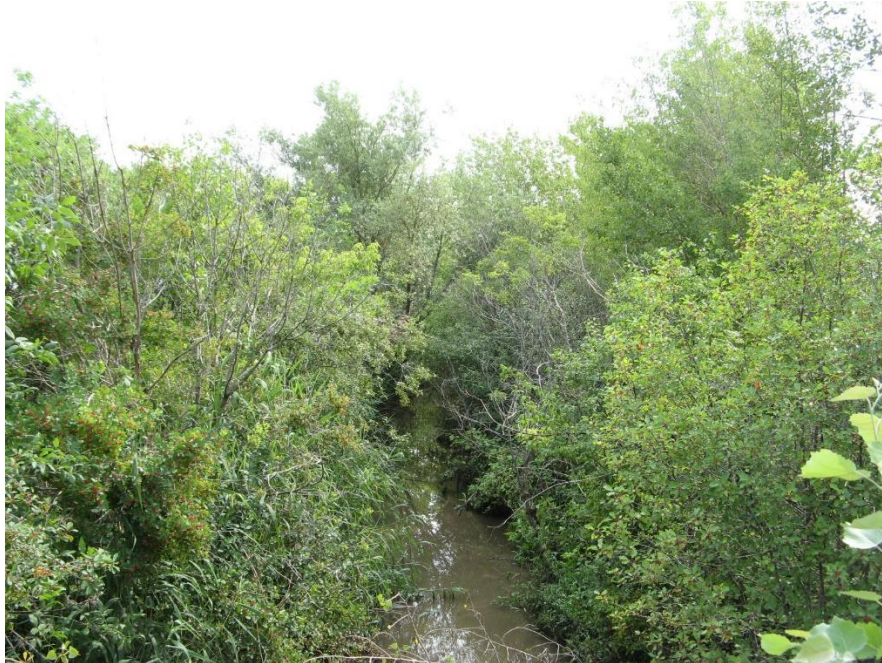
The wetted width of the South Cyrville Municipal Drain is between 2.5 and 3.5 metres. The water on July 11th was turbid (Photo 1). The canopy cover from an adjacent upland poplar deciduous forest is good in many areas. Small woody debris provides some instream habitat structure but there was no evidence of boulders, other coarse material, notable areas of aquatic vegetation, or undercut banks. The channel is straight with connecting sharp turns to the west of the site and as described above is open for approximately 750 metres.

*Photo 1 - South Cyrville Municipal Drain immediately to the north of the site.
View looking east from the northwest entrance to the site*

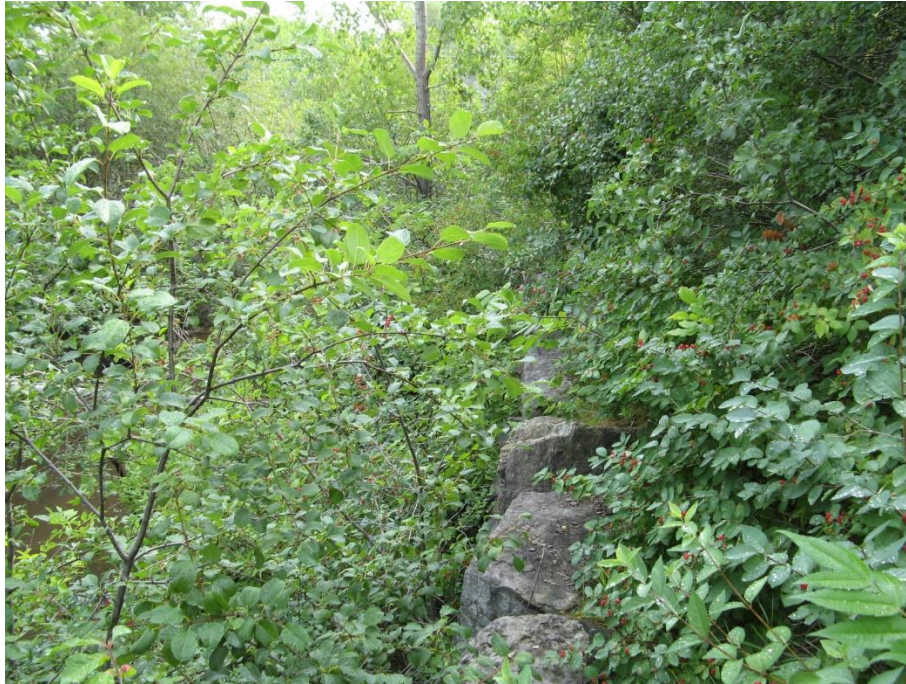
A retaining wall of large boulders is along the top of slope of both sides of the channel corridor (Photo 2). There is a setback of 7.5 metres from the retaining wall to the north edge of the site. Trembling aspens up to 30 cm diameter at breast height (dbh) are dominant in the setback, along with smaller green ash and Manitoba maple (Photos 3 and 4). The understory in the setback area is thick in most areas, with glossy buckthorn dominant in areas and staghorn sumac, red-osier dogwood, and tartarian honeysuckle common, along with regenerating stems of poplar, ash, and Manitoba maple. A chain-link fence is around the north and south edges of the channel setback and two surface connections crossing the channel between 1282 Algoma Road and the site (Photo 4). A gate in the fencing between the two crossing along the north site boundary provides access to the corridor, including for the plantings recommended below.

Photo 2 – South side of the Municipal Drain corridor to the north of the site, with large boulder retaining wall. View looking east, with site beginning 7.5 metres from wall

Although much less than a typical setback, a setback of 7.5 metres from the retaining wall top of slope to the south edge of the riparian corridor is considered suitable due to the highly disturbed nature of the channel, including limited exposed reaches, straight alignment that was excavated and associated artificial cross-section. The 7.5 metres setback is greater than that provided for other open sections of the Drain to the west of the site. The drain is enclosed to the east of Star Top Road.

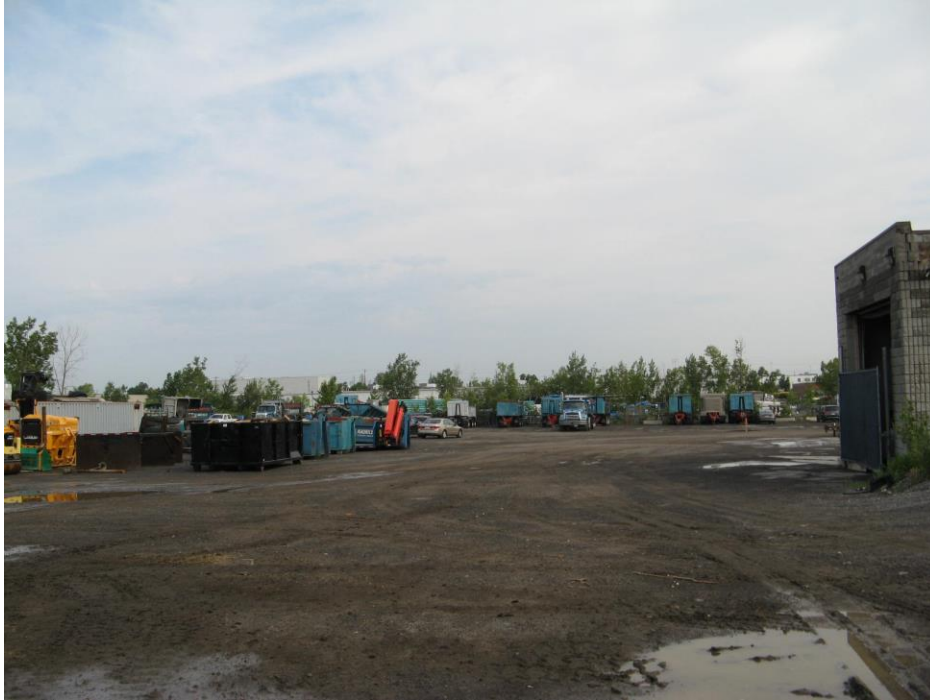
The site is dominated by fill material with a generally level topography (Photo 6). Paterson (2023) identified crushed stone, topsoil, brown silty sand, trace clay and occasional gravel in the fill. Bedrock consisting of black shale was noted by Paterson (2023) at depths ranging between approximately 1.9 to 2.9 metres below grade. Similarly, Paterson (2023) observed groundwater depths between approximately 1.9 and 2.9 metres below the existing ground surface, with groundwater flow generally in a northern direction.

Photo 6 – West portion of the site looking north from south edge

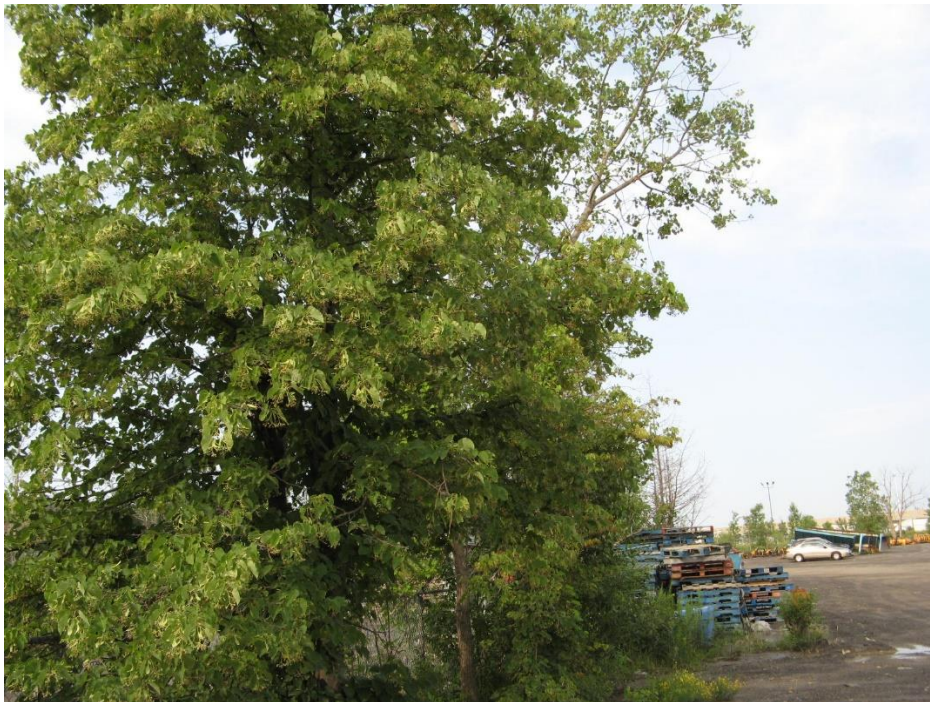
Scattered regenerating deciduous trees are along portions of the site boundaries and these areas are referred to as intermittent deciduous hedgerows on Figure 1. Trembling aspens are dominant, with eastern cottonwood well represented and green ash, white elm, and linden also present (Photo 7). Regenerating poplar, birch, ash, linden, and white poplar stems are among the intermittent hedgerow trees, along with staghorn sumac, Bebb's willow, red-osier dogwood, tartarian honeysuckle, and glossy buckthorn shrubs. The largest trees in the intermittent hedgerows are cottonwood and trembling aspen up to 32cm dbh. Many of the white elms are dead and leaf-out is greatly reduced on many of the poplars. The larger eastern cottonwoods along the west ditch appear dead as well. Wild grape coverage is common on the lower portions of some of the trees.

Photo 7 – Cottonwood along southeast boundary of the site. View looking west

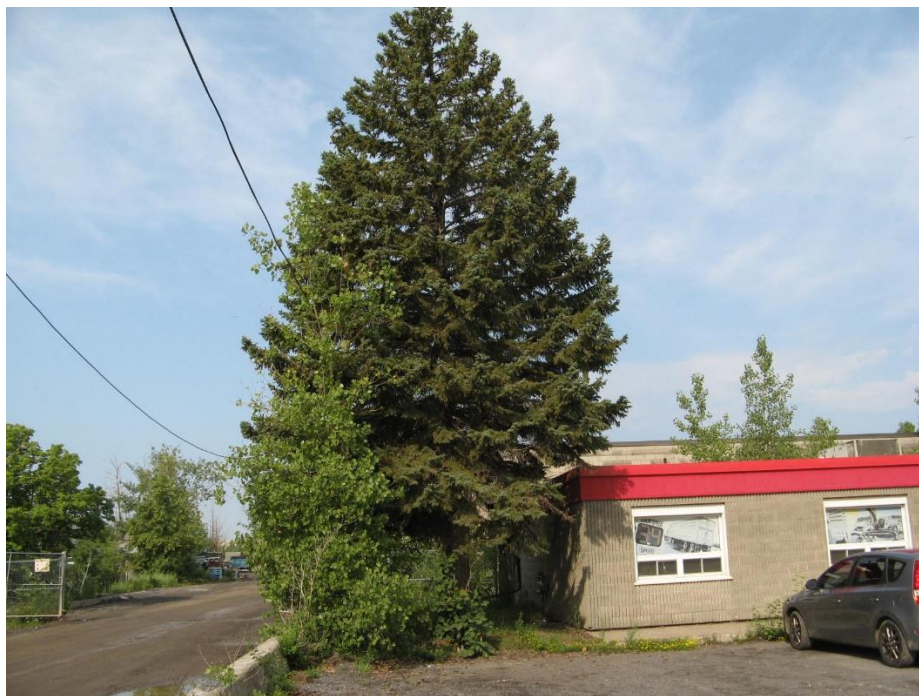
A twin-stem bur oak, with individual stems up to 30cm dbh and a 48cm dbh white spruce are adjacent to the existing office building west of Star Top Road (Photo 8).

Photo 8 – White spruce in the east portion of the site, west of Star Top Road was the largest tree observed on or adjacent to the site. View looking west

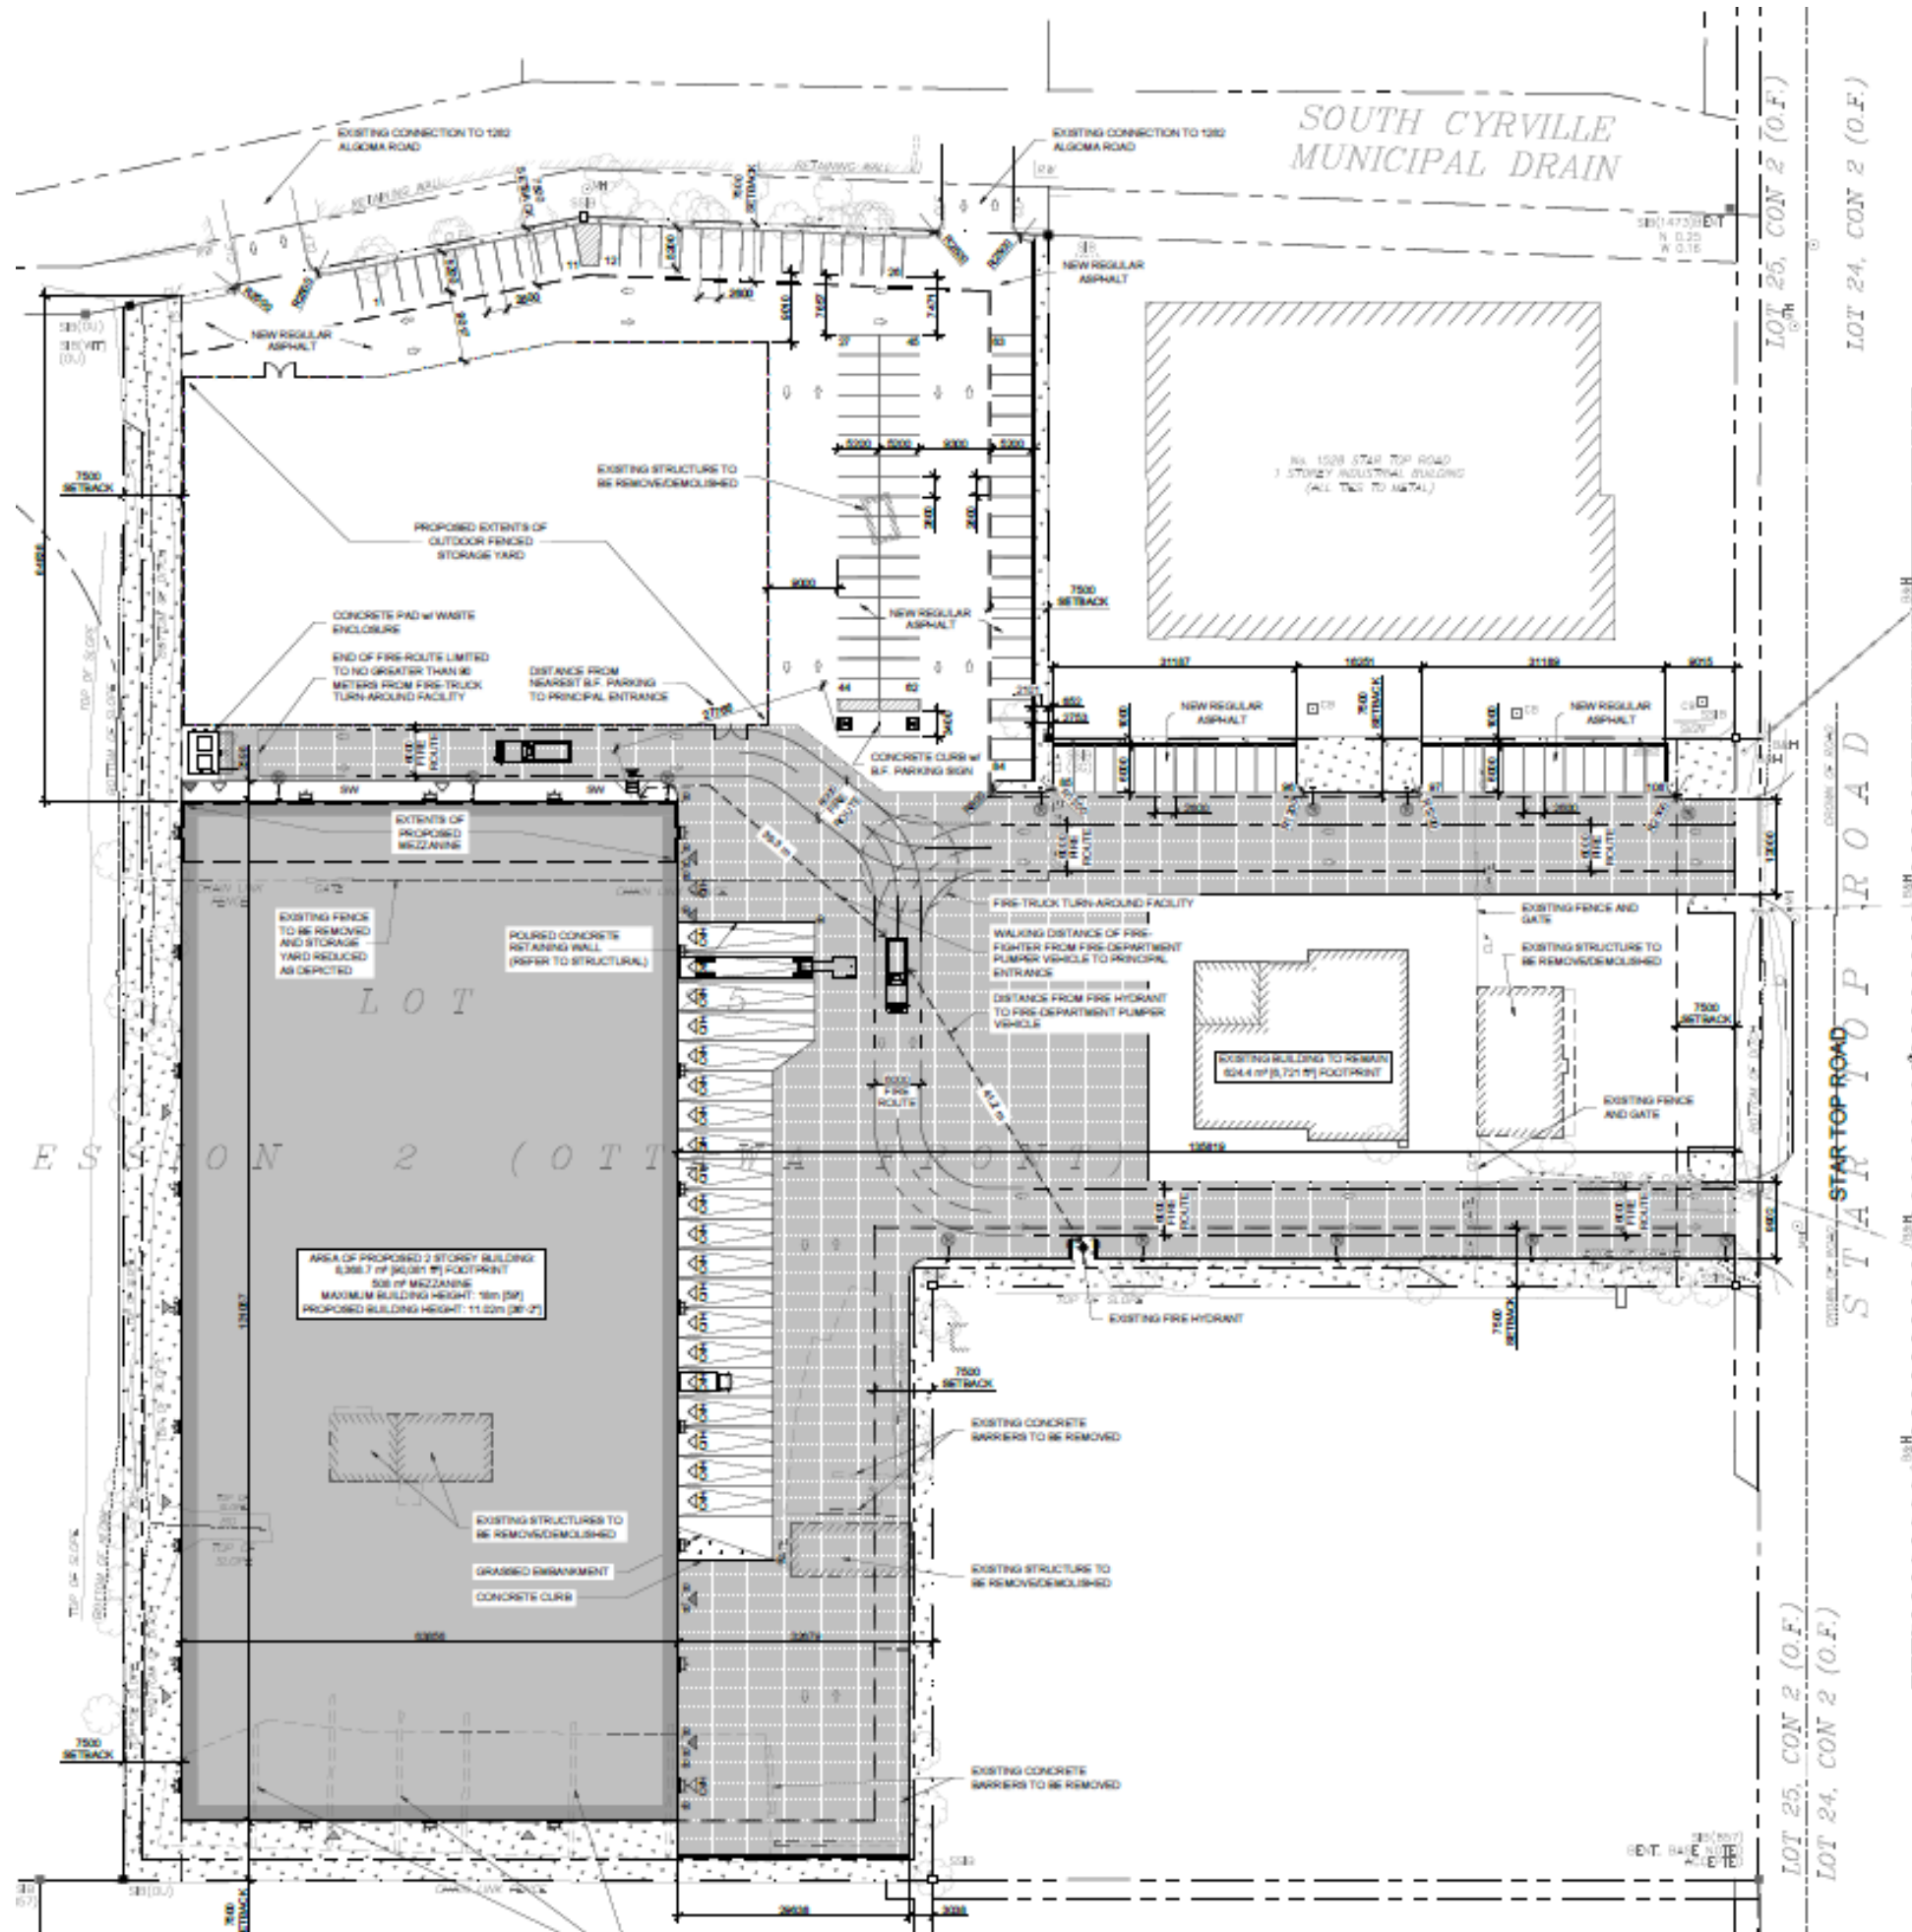
FIGURE 2 – SITE PLAN (by Deimling Architecture & Interior Design)

It is proposed to construct a two storey building in the west portion of the site, with a footprint of approximately 90,000 sq ft (Figure 2). This building will be on mostly existing surface storage, with two small structures to be removed. There are two existing buildings in the east portion of the site. The smaller one closer to Star Top Road will be removed, with the one to the west, approximately 6,700 sq ft., to be retained. One-hundred and eight surface parking spaces will be provided, with the balance of the site to be used for access and an outdoor fenced storage yard.
