TO: Josiane Gervais, P.Eng – Project Manager, Infrastructure Approvals
FROM: Adam Howell, P.Eng.
SUBJECT: 1083 Merivale Road – Transportation Safety Memo
DATE: October 23, 2023

This transportation safety memo has been prepared in support of the Site Plan Control Application for the proposed development at 1083 Merivale Road. The site currently includes a vacated single-family detached house. The proposed redevelopment of the site is for the construction of a multi-storey residential care facility with 53 units, cafeteria, kitchen and programming space as well as a basement facility to be utilized by the Shepherds of Good Hope.

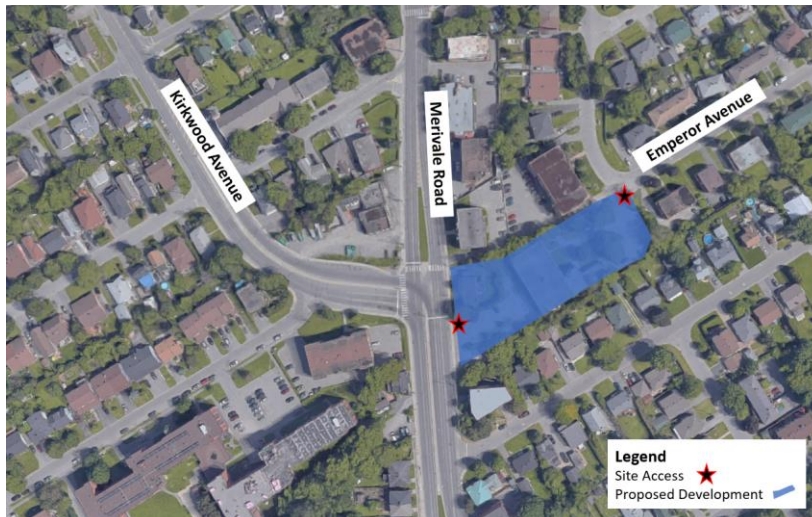
Figure 1: Location of Proposed Development (Source: Google Maps)

The proposed development, shown in **Figure 1**, is located on Merivale Road at the Kirkwood Avenue intersection. The development will share a parking lot with the existing building at 1095 Merivale Road that is accessible by Emperor Avenue. Additionally, the development will be accessible by an existing driveway on Merivale Road.

The access on Merivale Road is less than 5m south of the stop line on the southern leg of the Merivale/Kirkwood intersection. The access is a right-in/right-out, does not connect to the parking lot on Emperor Avenue and will be used by delivery trucks and as a fire route only. It is anticipated that up to two food/supply deliveries will be made per day, generally between 8 a.m. and noon. The site plan for the proposed development can be found in **Appendix B**.

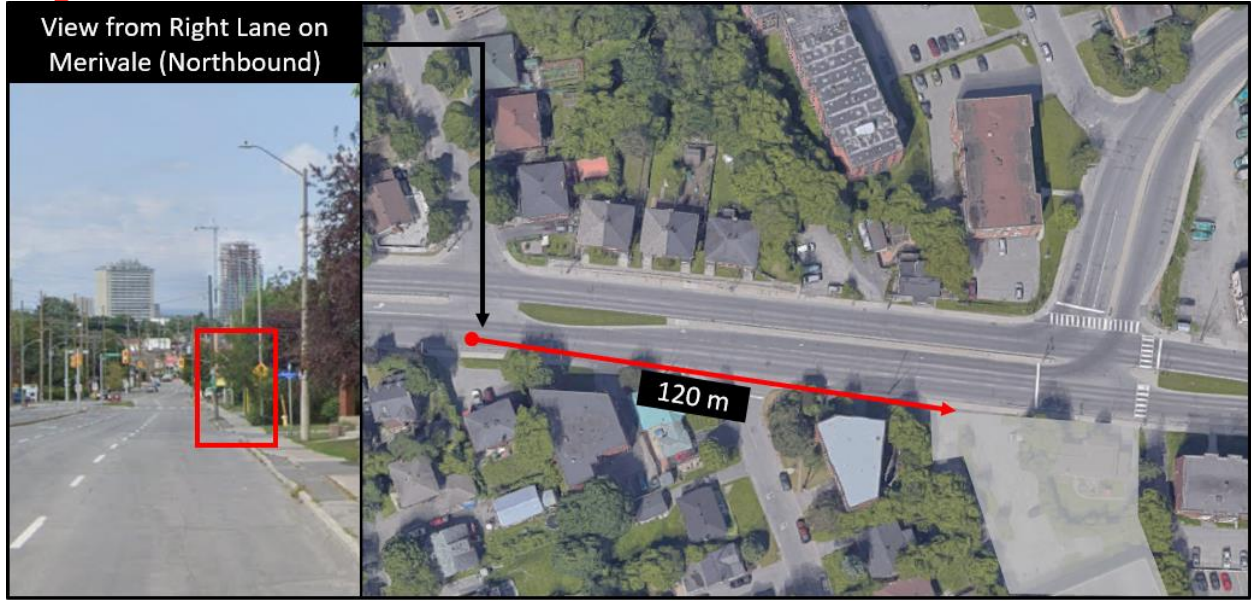
Figure 2: Desktop Sightline Review

Finally, the 2017 Transportation Association of Canada (TAC) Geometric Design Guide for Canadian Roads requires a sight distance for right-turns from a minor road of 120 m for a single-unit truck along a road with a design speed of 50 km/h. From our desktop review of the access, see **Figure 2**, there appear to be no sightline issues.

The AutoTurn analysis indicated that both MSUs and Fire Trucks will be able to manoeuvre the right-in/right-out access along Merivale Road without issue. The desktop sightline review indicated that there are no obstructions within the line of sight for exiting trucks turning back on to Merivale Road.
