McKINLEY
ENVIRONMENTAL
SOLUTIONS

RE: 2750 & 2760 Sheffield Development
Combined Environmental Impact Statement & Tree Conservation Report – Addendum #1

1.0 BACKGROUND & PURPOSE

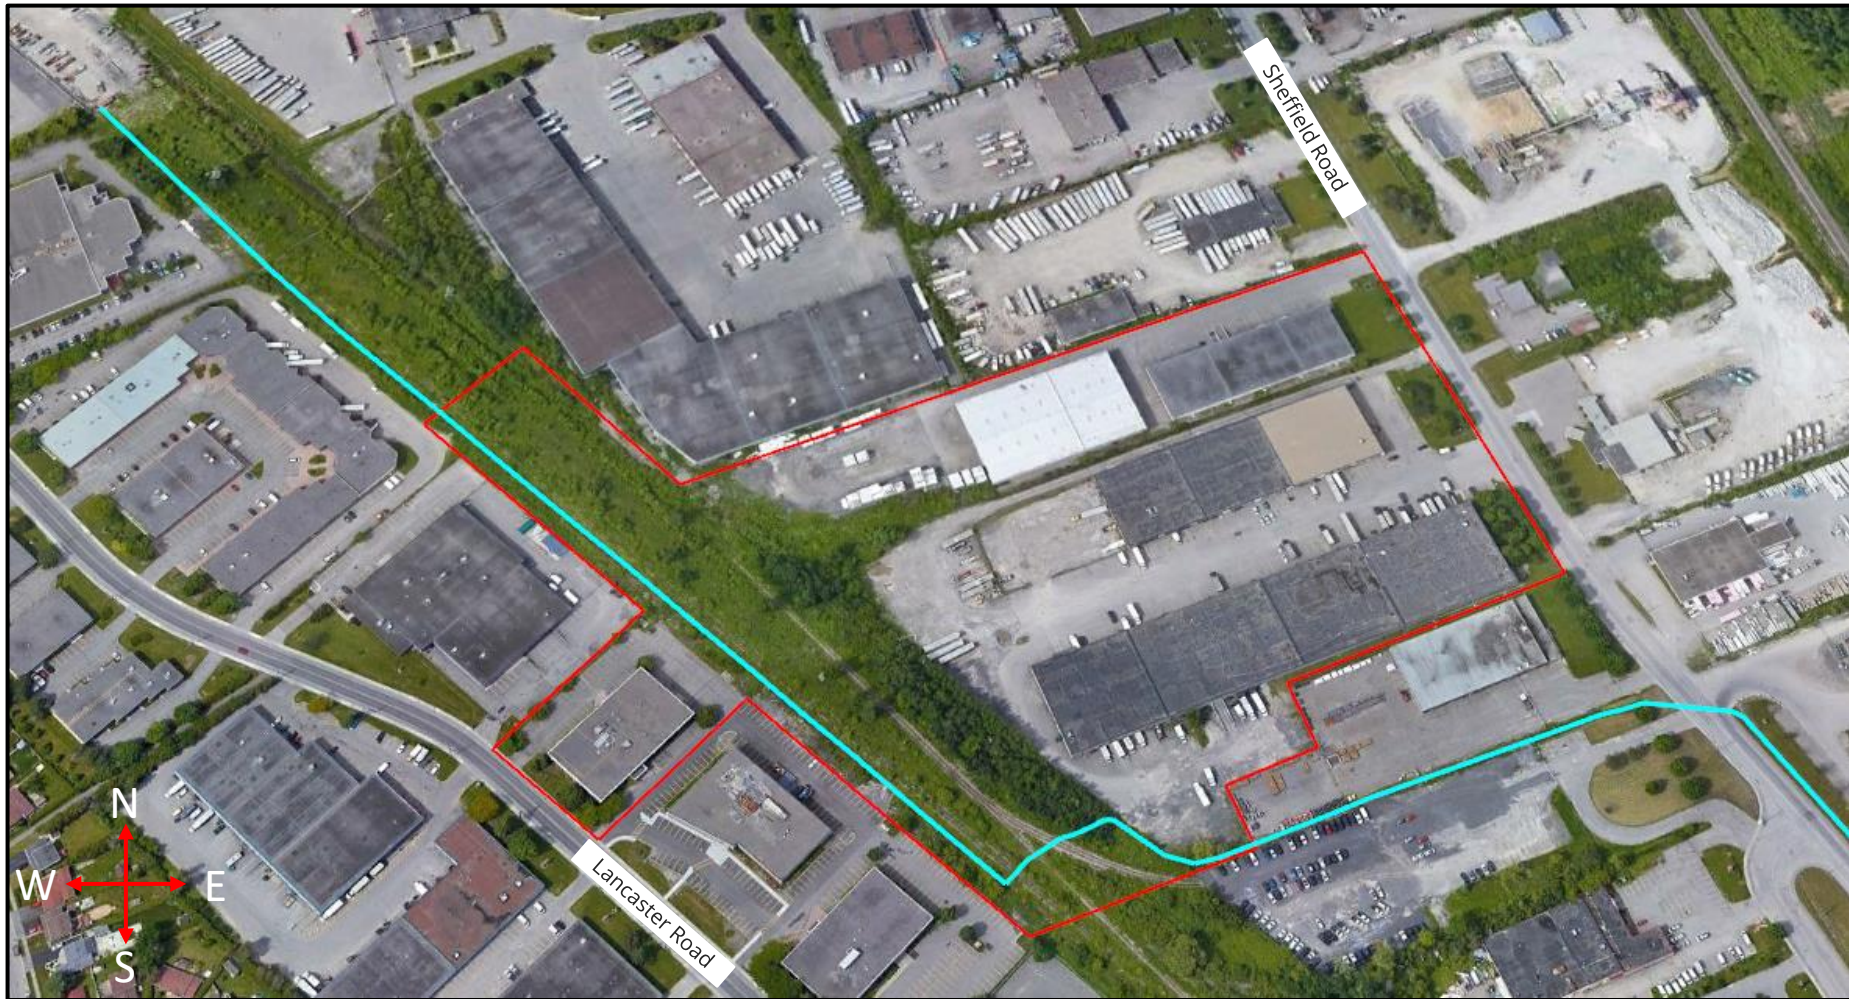
FIGURE 1: SITE OVERVIEW

McKinley Environmental Solutions (MES) was previously retained by Richcraft Properties Ltd. to prepare a Combined Environmental Impact Statement (EIS) & Tree Conservation Report (TCR) to support the proposed development of a new industrial building on Sheffield Road. The Site includes several connected parcels located at the municipal addresses 2750, 2760, 2713 and 2865 Sheffield Road, Ottawa (Ontario) (the Site) (Refer to Figure 1). The following studies were completed by MES to support the proposed development of the Site:

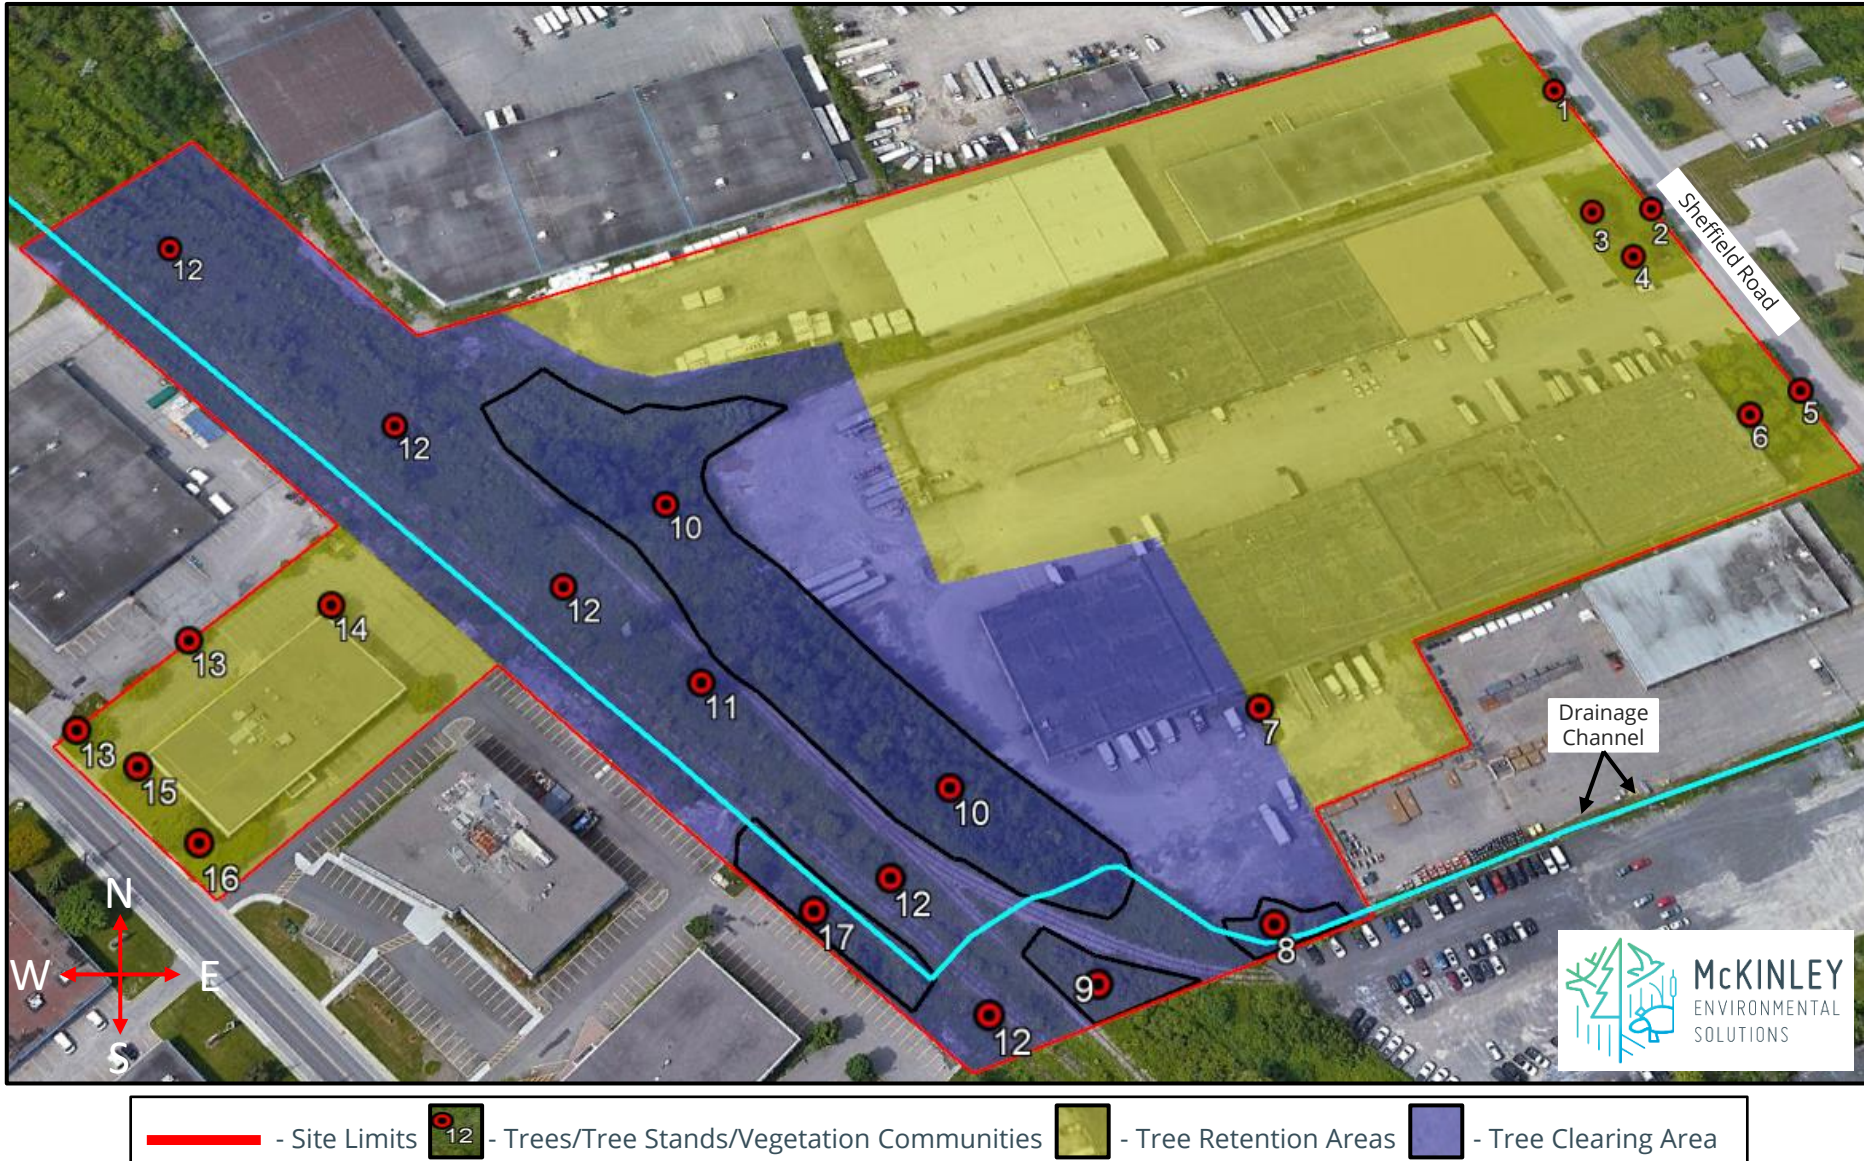
FIGURE 5: TREES & VEGETATION COMMUNITIES (POST DEVELOPMENT)

The legend of Figure 5 has been updated in order to make the figure easier to interpret. The updated version of Figure 5 is included below. It should be noted that the figure numbering from the Combined Environmental Impact Statement (EIS) & Tree Conservation Report (TCR) has been retained throughout this letter in order to maintain consistency with MES (2023a).

- Site Limits
- 12 - Trees/Tree Stands/Vegetation Communities
- Tree Retention Areas
- Tree Clearing Area

The tree stands that were described as Feature #1, Feature #2, and Feature #5 in MES (2023a) occur within the right-of-way of Sheffield Road. Feature #1, Feature #2, and Feature #5 were labelled as 'Private – On Site' trees in MES (2023a). However, Feature #1, Feature #2, and Feature #5 are City of Ottawa owned trees. The ownership of Feature #1, Feature #2, and Feature #5 has been corrected in Table B (below). It should be noted that all of the City of Ottawa owned trees will be retained during the future development of the Site.
