**98 + 100 BEARBROOK  
LANDRIC HOMES**  
98 + 100 BEARBROOK ROAD  
OTTAWA, ON, K1B 3B9

**PRE-DEVELOPMENT  
VEGETATION**

**LA PROJECT NO.** 21813-1 **L-TP1**

**POST-DEVELOPMENT  
VEGETATION**

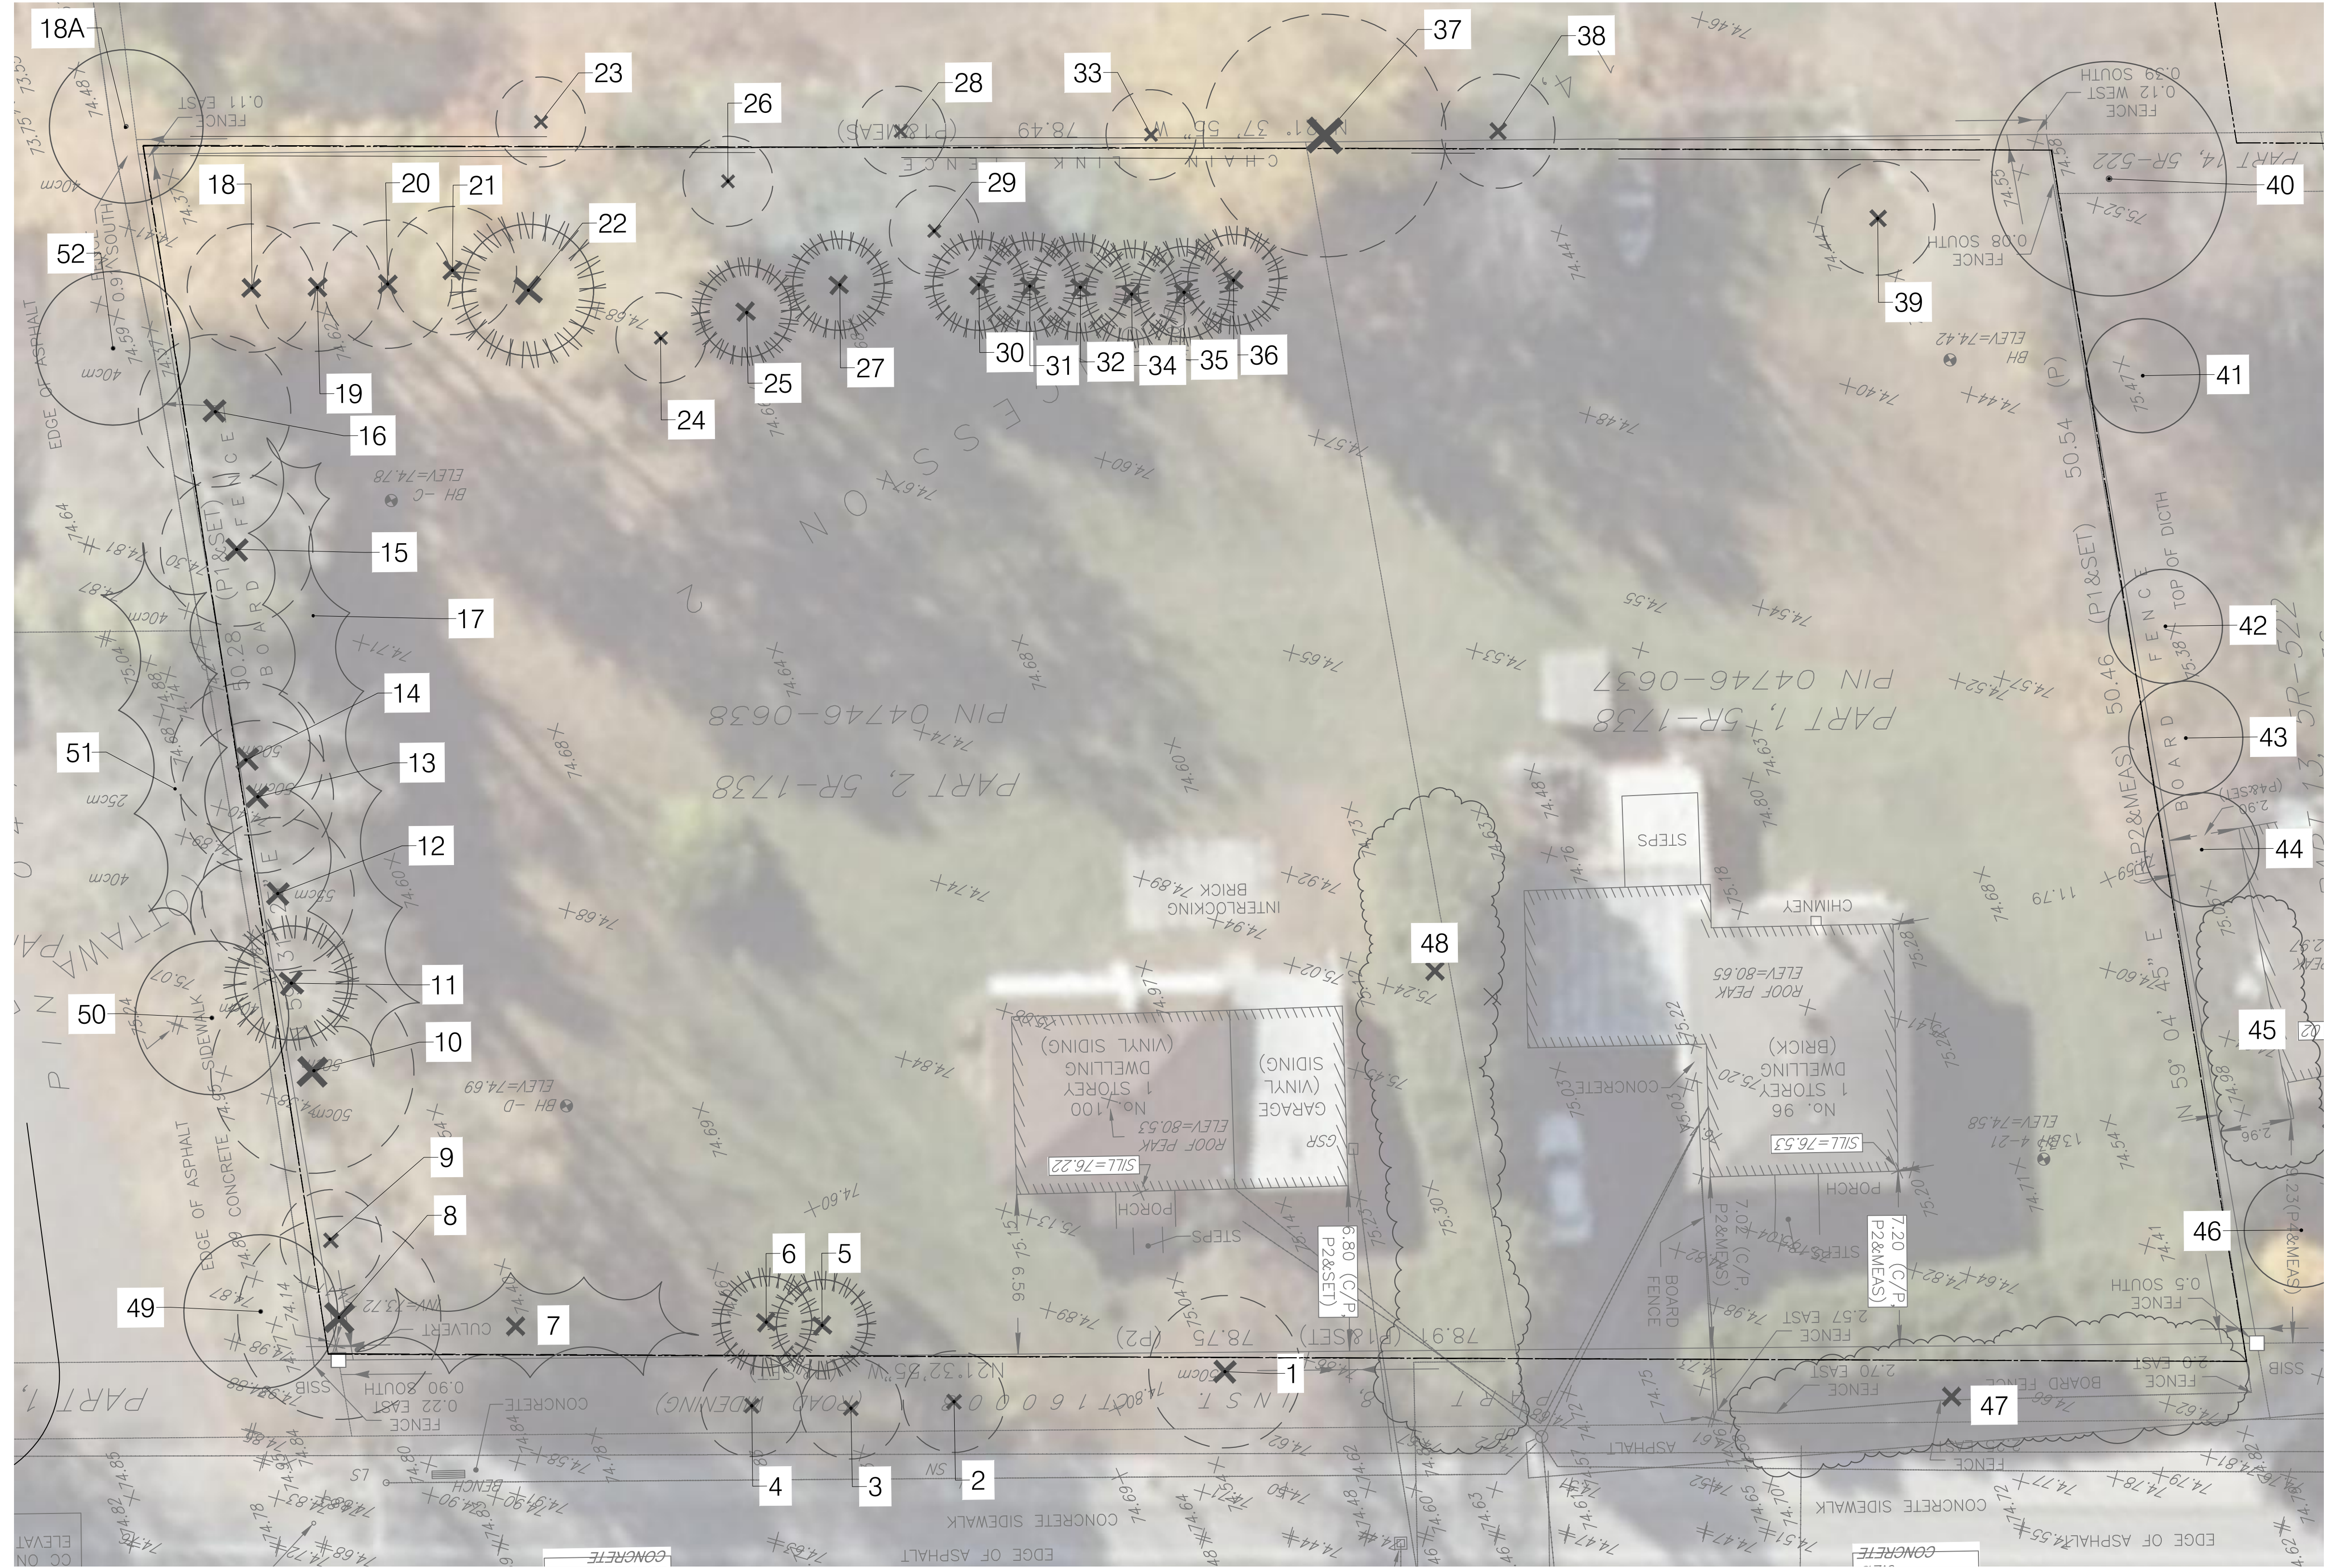
**1 PRE-DEVELOPMENT PLAN**

TREES TO REMAIN				
NO.	SPECIES	DBH (CM)	HEALTH	COMMENTS
18	Trembling Aspen/ <i>Populus tremuloides</i>	35	Good	Adjacent Property
40	Manitoba Maple / <i>Acer negundo</i>	52	Fair	Adjacent Property. Identified as #1 in dendron report
41	Manitoba Maple / <i>Acer negundo</i>	20	Poor	Adjacent Property
42	Red Maple / <i>Acer rubrum</i>	20	Good	Adjacent Property
43	Apple / <i>Malus sp.</i>	20, 22, 18	Poor	Adjacent Property
44	Manitoba Maple / <i>Acer negundo</i>	33	Fair	Adjacent Property
45	European Buckthorn / <i>Rhamnus cathartica</i>	10-15	Fair	Adjacent Property, Hedge
46	Red Maple / <i>Acer rubrum</i>	16	Fair	Adjacent Property
49	Norway Maple / <i>Acer platanoides</i>	30	Poor	Adjacent Property
50	Norway Maple / <i>Acer platanoides</i>	30	Fair	Adjacent Property
51	Austrian Pine / <i>Pinus nigra</i>	20-28	Good	Adjacent Property, 4 Stems
52	Norway Maple / <i>Acer platanoides</i>	40	Good	Adjacent Property

TREES ON CITY PROPERTY TO BE REMOVED				
NO.	SPECIES	DBH (CM)	HEALTH	COMMENTS
1	Basswood/ <i>Tilia americana</i>	46	Good	
2	Apple sp. / <i>Malus sp.</i>	33	Poor	Poor pruning / dieback
3	Apple sp. / <i>Malus sp.</i>	22	Poor	Poor pruning / dieback
4	Apple sp. / <i>Malus sp.</i>	14 / 15	Poor	Poor pruning / dieback
47	Eastern White Cedar / <i>Thuja occidentalis</i>	8-14	Poor-Fair	Hedge

TREES ON PRIVATE PROPERTY TO BE REMOVED				
NO.	SPECIES	DBH (CM)	HEALTH	COMMENTS
5	Eastern White Cedar / <i>Thuja occidentalis</i>	19	Good	
6	Eastern White Cedar / <i>Thuja occidentalis</i>	20	Good	
7	Eastern White Cedar / <i>Thuja occidentalis</i>	8-14	Fair	Hedge
8	Silver Maple / <i>Acer saccharinum</i>	15, 15, 20, 26, 32	Fair	5 stems joined at 1.3m
9	Silver Maple / <i>Acer saccharinum</i>	10, 13, 13, 15	Fair	4 stems joined at base
10	Eastern Cottonwood / <i>Populus deltoides</i>	43, 45	Good	2 stems joined at 1.0m
11	Eastern White Cedar / <i>Thuja occidentalis</i>	35	Good	
12	Eastern Cottonwood / <i>Populus deltoides</i>	64	Good
