**1184-1196 CUMMINGS AVENUE
SERVICING AND STORMWATER
MANAGEMENT REPORT**

January 11, 2024

Prepared for:
TCU Development Corporation

Prepared by:
Stantec Consulting Ltd.

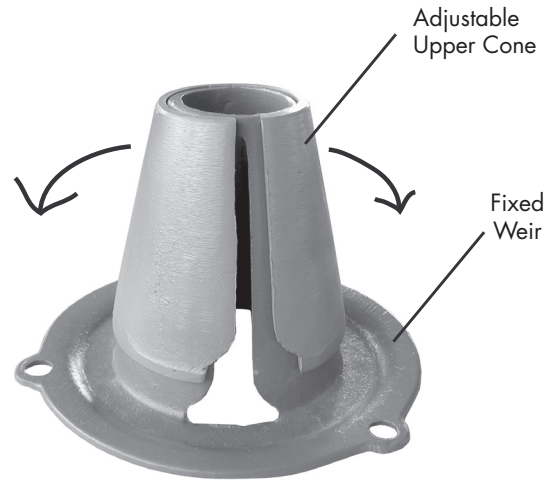
1/2 Weir Opening Exposed Shown Above

For example, if the adjustable upper cone is set to cover 1/2 of the weir opening, flow rates above 2" of head will be restricted to 2-1/2 gpm per inch of head.

Therefore, at 3" of head, the flow rate through the Accutrol Weir that has 1/2 the slot exposed will be:
 [5 gpm (per inch of head) x 2 inches of head] + 2-1/2 gpm (for the third inch of head) = 12-1/2 gpm.

Watts Drainage Adjustable Accutrol roof drain weir data (see **Appendix D.2**) and the roof plan (see **Appendix B**) has been used to calculate a practical roof release rate and detention storage volume for the rooftop areas, with 80 % of the roof area assumed to be available for storage. It should be noted that the Accutrol weir has been used as an example only, and that other products may be specified for use, provided that:
