ENVIRO-EXPERTS ENVIRONMENTAL SITE ASSESSMENT PHASE II

630, Montreal Road, Ottawa, On

Project 3260

Subject: Phase II Environmental Site Assessment for the property legally corresponding to **630, Montreal Road, Ottawa, ON.**

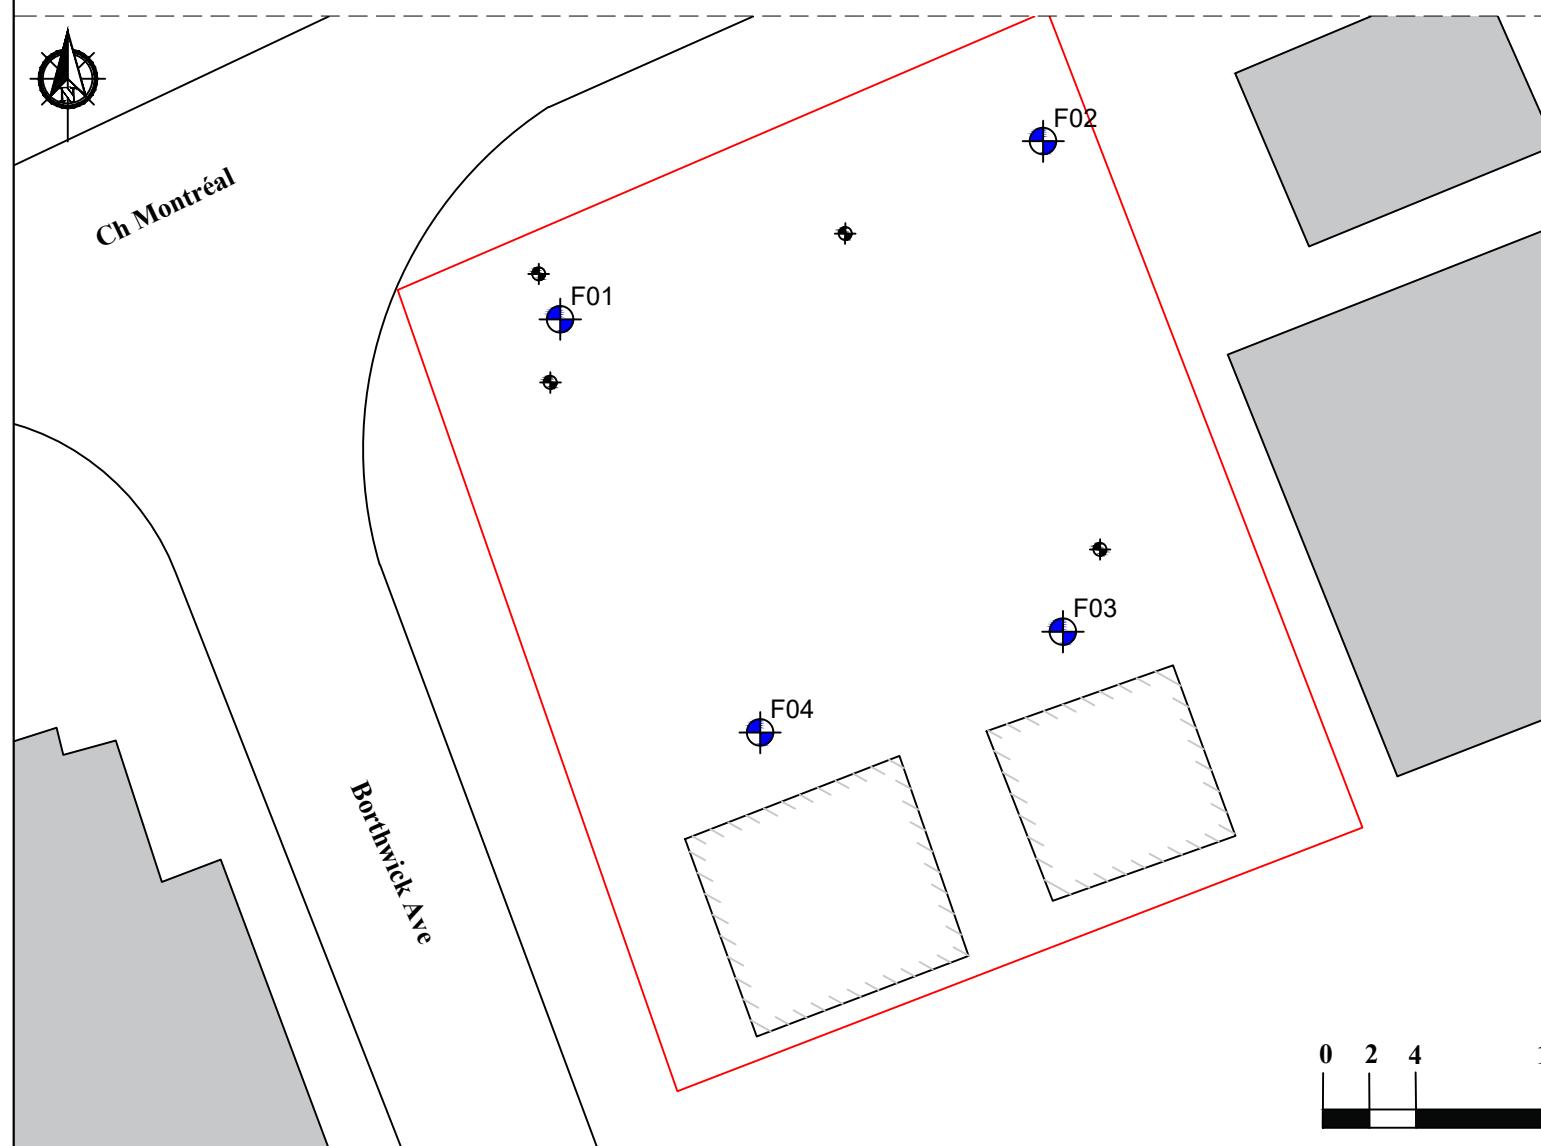
Scale: SN Plan N° : 1 Page: 1/1

A soil sampling and characterization plan was discussed and accepted by the client. This plan included the execution of four (4) boreholes, outside the building, identified as (F1 – F4). See appendix C (plan of borehole locations).

Appendix C shows a plan of borehole locations.
