**Hydrogeological Investigation &  
Terrain Analysis  
Proposed Lot Line Adjustment  
106 & 122 Reis Road  
Ottawa (Carp), Ontario**

File: 100165.024

**Re: Hydrogeological Investigation and Terrain Analysis  
Proposed I Lot Line Adjustment  
106 and 122 Reis Road, Ottawa (Carp), Ontario**

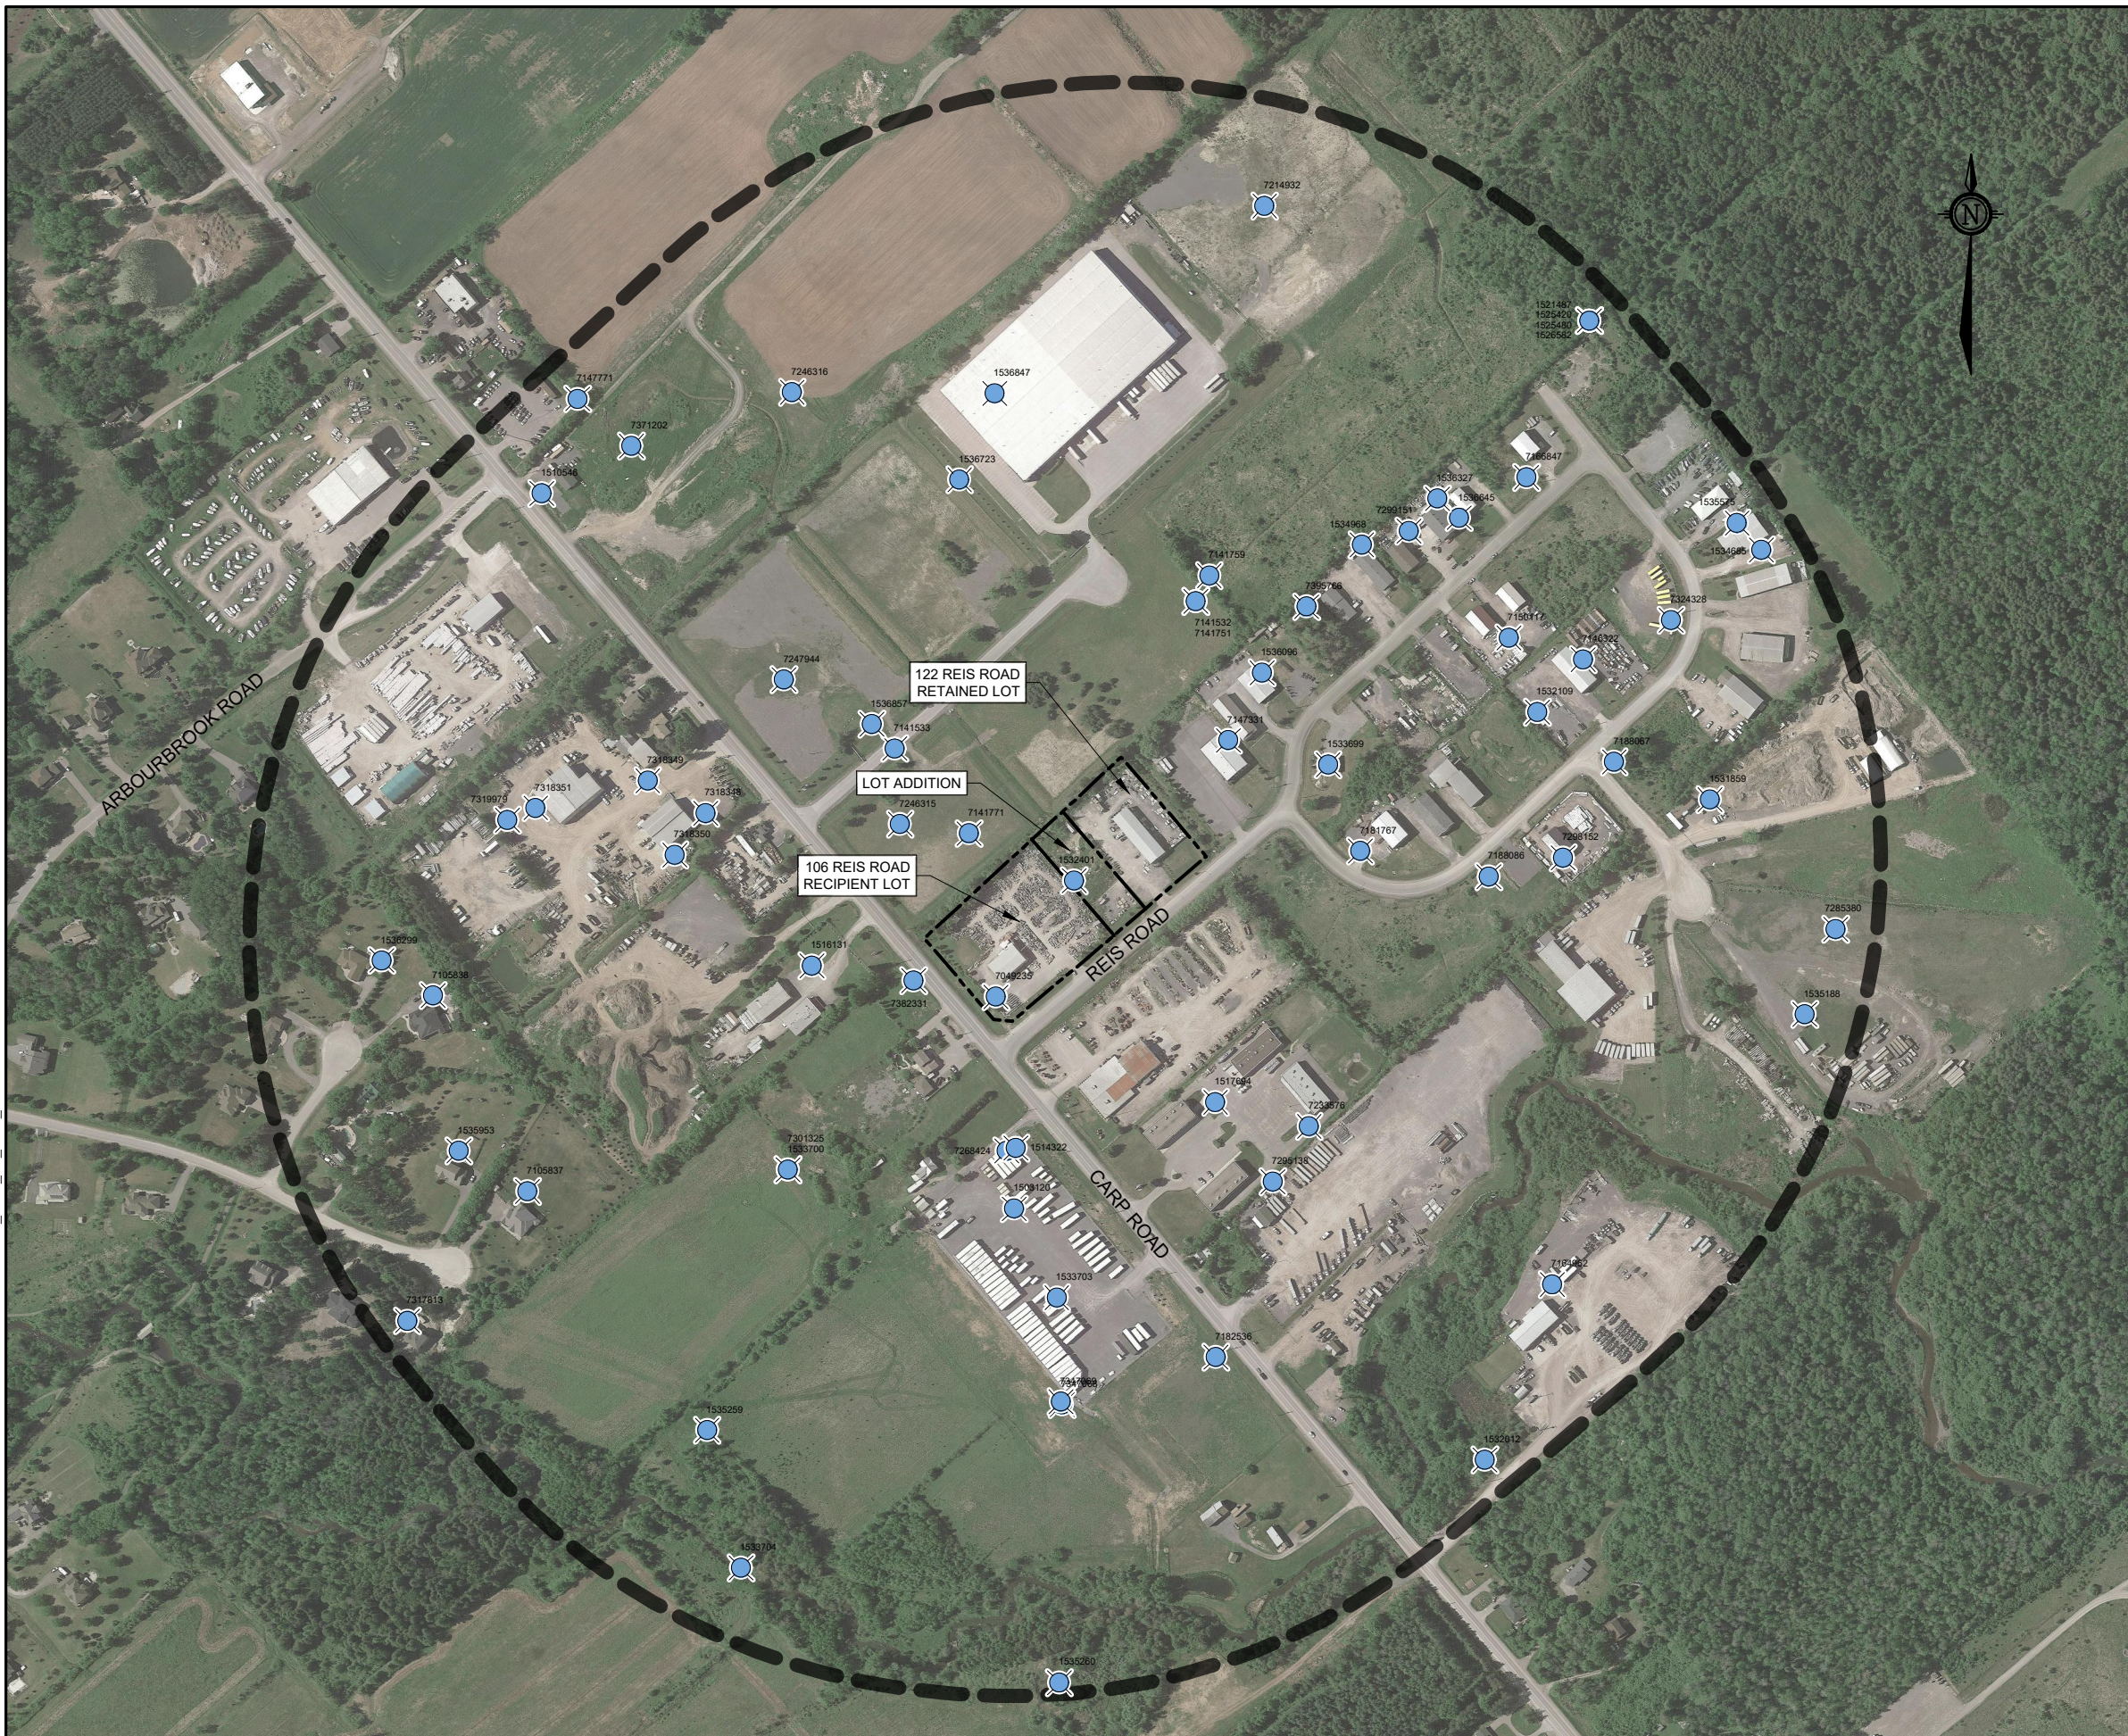
The "Site", referring to lots 106 and 122 Reis Road, is bounded to the south by Reis Road, Carp Road to the west, vacant rural commercial/industrial lots to the north and a commercial/industrial lot to the east (Figure 1).

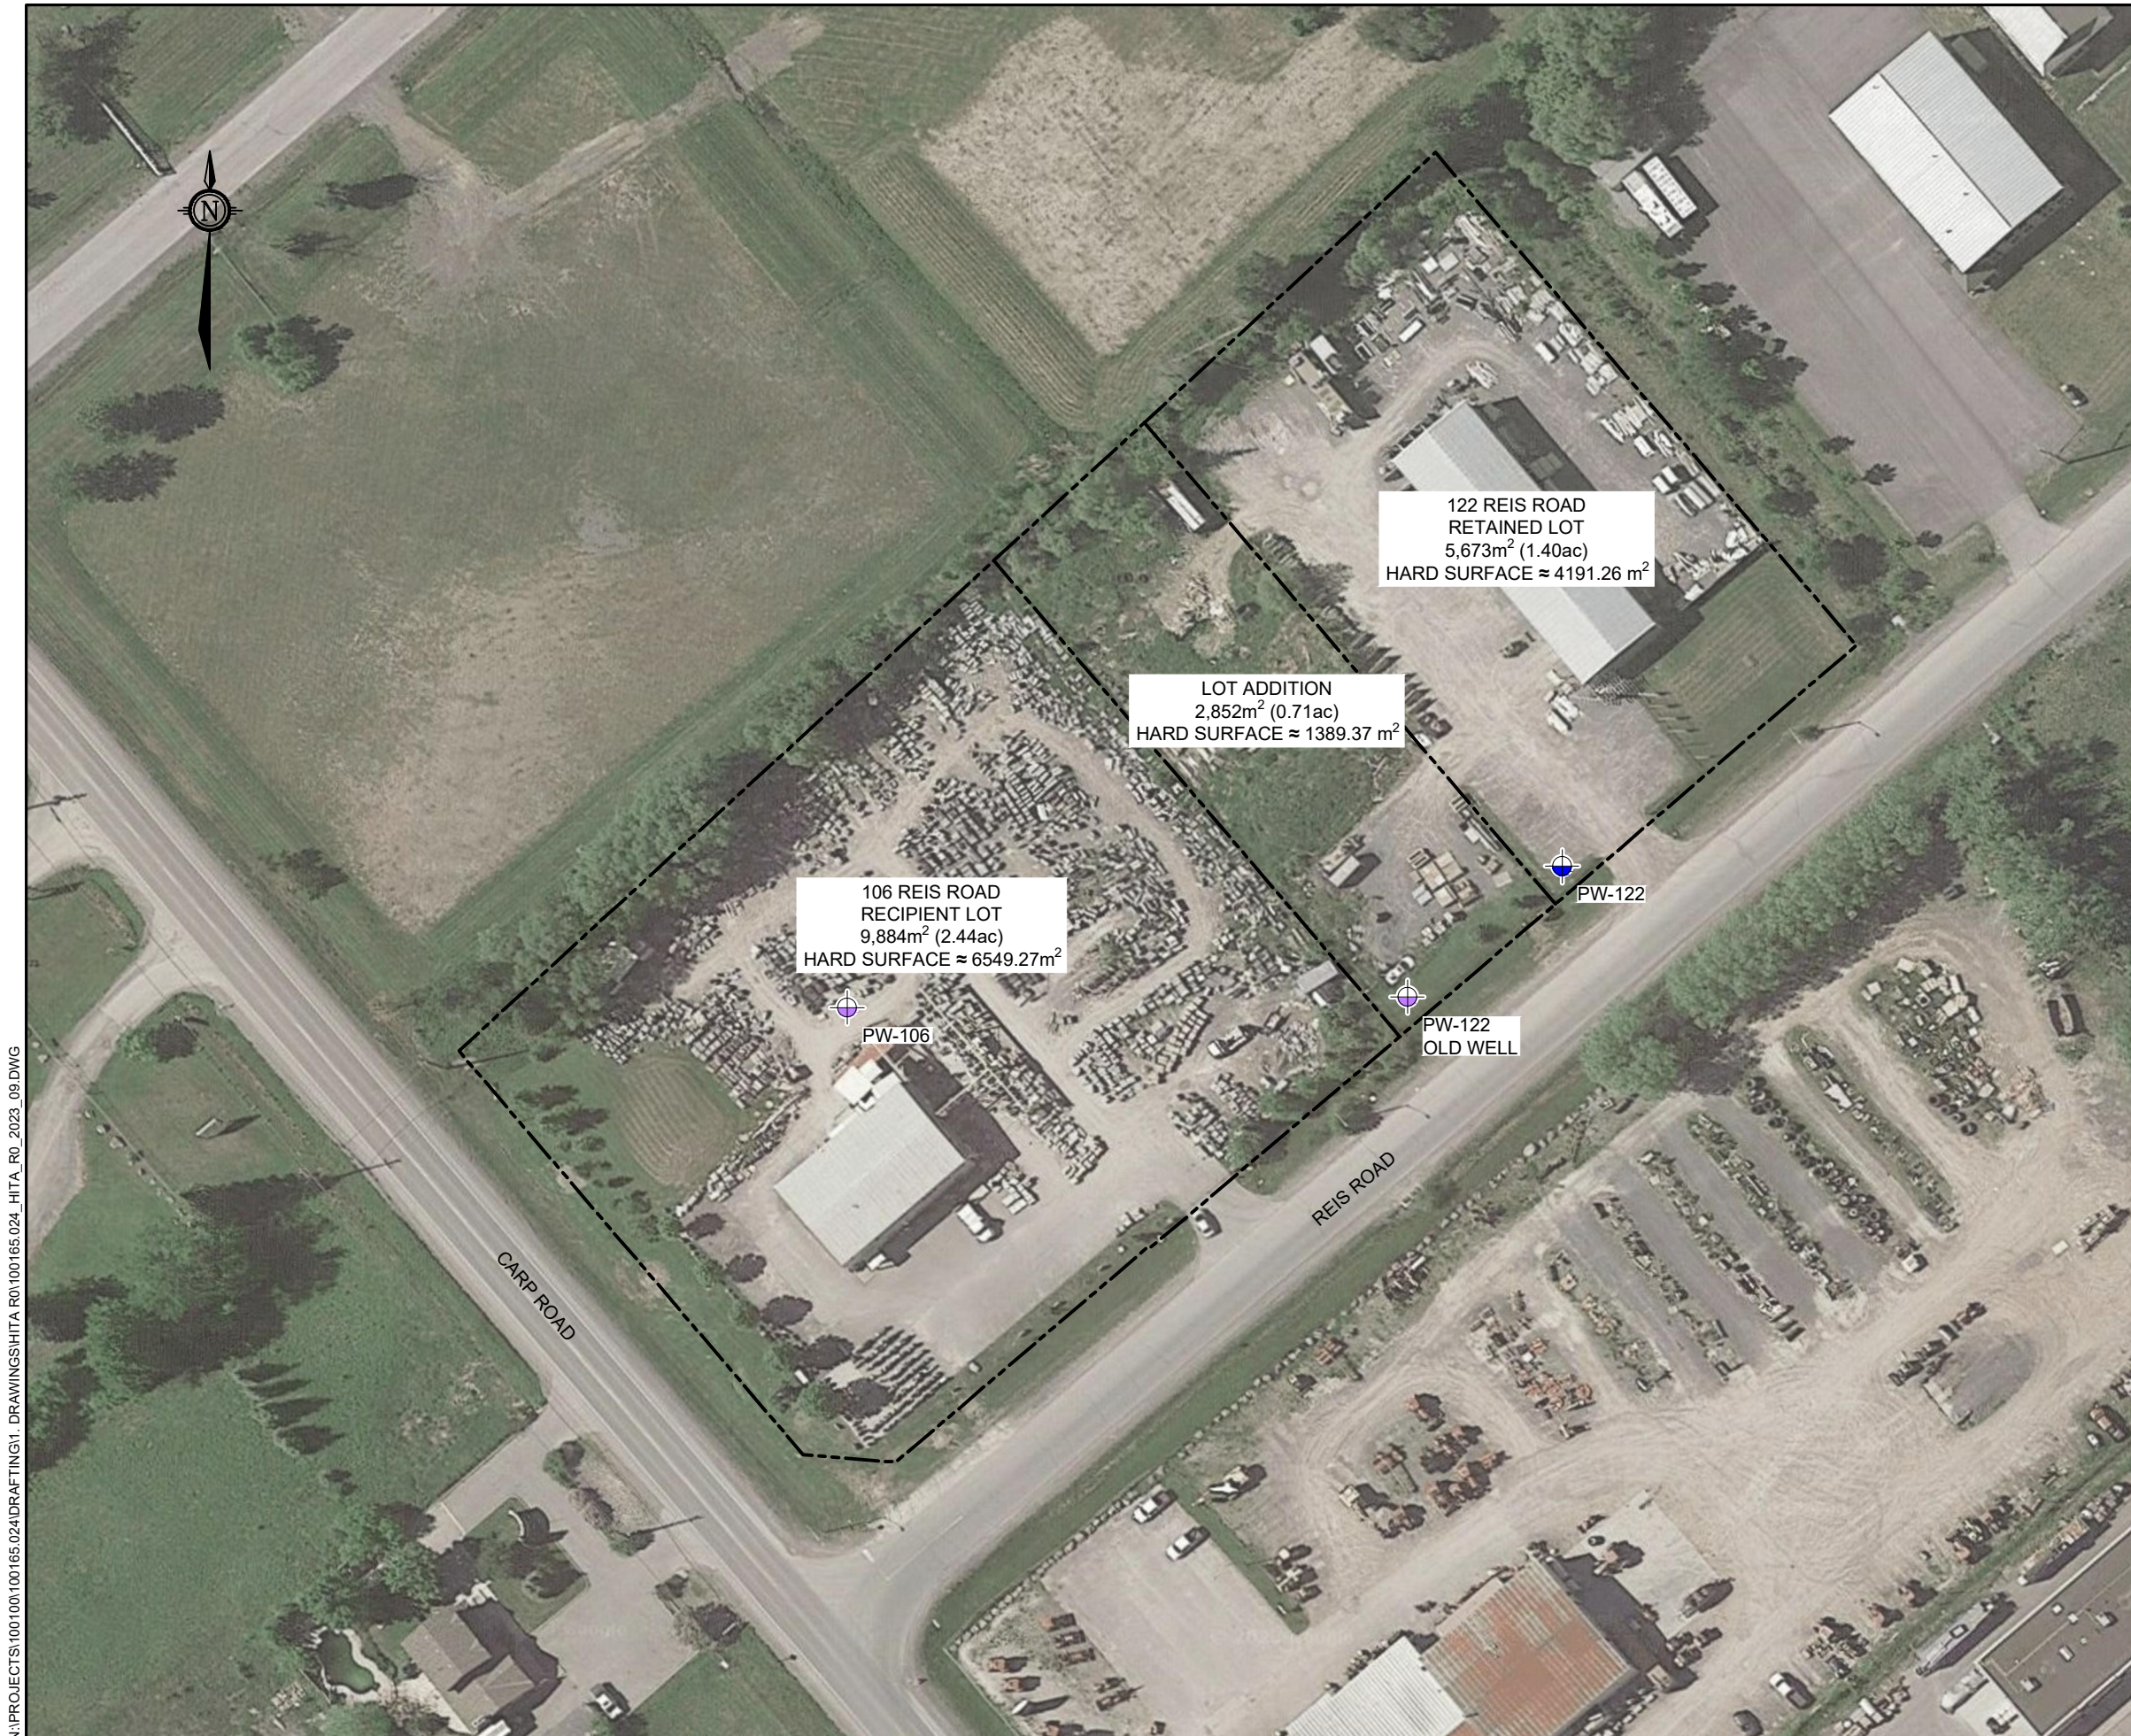
- APPROXIMATE TEST WELL LOCATION (CURRENT GEMTEC INVESTIGATION)
- EXISTING WATER WELLS
- APPROXIMATE SITE BOUNDARY

An existing water supply well, PW-122, located at 122 Reis Road lot was used to evaluate water quantity on the Site (MECP ID: A320528). The well construction details are summarized in Table 1 below, and the MECP water well record is found in Appendix C. The location of PW-122 is displayed in Figure 2. Information related to other existing water supply wells on the Site is displayed in Table 1, and the well locations are displayed in Figure 2.

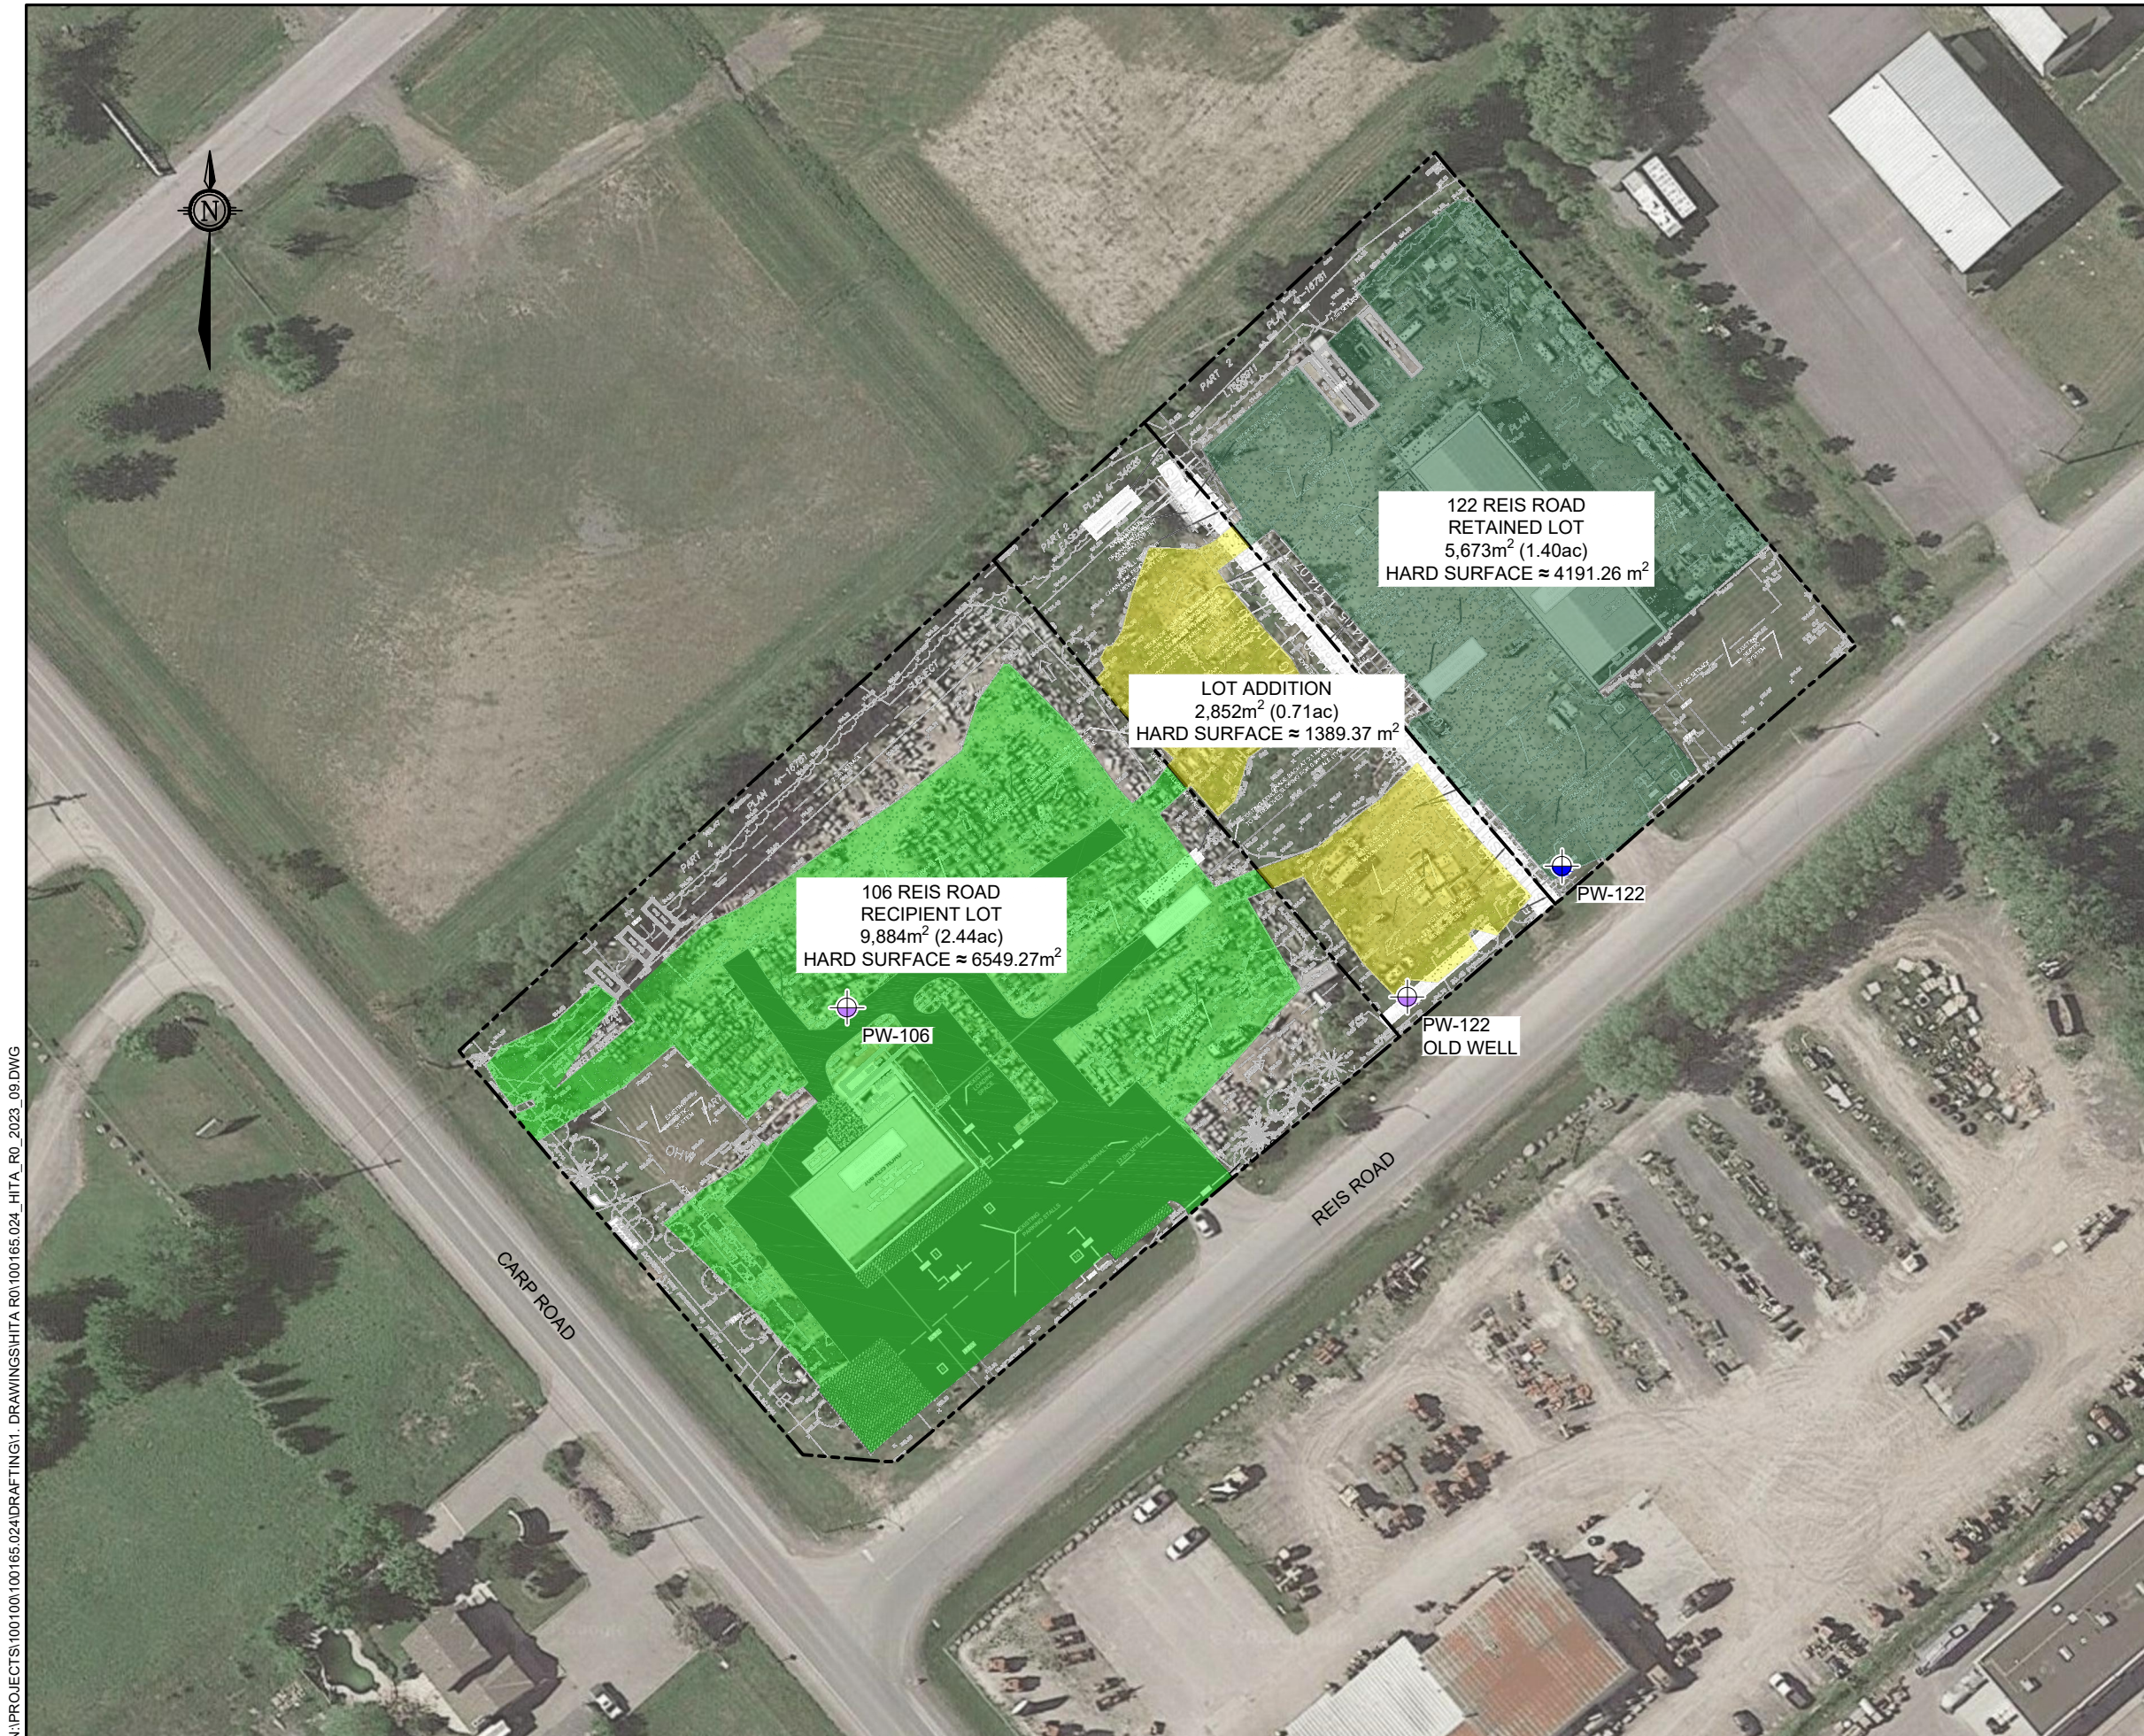
- APPROXIMATE TEST WELL LOCATION (CURRENT GEMTEC INVESTIGATION)
- EXISTING WATER WELLS
- APPROXIMATE SITE BOUNDARY
