New Campus Development

Hospital and Central Utility Plant (Phase 3 and 4)

Final Environmental Effects Evaluation

**Environmental Impact Statement and Tree
Conservation Report Update**

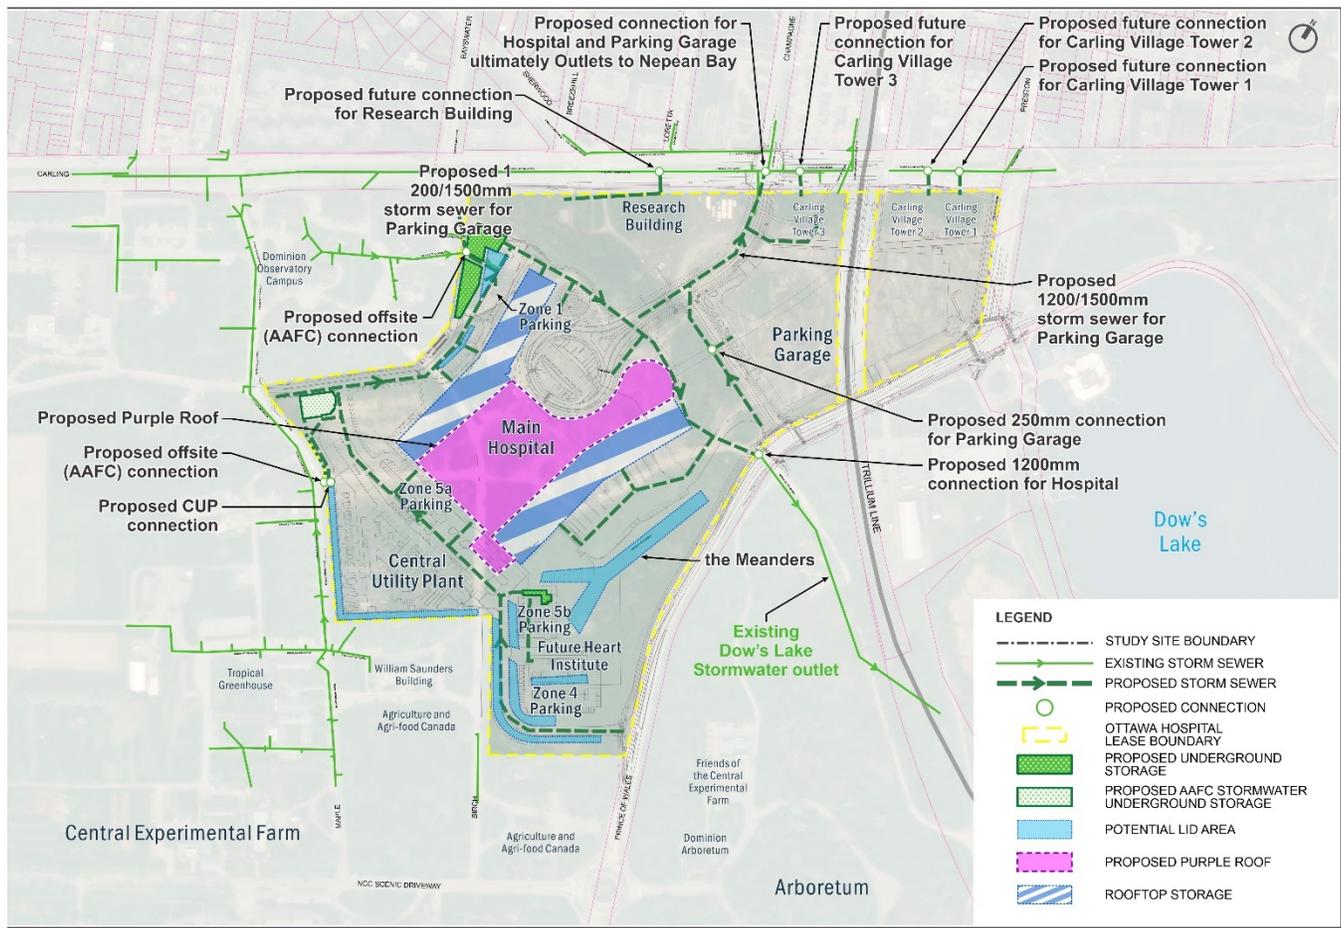
Figure 6: Stormwater Management Approach

- Finally, the plan is to provide a series of bioswales, sunken gardens, and infiltration galleries on-site to assist with requirements for improving storm water quality before it is discharged. Both systems encourage infiltration and help to filter out impurities.

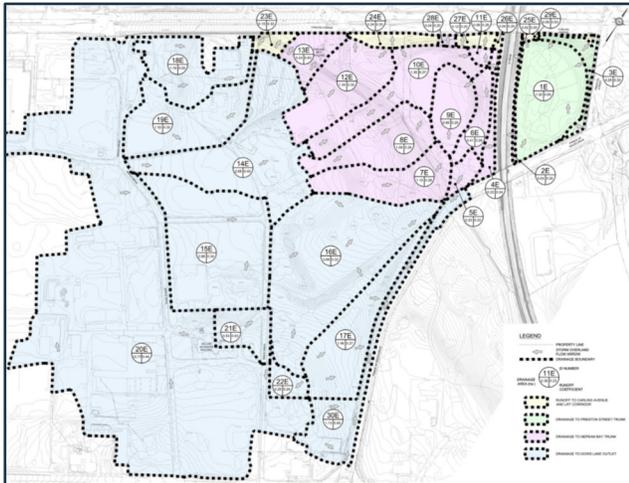
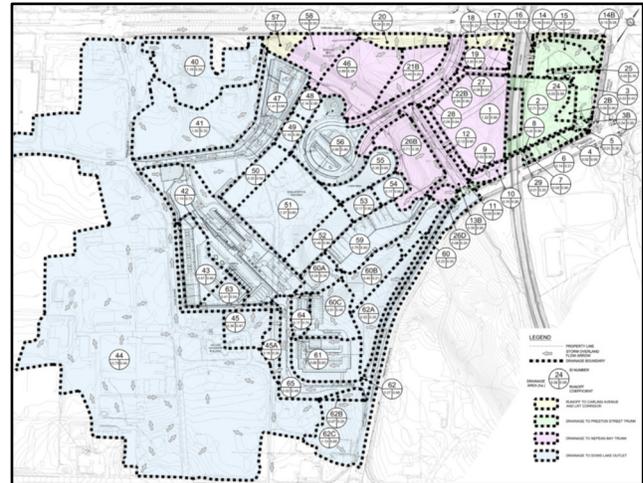
The total NCD area has been categorized into four main drainage areas based on their outlet as illustrated below: areas that drain to the Preston Street Trunk (green areas); areas that drain to Carling Avenue and the LRT Corridor (yellow areas); areas that drain to the Nepean Bay Trunk (pink areas); and areas that drain to Dow's Lake Outlet (blue areas). The post-development drainage areas reflect the drainage conditions once the NCD has been constructed. The NCD on-site stormwater management for the Phase 3 and 4 Projects has been designed to implement quantity control capable of attenuating 100-year post-development flow rates to the 2-year pre-development flow rates as it relates to the Nepean Bay Trunk Sewer and the 5-year pre-development flow rates for the Dow's Lake Outlet proposed in the current design.

Pre-Development Drainage Areas

Post-Development Drainage Areas

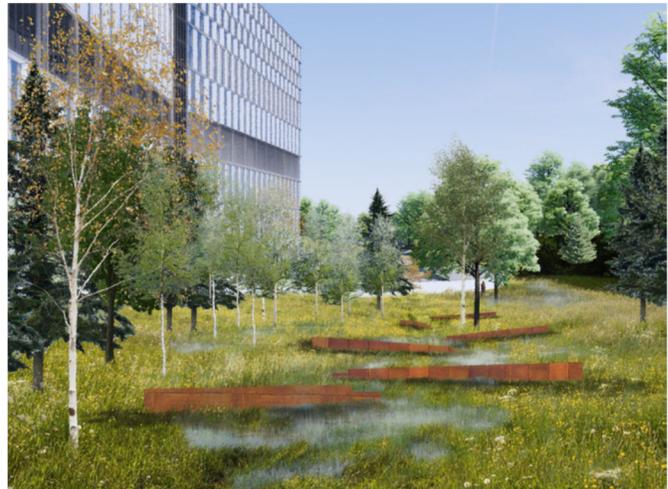
The Meanders are a series of proposed bioswales near Prince of Wales Drive and the loading dock, which feature long meandering overland flow routes that slow storm flows, provide stormwater to plants, and assist with improving storm water quality (see adjacent architects rendering of this feature). The slowed flow rates will also act to encourage infiltration and reduce time of concentration to site stormwater outlets. The bioswales will feature a ditch inlet that will capture and release the flow at a controlled rate into the oversized storm sewer.

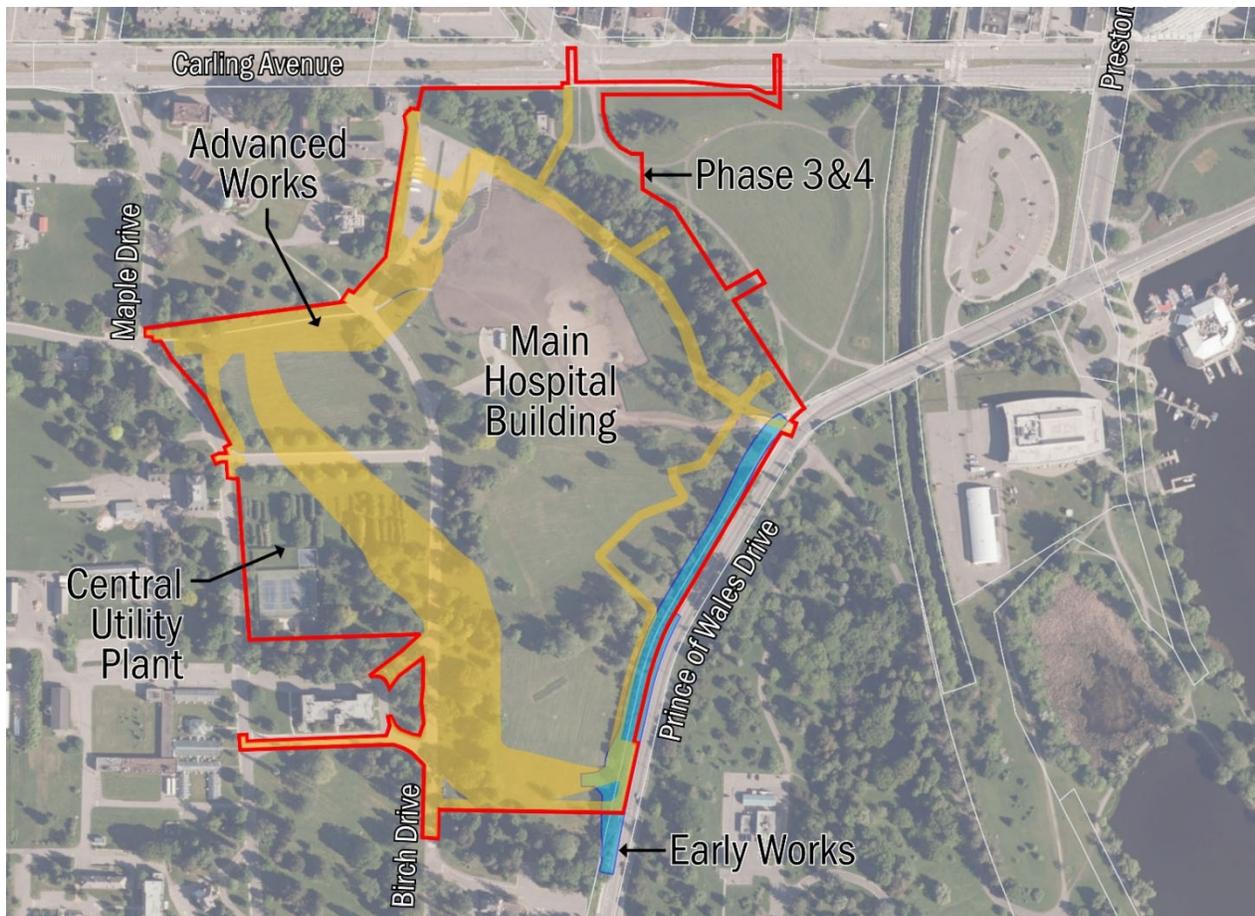
Figure 10: Advance and Early Works Construction Footprints

The requirement for a new permanent access to Prince of Wales Drive to facilitate construction and serve as the secondary ambulance and staff entrance to the western side of the NCD are referred to as Early Works to support the Phase 3 and 4 Projects. The anticipated advance and early works construction footprints is illustrated in **Figure 10**.

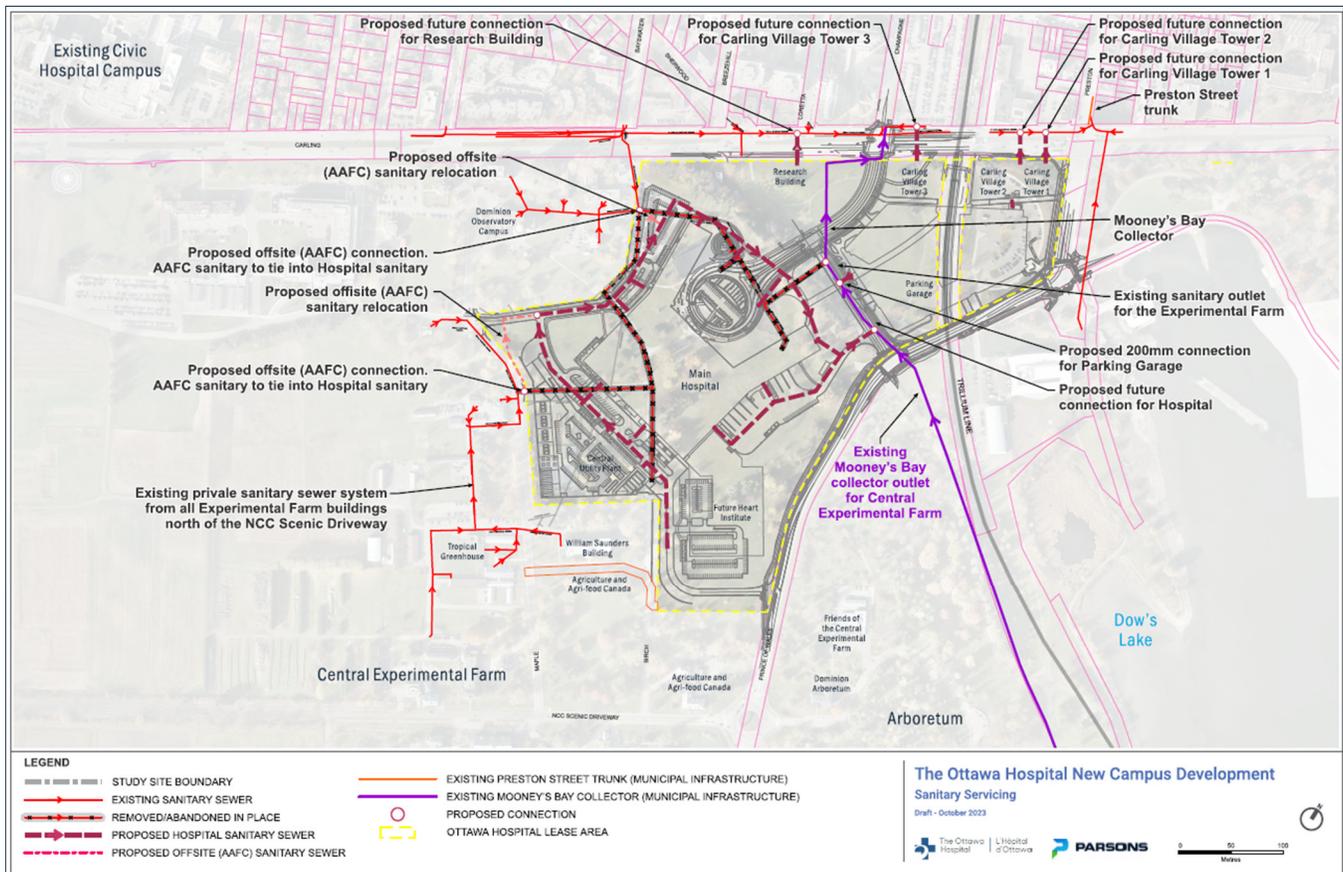
Figure 12: Existing and Proposed Sanitary Works

A 250 mm/300 mm diameter private sanitary sewer is located within Birch Drive that extends north and east around the existing former Sir John Carling building and outlets to the Mooney’s Bay Collector which is situated within an easement south of the wooded ridgeline. This private sanitary sewer services the existing AAFC buildings located to the west of the NCD project.

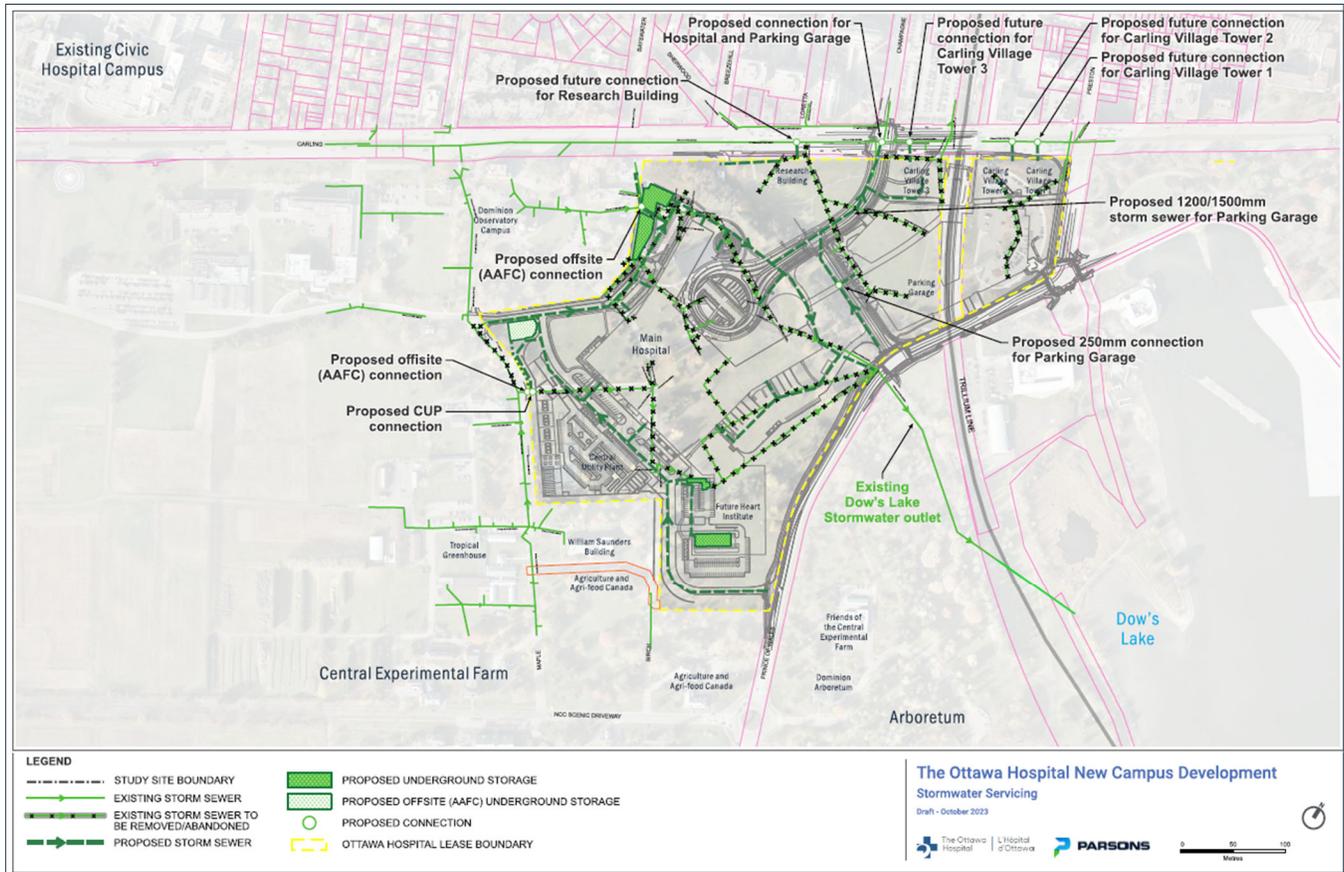
Figure 13: Existing and Proposed Stormwater Works

Approximately 25 ha of the CEF lands drain towards the existing Dow's Lake Storm Outlet. The drainage area is a combination of lands to the east and west of Maple Drive, which includes the Hospital Lease Area. A 900 mm diameter private stormwater sewer within Birch Drive is located within the Hospital Lease Area and will need to be relocated/realigned to accommodate the NCD project. A 300 mm/450 mm/600 mm diameter private stormwater sewer that services the existing buildings and land west of the NCD is also located within the Hospital Lease Area and will need to be relocated/realigned to accommodate the proposed development.

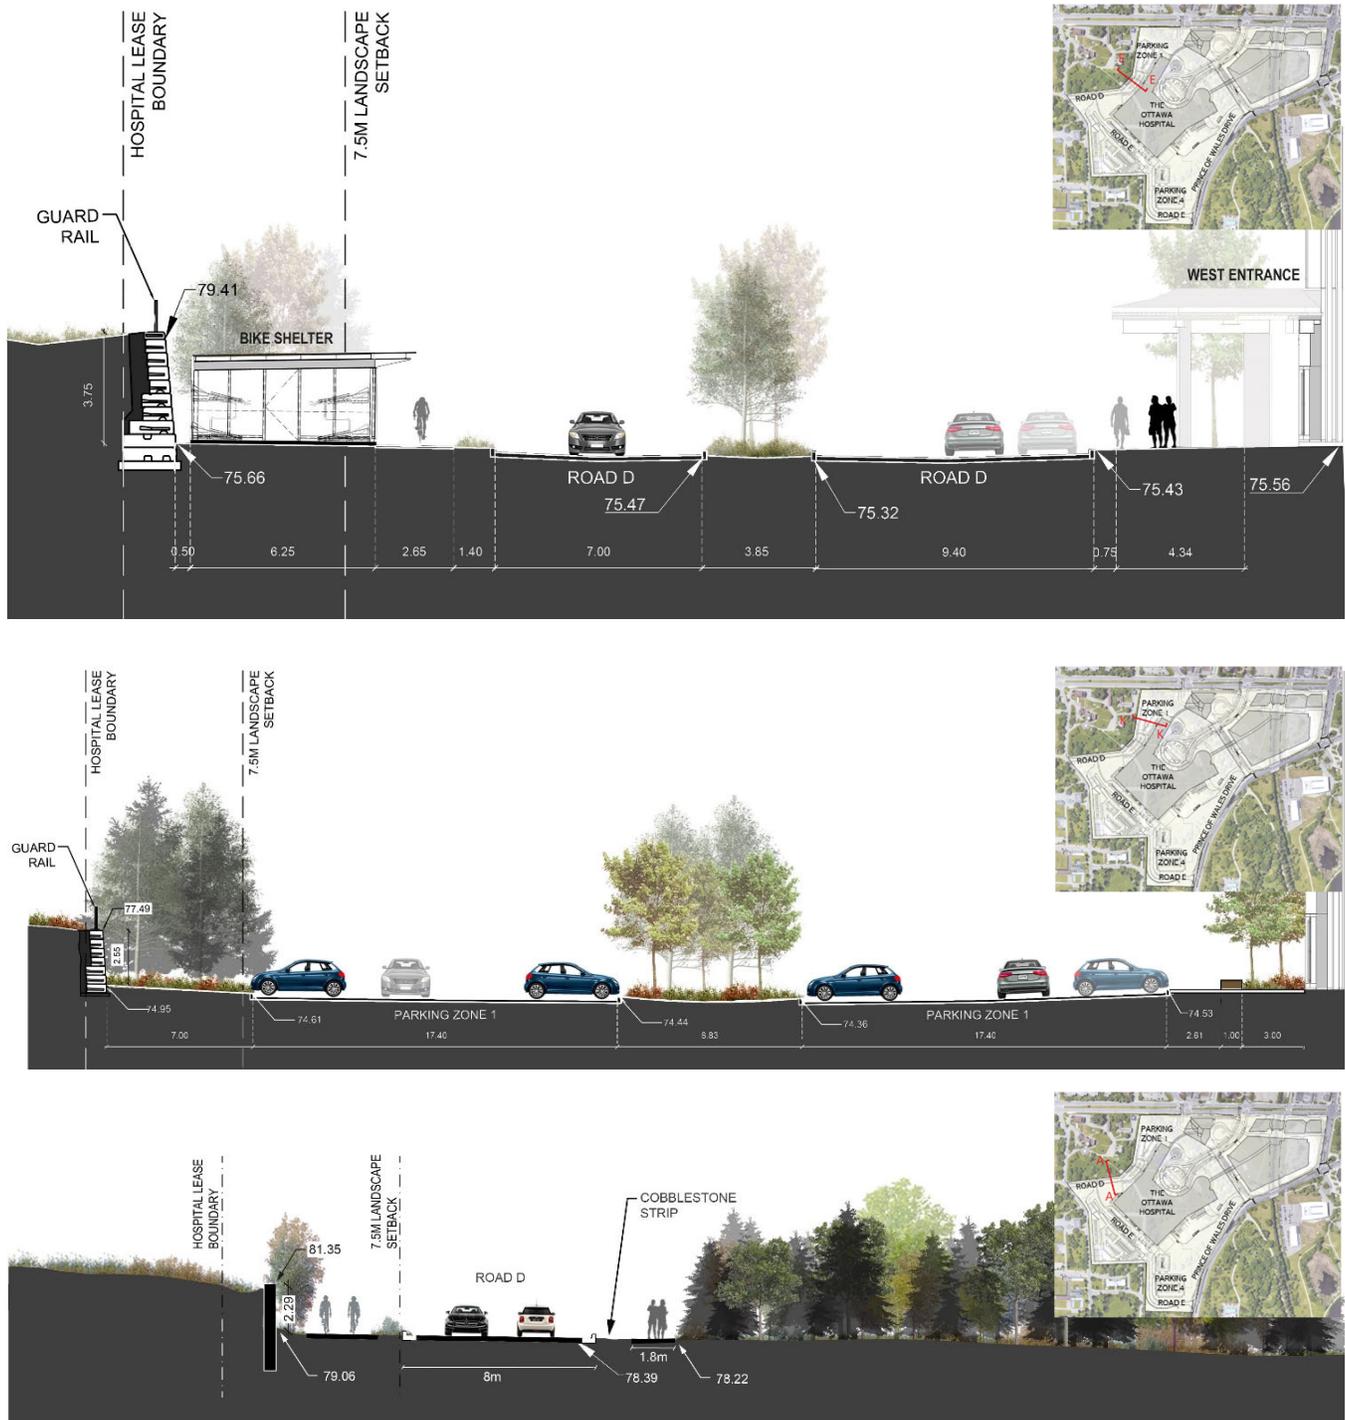
Figure 14: Retaining Wall Sections at Road D

Based on the proposed elevations of access Road D and the Dominion Observatory Campus and Road E and Birch Drive, retaining walls will need to be constructed between the Hospital Lease Area and the CEF. A description of each is provided below.

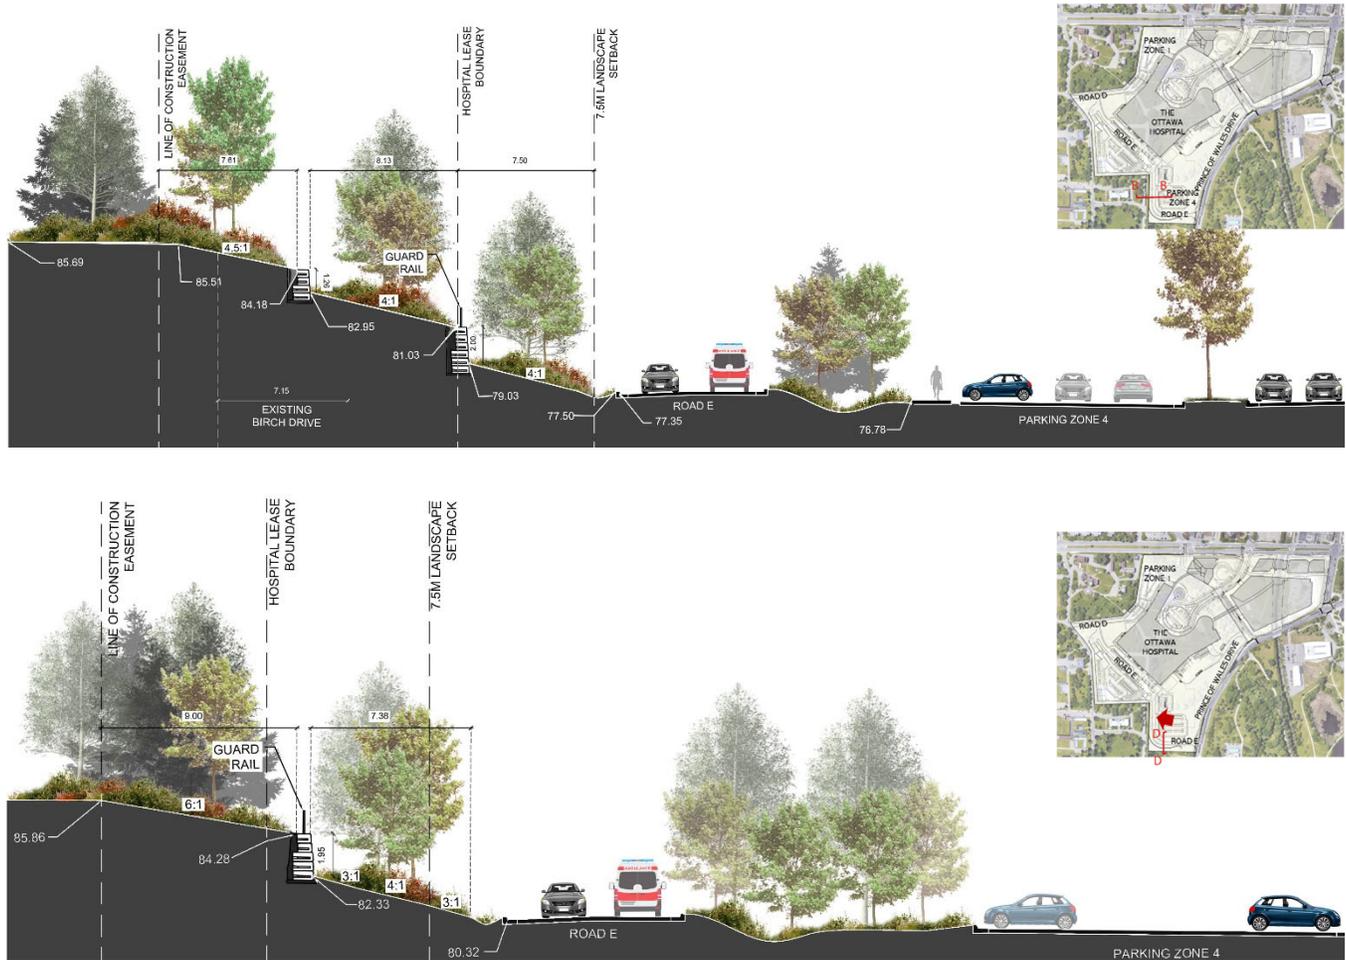
Figure 15: Retaining Wall Sections at Road E

Road E Retaining Wall: The Road E retaining walls are proposed as two-tier precast modular block gravity walls constructed along a section of the south perimeter of the site immediately adjacent to Birch Drive and the southern boundary of the Hospital Lease Area as shown in cross-section in **Figure 15**. The walls run along the west and south side of Road E. The walls will be 9 m apart (front of wall to front of wall). The upper wall will be 105 m long (including a 6 m long temporary wall at the north end to accommodate the future retaining wall of the CUP) and will have a maximum height of 2415 mm whereas the lower wall will be 156 m long (including a 4 m long temporary wall at the north end) and will have a maximum height of 2500 mm. Both walls are at their tallest when they connect to the temporary sections of wall at the north end. The upper wall will be entirely on AAFC land (8 m back from the Hospital Lease Area boundary to the face of wall) and the lower wall will only encroach on AAFC land below grade given that the lower precast blocks are

larger. The construction of these walls will require 1:1 grade from the backs of the drains behind the walls. There will be a 4:1 grade at the top of both walls. The 4:1 grade above the upper wall will extend 5.2 m back from the face of the wall to match the existing grade however, the 1:1 limit of excavation may extend further onto AAFC land in some cases.

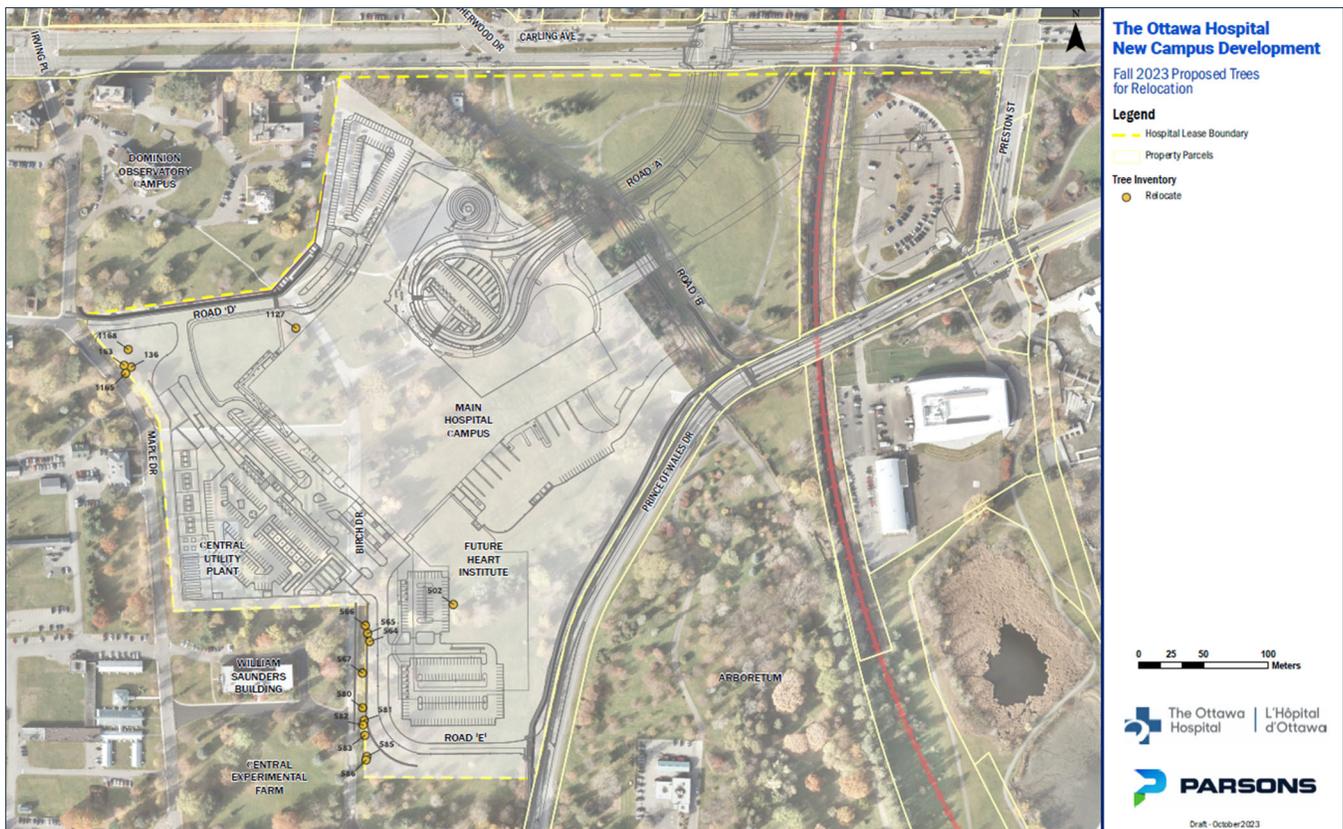
Figure 18: Tree Relocations

An initial desktop assessment that identified trees of suitable size, condition, species, and location in relation to landform features, infrastructure, and existing buildings was followed by an on-site inspection by a local tree moving company. Trees that are confirmed in the field to not be candidates will be removed from the site as part of project implementation. A total of 16 trees were identified through the desktop assessment and were subject to an on-site inspection prior to relocation. Relocated trees are illustrated in **Figure 18** below. These trees were relocated in November 2023 and subject to a separate Environmental Record of Decision.

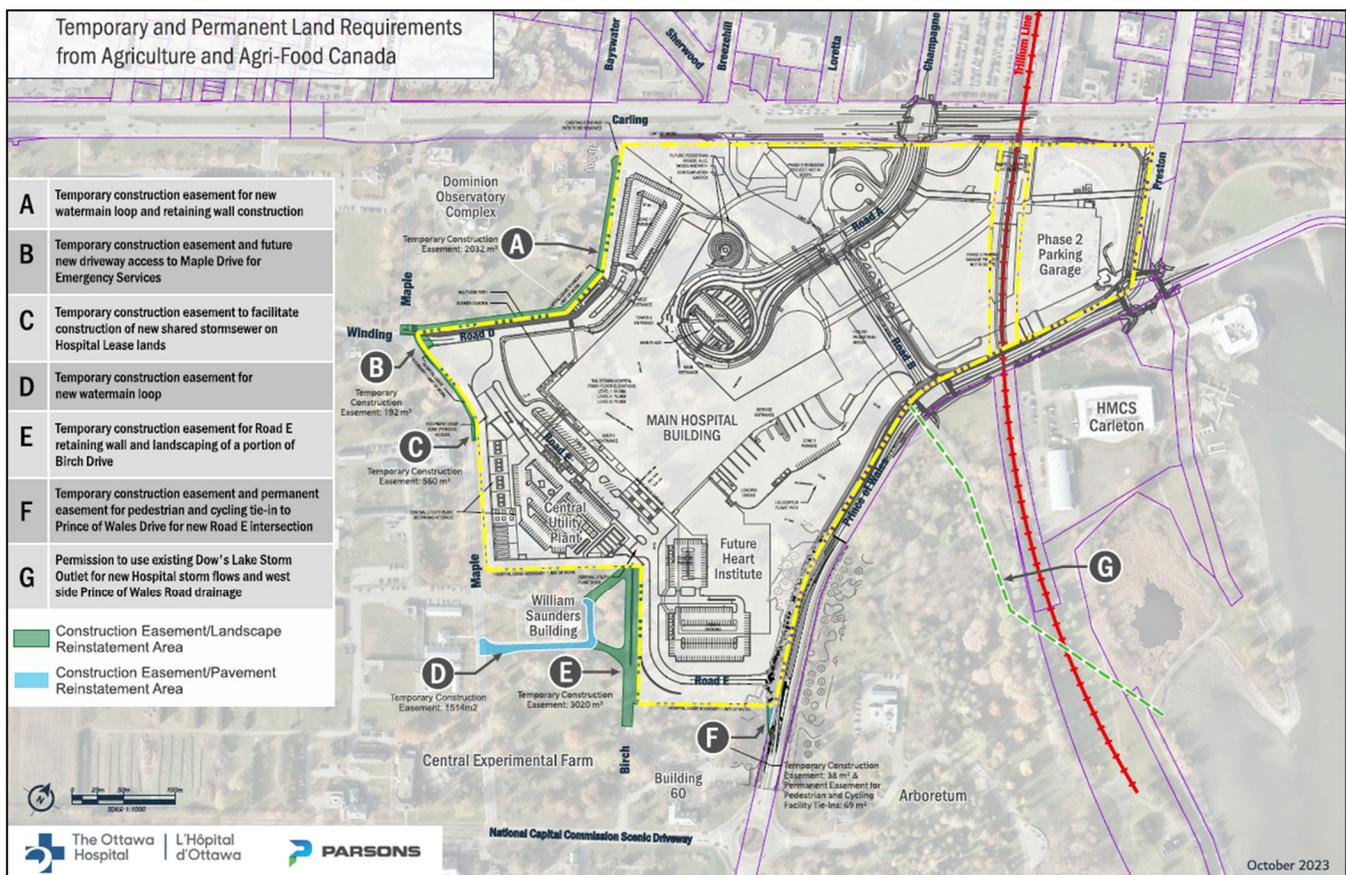
Figure 19: Temporary and Permanent Land Requirements From AAFC

Figure 19 identifies the temporary and permanent land requirements from AAFC off-site to accommodate the Advance and Early Works. The use for each of these is described below. The figure includes all the land requirements and associated works required to fully implement the Phase 3 and 4 Project.

- Area D: Temporary construction easement required to construct a new watermain loop within the driveway in front of the William Saunders Building connecting to Maple Drive. The existing asphalt would be reinstated within this area.
- Area E: Temporary construction easement required to construct a tiered retaining wall between Birch Drive and the Road E access road to the NCD. Birch Drive would be closed in this area extending to the driveway of Building 60 along Birch Drive and replaced with landscaping within this area.
- Area F: Temporary construction easement and permanent easement or land requirement for pedestrian and cycling tie-ins from the new Road E intersection at Prince of Wales Drive to allow for the tie-ins to the existing on-road cycling and separate sidewalk facilities.

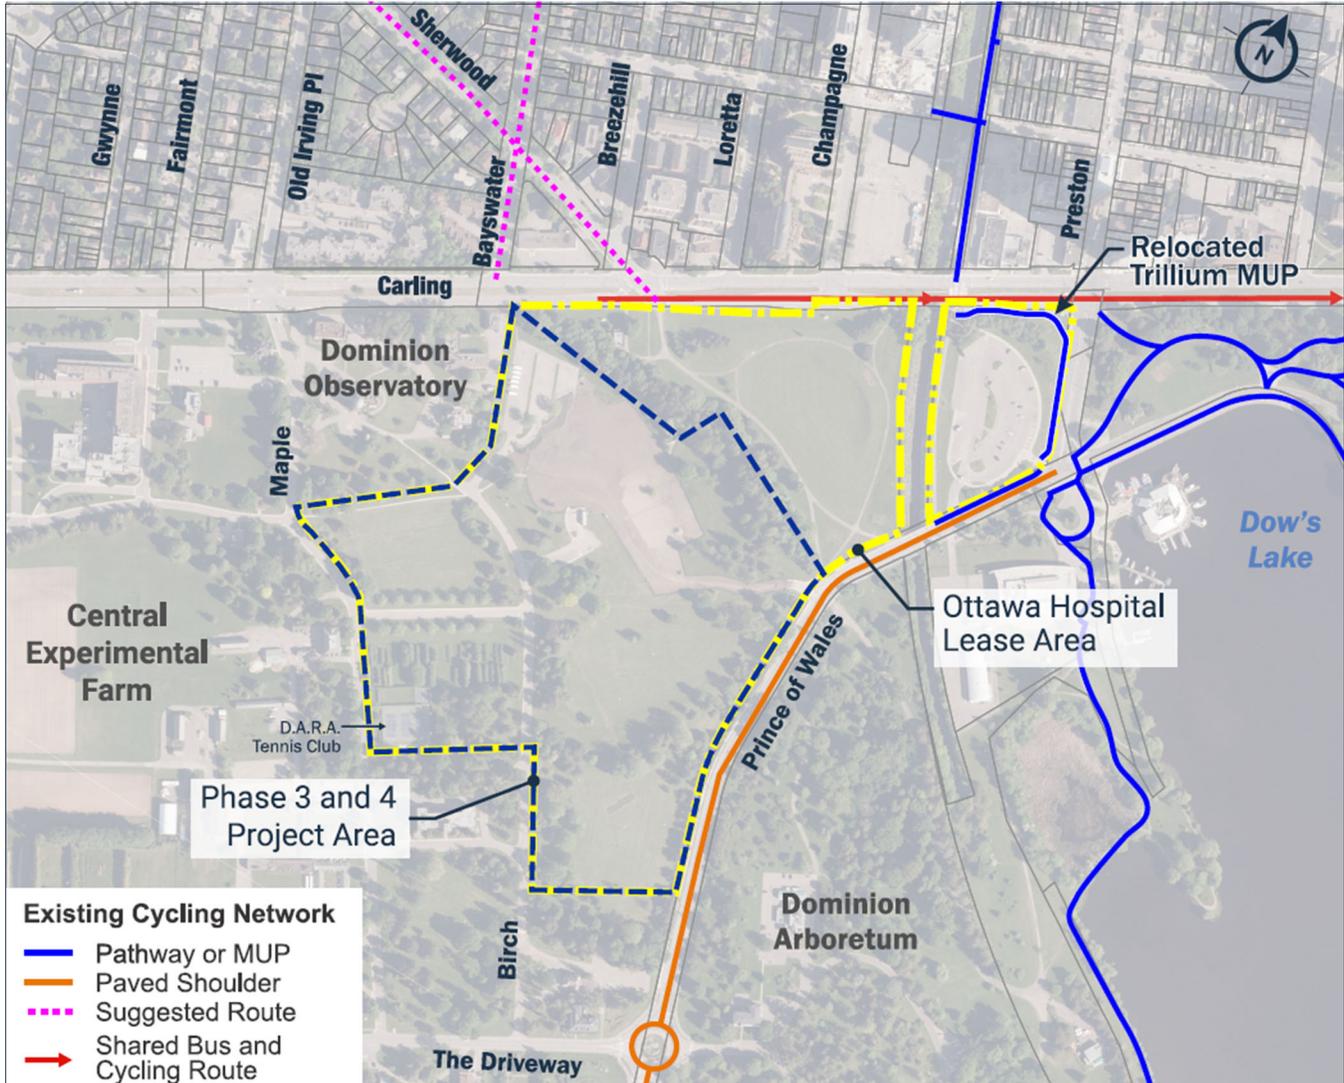
Figure 25: Existing Cycling Networks and Pathways

Numerous pathways are present within the NCD site, with the majority occurring in the eastern portion. The majority of these pathways will be replaced with the facilities proposed as part of the Phase 2 Parking Garage Project. No existing designated pathways have been identified within the Phase 3 and 4 Project Area; however the open space and grassed areas are used by the public to access the features of the site and beyond (Figure 25).

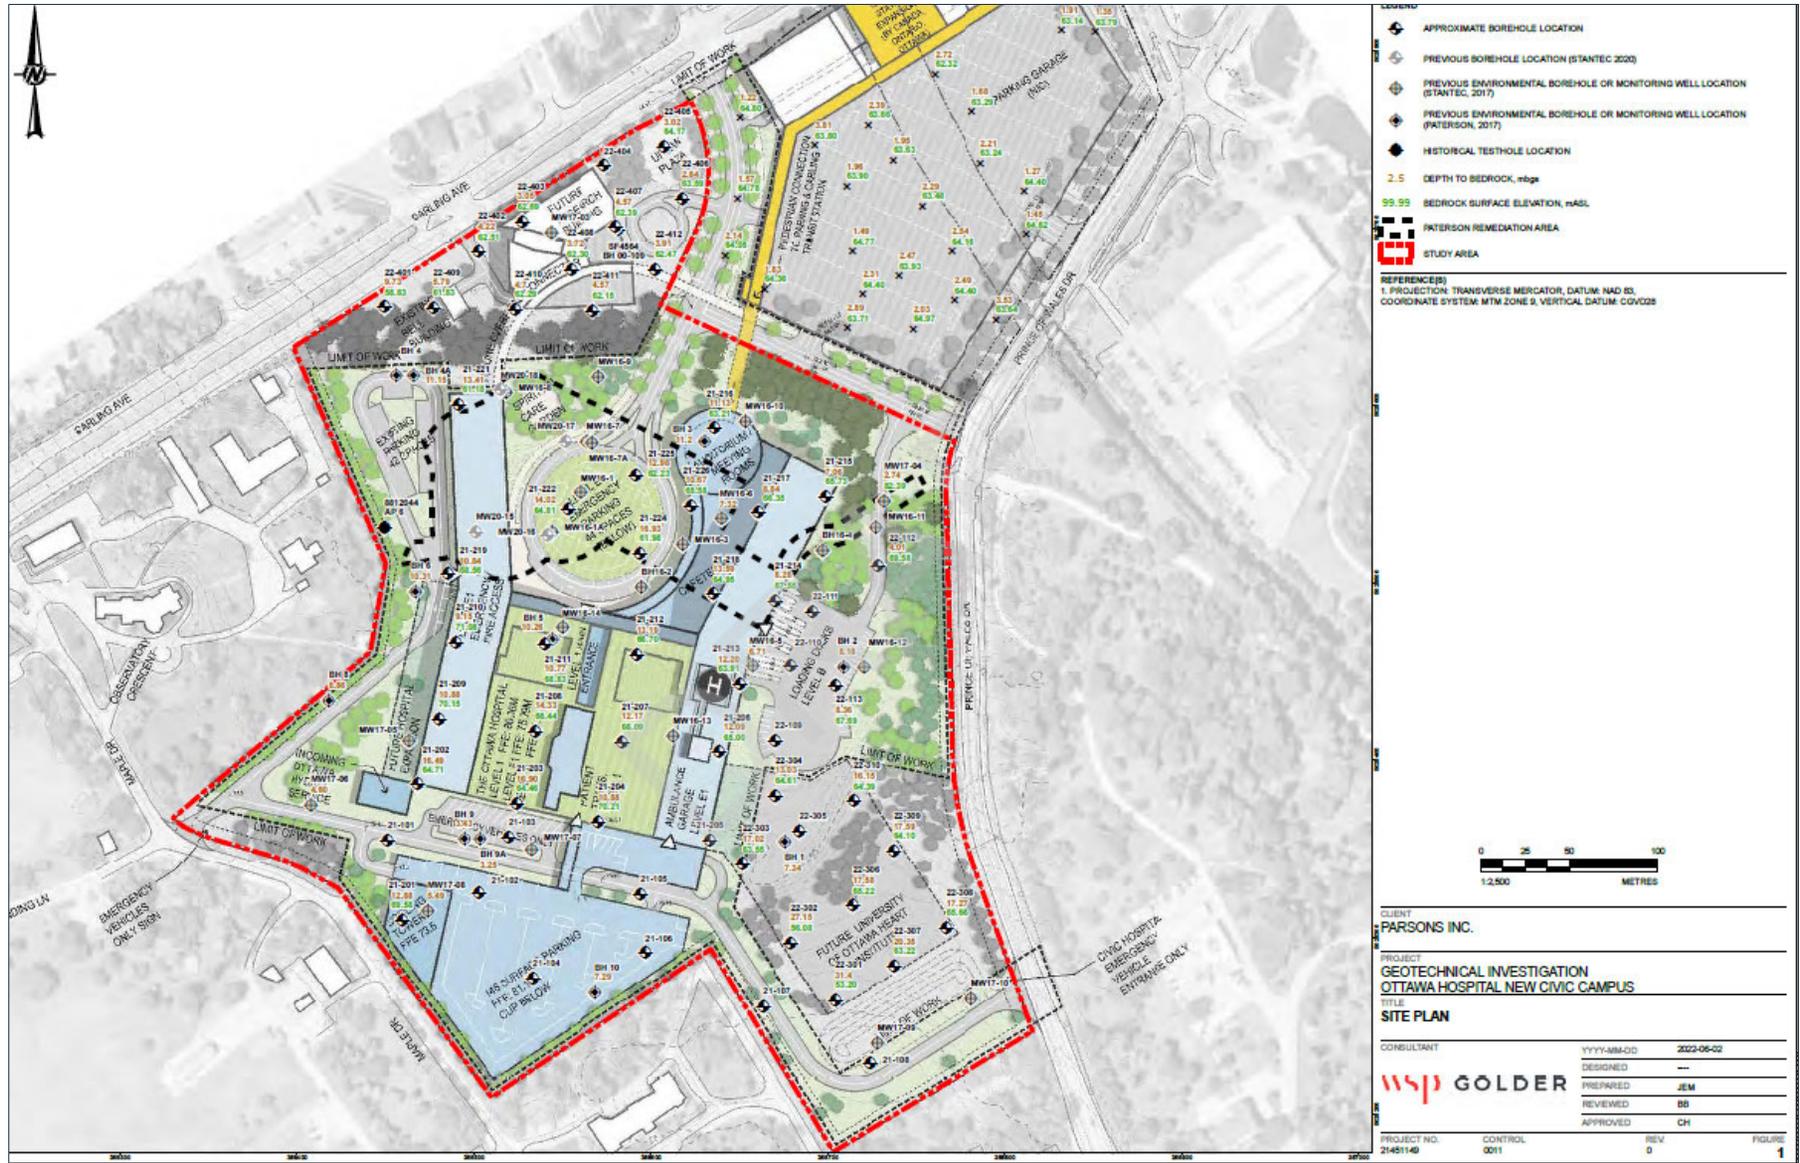
Figure 42: Borehole Locations

Subsurface conditions were confirmed within the Phase 3 and 4 Project Area through previous borehole information as well as 23 confirmatory boreholes (Golder, 2022a) (**Figure 42**). Boreholes in this area encountered topsoil, variable deposits of fill, overlying localized areas of silty clay, glacial till and silty sand/sand and gravel deposits over bedrock; bedrock was encountered between 2.7 m and 16.9 m below the ground surface. Additionally, groundwater levels were obtained through the installation of 14 monitoring wells and through previous investigations undertaken. Groundwater levels generally ranges from 1 m to 9.25 m below the ground surface. A technical Memorandum prepared by Golder/WSP (Golder, 2022b, WSP 2023a) provided preliminary estimates of groundwater inflow to the excavations related to the Main Hospital and CUP. Given the depth of the proposed excavations and the existing elevation of ground water levels, it is expected that significant groundwater dewatering will be required, and it will be necessary to temporarily lower the groundwater table below the depth of excavation during construction.

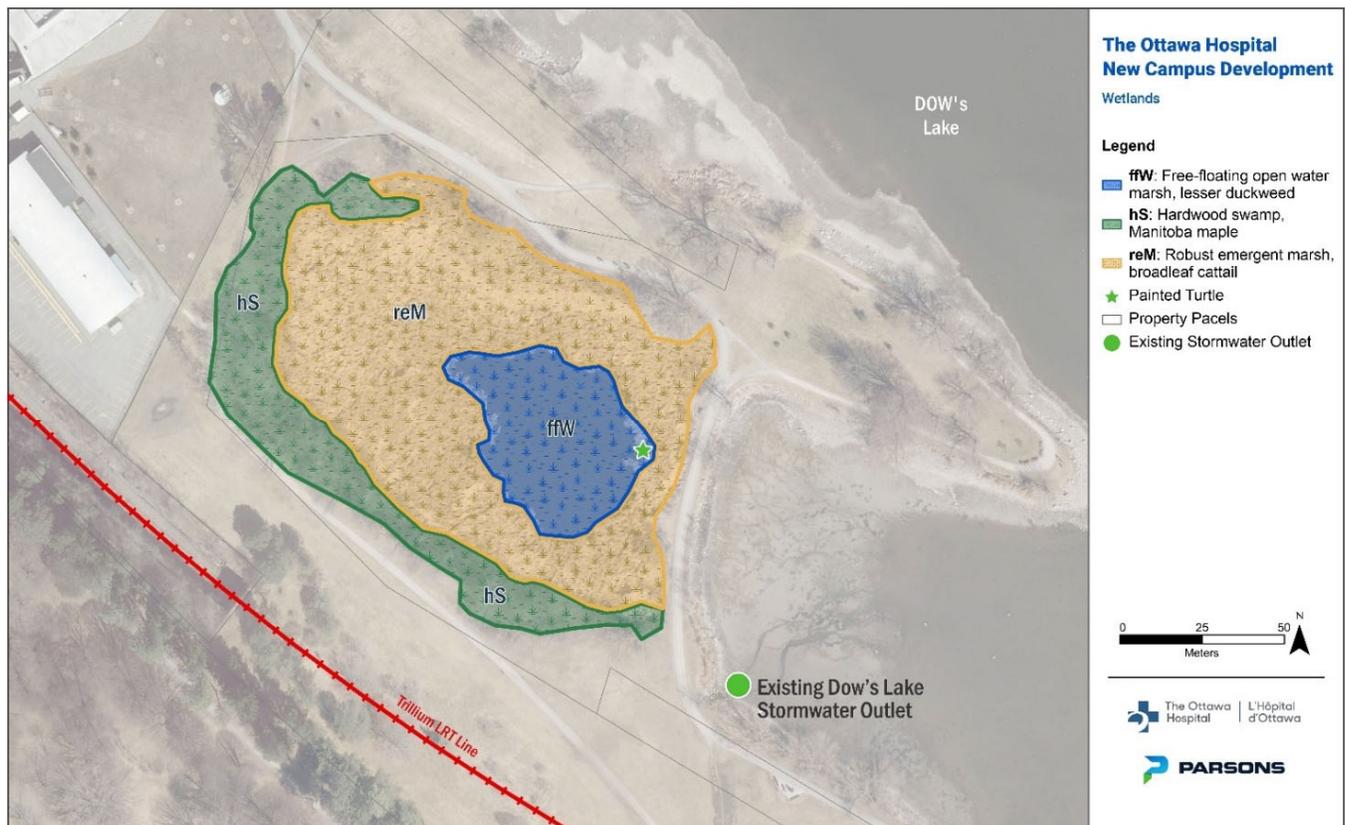
Figure 47: Dow's Lake Constructed Wetland

A constructed wetland is located 250 m from the Phase 3 and 4 Project limits and is not connected to Dow’s Lake through any outlets, culverts, or pipes, and is not impacted by the annual flooding and draining of the Rideau Canal and Dow’s Lake, as such not impacted by any changes in storm water discharge to Dow’s Lake. Prior to 1976, the current wetland area was hydraulically connected to Dow’s Lake. This wetland is a robust emergent mineral marsh, with an open water community in the center, and bordered by a narrow deciduous swamp community. The wetland is known to provide breeding habitat for red-winged blackbird (*Agelaius phoeniceus*). Additionally, 3 midland painted turtles (*Chrysemys picta marginata*) and American redstart (*Setophaga ruticilla*) fledglings were observed during site visits. As this wetland is not within the Project Area and is not hydrologically connected to any identified stormwater outlets, no impacts to this feature are anticipated. In accordance with The Federal Policy on Wetland Conservation (Government of Canada, 1991) there will be no loss of wetland area or function associated with the project. **Figure 47** illustrates the location of the Dow’s Lake constructed wetland and the associated vegetation community.

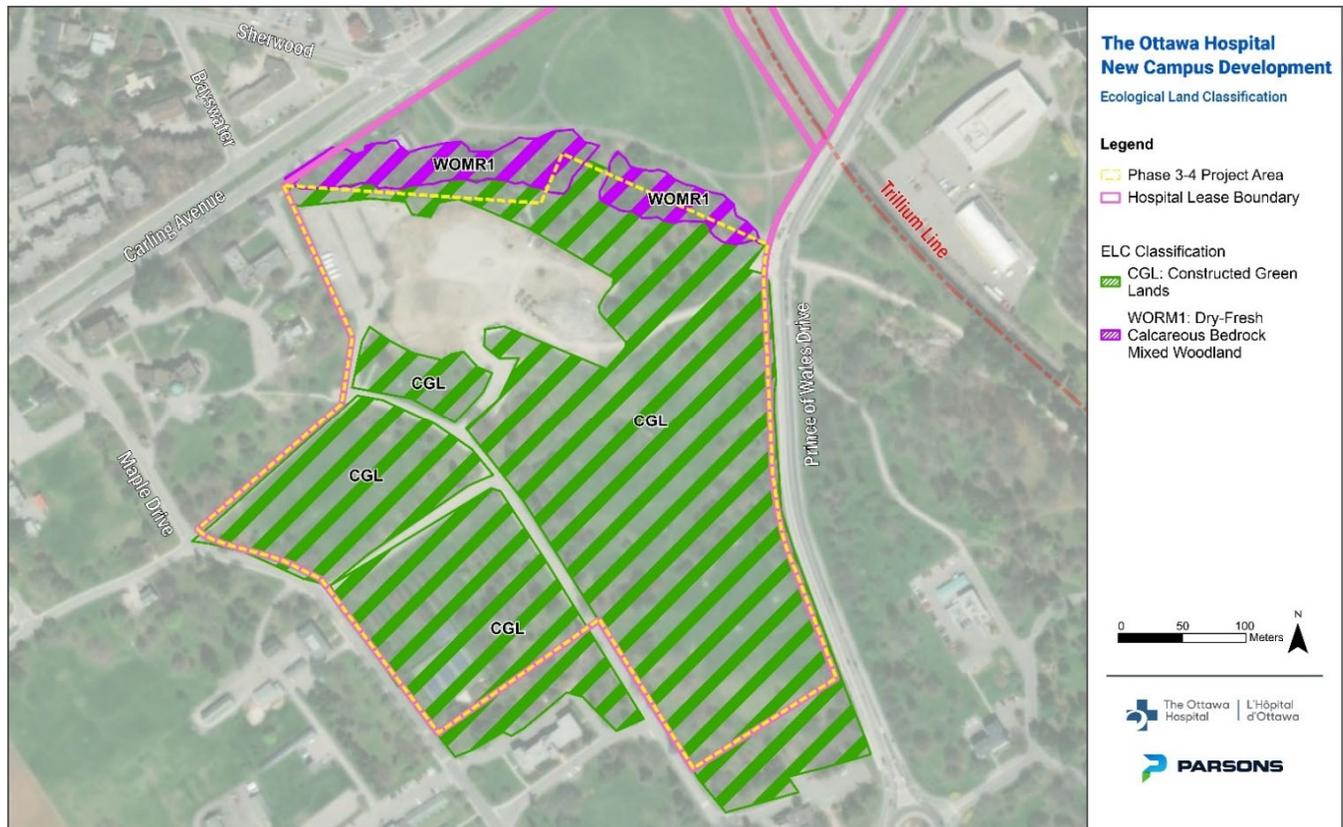
Figure 48: Vegetation Communities

ELC Ecosite	Description
Dry - Fresh Calcareous Bedrock Mixed Woodland (WOMR1)	Cultural woodland following ridgeline, with approximately 60% canopy cover. Dominated by Manitoba maple, Norway maple, and green ash along toe of slope (north), with planted white spruce (<i>Picea glauca</i>), Norway spruce (<i>Picea abies</i>), red pine (<i>Pinus rubra</i>) and white pine (<i>Pinus strobus</i>) along the crest of the ridge (south). Common buckthorn and dog-strangling vine is dominant in the understory.
Constructed Green Lands (CGL_4)	Manicured lawn with clusters of planted trees and shrubs. Groundcover is dominated by turf grasses and occasional non-native wildflowers.
Transportation (CVI_1)	Paved roadways and parking lots.

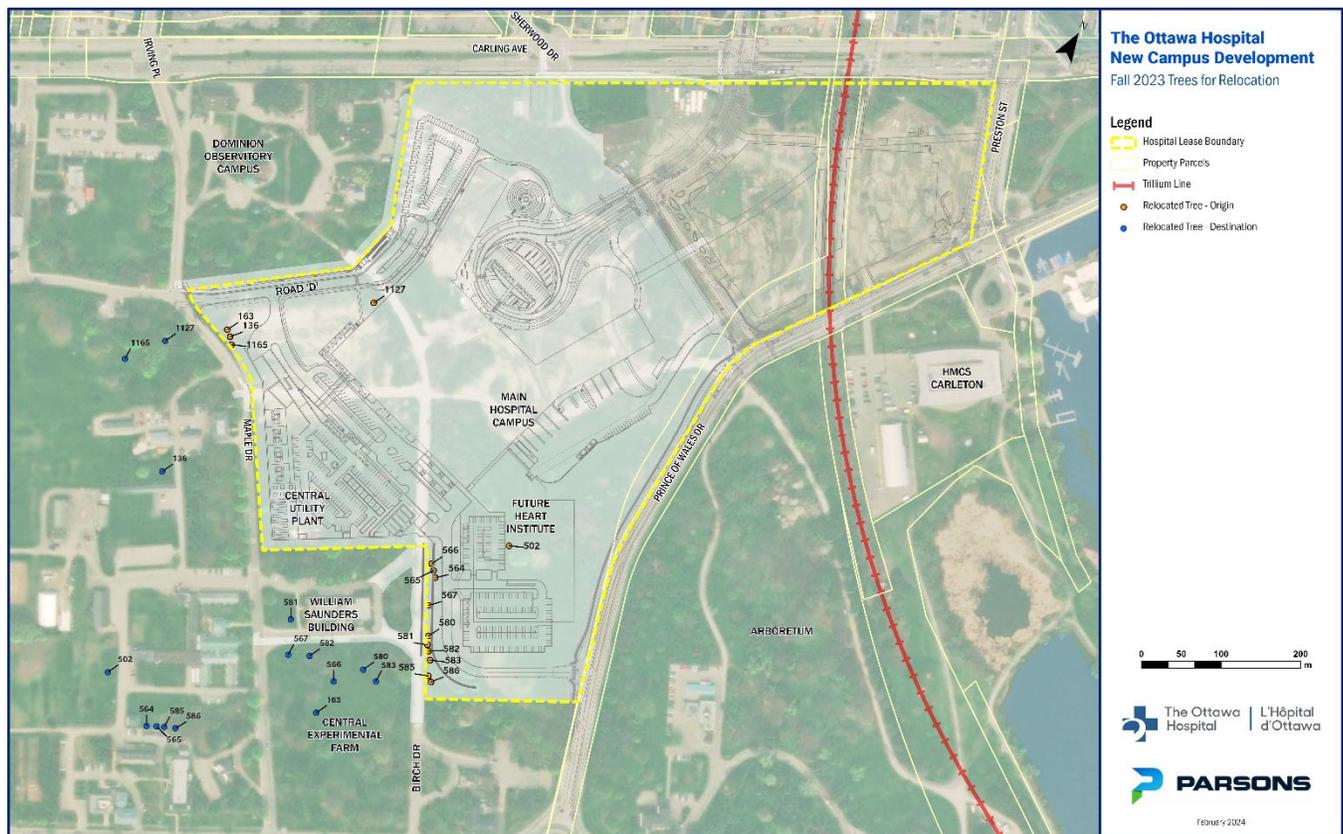
Figure 50: Proposed Phase 3 and 4 Tree Relocations

The relocated trees, including tree inventory ID#, species, DBH, condition are identified in **Table 17** and also identified within the Tree Inventory found in **Appendix C**.

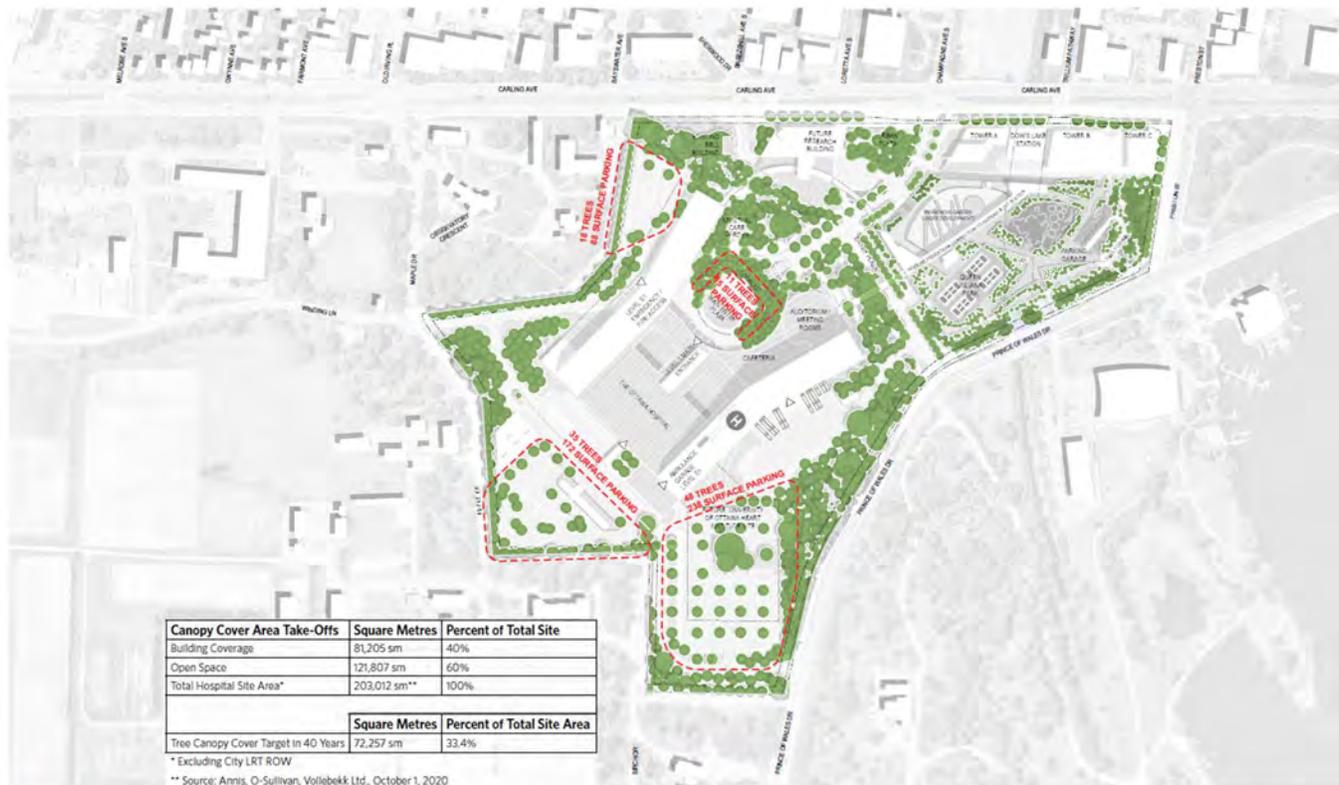
Figure 3: Master Site Plan Canopy Cover Plan

A Master Tree Canopy Cover Plan (**Figure 3**) was approved as part of the Site Plan Control and Federal Land Use and Design Approval for the Master Site Plan that illustrates an estimated layout of 30% canopy cover at-grade recognizing that additional cover may be achieved on the green roof of the parking garage as well as plantings off-site. The Master Tree Canopy Cover Plan represents a high level estimate. It is not the intention to quote forecasted sizes of canopies and specifics of future landscaping plans in this document
