New Campus Development

Hospital and Central Utility Plant (Phase 3 and 4)

Final Environmental Effects Evaluation

**Environmental Impact Statement and Tree
Conservation Report Update**

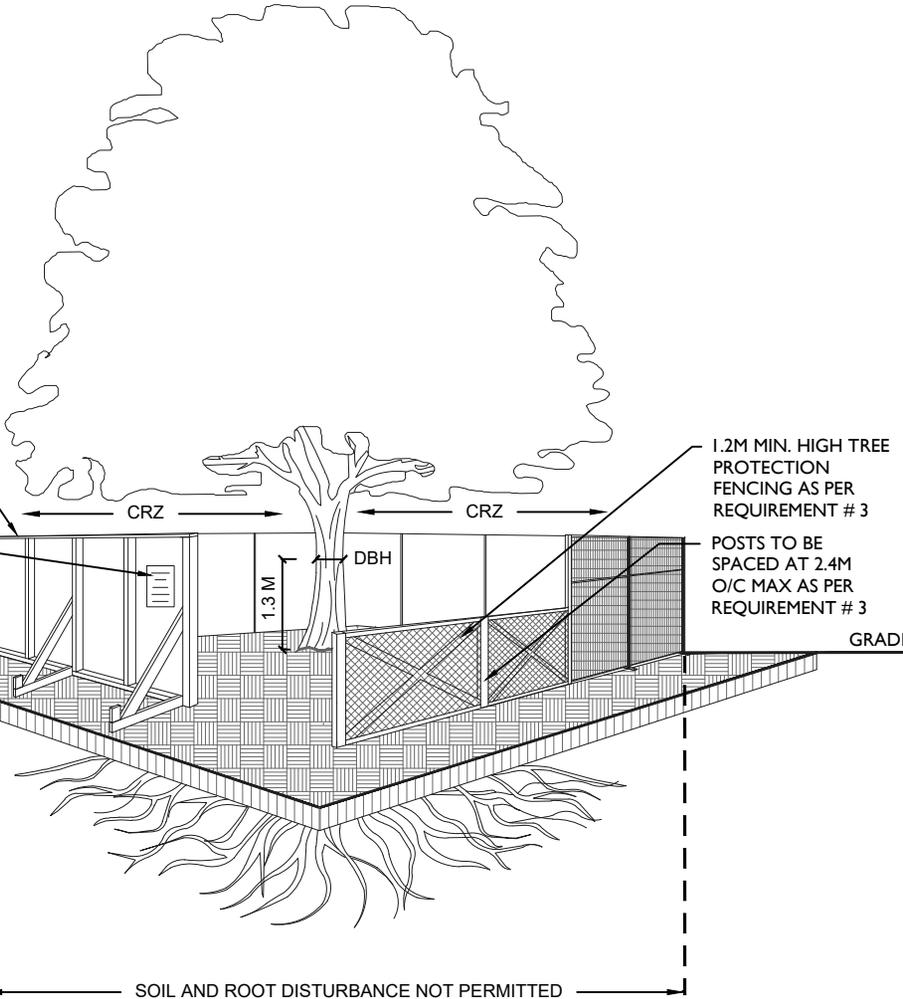
GRADE

1.2M MIN. HIGH TREE PROTECTION FENCING AS PER REQUIREMENT # 3
