Phase II Environmental Site Assessment

145 Thad Johnson Private
Ottawa, Ontario

Prepared for Jennings Developments

Report: PE6238-2
September 29, 2023

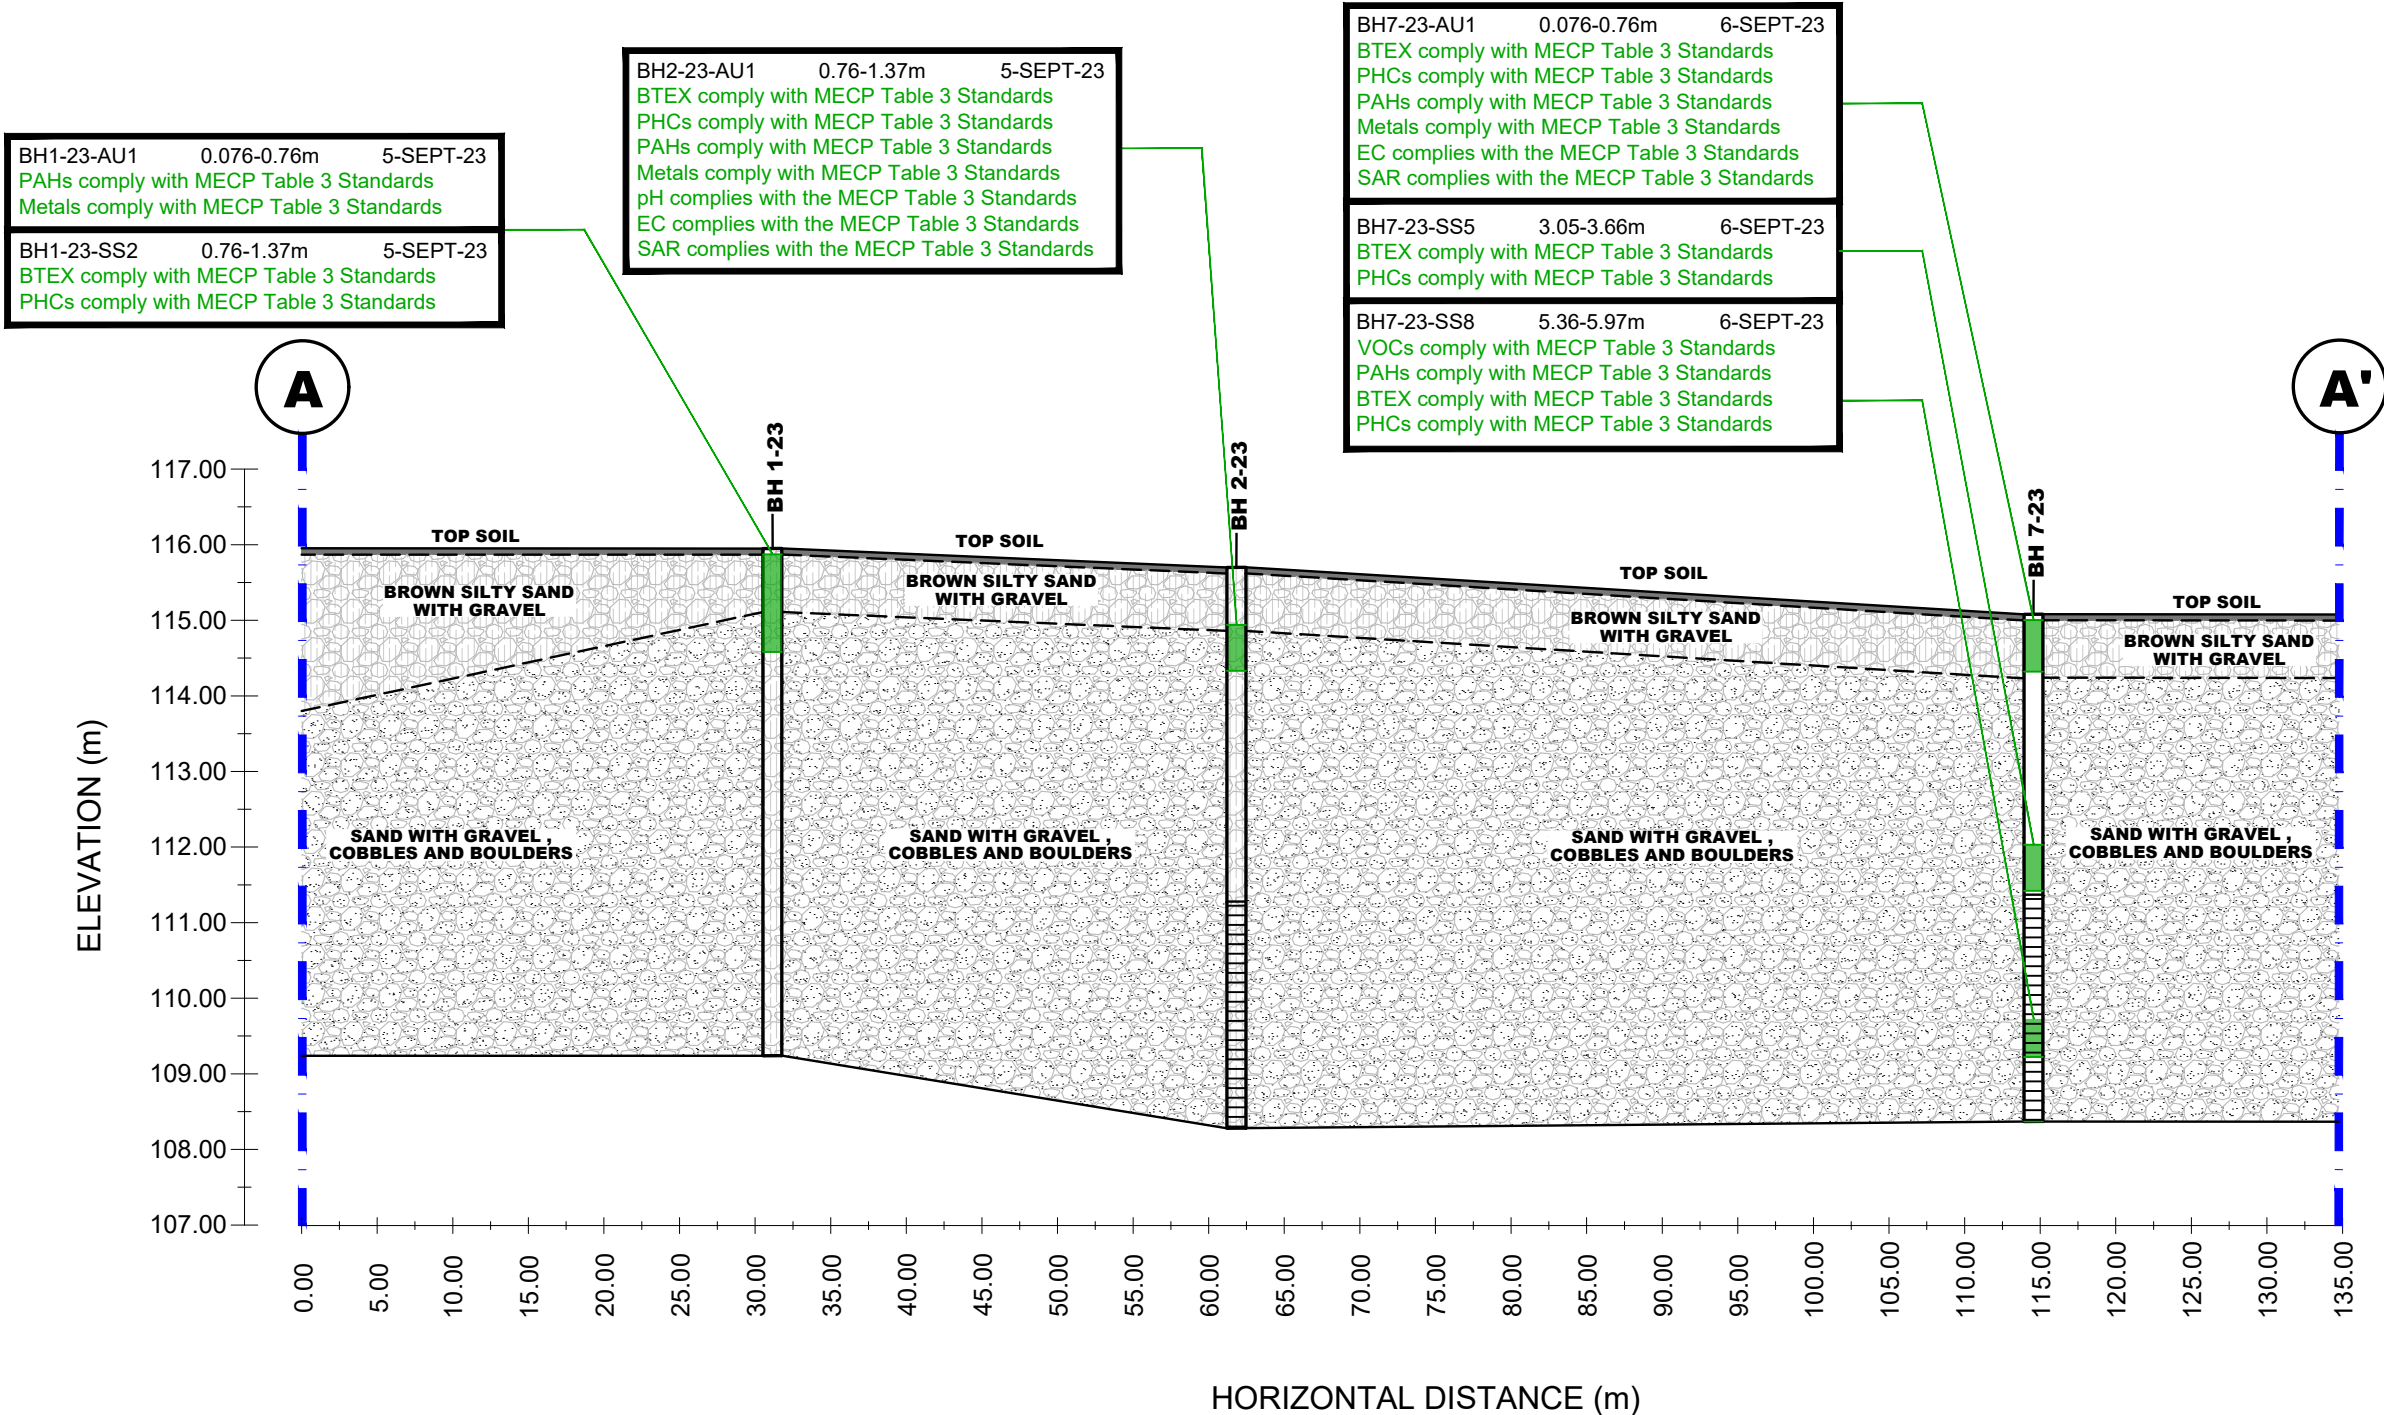
Drawing PE6238-4A – Cross-Section A-A' Plan – Soil

SOIL RESULT COMPLIES WITH THE MECP TABLE 3 STANDARDS

BH6-23-SS4	1.37-2.89m	6-SEPT-23
BTEX comply with MECP Table 3 Standards		
PHCs comply with MECP Table 3 Standards		
BH6-23-SS8	5.36-5.97m	6-SEPT-23
VOCs comply with MECP Table 3 Standards		
PAHs comply with MECP Table 3 Standards		
BTEX comply with MECP Table 3 Standards		
PHCs comply with MECP Table 3 Standards

BH7-23-AU1	0.076-0.76m	6-SEPT-23
BTEX comply with MECP Table 3 Standards		
PHCs comply with MECP Table 3 Standards		
PAHs comply with MECP Table 3 Standards		
Metals comply with MECP Table 3 Standards		
EC complies with the MECP Table 3 Standards		
SAR complies with the MECP Table 3 Standards		
BH7-23-SS5	3.05-3.66m	6-SEPT-23
BTEX comply with MECP Table 3 Standards		
PHCs comply with MECP Table 3 Standards		
BH7-23-SS8	5.36-5.97m	6-SEPT-23
VOCs comply with MECP Table 3 Standards		
PAHs comply with MECP Table 3 Standards		
BTEX comply with MECP Table 3 Standards		
PHCs comply with MECP Table 3 Standards

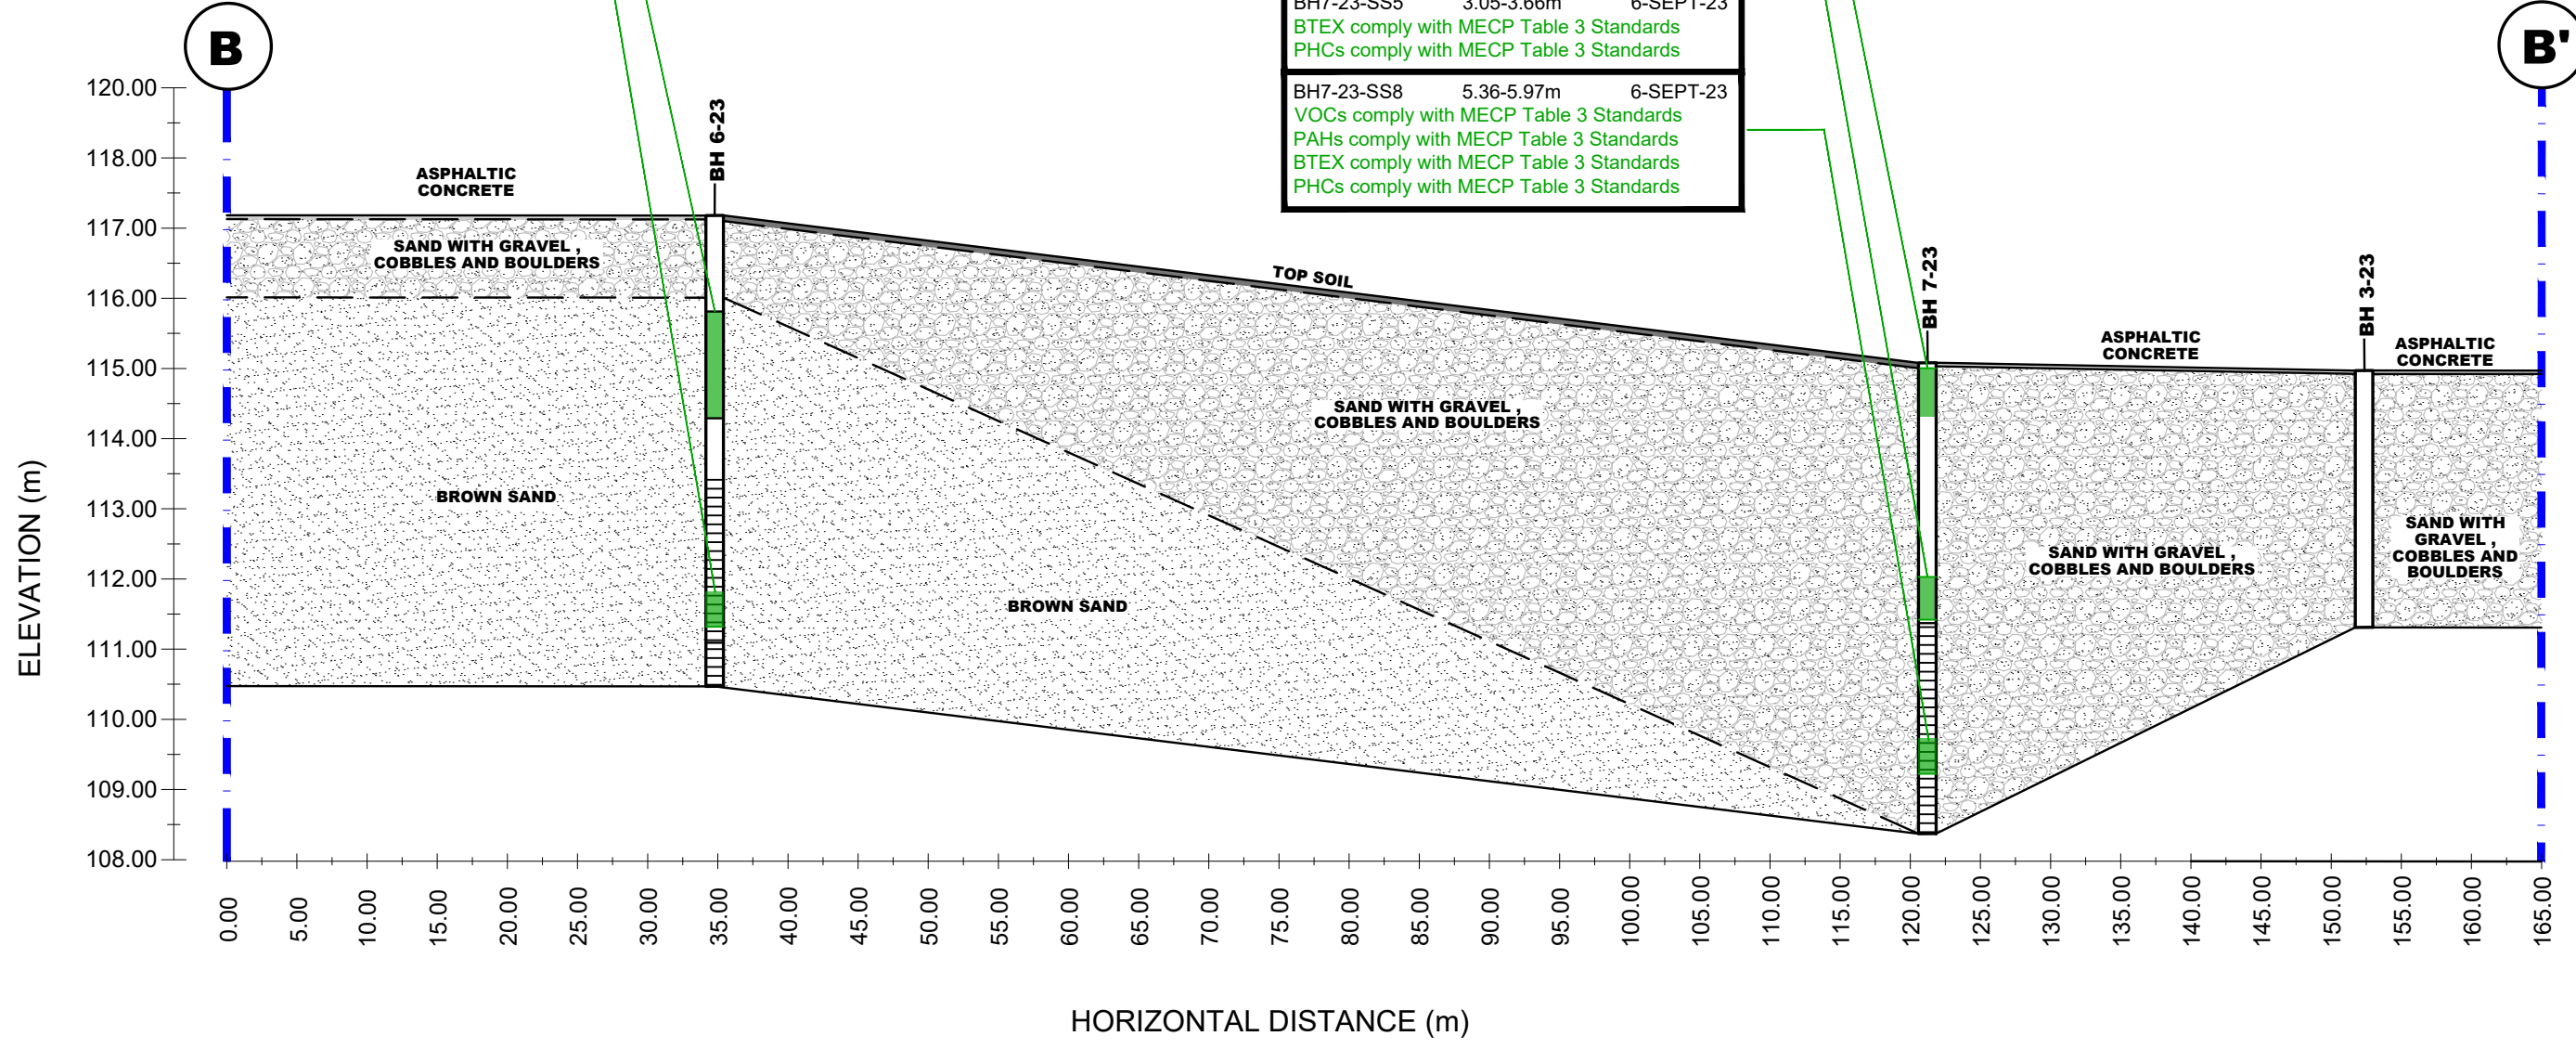
Drawing PE6238-4B – Cross-Section B-B' Plan – Soil

SOIL RESULT COMPLIES WITH THE MECP TABLE 3 STANDARDS
