Muncaster
Environmental
Planning Inc.

**RE: 1540 Star Top Road, Gloucester
Environmental Impact Study - Updated**

ENVIRONMENTAL IMPACT STATEMENT

**1540 Star Top Road
Gloucester, City of Ottawa**

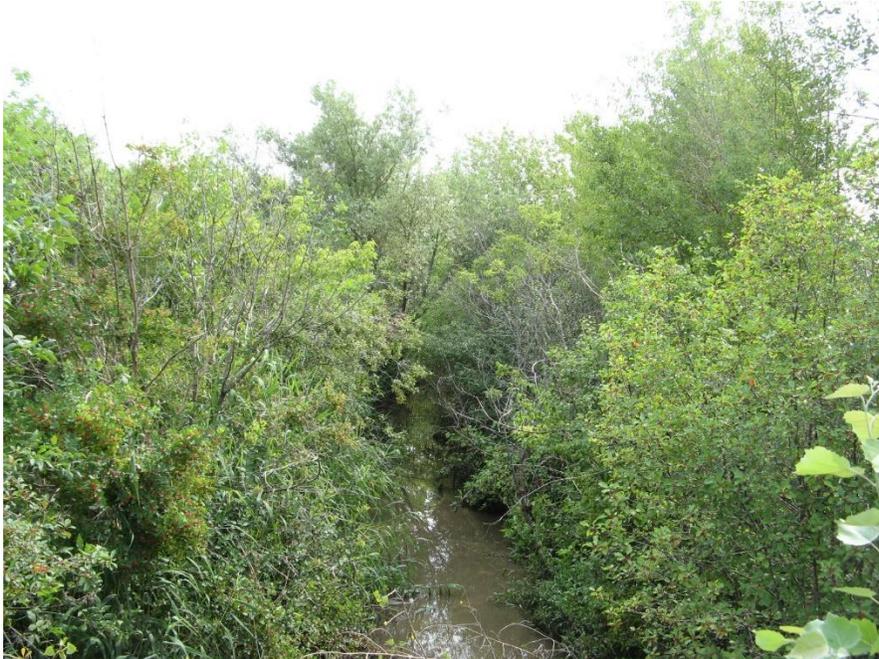
The wetted width of the South Cyrville Municipal Drain is between 2.5 and 3.5 metres. The water on July 11th was turbid (Photo 1). The canopy cover from an adjacent upland poplar deciduous forest is good in many areas. Small woody debris provides some instream habitat structure but there was no evidence of boulders, other coarse material, notable areas of aquatic vegetation, or undercut banks. The channel is straight with connecting sharp turns to the west of the site and as described above is open for approximately 750 metres.

*Photo 1 - South Cyrville Municipal Drain immediately to the north of the site.
View looking east from the northwest entrance to the site*

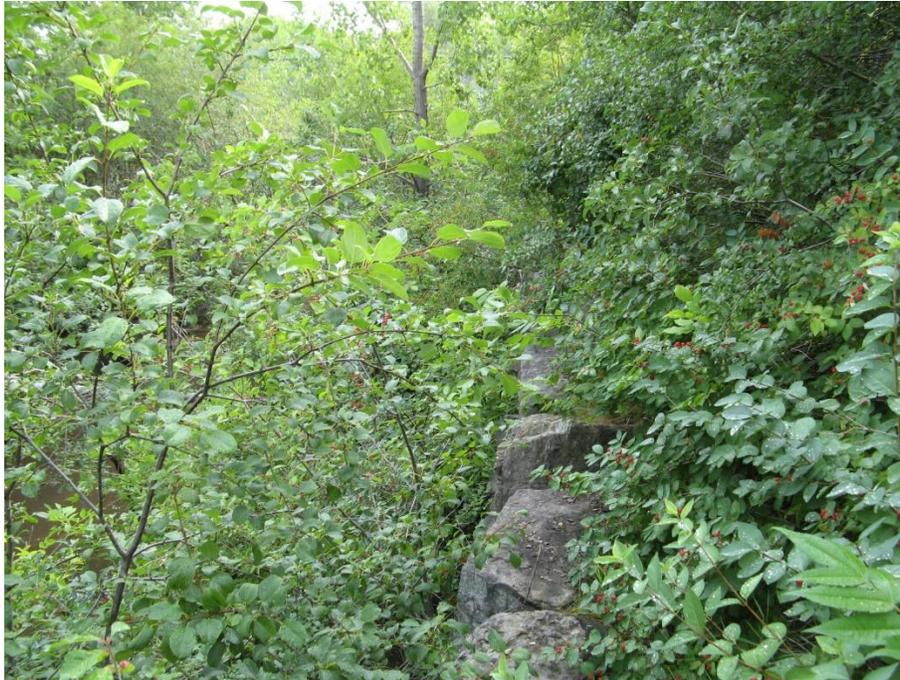
A retaining wall of large boulders is along the top of slope of both sides of the channel corridor (Photo 2). There is a setback of 7.5 metres from the retaining wall to the north edge of the site. Trembling aspens up to 30 cm diameter at breast height (dbh) are dominant in the setback, along with smaller green ash and Manitoba maple (Photos 3 and 4). The understory in the setback area is thick in most areas, with glossy buckthorn dominant in areas and staghorn sumac, red-osier dogwood, and tartarian honeysuckle common, along with regenerating stems of poplar, ash, and Manitoba maple. A chain-link fence is around the north and south edges of the channel setback and two surface connections crossing the channel between 1282 Algoma Road and the site (Photo 4). A gate in the fencing between the two crossing along the north site boundary provides access to the corridor, including for the plantings recommended below.

Photo 2 – South side of the Municipal Drain corridor to the north of the site, with large boulder retaining wall. View looking east, with site beginning 7.5 metres from wall

Although much less than a typical setback, a setback of 7.5 metres from the retaining wall top of slope to the south edge of the riparian corridor is considered suitable due to the highly disturbed nature of the channel, including limited exposed reaches, straight alignment that was excavated and associated artificial cross-section. The 7.5 metres setback is greater than that provided for other open sections of the Drain to the west of the site. The drain is enclosed to the east of Star Top Road.

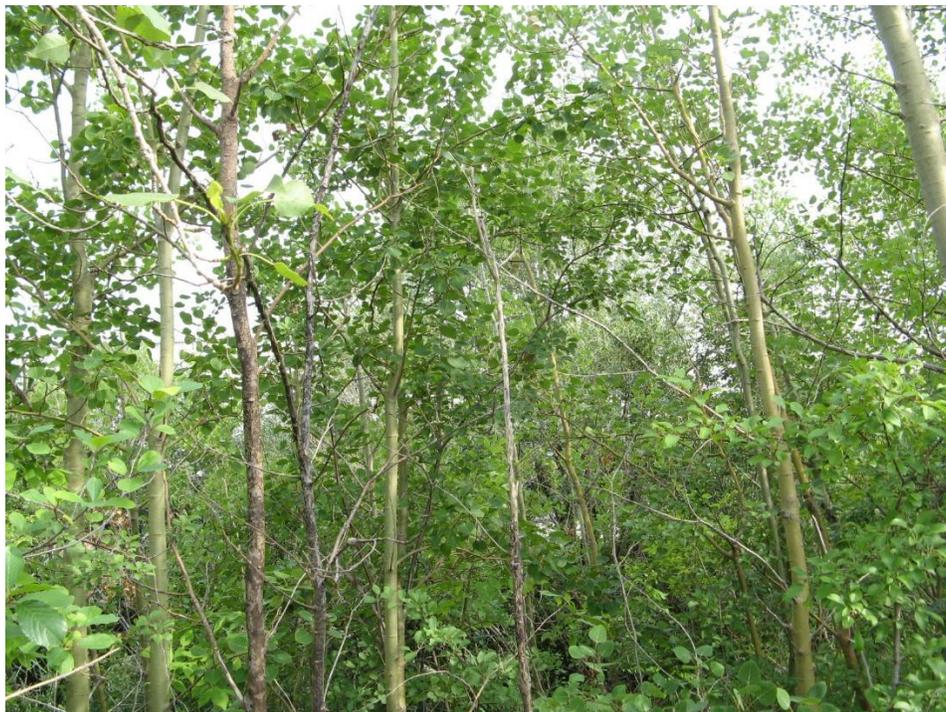
Photo 3 – The corridor between the Municipal Drain and the site is generally well treed with young poplars. View looking north from the centre of the north property line

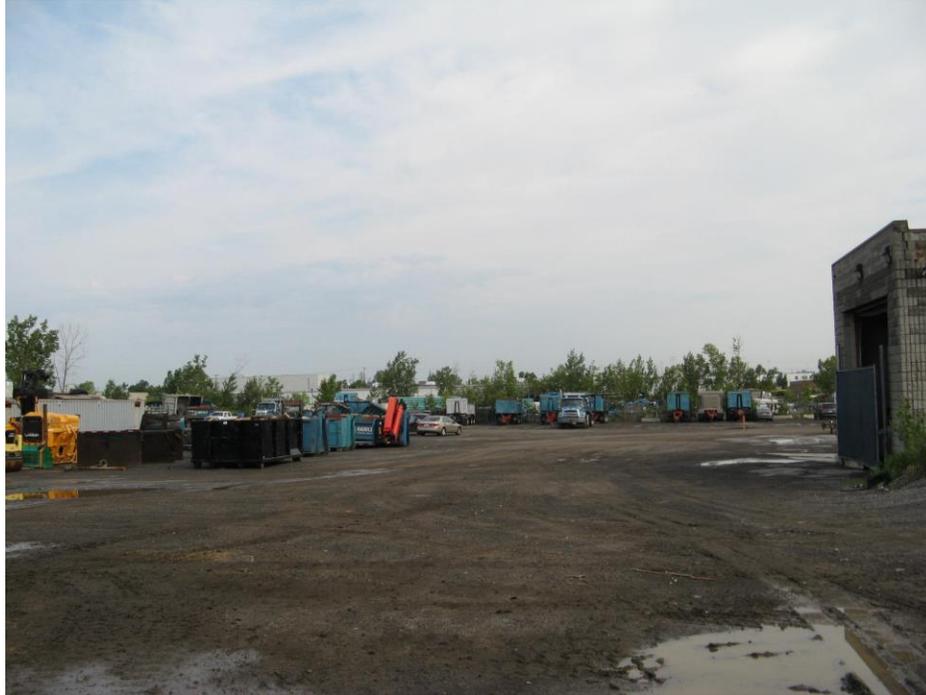
The site is dominated by fill material with a generally level topography (Photo 6). Paterson (2023) identified crushed stone, topsoil, brown silty sand, trace clay and occasional gravel in the fill. Bedrock consisting of black shale was noted by Paterson (2023) at depths ranging between approximately 1.9 to 2.9 metres below grade. Similarly, Paterson (2023) observed groundwater depths between approximately 1.9 and 2.9 metres below the existing ground surface, with groundwater flow generally in a northern direction.

Photo 6 – West portion of the site looking north from south edge

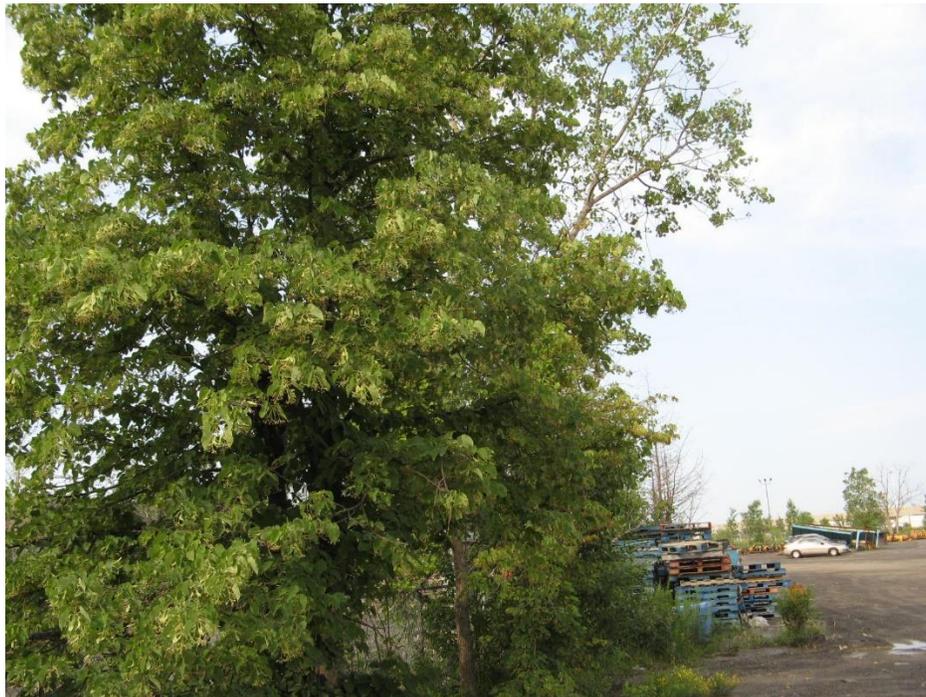
Scattered regenerating deciduous trees are along portions of the site boundaries and these areas are referred to as intermittent deciduous hedgerows on Figure 1. Trembling aspens are dominant, with eastern cottonwood well represented and green ash, white elm, and linden also present (Photo 7). Regenerating poplar, birch, ash, linden, and white poplar stems are among the intermittent hedgerow trees, along with staghorn sumac, Bebb's willow, red-osier dogwood, tartarian honeysuckle, and glossy buckthorn shrubs. The largest trees in the intermittent hedgerows are cottonwood and trembling aspen up to 32cm dbh. Many of the white elms are dead and leaf-out is greatly reduced on many of the poplars. The larger eastern cottonwoods along the west ditch appear dead as well. Wild grape coverage is common on the lower portions of some of the trees.

Photo 7 – Cottonwood along southeast boundary of the site. View looking west

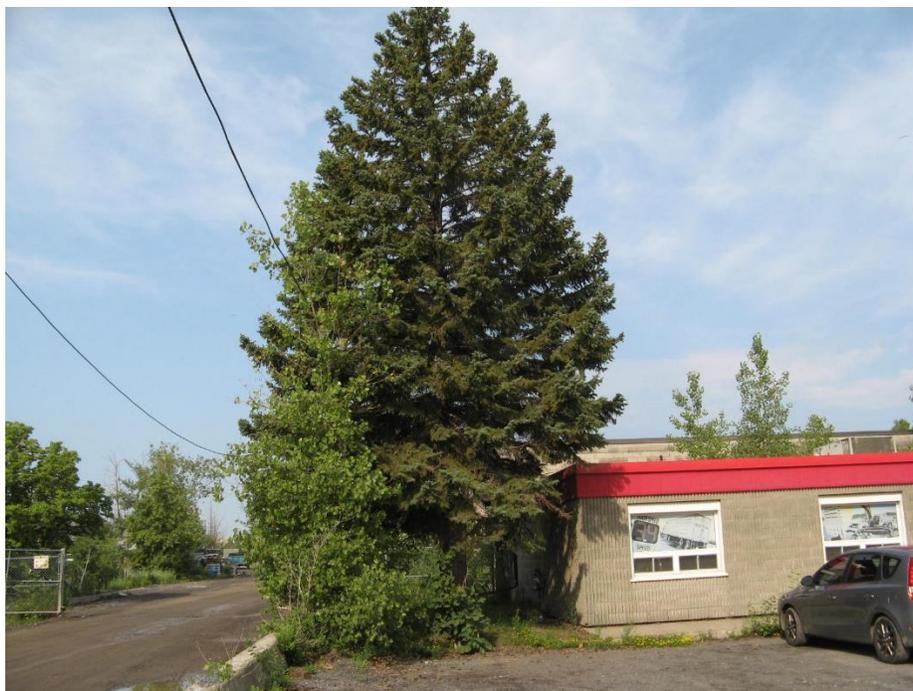
A twin-stem bur oak, with individual stems up to 30cm dbh and a 48cm dbh white spruce are adjacent to the existing office building west of Star Top Road (Photo 8).

Photo 8 – White spruce in the east portion of the site, west of Star Top Road was the largest tree observed on or adjacent to the site. View looking west

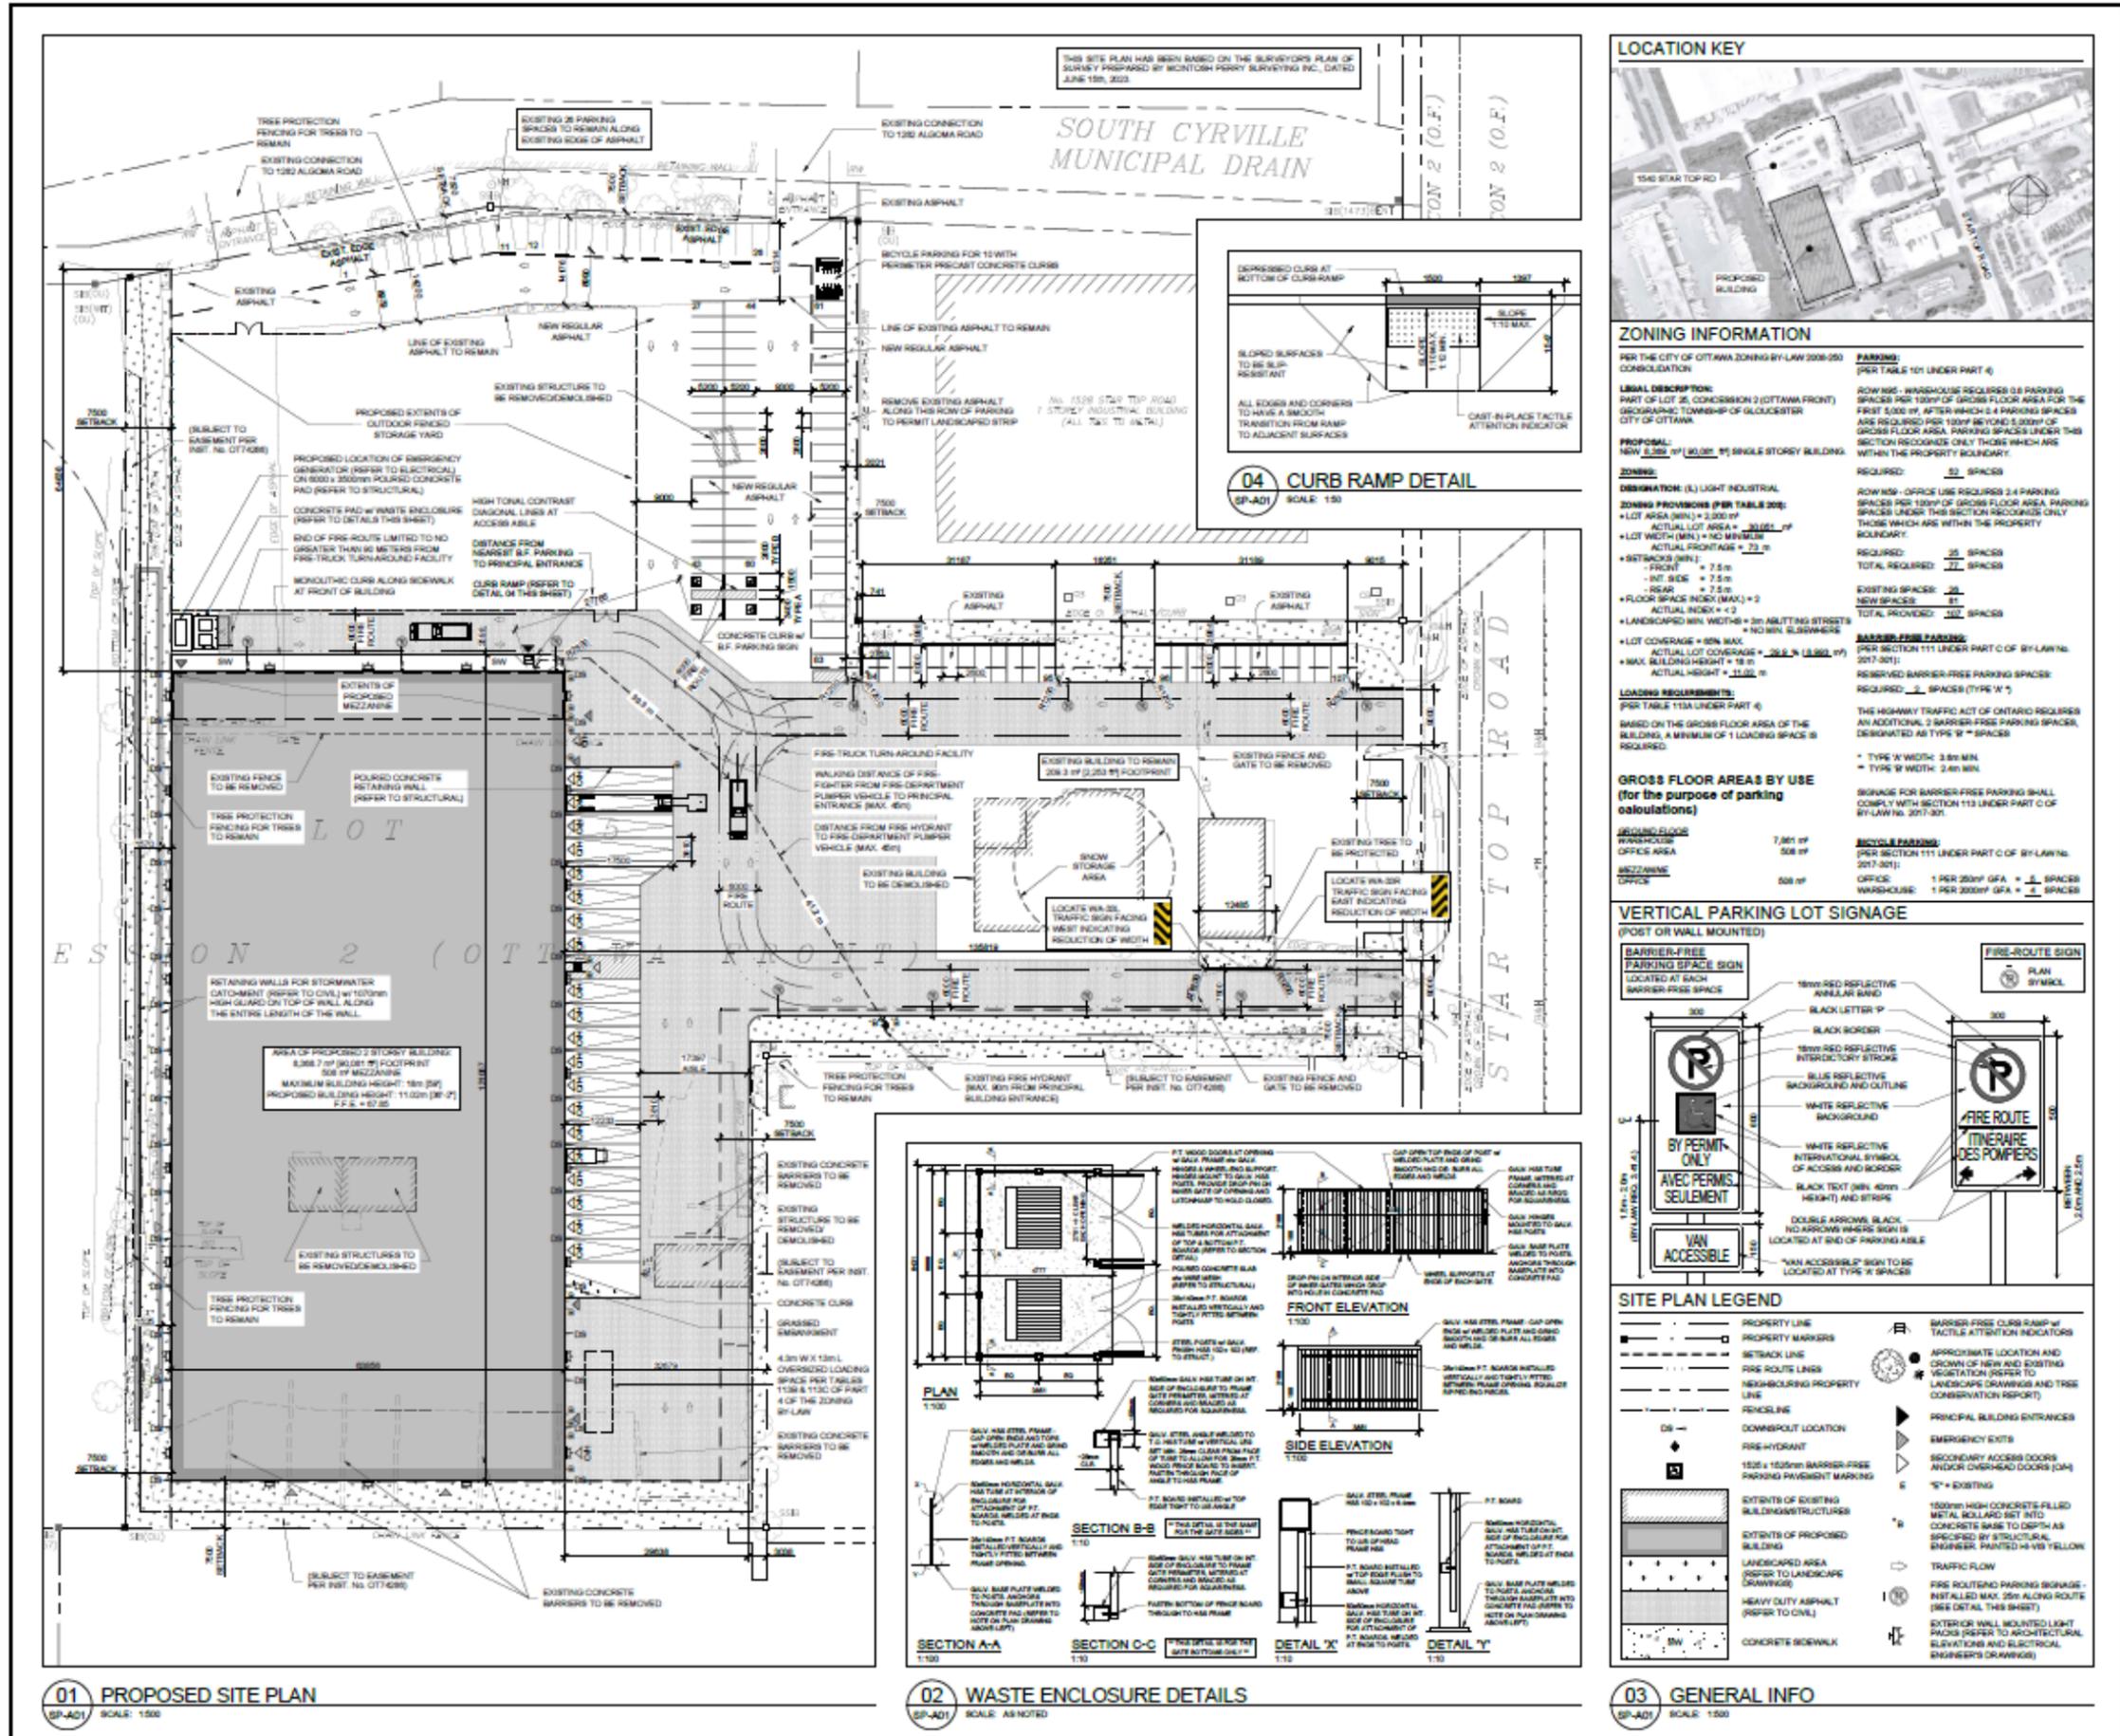
FIGURE 2 – SITE PLAN (by Deimling Architecture & Interior Design, Revised March 26th, 2024)

It is proposed to construct a two storey building in the west portion of the site, with a footprint of approximately 90,000 sq ft (Figure 2). This building will be on mostly existing surface storage, with two small structures to be removed. There are two existing buildings in the east portion of the site. The smaller one closer to Star Top Road will be removed, with the one to the west, approximately 6,700 sq ft., to be retained. One-hundred and eight surface parking spaces will be provided, with the balance of the site to be used for access and an outdoor fenced storage yard.
