Phase One Environmental Site Assessment 7-9 Hilliard Avenue, Ottawa, Ontario

Phase One Environmental Site Assessment

OTT-21011499-E0

June 29, 2023

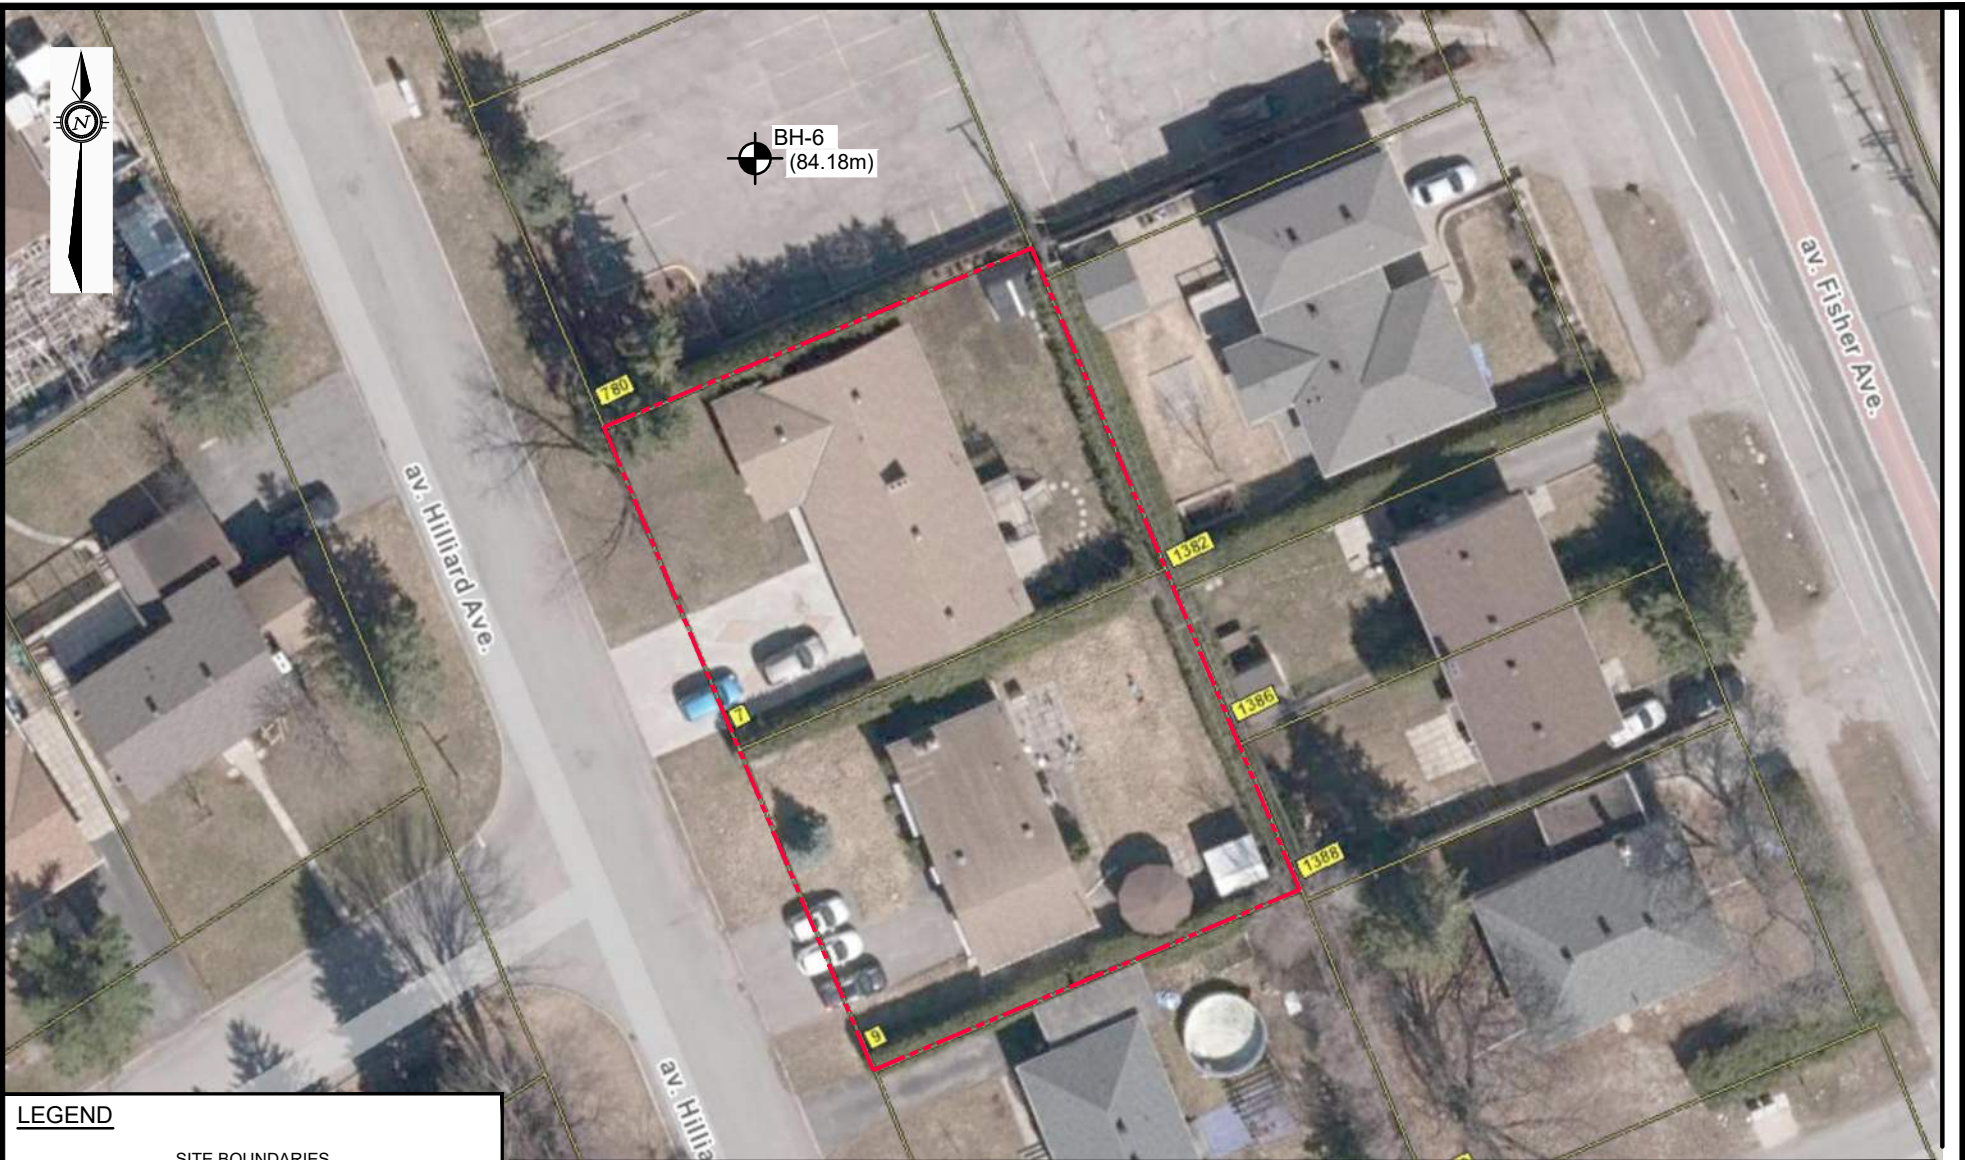
DATE JUNE 2023	PROPOSED MULTI-USE TOWERS 7-9 HILLIARD AVENUE, OTTAWA, ONTARIO	project no. OTT-21011499-E0
DESIGN LW	CHECKED MM	scale 1:500
DRAWN BY AS	PHASE ONE ENVIRONMENTAL SITE ASSESSMENT BOREHOLE / MONITORING WELL LOCATION PLAN	FIG 2

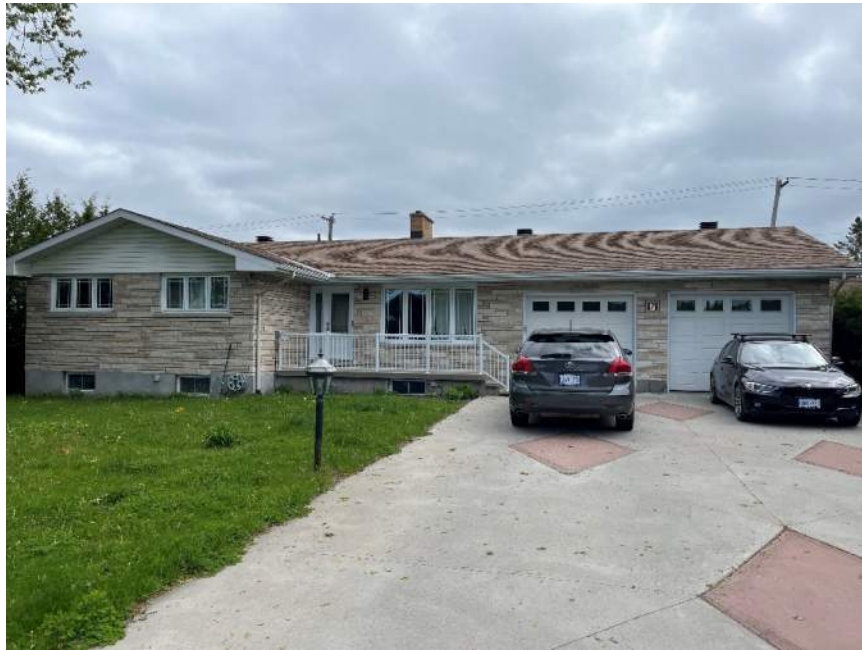
Photograph No. 1

The property at 7 Hilliard Avenue was occupied by a single storey residence with a full basement. The residence was heated via a forced air natural gas fired furnace. An air conditioning unit was present on the north side of the residence.

View of the front of 7 Hilliard Avenue.

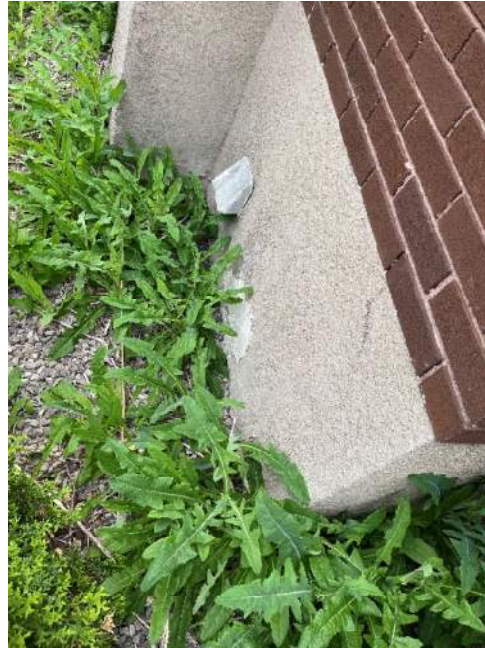
Photograph No. 7

No above ground storage tanks (ASTs) were observed at the Phase One property. It is possible based on the age of the residences that the buildings were historically heated with oil. No evidence of a former AST was observed at 7 Hilliard Avenue. A disconnected pipe, and a patched wall which may have been associated with vent/fill pipes for an AST were observed in the basement of 9 Hilliard Avenue. No staining was observed on the floor in the basement of 9 Hilliard Avenue.

Suspected location of former vent/fill pipes (removed and patched) at 9 Hilliard Avenue.

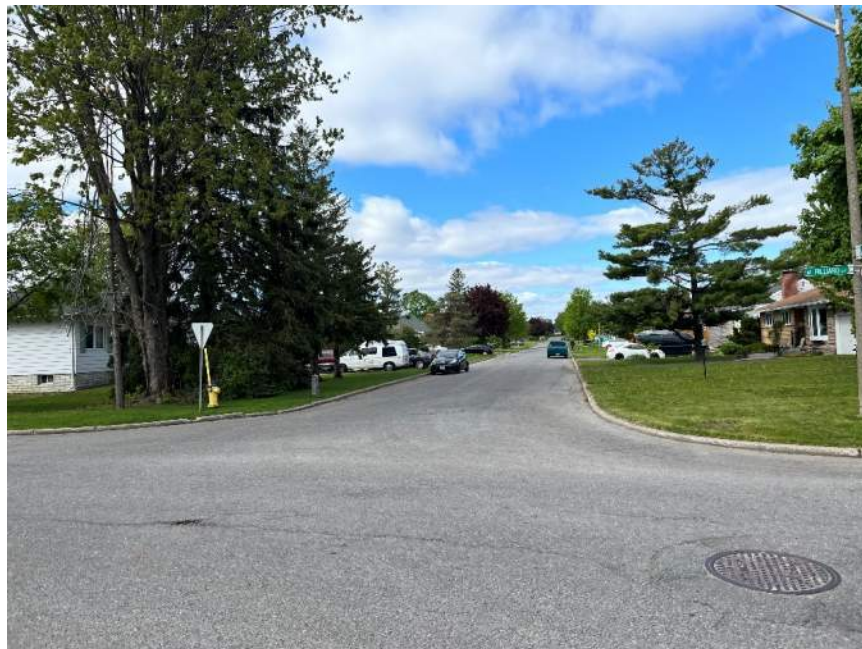
Photograph No. 8

No environmental concerns relating to the adjacent properties were found at the time of the site visit.

View of the adjacent residential properties.

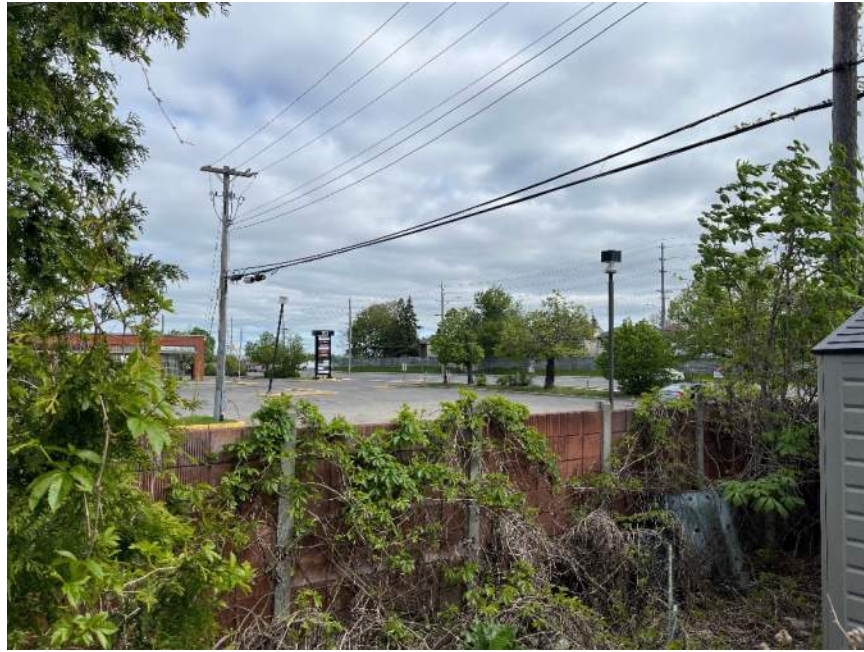
Photograph No. 9

View of the north adjacent commercial property.
