Phase I Environmental Site Assessment

2506 Innes Road
Ottawa, Ontario

Report: PE6214-1R
November 29, 2023

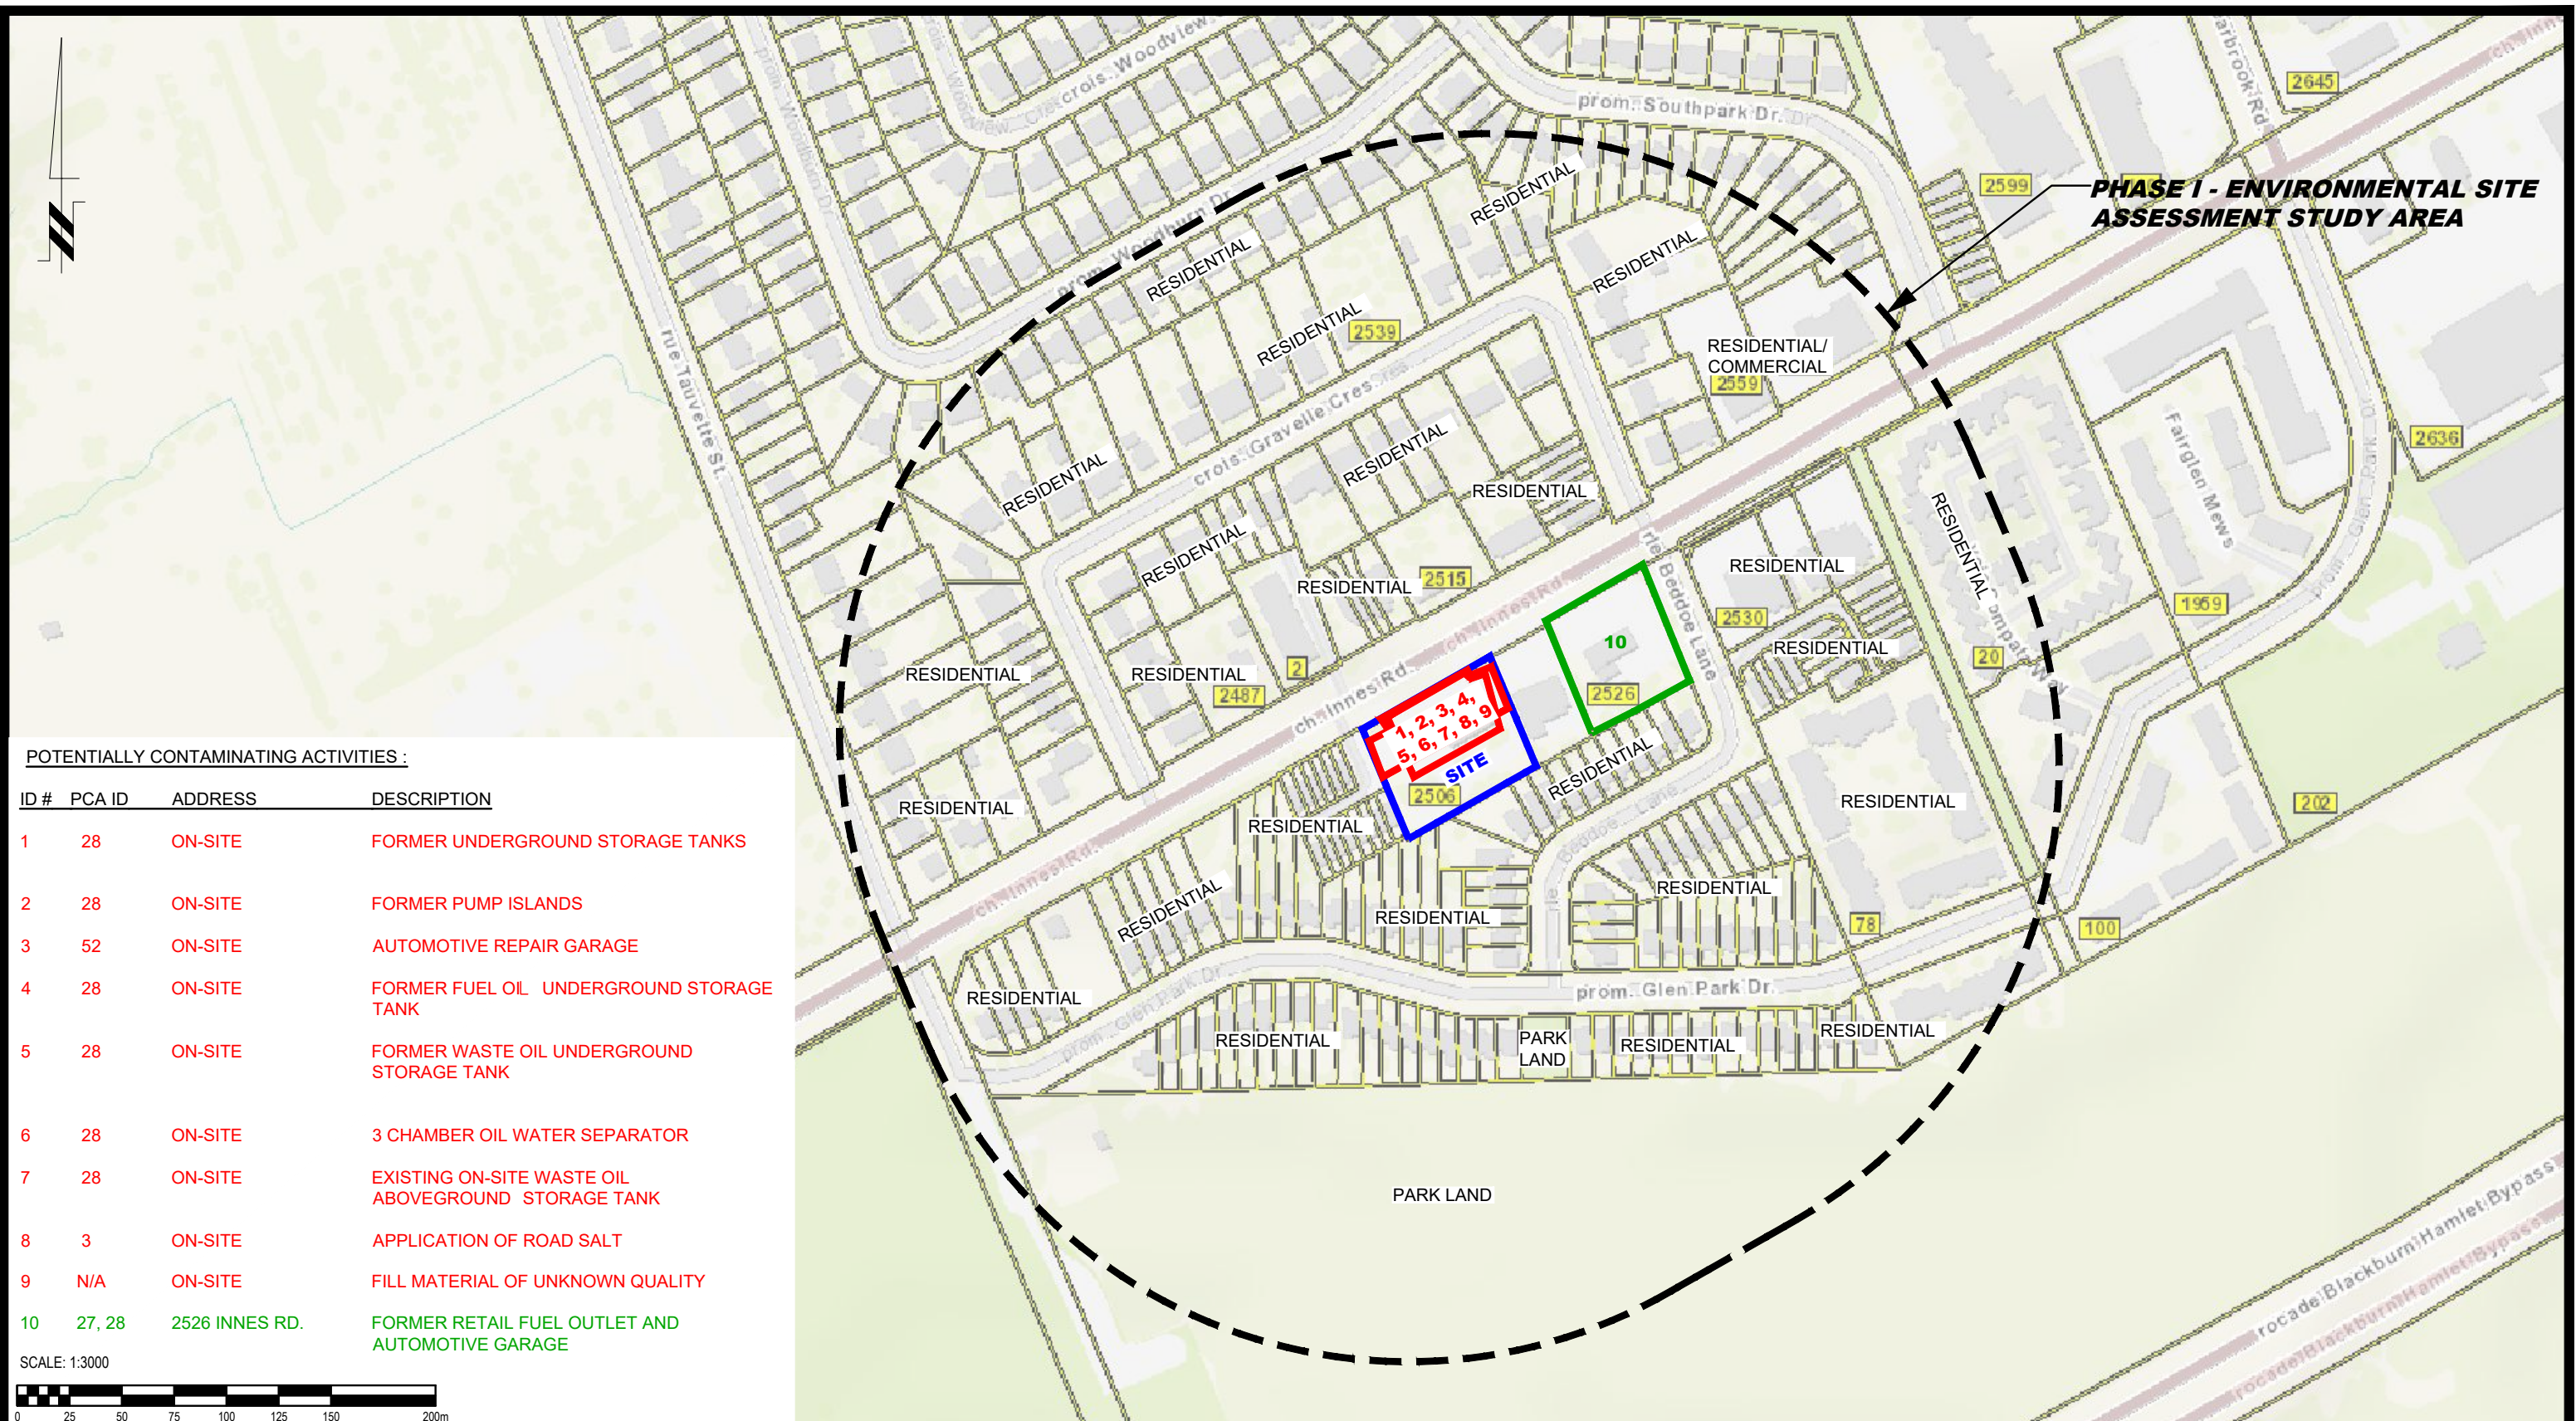
DRAWING PE6214-2 – SURROUNDING LAND USE PLAN

POTENTIALLY CONTAMINATING ACTIVITIES :

ID #	PCA ID	ADDRESS	DESCRIPTION
1	28	ON-SITE	FORMER UNDERGROUND STORAGE TANKS
2	28	ON-SITE	FORMER PUMP ISLANDS
3	52	ON-SITE	AUTOMOTIVE REPAIR GARAGE
4	28	ON-SITE	FORMER FUEL OIL UNDERGROUND STORAGE TANK
5	28	ON-SITE	FORMER WASTE OIL UNDERGROUND STORAGE TANK
6	28	ON-SITE	3 CHAMBER OIL WATER SEPARATOR
7	28	ON-SITE	EXISTING ON-SITE WASTE OIL ABOVEGROUND STORAGE TANK
8	3	ON-SITE	APPLICATION OF ROAD SALT
9	N/A	ON-SITE	FILL MATERIAL OF UNKNOWN QUALITY
10	27, 28	2526 INNES RD.	FORMER RETAIL FUEL OUTLET AND AUTOMOTIVE GARAGE

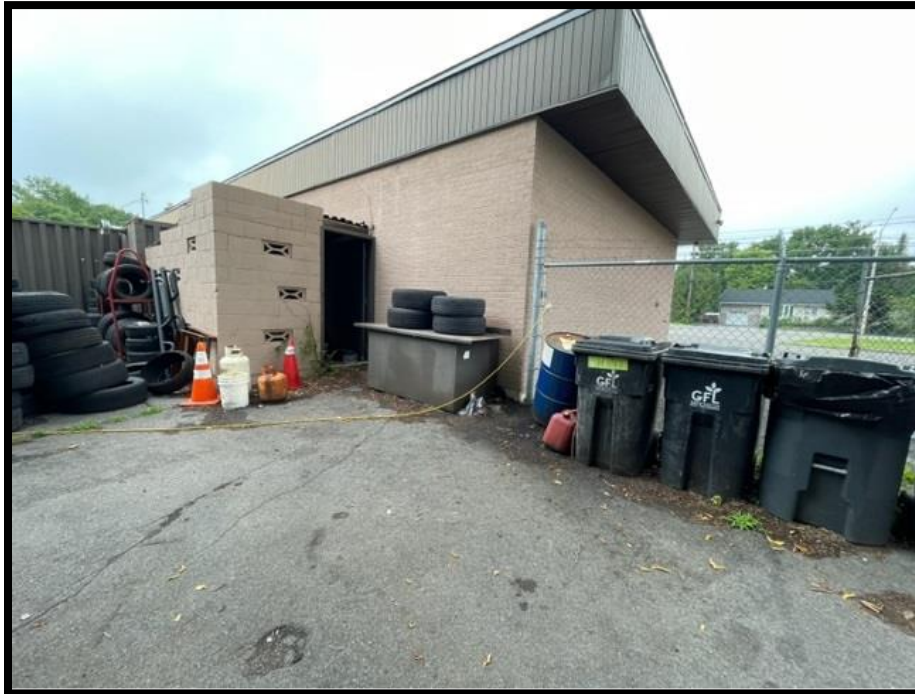
One waste oil AST was noted on the eastern side of the south exterior wall of the subject building. Some minor staining was noted on the ground surface in the immediate area of the AST.

Photograph 7: View of the exterior south wall on the eastern side of the Phase I Property showing the waste oil AST (with 4 tires stacked on top of it).

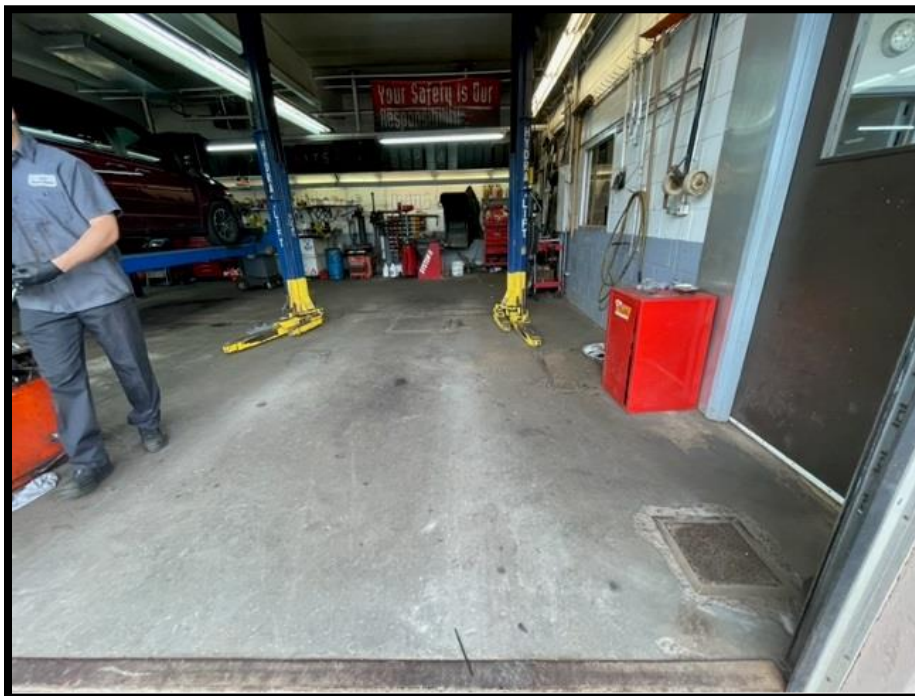
Engine oil, transmission and brake fluids, greasing and degreasing chemicals were noted along the interior south wall stored in properly labelled containers and bins. No potential environmental concerns were noted with storage and handling of chemicals.

Photograph 8: Interior view of the subject building (service garage).

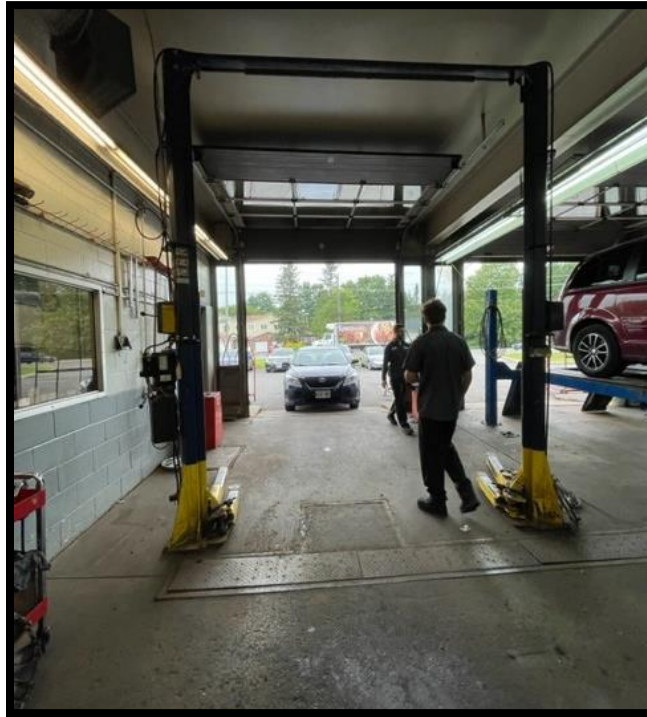
At the time of the site visit, the 3-chamber water-oil separator was noted and in-use, inside the garage. The oil-water separator is emptied on an as-needed-basis by a licenced contractor. Waste oil produced on-site as part of the automotive service garage operation is stored on-site in an (approximately) 800-L capacity AST. The waste-oil AST is situated on the eastern side of the south exterior wall of the subject building. Three service bays with above ground electric hoists were noted as well.

Photograph 9: Interior view of the garage showing the oil-water separator channel.
