# **Phase II Environmental Site Assessment**

2506 Innes Road  
Ottawa, Ontario

Prepared for Concorde Properties

Report: PE6214-2R  
November 29, 2023

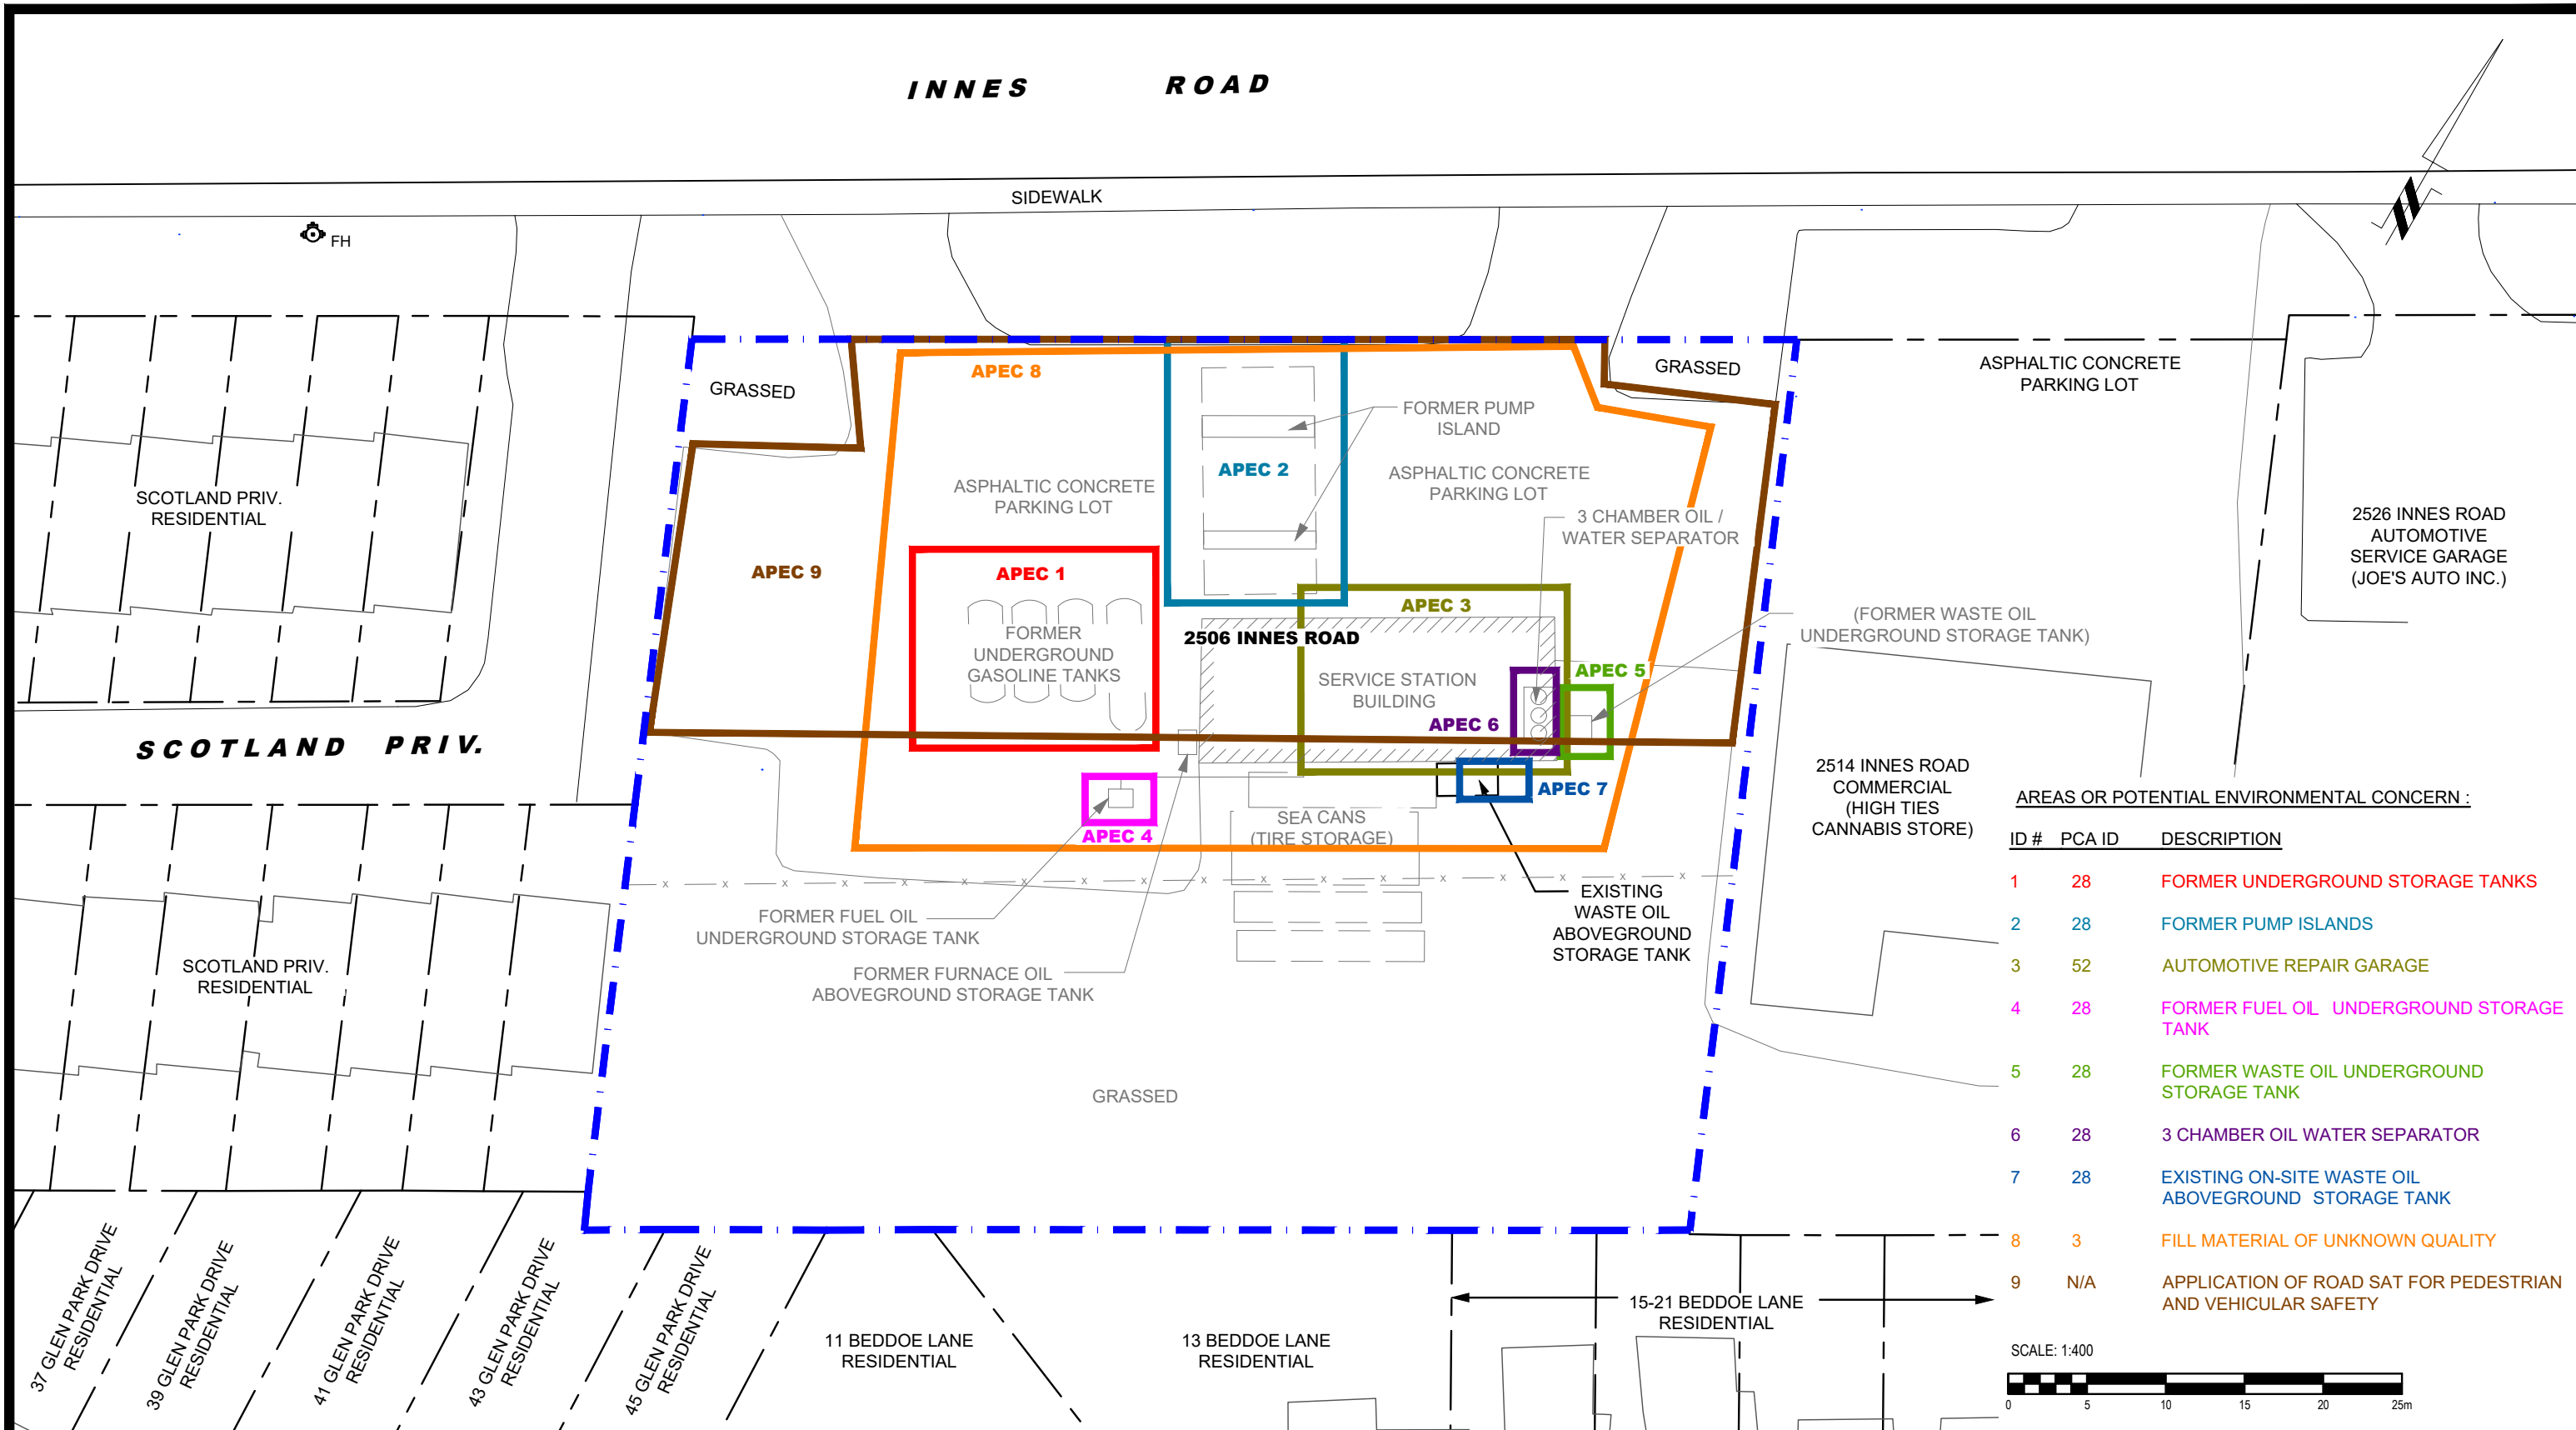
**Drawing PE6214-5R –Soil Remediation Plan**

Based on the findings of this limited subsurface investigation, PHC -F2 contaminated fill material was identified in BH2-23-SS4, from 2.29 to 2.90 mbgs, which was retrieved from the immediate area of the former UST nest. It should be noted that the underlying soil sample from 3.05 to 3.34 mbgs complied with the selected MECP Table 3 Residential Standards.

Contaminated soil/fill material identified in the immediate area of the former UST nest will require remediation of any PHCs in excess of the selected standards as well as any additional soil/fill material containing BTEX and PHCs from the former remediation excavation that may be encountered during the supplemental subsurface program.

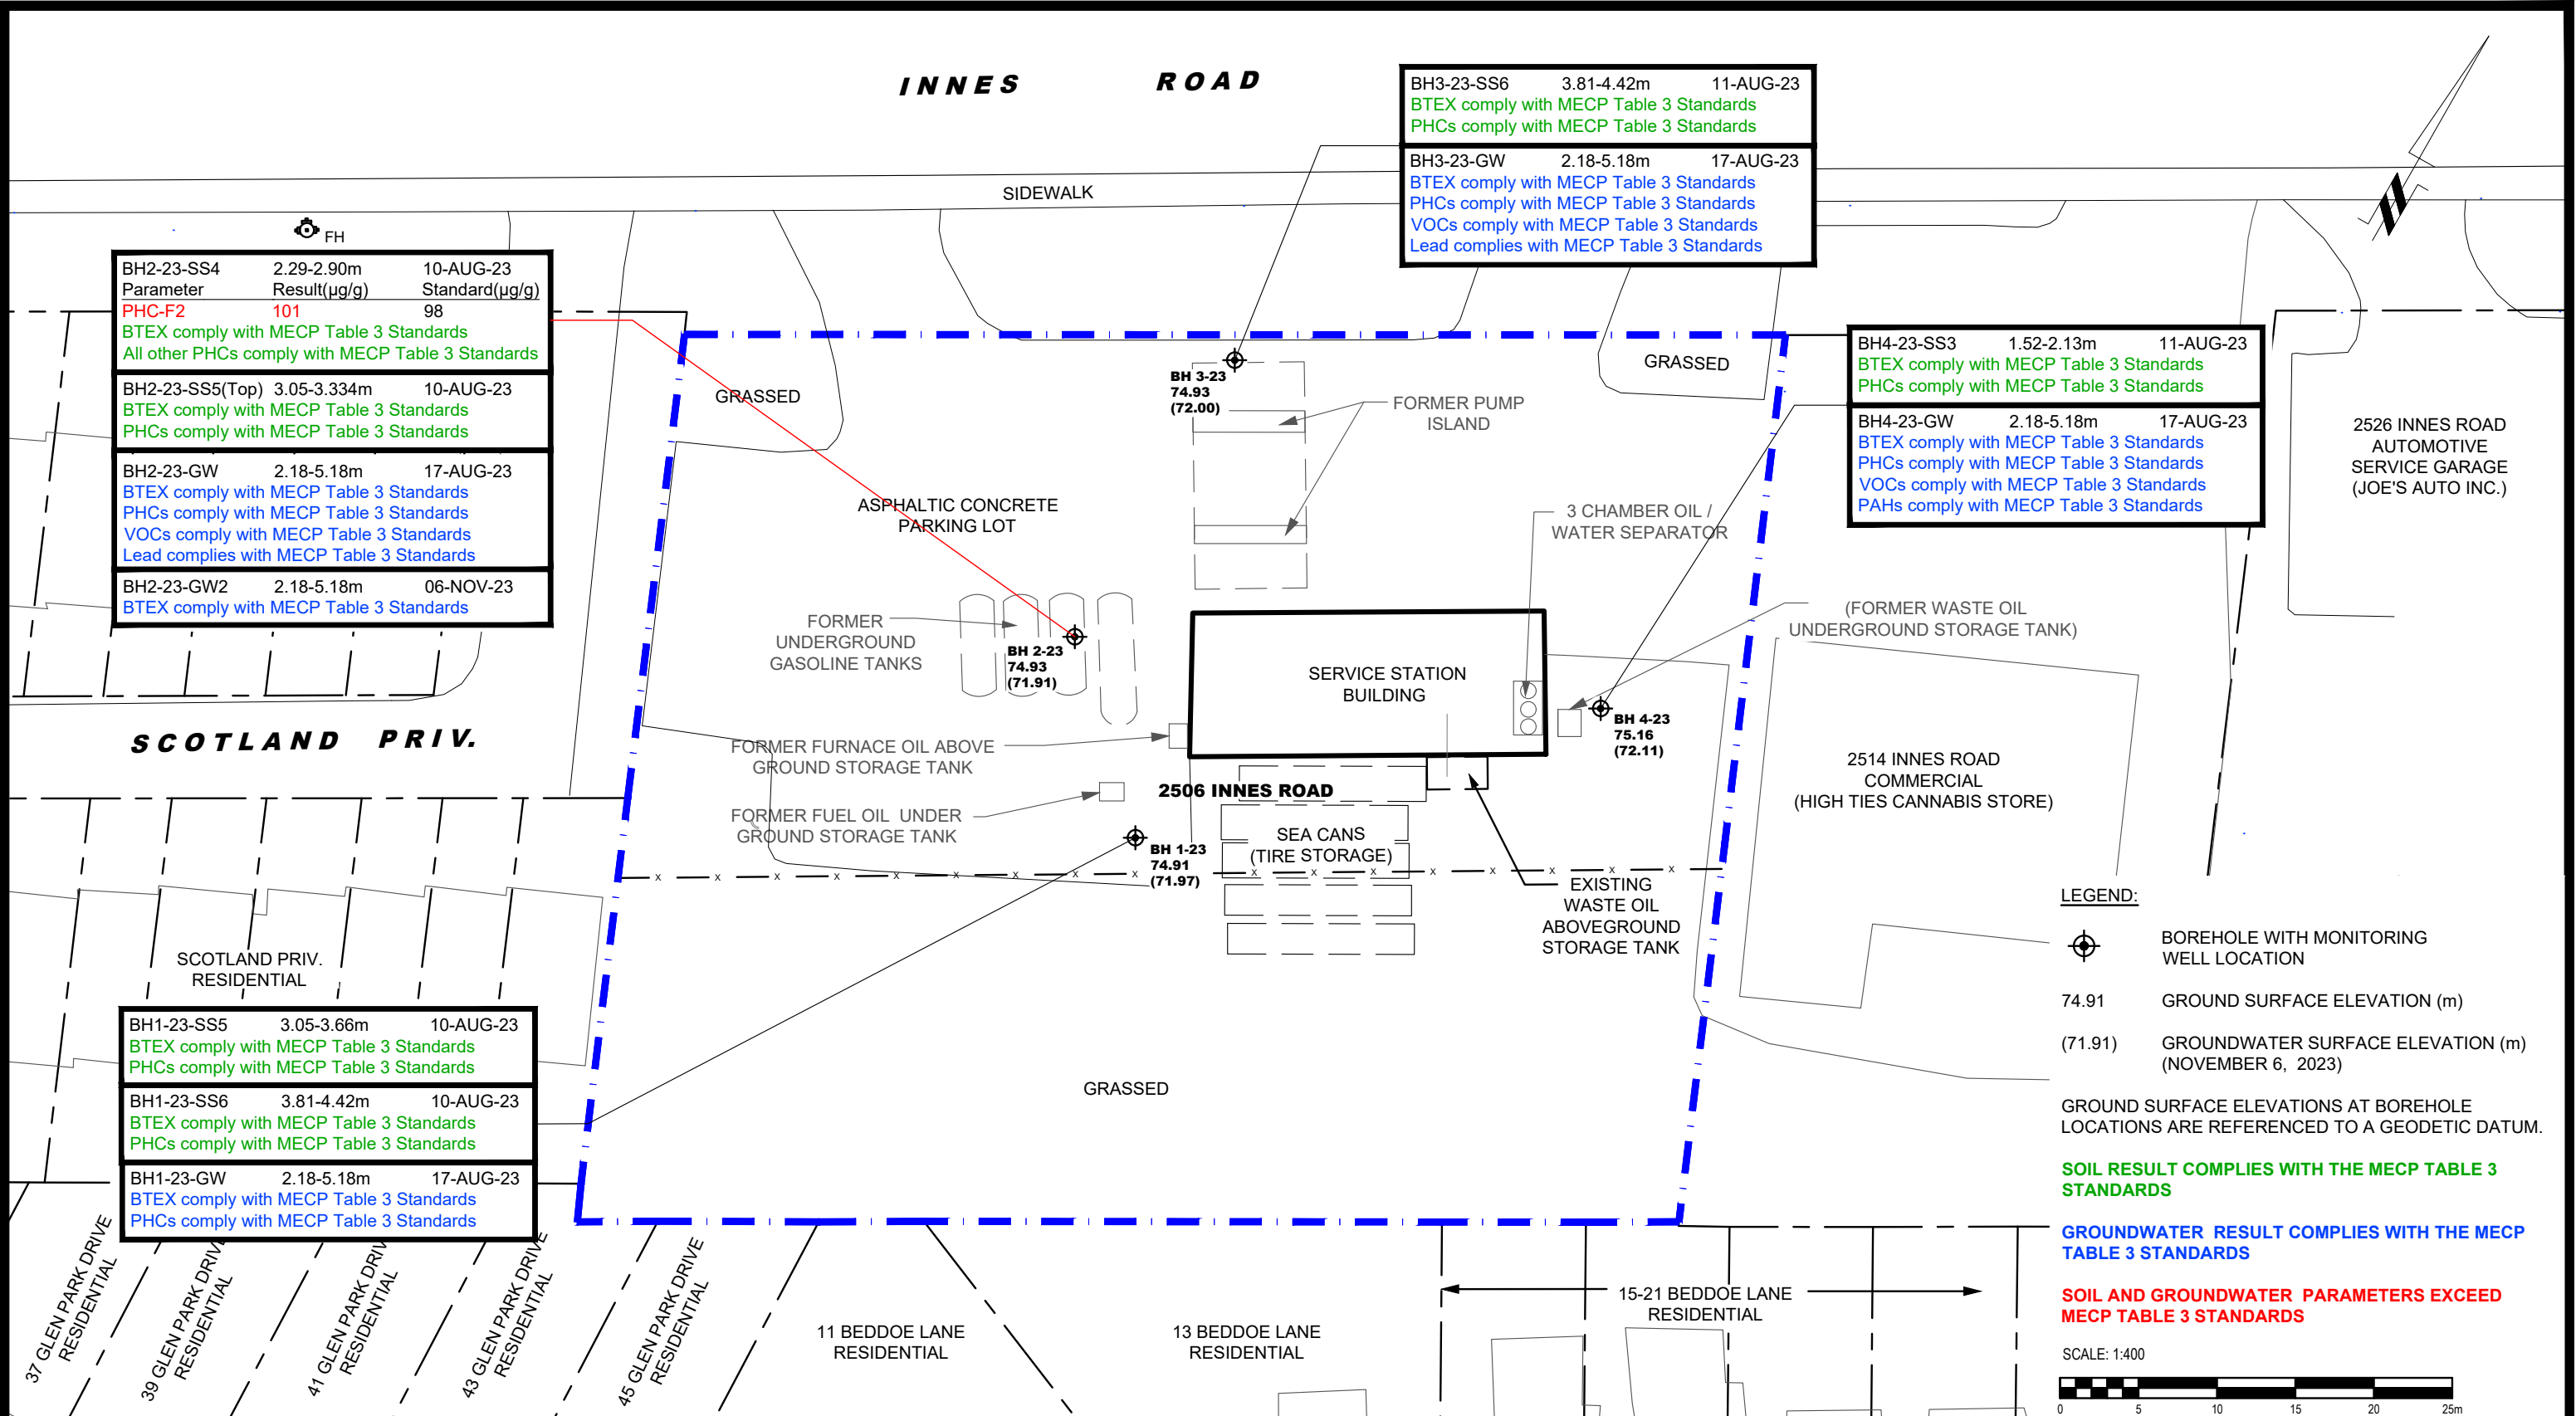
Title: **TEST HOLE LOCATION PLAN**

BH2-23-SS4	2.29-2.90m	10-AUG-23
Parameter	Result(µg/g)	Standard(µg/g)
PHC-F2	101	98
BTEX comply with MECP Table 3 Standards		
All other PHCs comply with MECP Table 3 Standards		
BH2-23-SS5(Top)	3.05-3.334m	10-AUG-23
BTEX comply with MECP Table 3 Standards		
PHCs comply with MECP Table 3 Standards		
BH2-23-GW	2.18-5.18m	17-AUG-23
BTEX comply with MECP Table 3 Standards		
PHCs comply with MECP Table 3 Standards		
VOCs comply with MECP Table 3 Standards		
Lead complies with MECP Table 3 Standards		
BH2-23-GW2	2.18-5.18m	06-NOV-23
BTEX comply with MECP Table 3 Standards

BH3-23-SS6	3.81-4.42m	11-AUG-23
BTEX comply with MECP Table 3 Standards		
PHCs comply with MECP Table 3 Standards		
BH3-23-GW	2.18-5.18m	17-AUG-23
BTEX comply with MECP Table 3 Standards		
PHCs comply with MECP Table 3 Standards		
VOCs comply with MECP Table 3 Standards		
Lead complies with MECP Table 3 Standards

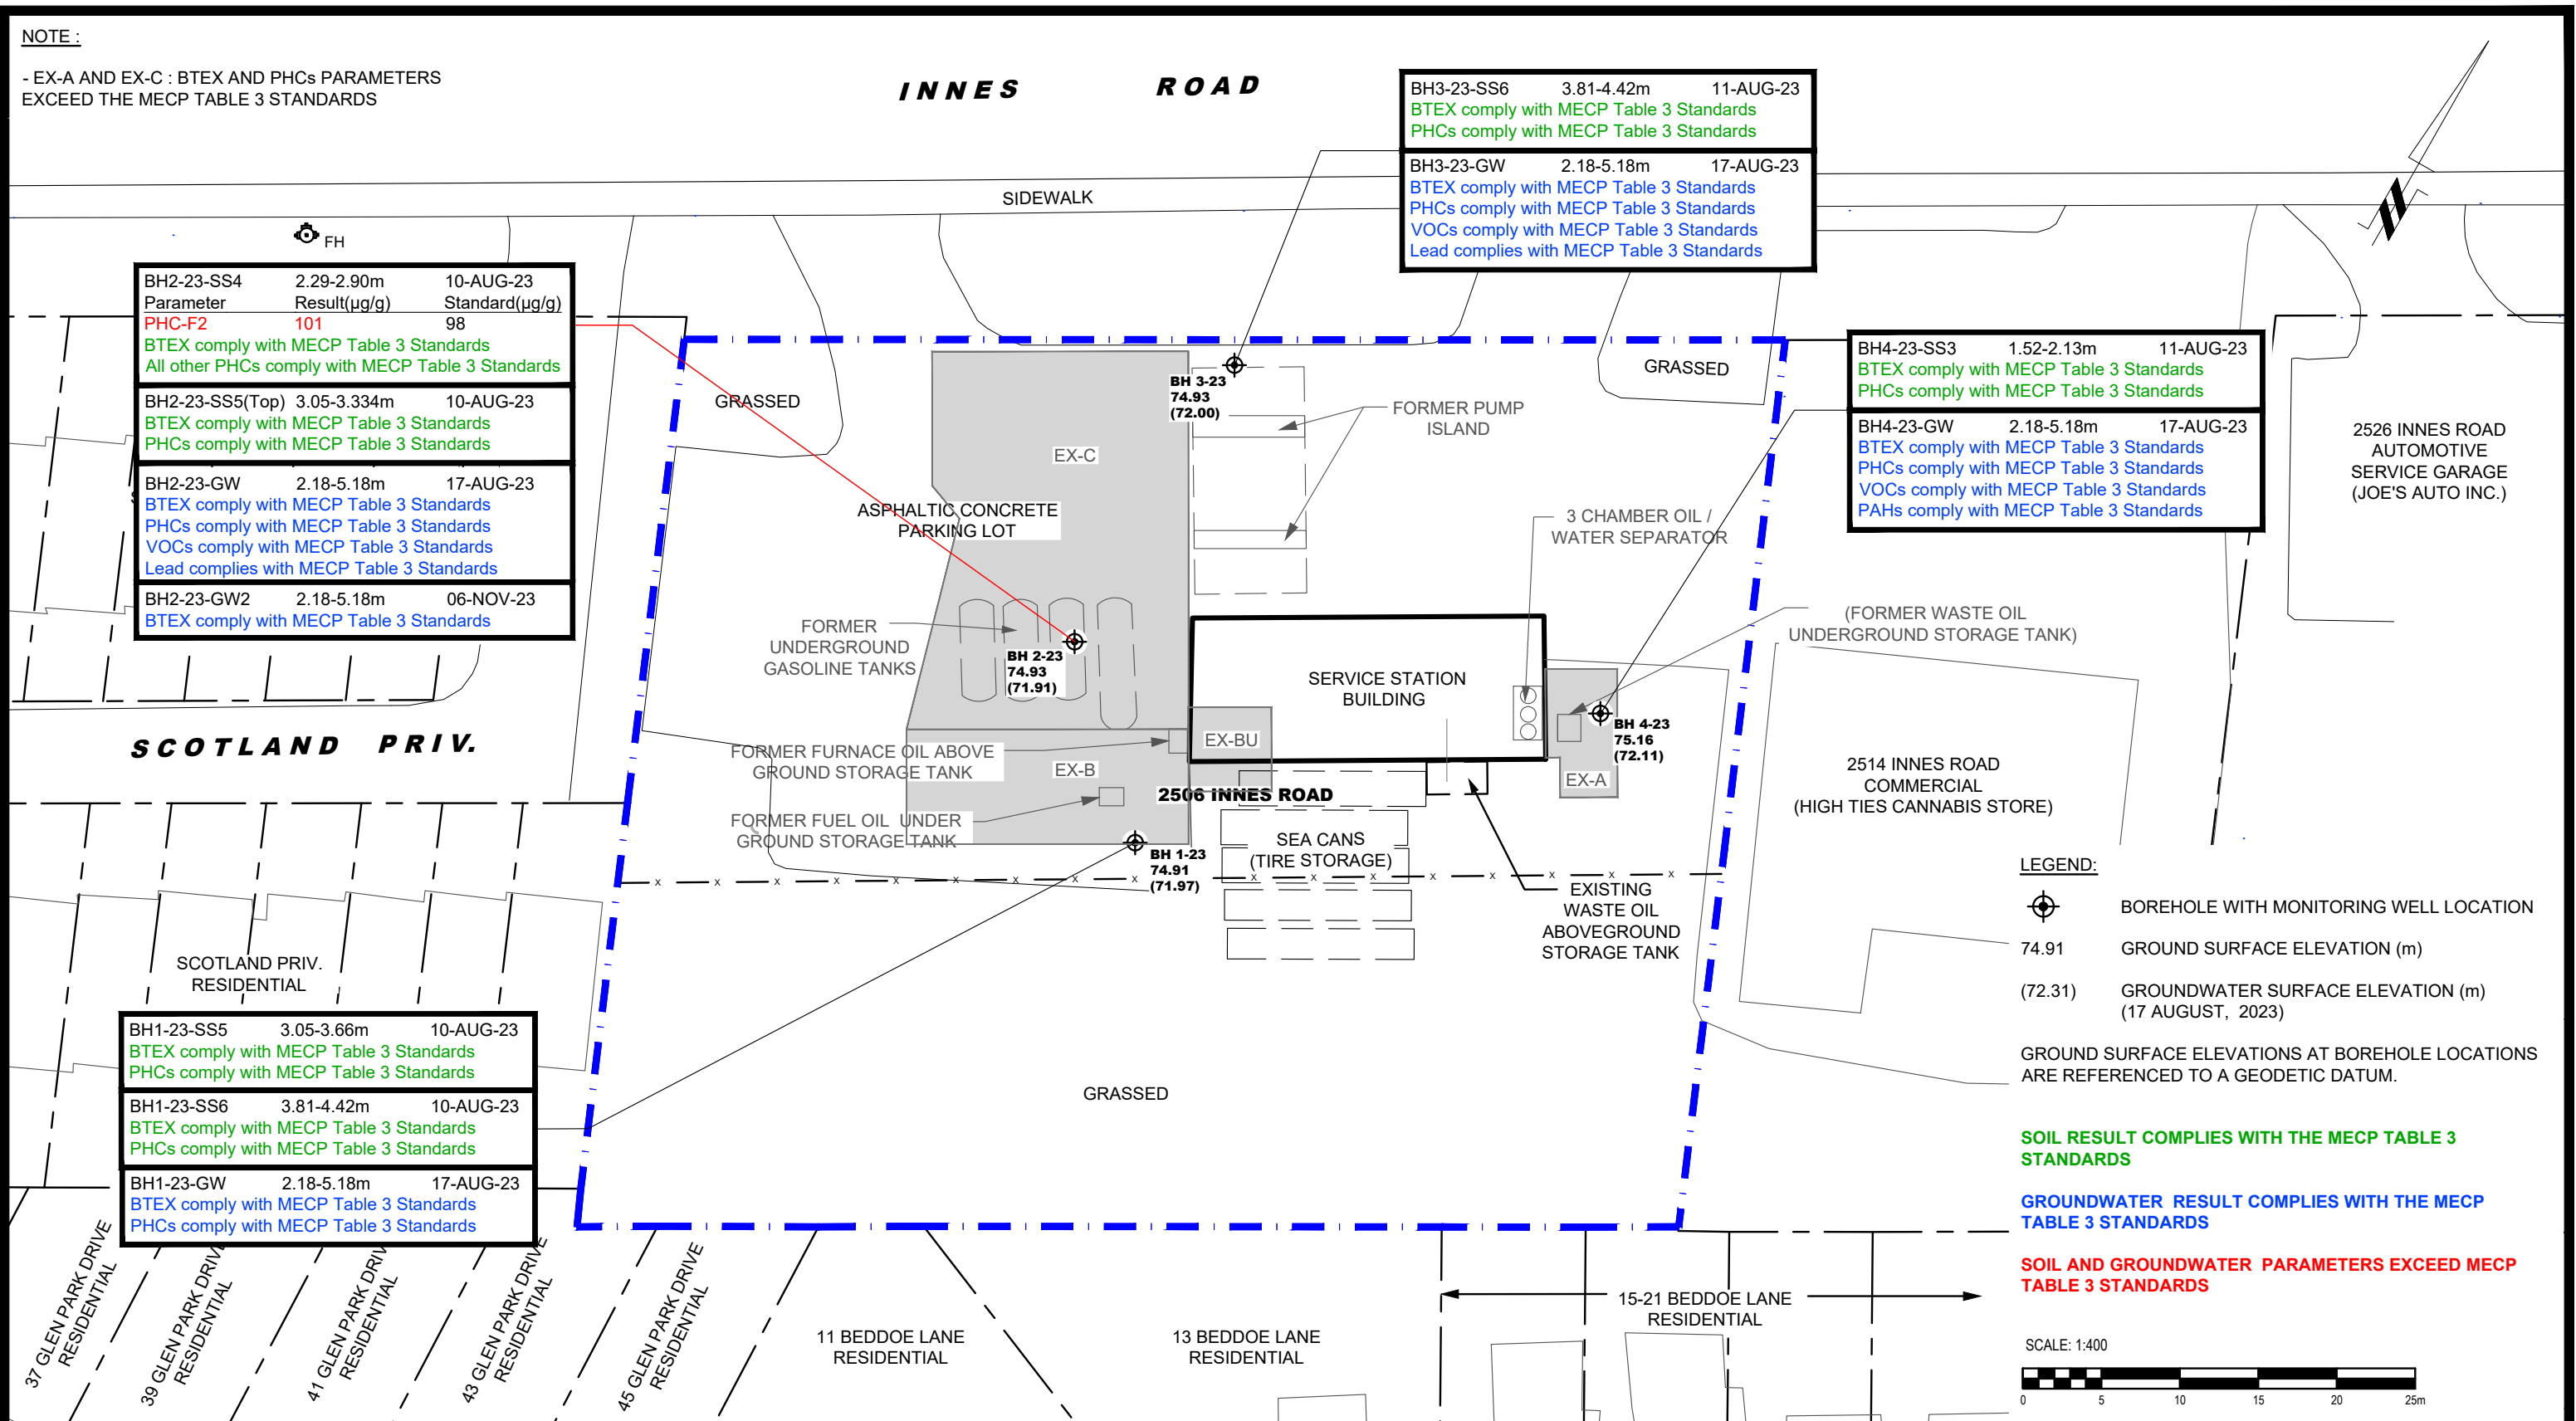
- EX-A AND EX-C : BTEX AND PHCs PARAMETERS EXCEED THE MECP TABLE 3 STANDARDS

BH2-23-SS4	2.29-2.90m	10-AUG-23
Parameter	Result(µg/g)	Standard(µg/g)
PHC-F2	101	98
BTEX comply with MECP Table 3 Standards		
All other PHCs comply with MECP Table 3 Standards		
BH2-23-SS5(Top)	3.05-3.334m	10-AUG-23
BTEX comply with MECP Table 3 Standards		
PHCs comply with MECP Table 3 Standards		
BH2-23-GW	2.18-5.18m	17-AUG-23
BTEX comply with MECP Table 3 Standards		
PHCs comply with MECP Table 3 Standards		
VOCs comply with MECP Table 3 Standards		
Lead complies with MECP Table 3 Standards		
BH2-23-GW2	2.18-5.18m	06-NOV-23
BTEX comply with MECP Table 3 Standards

BH3-23-SS6	3.81-4.42m	11-AUG-23
BTEX comply with MECP Table 3 Standards		
PHCs comply with MECP Table 3 Standards		
BH3-23-GW	2.18-5.18m	17-AUG-23
BTEX comply with MECP Table 3 Standards		
PHCs comply with MECP Table 3 Standards		
VOCs comply with MECP Table 3 Standards		
Lead complies with MECP Table 3 Standards

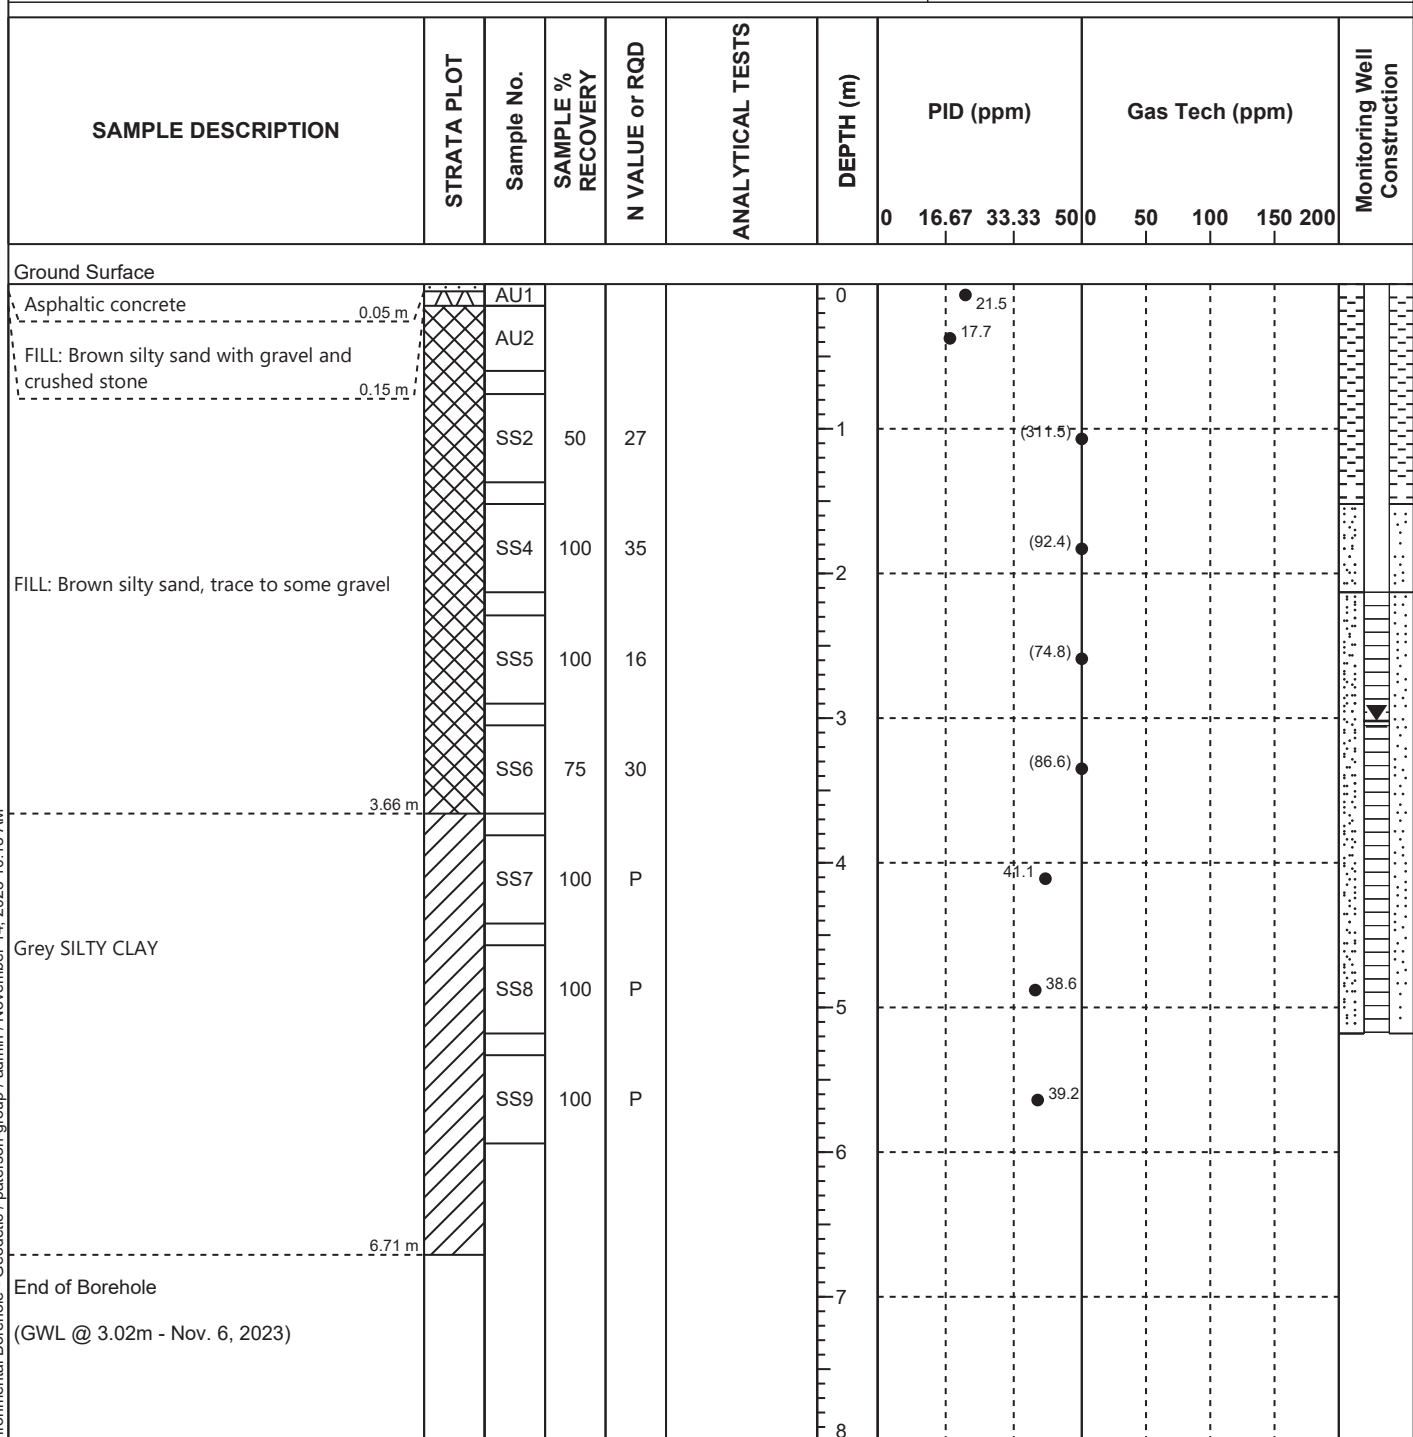
DATUM: Geodetic	EASTING:	NORTHING:	ELEVATION:
PROJECT: Phase II - Environmental Site Assessment		FILE NO. <b>PE6214</b>	
BORINGS BY: CME Low Clearance Drill		HOLE NO. BH 2-23	
REMARKS:		DATE: August 10, 2023

Olfactory odours and some staining were observed in all of the boreholes, except BH1-23, at depths ranging from 0.76 to 3.81 m below the ground surface (mbgs) at during the field program.
